## Profile/Photo Observation Report

Street:	<b>Norris</b>	Flow Control:	<b>Not Controlled</b>
City:	<b>Hobart, IN</b>	Year Renewed:	
Location:	<b>Sidewalk</b>	Tape/Media #:	
Purpose:	<b>Maintenance Related</b>	Dia/Height:	<b>8"</b>
Use:	<b>Sanitary</b>	Material:	<b>PVC</b>
Drain Area:	<b>NA</b>	Lining:	
Category:	<b>NA</b>		
Comment:	<b>Flow direction wrong.</b>

Location Details:		Direction of Survey:	<b>Downstream</b>
US MH:	<b>M-910-009</b>	DS MH:	<b>M-910-010</b>
		Total Length Surveyed (ft):	<b>82.1</b>

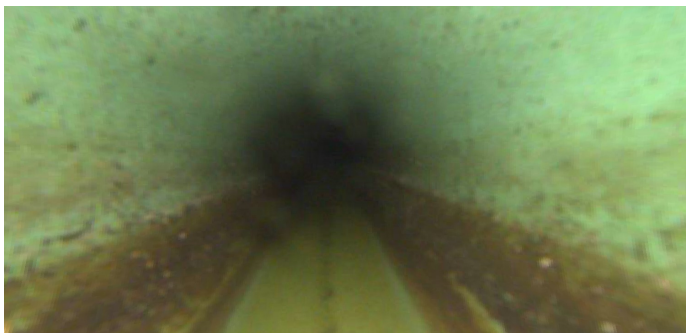
Code: **AMH**  
Description: **Manhole**

Distance (ft): **.0**  
Structural Grade: **0**  
O&M Grade: **0**  
Clock Start/From:  
Clock To:  
1st Value:  
2nd Value:  
Value Percent:  
Continuous Index:  
Within 8" of Joint: **NO**  
Remarks: **M-910-009**

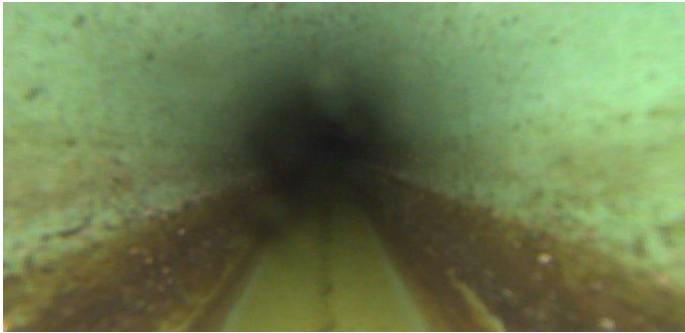
Code:	<b>MWL</b>
Description:	<b>Water Level</b>

Distance (ft):	<b>.0</b>
Structural Grade:	<b>0</b>
O&M Grade:	<b>0</b>
Clock Start/From:	
Clock To:	
1st Value:	
2nd Value:	
Value Percent:	<b>5.000</b>
Continuous Index:	
Within 8" of Joint:	<b>NO</b>
Remarks:

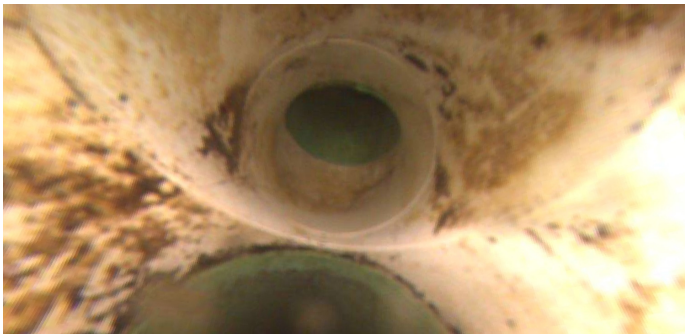
Code:	<b>TF</b>
Description:	<b>Tap Factory</b>

Distance (ft):	<b>5.8</b>
Structural Grade:	<b>0</b>
O&M Grade:	<b>0</b>
Clock Start/From:	<b>12</b>
Clock To:	
1st Value:	<b>4.000</b>
2nd Value:	
Value Percent:	
Continuous Index:	
Within 8" of Joint:	<b>YES</b>
Remarks:

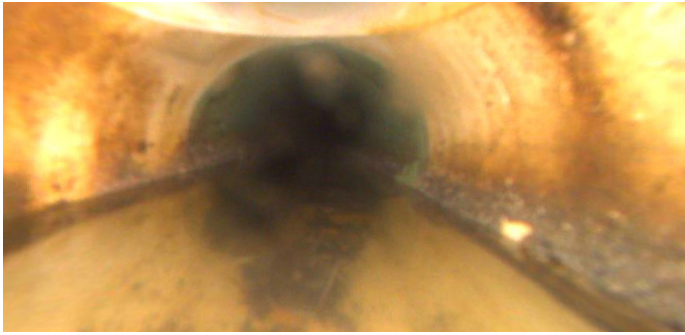
Code: **MWL**  
Description: **Water Level**

Distance (ft): **63.0**  
Structural Grade: **0**  
O&M Grade: **0**  
Clock Start/From:  
Clock To:  
1st Value:  
2nd Value:  
Value Percent: **30.000**  
Continuous Index:  
Within 8" of Joint: **NO**  
Remarks:

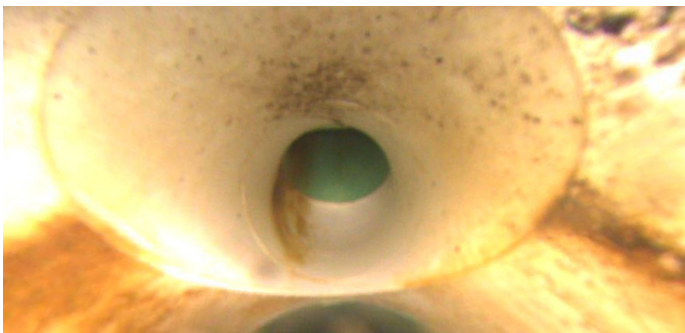
Code: **TF**  
Description: **Tap Factory**

Distance (ft): **63.1**  
Structural Grade: **0**  
O&M Grade: **0**  
Clock Start/From: **12**  
Clock To:  
1st Value: **4.000**  
2nd Value:  
Value Percent:  
Continuous Index:  
Within 8" of Joint:  
Remarks:

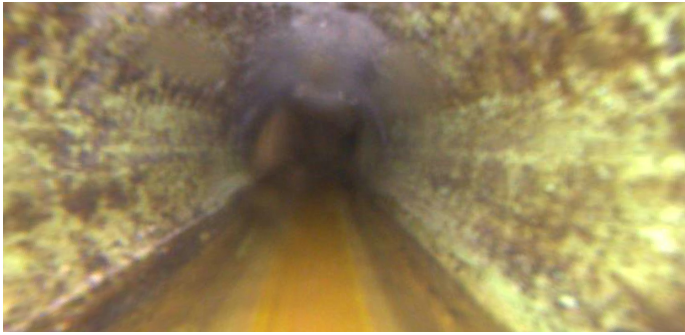
Code: **MWL**  
Description: **Water Level**

Distance (ft): **78.4**  
Structural Grade: **0**  
O&M Grade: **0**  
Clock Start/From:  
Clock To:  
1st Value:  
2nd Value:  
Value Percent: **10.000**  
Continuous Index:  
Within 8" of Joint: **NO**  
Remarks:

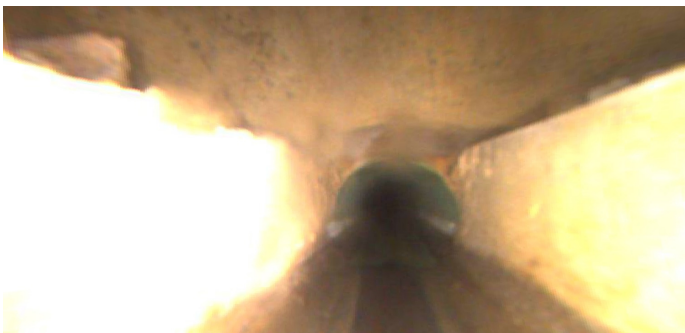
Code: **AMH**  
Description: **Manhole**

Distance (ft): **82.1**  
Structural Grade: **0**  
O&M Grade: **0**  
Clock Start/From:  
Clock To:  
1st Value:  
2nd Value:  
Value Percent:  
Continuous Index:  
Within 8" of Joint: **NO**  
Remarks: **M-910-010**
