## Profile/Photo Observation Report

Street:	<b>NORRIS DR</b>	Flow Control:	<b>Not Controlled</b>
City:	<b>Hobart, IN</b>	Year Renewed:	
Location:	<b>Sidewalk</b>	Tape/Media #:	
Purpose:	<b>Maintenance Related</b>	Dia/Height:	<b>8"</b>
Use:	<b>Sanitary</b>	Material:	<b>PVC</b>
Drain Area:	<b>NA</b>	Lining:	
Category:	<b>NA</b>		
Comment:	<b>Flow direction wrong.</b>

Location Details:		Direction of Survey:	<b>Downstream</b>
US MH:	<b>M-910-009</b>	DS MH:	<b>M-910-024</b>
		Total Length Surveyed (ft):	<b>59.3</b>

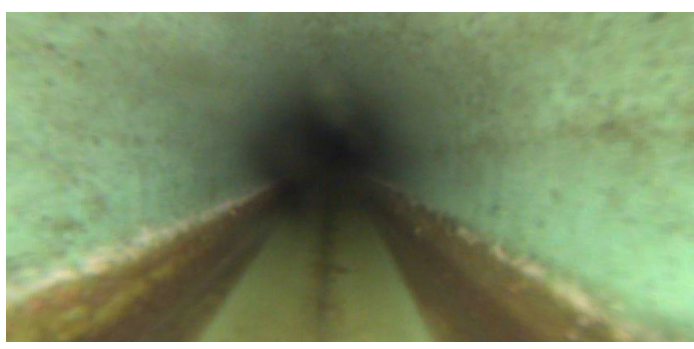
Code: **AMH**  
Description: **Manhole**

Distance (ft): **.0**  
Structural Grade: **0**  
O&M Grade: **0**  
Clock Start/From:  
Clock To:  
1st Value:  
2nd Value:  
Value Percent:  
Continuous Index:  
Within 8" of Joint: **NO**  
Remarks: **M-910-009**

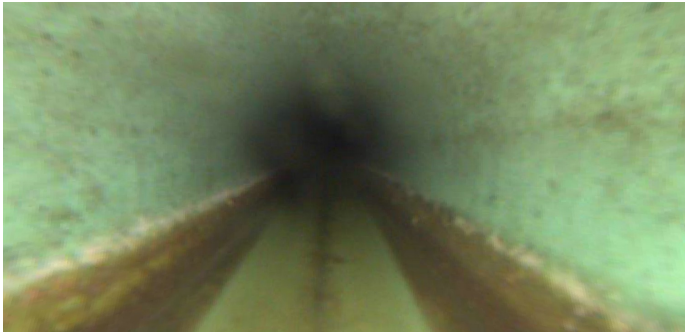
Code:	<b>MWL</b>
Description:	<b>Water Level</b>

Distance (ft):	<b>.0</b>
Structural Grade:	<b>0</b>
O&M Grade:	<b>0</b>
Clock Start/From:	
Clock To:	
1st Value:	
2nd Value:	
Value Percent:	<b>5.000</b>
Continuous Index:	
Within 8" of Joint:	<b>NO</b>
Remarks:

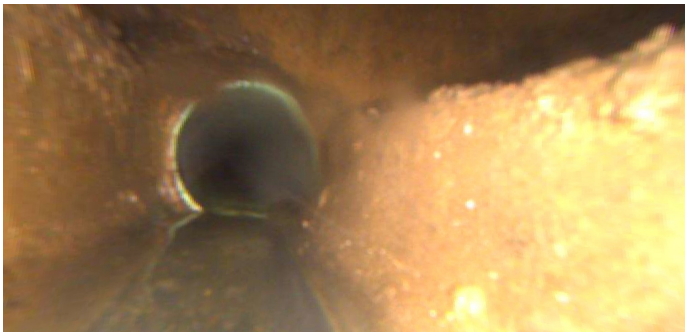
Code:	<b>AMH</b>
Description:	<b>Manhole</b>

Distance (ft):	<b>59.3</b>
Structural Grade:	<b>0</b>
O&M Grade:	<b>0</b>
Clock Start/From:	
Clock To:	
1st Value:	
2nd Value:	
Value Percent:	
Continuous Index:	
Within 8" of Joint:	<b>NO</b>
Remarks:	<b>M-910-024</b>
