Profile/Photo Observation Report

Street:	NORRIS DR	Flow Control:	Not Controlled
City:	Hobart, IN	Year Renewed:	
Location:	Sidewalk	Tape/Media #:	
Purpose:	Maintenance Related	Dia/Height:	8"
Use:	Sanitary	Material:	PVC
Drain Area:	NA	Lining:	
Category:	NA		
Comment:	Flow direction wrong.

Location Details:		Direction of Survey:	Upstream
US MH:	M-910-010	DS MH:	M-910-011
		Total Length Surveyed (ft):	83.5

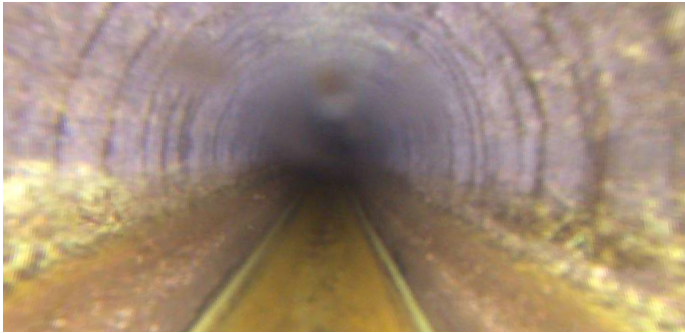
Code:	MWL
Description:	Water Level

Distance (ft):	.0
Structural Grade:	0
O&M Grade:	0
Clock Start/From:	
Clock To:	
1st Value:	
2nd Value:	
Value Percent:	5.000
Continuous Index:	
Within 8" of Joint:	NO
Remarks:

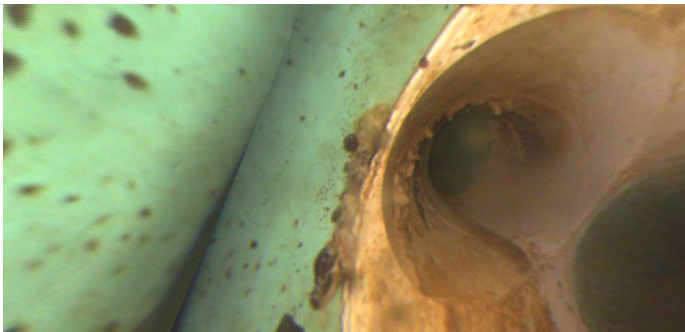
Code:	TF
Description:	Tap Factory

Distance (ft):	50.1
Structural Grade:	0
O&M Grade:	0
Clock Start/From:	2
Clock To:	
1st Value:	4.000
2nd Value:	
Value Percent:	
Continuous Index:	
Within 8" of Joint:	YES
Remarks:

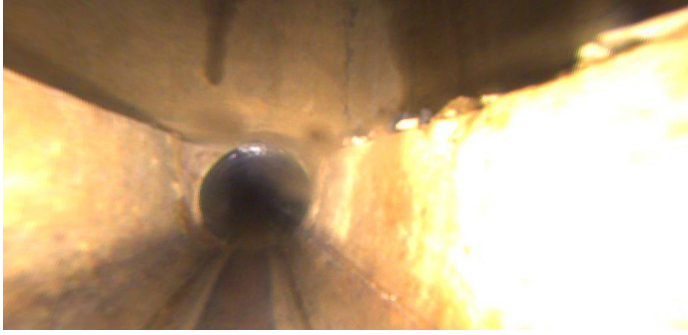
Code:	AMH
Description:	Manhole
Distance (ft):	83.5
Structural Grade:	0
O&M Grade:	0
Clock Start/From:	
Clock To:	
1st Value:	
2nd Value:	
Value Percent:	
Continuous Index:	
Within 8" of Joint:	NO
Remarks:	M-910-010
