Profile/Photo Observation Report

Street:	NORRIS DR	Flow Control:	Not Controlled
City:	Hobart, IN	Year Renewed:	
Location:	Sidewalk	Tape/Media #:	
Purpose:	Maintenance Related	Dia/Height:	8"
Use:	Sanitary	Material:	PVC
Drain Area:	NA	Lining:	
Category:	NA		
Comment:	Flow direction wrong.

Location Details:		Direction of Survey:	Downstream
US MH:	M-910-011	DS MH:	M-910-012
		Total Length Surveyed (ft):	85.5

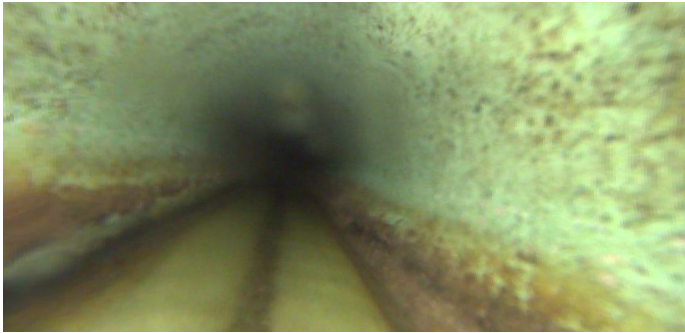
Code:	MWL
Description:	Water Level

Distance (ft):	.0
Structural Grade:	0
O&M Grade:	0
Clock Start/From:	
Clock To:	
1st Value:	
2nd Value:	
Value Percent:	5.000
Continuous Index:	
Within 8" of Joint:	NO
Remarks:

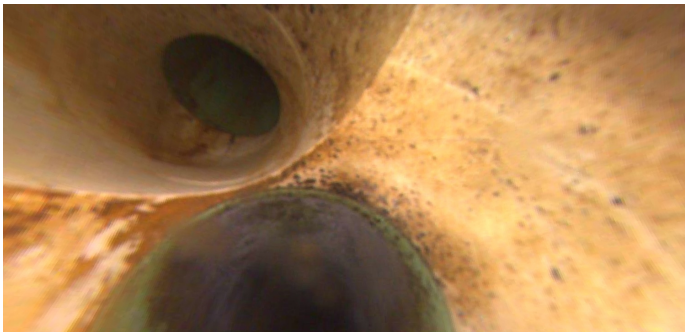
Code:	TF
Description:	Tap Factory

Distance (ft):	67.2
Structural Grade:	0
O&M Grade:	0
Clock Start/From:	11
Clock To:	
1st Value:	4.000
2nd Value:	
Value Percent:	
Continuous Index:	
Within 8" of Joint:	YES
Remarks:

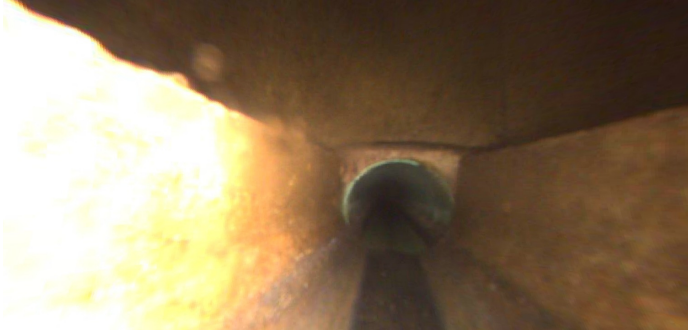
Code:	AMH
Description:	Manhole
Distance (ft):	84.4
Structural Grade:	0
O&M Grade:	0
Clock Start/From:	
Clock To:	
1st Value:	
2nd Value:	
Value Percent:	
Continuous Index:	
Within 8" of Joint:	NO
Remarks:	M-910-012
