Profile/Photo Observation Report

Date:	03/28/2018	Weather:		Coding:	PACP 6.0
Pipe Length (ft):	91.1	Owner:	NA	Pre Clean:	Not Known
P.O.#:		Surveyor:	Selasie Honu	PSR:	P-910-014-013
Customer:		Clean Date:	01/01/1900	Shape:	C

Street:	NORRIS DR	Flow Control:	Not Controlled
City:	Hobart, IN	Year Renewed:	
Location:	Sidewalk	Tape/Media #:	
Purpose:	Maintenance Related	Dia/Height:	8"
Use:	Sanitary	Material:	PVC
Drain Area:	NA	Lining:	
Category:	NA		
Comment:	Flow direction wrong.

Location Details:		Direction of Survey:	Downstream
US MH:	M-910-013	DS MH:	M-910-014
		Total Length Surveyed (ft):	89.0

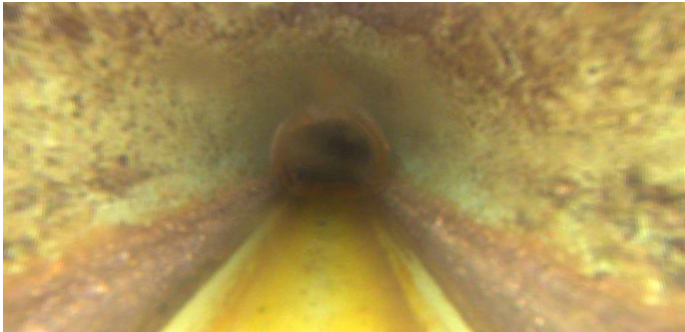
Code:	MWL
Description:	Water Level

Distance (ft):	.0
Structural Grade:	0
O&M Grade:	0
Clock Start/From:	
Clock To:	
1st Value:	
2nd Value:	
Value Percent:	5.000
Continuous Index:	
Within 8" of Joint:	NO
Remarks:

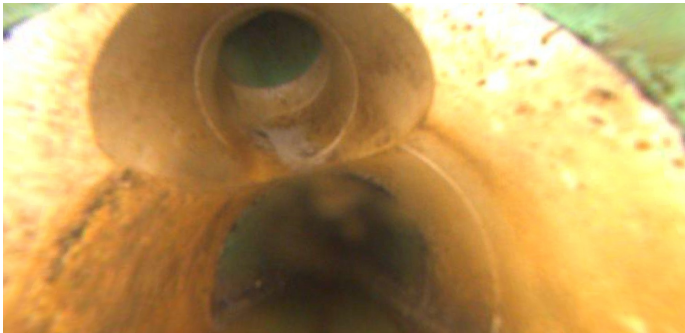
Code:	TF
Description:	Tap Factory

Distance (ft):	2.4
Structural Grade:	0
O&M Grade:	0
Clock Start/From:	12
Clock To:	
1st Value:	4.000
2nd Value:	
Value Percent:	
Continuous Index:	
Within 8" of Joint:	
Remarks:

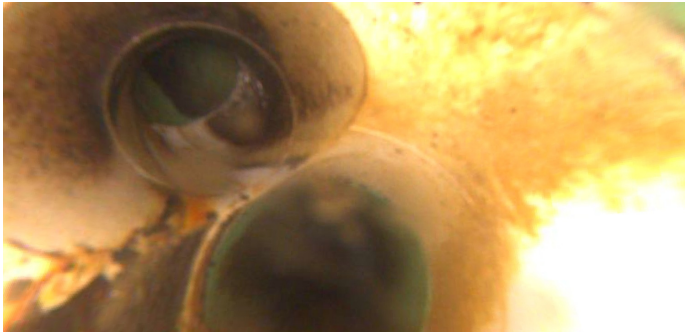
Code: **TF**
Description: **Tap Factory**

Distance (ft): **66.1**
Structural Grade: **0**
O&M Grade: **0**
Clock Start/From: **10**
Clock To:
1st Value: **4.000**
2nd Value:
Value Percent:
Continuous Index:
Within 8" of Joint:
Remarks:

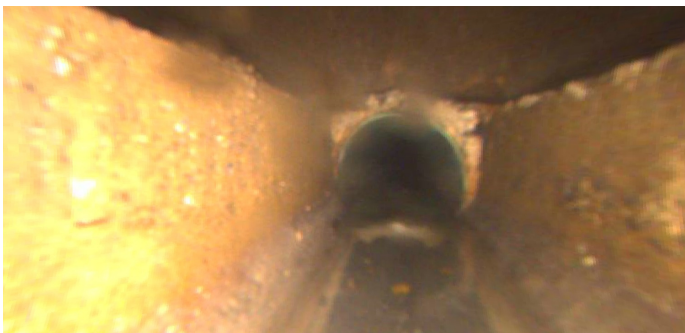
Code: **AMH**
Description: **Manhole**

Distance (ft): **89.0**
Structural Grade: **0**
O&M Grade: **0**
Clock Start/From:
Clock To:
1st Value:
2nd Value:
Value Percent:
Continuous Index:
Within 8" of Joint: **NO**
Remarks: **M-910-014**
