## Profile/Photo Observation Report

Street:	<b>NORRIS DR</b>	Flow Control:	<b>Not Controlled</b>
City:	<b>Hobart, IN</b>	Year Renewed:	
Location:	<b>Sidewalk</b>	Tape/Media #:	
Purpose:	<b>Maintenance Related</b>	Dia/Height:	<b>8"</b>
Use:	<b>Sanitary</b>	Material:	<b>PVC</b>
Drain Area:	<b>NA</b>	Lining:	
Category:	<b>NA</b>		
Comment:	<b>Flow direction wrong.</b>

Location Details:		Direction of Survey:	<b>Downstream</b>
US MH:	<b>M-910-015</b>	DS MH:	<b>M-910-016</b>
		Total Length Surveyed (ft):	<b>87.7</b>

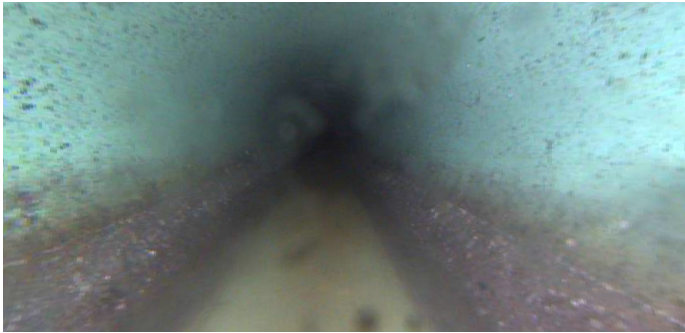
Code:	<b>MWL</b>
Description:	<b>Water Level</b>

Distance (ft):	<b>.0</b>
Structural Grade:	<b>0</b>
O&M Grade:	<b>0</b>
Clock Start/From:	
Clock To:	
1st Value:	
2nd Value:	
Value Percent:	<b>5.000</b>
Continuous Index:	
Within 8" of Joint:	<b>NO</b>
Remarks:

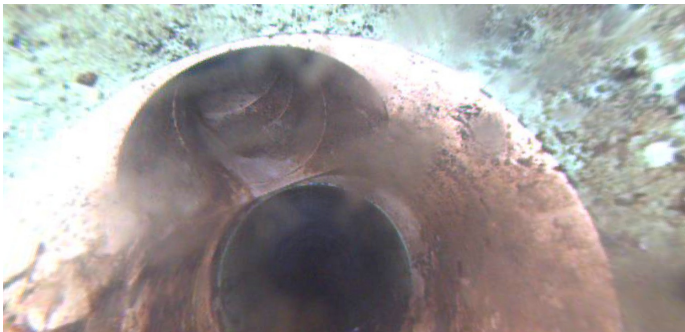
Code:	<b>TF</b>
Description:	<b>Tap Factory</b>

Distance (ft):	<b>27.0</b>
Structural Grade:	<b>0</b>
O&M Grade:	<b>0</b>
Clock Start/From:	<b>11</b>
Clock To:	
1st Value:	<b>4.000</b>
2nd Value:	
Value Percent:	
Continuous Index:	
Within 8" of Joint:	
Remarks:

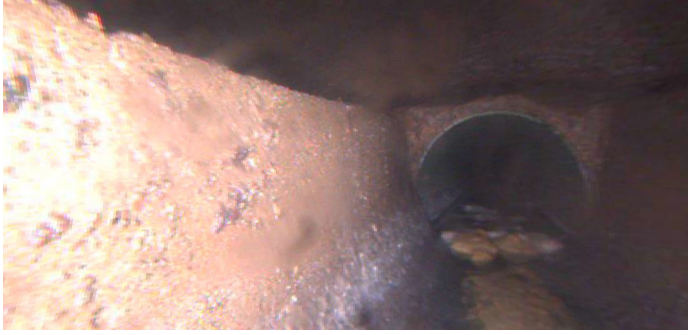
Code:	<b>AMH</b>
Description:	<b>Manhole</b>
Distance (ft):	<b>87.7</b>
Structural Grade:	<b>0</b>
O&M Grade:	<b>0</b>
Clock Start/From:	
Clock To:	
1st Value:	
2nd Value:	
Value Percent:	
Continuous Index:	
Within 8" of Joint:	<b>NO</b>
Remarks:	<b>M-910-016</b>
