Profile/Photo Observation Report

Date:	03/28/2018	Weather:		Coding:	PACP 6.0
Pipe Length (ft):	94.4	Owner:	NA	Pre Clean:	Not Known
P.O.#:		Surveyor:	Selasie Honu	PSR:	P-910-016-015
Customer:		Clean Date:	01/01/1900	Shape:	C

Street:	Norris	Flow Control:	Not Controlled
City:	Hobart, IN	Year Renewed:	
Location:	Sidewalk	Tape/Media #:	
Purpose:	Maintenance Related	Dia/Height:	8"
Use:	Sanitary	Material:	PVC
Drain Area:	NA	Lining:	
Category:	NA		
Comment:	Flow direction wrong.

Location Details:		Direction of Survey:	Downstream
US MH:	M-910-015	DS MH:	M-910-016
		Total Length Surveyed (ft):	87.7

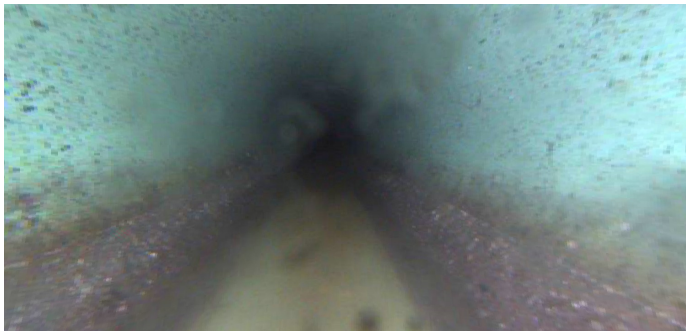
Code: **AMH**
Description: **Manhole**

Distance (ft): **.0**
Structural Grade: **0**
O&M Grade: **0**
Clock Start/From:
Clock To:
1st Value:
2nd Value:
Value Percent:
Continuous Index:
Within 8" of Joint: **NO**
Remarks: **M-910-015**

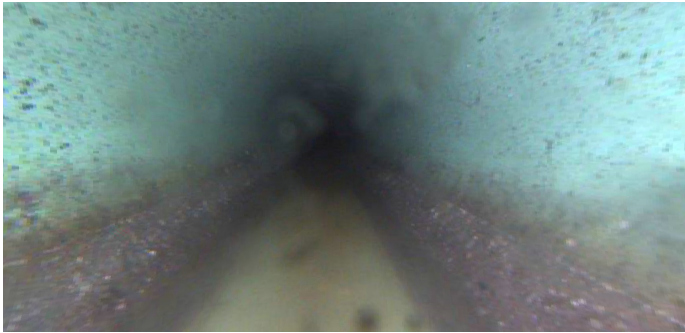
Code:	MWL
Description:	Water Level

Distance (ft):	.0
Structural Grade:	0
O&M Grade:	0
Clock Start/From:	
Clock To:	
1st Value:	
2nd Value:	
Value Percent:	5.000
Continuous Index:	
Within 8" of Joint:	NO
Remarks:

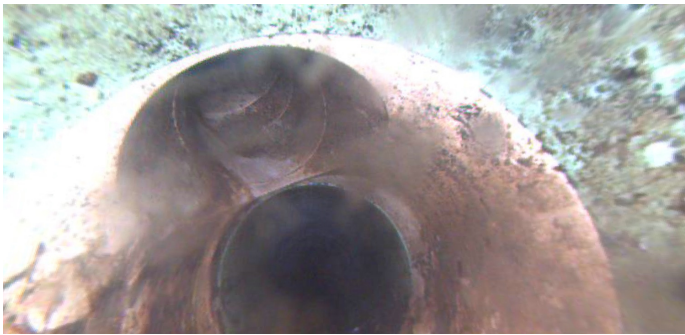
Code:	TF
Description:	Tap Factory

Distance (ft):	27.0
Structural Grade:	0
O&M Grade:	0
Clock Start/From:	11
Clock To:	
1st Value:	4.000
2nd Value:	
Value Percent:	
Continuous Index:	
Within 8" of Joint:	
Remarks:

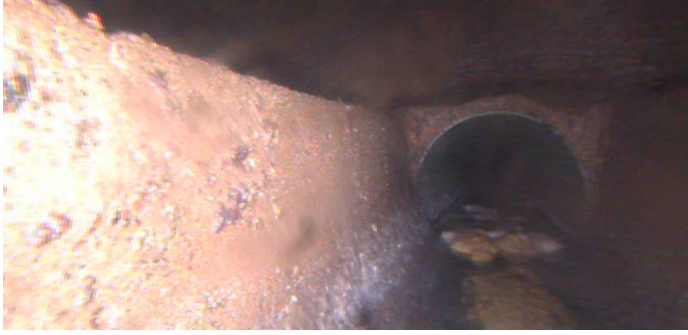
Code:	AMH
Description:	Manhole
Distance (ft):	87.7
Structural Grade:	0
O&M Grade:	0
Clock Start/From:	
Clock To:	
1st Value:	
2nd Value:	
Value Percent:	
Continuous Index:	
Within 8" of Joint:	NO
Remarks:	M-910-016
