Profile/Photo Observation Report

Date:	03/28/2018	Weather:		Coding:	PACP 6.0
Pipe Length (ft):	135.9	Owner:	NA	Pre Clean:	Not Known
P.O.#:		Surveyor:	Selasie Honu	PSR:	P-910-018-017
Customer:		Clean Date:	01/01/1900	Shape:	C

Street:	NORRIS DR	Flow Control:	Not Controlled
City:	Hobart, IN	Year Renewed:	
Location:	Sidewalk	Tape/Media #:	
Purpose:	Maintenance Related	Dia/Height:	8"
Use:	Sanitary	Material:	PVC
Drain Area:	NA	Lining:	
Category:	NA		
Comment:	Flow direction wrong.

Location Details:		Direction of Survey:	Downstream
US MH:	M-910-017	DS MH:	M-910-018
		Total Length Surveyed (ft):	129.3

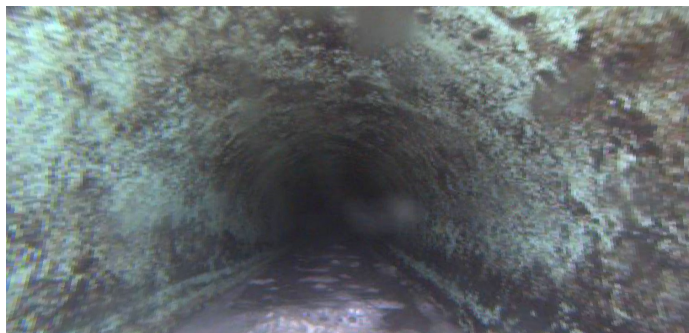
.0	AMH	Manhole	10	NA
	.0	MWL	Water Level	21	NA
	15.1	TFA	Tap Factory Active	63	NA
	16.5	TFA	Tap Factory Active	78	NA
	129.3	AMH	Manhole	315	NA
<div> <div>Code:</div> <div>AMH</div> </div> <div> <div>Description:</div> <div>Manhole</div> </div> <div> <div>Distance (ft):</div> <div>.0</div> </div> <div> <div>Structural Grade:</div> <div>0</div> </div> <div> <div>O&M Grade:</div> <div>0</div> </div> <div> <div>Clock Start/From:</div> <div></div> </div> <div> <div>Clock To:</div> <div></div> </div> <div> <div>1st Value:</div> <div></div> </div> <div> <div>2nd Value:</div> <div></div> </div> <div> <div>Value Percent:</div> <div></div> </div> <div> <div>Continuous Index:</div> <div></div> </div> <div> <div>Within 8" of Joint:</div> <div>NO</div> </div> <div> <div>Remarks:</div> <div>M-910-017</div> </div>

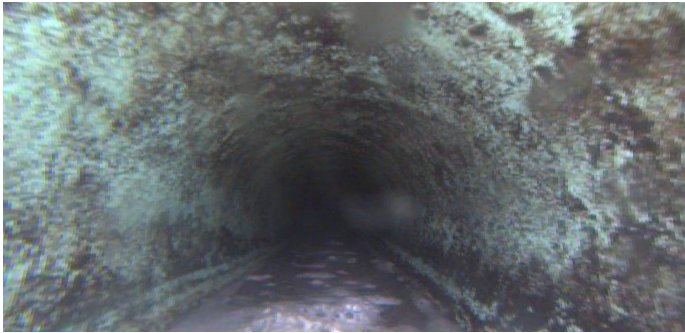
Code:	MWL
Description:	Water Level

Distance (ft):	.0
Structural Grade:	0
O&M Grade:	0
Clock Start/From:	
Clock To:	
1st Value:	
2nd Value:	
Value Percent:	5.000
Continuous Index:	
Within 8" of Joint:	NO
Remarks:

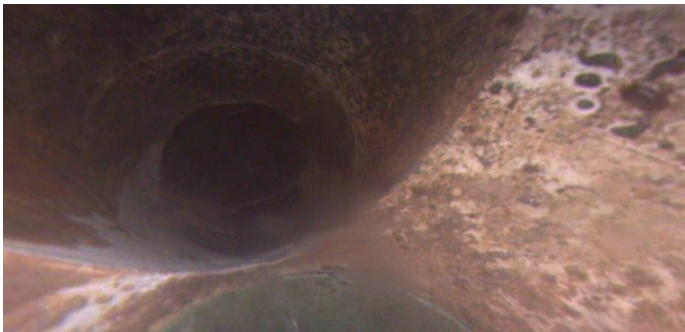
Code:	TFA
Description:	Tap Factory Active

Distance (ft):	15.1
Structural Grade:	0
O&M Grade:	0
Clock Start/From:	11
Clock To:	
1st Value:	4.000
2nd Value:	
Value Percent:	
Continuous Index:	
Within 8" of Joint:	
Remarks:

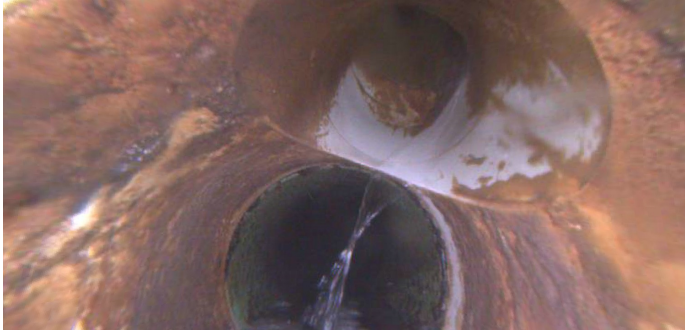
Code: **TFA**
Description: **Tap Factory Active**

Distance (ft): **16.5**
Structural Grade: **0**
O&M Grade: **0**
Clock Start/From: **1**
Clock To:
1st Value: **4.000**
2nd Value:
Value Percent:
Continuous Index:
Within 8" of Joint:
Remarks:

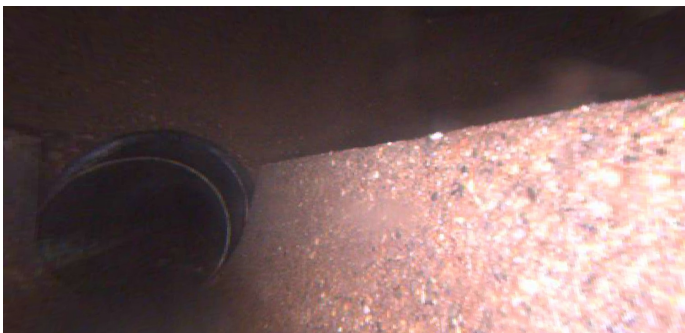
Code: **AMH**
Description: **Manhole**

Distance (ft): **129.3**
Structural Grade: **0**
O&M Grade: **0**
Clock Start/From:
Clock To:
1st Value:
2nd Value:
Value Percent:
Continuous Index:
Within 8" of Joint: **NO**
Remarks: **M-910-018**
