Profile/Photo Observation Report

Date:	03/28/2018	Weather:		Coding:	PACP 6.0
Pipe Length (ft):	172.1	Owner:	NA	Pre Clean:	Not Known
P.O.#:		Surveyor:	Selasie Honu	PSR:	P-910-028-018
Customer:		Clean Date:	01/01/1900	Shape:	C

Street:	River Pointe CC	Flow Control:	Not Controlled
City:	Hobart, IN	Year Renewed:	
Location:	Ditch	Tape/Media #:	
Purpose:	Maintenance Related	Dia/Height:	8"
Use:	Sanitary	Material:	PVC
Drain Area:	NA	Lining:	
Category:	NA		
Comment:	Flow direction wrong. Redeployment.		
Location Details:		Direction of Survey:	Upstream
US MH:	M-910-018	DS MH:	M-910-028
		Total Length Surveyed (ft):	28.3

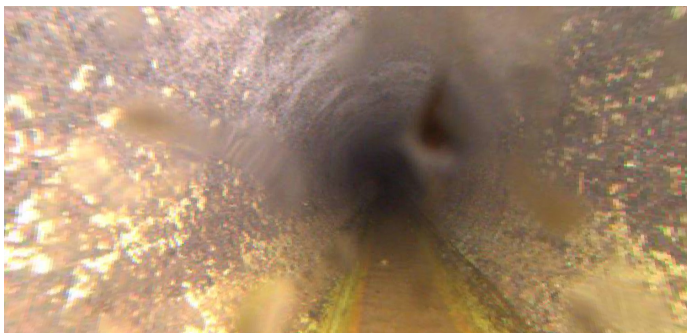
Code: **AMH**
 Description: **Manhole**
 Distance (ft): **.0**
 Structural Grade: **0**
 O&M Grade: **0**
 Clock Start/From:
 Clock To:
 1st Value:
 2nd Value:
 Value Percent:
 Continuous Index:
 Within 8" of Joint: **NO**
 Remarks: **M-910-028**

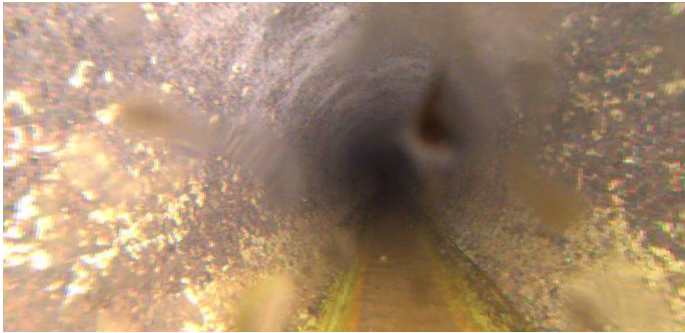
Code:	MWL
Description:	Water Level

Distance (ft):	.0
Structural Grade:	0
O&M Grade:	0
Clock Start/From:	
Clock To:	
1st Value:	
2nd Value:	
Value Percent:	5.000
Continuous Index:	
Within 8" of Joint:	NO
Remarks:

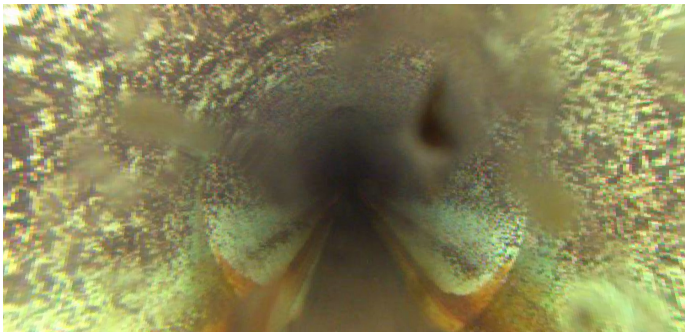
Code:	MSA
Description:	Abandoned Survey

Distance (ft):	28.3
Structural Grade:	0
O&M Grade:	0
Clock Start/From:	
Clock To:	
1st Value:	
2nd Value:	
Value Percent:	
Continuous Index:	
Within 8" of Joint:	NO
Remarks:	camera stopped
