Profile/Ph	oto Observatio	n Report				RedZone
Date: Pipe Length (ft P.O.#: Customer:	03/28/2018): 172.1	Weather: Owner: Surveyor: Clean Date	NA Selasie Honu : 01/01/1900		Coding: Pre Clean: PSR: Shape:	PACP 6.0 Not Known P-910-028-018 C
Street:	River Pointe CC		Flow Control:		Not Controlled	-
City:	Hobart, IN		Year Renewed	:		
Location:	Ditch		Tape/Media #			
Purpose:	Maintenance Rela	ated	Dia/Height:		8"	
Use:	Sanitary		Material:		PVC	
Drain Area:	NA		Lining:			
Category:	NA					
Comment:	Flow direction wr	ong. Redeploym	ient.			
Location Detai	ls:		Direction of Su	rvey:	Upstream	
US MH:	M-910-018	DS MH:	M-910-028	Tota	al Length Surveyed (ft):	170.3
D&M Index:	2.00	O&M Quick	22	200	O&M Rating:	4.00
Structural Index:	0.00	Structural Q	uick: 0	000	Structural Rating:	0.00
Overall Index:	2.00	Overall Quid	:k: 2 2	200	Overall Rating:	4.00

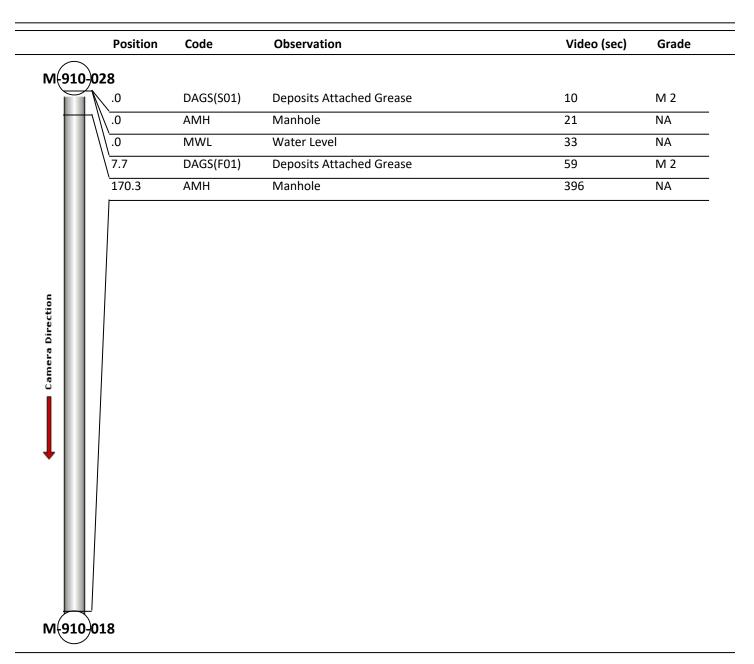
Code: Description:	DAGS Deposits Attached Grease
Distance (ft):	.0
Structural Grade:	0
O&M Grade:	2
Clock Start/From:	7
Clock To:	5
1st Value:	
2nd Value:	
Value Percent:	5.000
Continuous Index:	S01
Within 8" of Joint:	NO
Remarks:
