## Profile/Photo Observation Report

Street:	<b>Norris</b>	Flow Control:	<b>Not Controlled</b>
City:	<b>Hobart, IN</b>	Year Renewed:	
Location:	<b>Sidewalk</b>	Tape/Media #:	
Purpose:	<b>Maintenance Related</b>	Dia/Height:	<b>8"</b>
Use:	<b>Sanitary</b>	Material:	<b>PVC</b>
Drain Area:	<b>NA</b>	Lining:	
Category:	<b>NA</b>		
Comment:

Location Details:		Direction of Survey:	<b>Upstream</b>
US MH:	<b>M-910-020</b>	DS MH:	<b>M-910-019</b>
		Total Length Surveyed (ft):	<b>66.3</b>

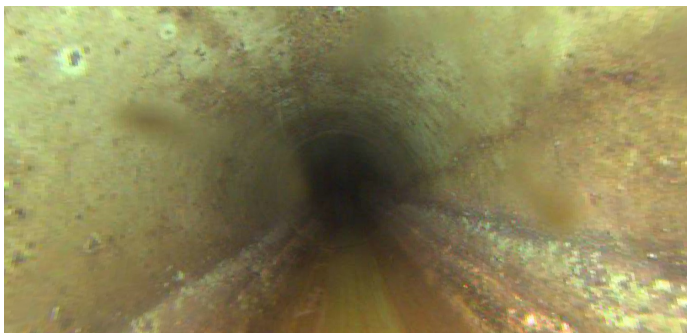
Code: **AMH**  
Description: **Manhole**

Distance (ft): **.0**  
Structural Grade: **0**  
O&M Grade: **0**  
Clock Start/From:  
Clock To:  
1st Value:  
2nd Value:  
Value Percent:  
Continuous Index:  
Within 8" of Joint: **NO**  
Remarks: **M-910-019**

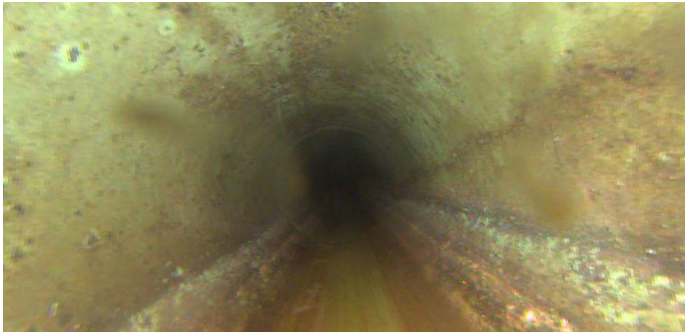
Code:	<b>MWL</b>
Description:	<b>Water Level</b>

Distance (ft):	<b>.0</b>
Structural Grade:	<b>0</b>
O&M Grade:	<b>0</b>
Clock Start/From:	
Clock To:	
1st Value:	
2nd Value:	
Value Percent:	<b>5.000</b>
Continuous Index:	
Within 8" of Joint:	<b>NO</b>
Remarks:

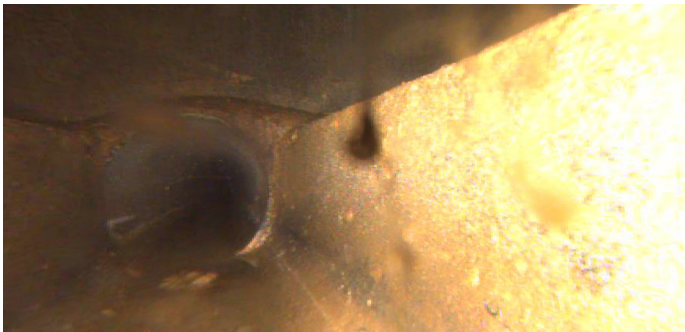
Code:	<b>AMH</b>
Description:	<b>Manhole</b>

Distance (ft):	<b>66.3</b>
Structural Grade:	<b>0</b>
O&M Grade:	<b>0</b>
Clock Start/From:	
Clock To:	
1st Value:	
2nd Value:	
Value Percent:	
Continuous Index:	
Within 8" of Joint:	<b>NO</b>
Remarks:	<b>M-910-020</b>
