Profile/Photo Observation Report

Street:	River Pointe CC	Flow Control:	Not Controlled
City:	Hobart, IN	Year Renewed:	
Location:	Ditch	Tape/Media #:	
Purpose:	Maintenance Related	Dia/Height:	8"
Use:	Sanitary	Material:	PVC
Drain Area:	NA	Lining:	
Category:	NA		
Comment:	Flow direction wrong.

Location Details:		Direction of Survey:	Upstream
US MH:	M-910-025	DS MH:	M-910-027
		Total Length Surveyed (ft):	206.0

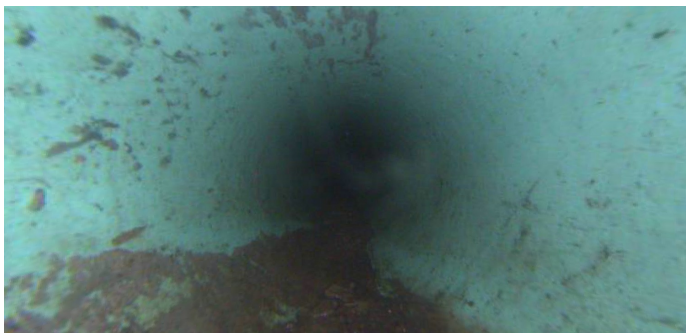
Code: **DSF**
Description: **Deposits Settled Fine**

Distance (ft): **.0**
Structural Grade: **0**
O&M Grade: **2**
Clock Start/From: **6**
Clock To:
1st Value:
2nd Value:
Value Percent: **5.000**
Continuous Index:
Within 8" of Joint: **NO**
Remarks:

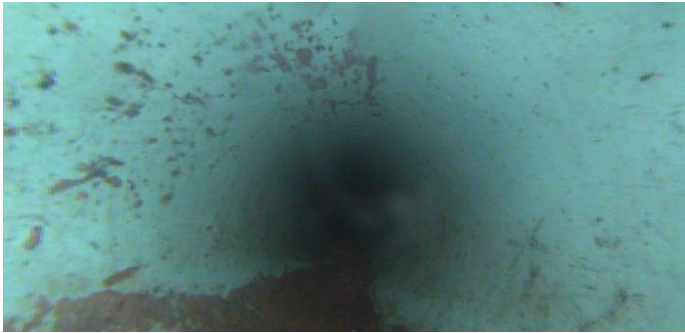
Code:	AMH
Description:	Manhole

Distance (ft):	.0
Structural Grade:	0
O&M Grade:	0
Clock Start/From:	
Clock To:	
1st Value:	
2nd Value:	
Value Percent:	
Continuous Index:	
Within 8" of Joint:	NO
Remarks:	M-910-027

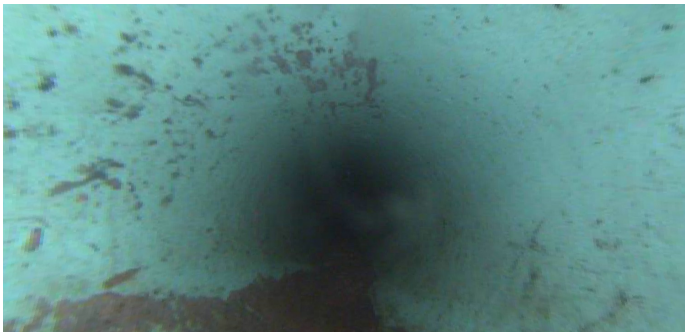
Code:	MWL
Description:	Water Level

Distance (ft):	.0
Structural Grade:	0
O&M Grade:	0
Clock Start/From:	
Clock To:	
1st Value:	
2nd Value:	
Value Percent:	5.000
Continuous Index:	
Within 8" of Joint:	NO
Remarks:

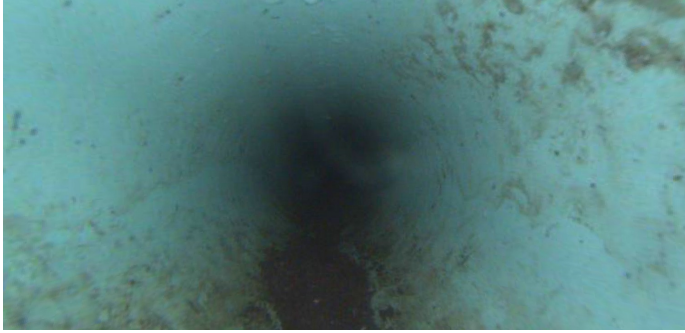
Code: **DSF**
Description: **Deposits Settled Fine**

Distance (ft): **62.2**
Structural Grade: **0**
O&M Grade: **2**
Clock Start/From: **6**
Clock To:
1st Value:
2nd Value:
Value Percent: **5.000**
Continuous Index:
Within 8" of Joint: **NO**
Remarks:

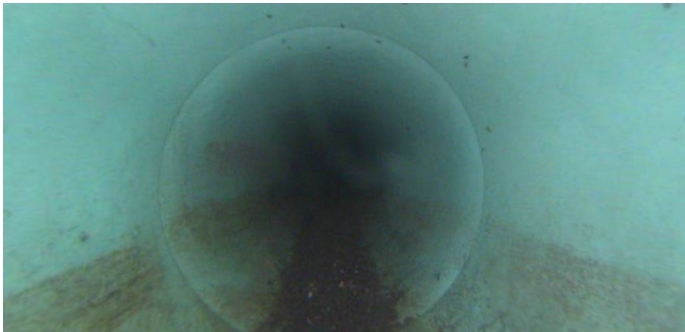
Code: **DSF**
Description: **Deposits Settled Fine**

Distance (ft): **141.8**
Structural Grade: **0**
O&M Grade: **2**
Clock Start/From: **6**
Clock To:
1st Value:
2nd Value:
Value Percent: **5.000**
Continuous Index:
Within 8" of Joint: **NO**
Remarks:

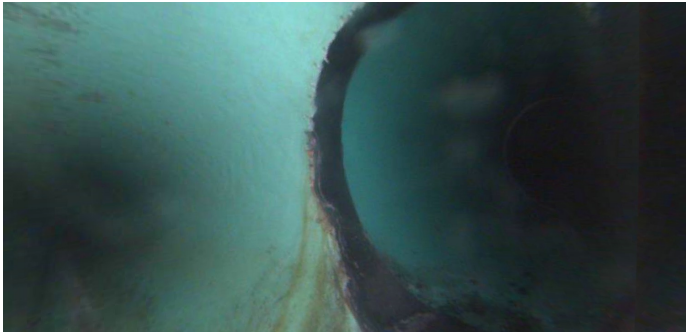
Code: **TB**
Description: **Tap Break-in**

Distance (ft): **145.2**
Structural Grade: **0**
O&M Grade: **0**
Clock Start/From: **3**
Clock To:
1st Value: **4.000**
2nd Value:
Value Percent:
Continuous Index:
Within 8" of Joint:
Remarks:

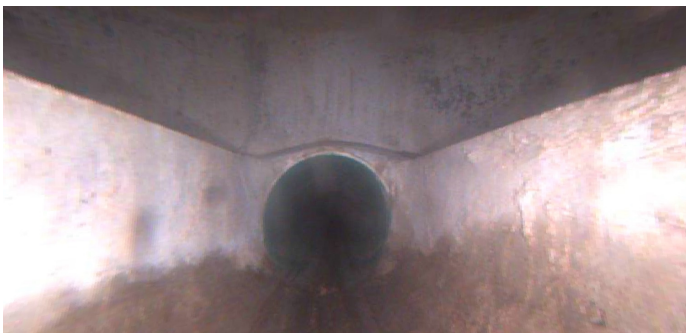
Code: **AMH**
Description: **Manhole**

Distance (ft): **206.0**
Structural Grade: **0**
O&M Grade: **0**
Clock Start/From:
Clock To:
1st Value:
2nd Value:
Value Percent:
Continuous Index:
Within 8" of Joint: **NO**
Remarks: **M-910-025**
