## **Profile/Photo Observation Report**

Date:	10/21/2021	Weather:		Codin	σ. ΒΛ	CP 6.0
Pipe Length (fi		Owner:	Hobart, IN	Pre Cl	_	t Known
P.O.#:	946_1	Surveyor:	M. Pielacha	PSR:		910-029-028
Customer:	Hobart, IN	Clean Date:	Will Ficiatina	Shape		,10 015 010
Street:	Country Club Lot		Flow Control:			
City:	Hobart, IN		Year Renewed:			
Location:	Parking Lot		Tape/Media #:	946		
Purpose:	Routine Assessmer	nt	Dia/Height:	8"		
Use:	Sanitary		Material:	CAS		
Drain Area:			Lining:			
Category:	NA					
Comment:						
Location Detai	ils:		Direction of Sur	vey: <b>Upstre</b>	eam	
US MH:	M-910-28	DS MH:	M-910-29	Total Length Surv	veyed (ft):	10.7
0&M Index:	5.00	O&M Quick:	510	00 O&M Rat	ing:	5.00
tructural Index	1.00	Structural Qu	ick: <b>12</b> 0		_	2.00
Overall Index:	2.33	Overall Quick	E44		_	7.00

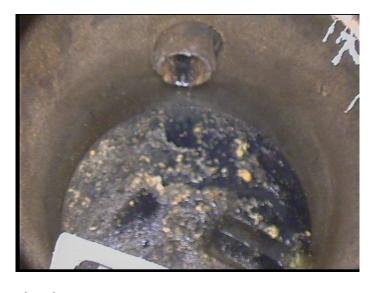
Code: Description:	AMH Manhole		
Distance (ft):	.0		
Structural Grade:	0		
O&M Grade:	0		
Clock Start/From:			
Clock To:			
1st Value:			
2nd Value:			
Value Percent:			
Continuous Index:			
Within 8" of Joint:	NO		
Remarks:	M-910-29

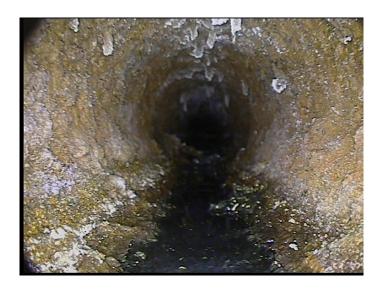
Code: MWL

Description: **Water Level**

Distance (ft): .0 Structural Grade: 0 O&M Grade: 0

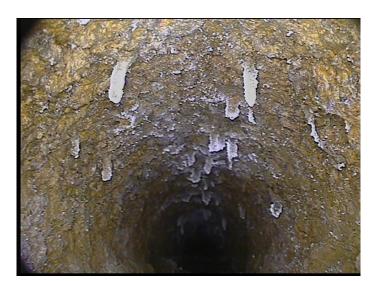
Code: SRI

Description: **Surface Roughness Increased**

Distance (ft): .0 Structural Grade: 1 O&M Grade: 0 Clock Start/From: 7 Clock To: 5 1st Value: 2nd Value: Value Percent:

Continuous Index: **S01** Within 8" of Joint: YES

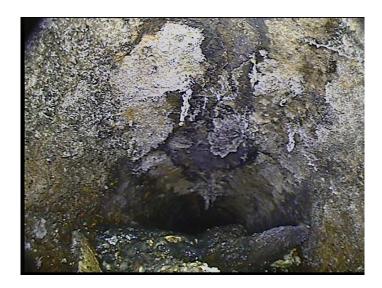
Code: SRI

Description: Surface Roughness Increased

Distance (ft): 10.7
Structural Grade: 1
O&M Grade: 0
Clock Start/From: 7
Clock To: 5

Continuous Index: F01
Within 8" of Joint: NO

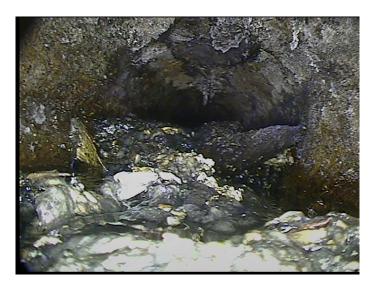
Code: OBZ

Description: Obstacle Other

Distance (ft): 10.7
Structural Grade: 0
O&M Grade: 5
Clock Start/From: 4
Clock To: 8
1st Value:

Value Percent: **35.000**

Within 8" of Joint: NO Remarks: Debris

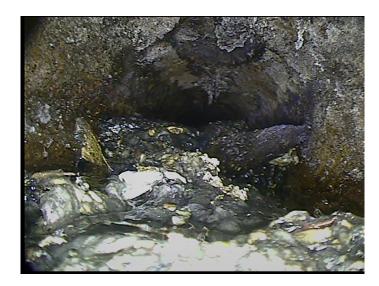
Code: MSA

Description: Abandoned Survey

Distance (ft): 10.7
Structural Grade: 0

Remarks: heavy debris
