Profile/Photo Observation Report

Date:	09/18/2021	Weather:		Coding:	PACP 7.0
Pipe Length (ft):	328.9	Owner:	City of Hobart	Pre Clean:	Light Cleaning
P.O.#:	YES502259	Surveyor:	S. Bucklin	PSR:	P-503-045-062
Customer:	City of Hobart	Clean Date:	08/25/2021	Shape:	C

Street:	North Wisconsin Street	Flow Control:	Not Controlled
City:	Hobart, IN	Year Renewed:	
Location:	Easement/Right of Way	Tape/Media #:	
Purpose:	Routine Assessment	Dia/Height:	10"
Use:	Sanitary Sewage Pipe	Material:	VCP
Drain Area:		Lining:	None
Category:	NA		
Comment:

Location Details:	JUST OFF THE SW CORNER OF THE C	Direction of Survey:	Downstream
US MH:	M-503-062	DS MH:	M-503-045
		Total Length Surveyed (ft):	328.9

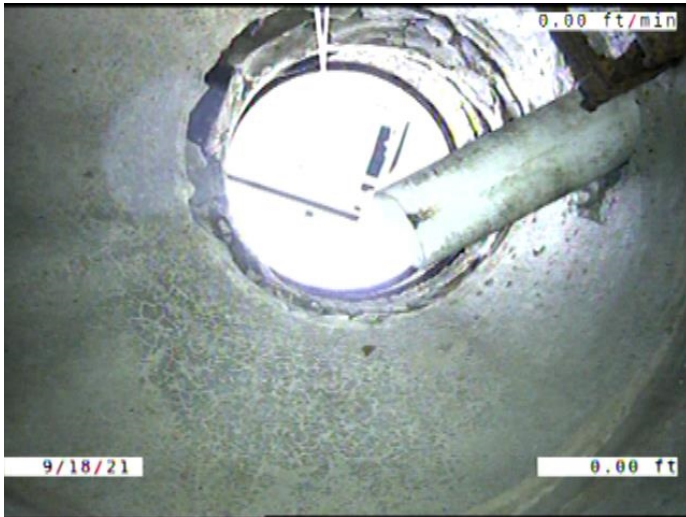
Code: **AMH**
Description: **Manhole**

Distance (ft): **.0**
Structural Grade: **0**
O&M Grade: **0**
Clock Start/From:
Clock To:
1st Value:
2nd Value:
Value Percent:
Continuous Index:
Within 8" of Joint: **NO**
Remarks: **M-503-062**

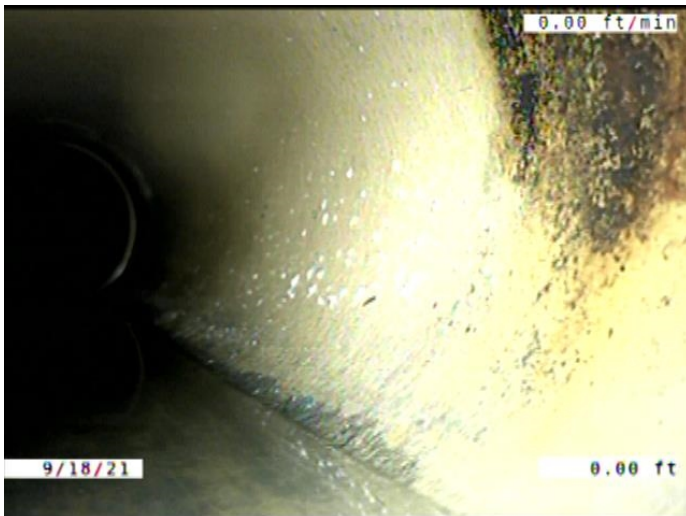
Code: **MWL**
Description: **Miscellaneous Water Level**

Distance (ft): **.0**
Structural Grade: **0**
O&M Grade: **0**
Clock Start/From:
Clock To:
1st Value:
2nd Value:
Value Percent: **5.000**
Continuous Index:
Within 8" of Joint: **NO**
Remarks:

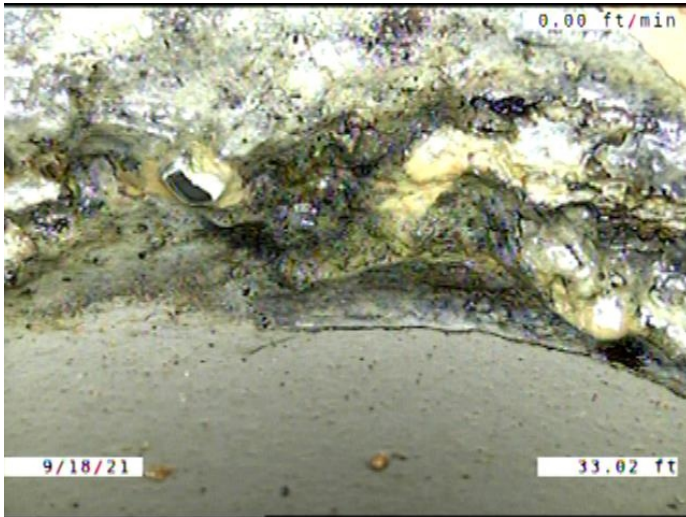
Code: **IWJ**
 Description: **Infiltration Weeper Joint**

Distance (ft): **33.0**
 Structural Grade: **0**
 O&M Grade: **2**
 Clock Start/From: **12**
 Clock To:
 1st Value:
 2nd Value:
 Value Percent:
 Continuous Index:
 Within 8" of Joint: **YES**
 Remarks:

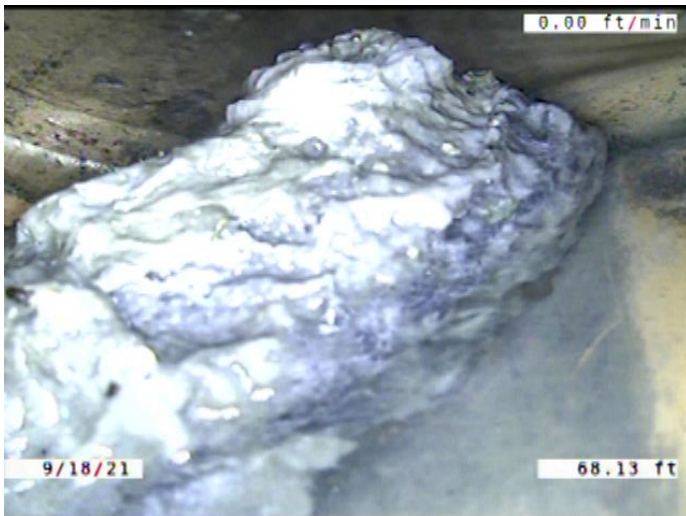
Code: **OBN**
 Description: **Obstruction Construction Debris**

Distance (ft): **68.1**
 Structural Grade: **0**
 O&M Grade: **2**
 Clock Start/From: **6**
 Clock To: **7**
 1st Value:
 2nd Value:
 Value Percent: **5.000**
 Continuous Index:
 Within 8" of Joint: **YES**
 Remarks:

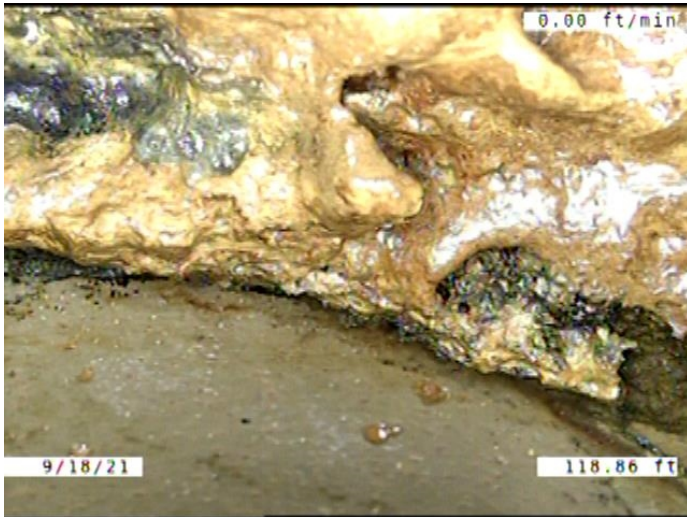
Code: **IDJ**
 Description: **Infiltration Dripper Joint**

Distance (ft): **118.9**
 Structural Grade: **0**
 O&M Grade: **3**
 Clock Start/From: **2**
 Clock To: **3**
 1st Value:
 2nd Value:
 Value Percent:
 Continuous Index:
 Within 8" of Joint: **YES**
 Remarks:

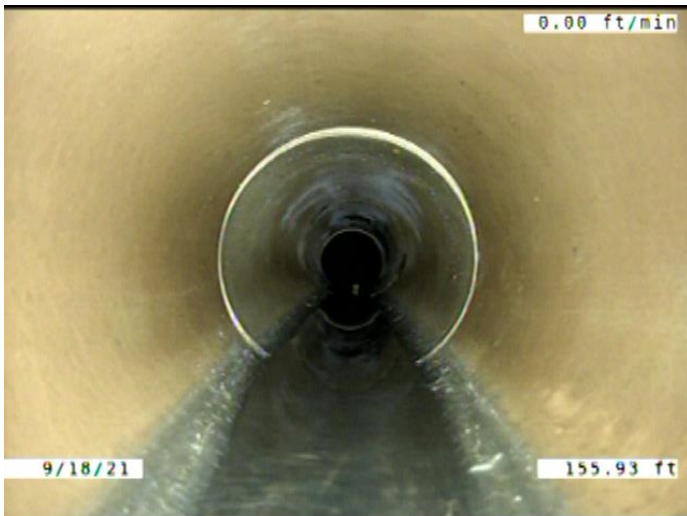
Code: **MWLS**
 Description: **Miscellaneous Water Level Sag**

Distance (ft): **155.9**
 Structural Grade: **2**
 O&M Grade: **0**
 Clock Start/From:
 Clock To:
 1st Value:
 2nd Value:
 Value Percent: **5.000**
 Continuous Index: **S02**
 Within 8" of Joint: **NO**
 Remarks:

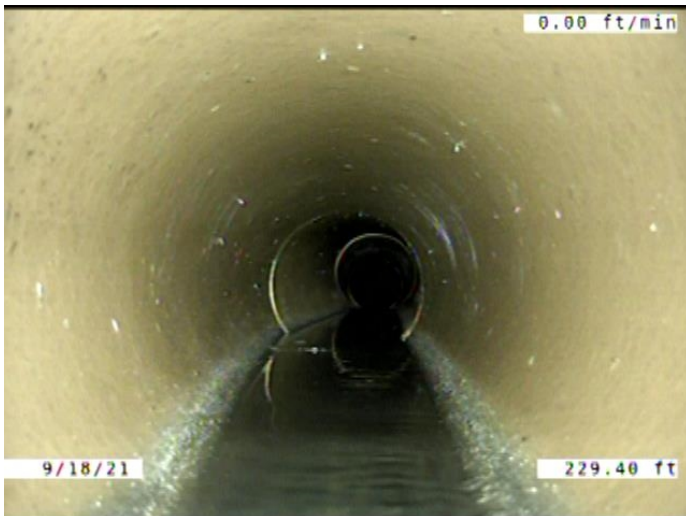
Code: **MWLS**
 Description: **Miscellaneous Water Level Sag**

Distance (ft): **229.4**
 Structural Grade: **2**
 O&M Grade: **0**
 Clock Start/From:
 Clock To:
 1st Value:
 2nd Value:
 Value Percent: **5.000**
 Continuous Index: **S03**
 Within 8" of Joint: **NO**
 Remarks:

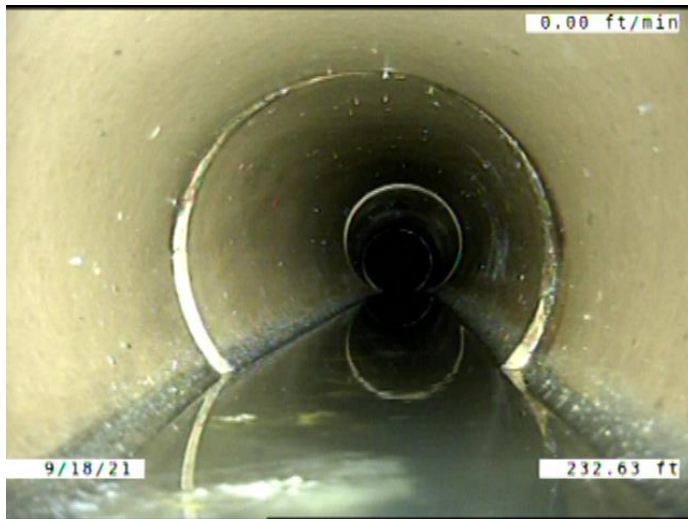
Code: **DSF**
Description: **Deposits Settled Fine**

Distance (ft): **232.6**
Structural Grade: **0**
O&M Grade: **2**
Clock Start/From: **5**
Clock To: **7**
1st Value:
2nd Value:
Value Percent: **5.000**
Continuous Index: **S04**
Within 8" of Joint: **YES**
Remarks:

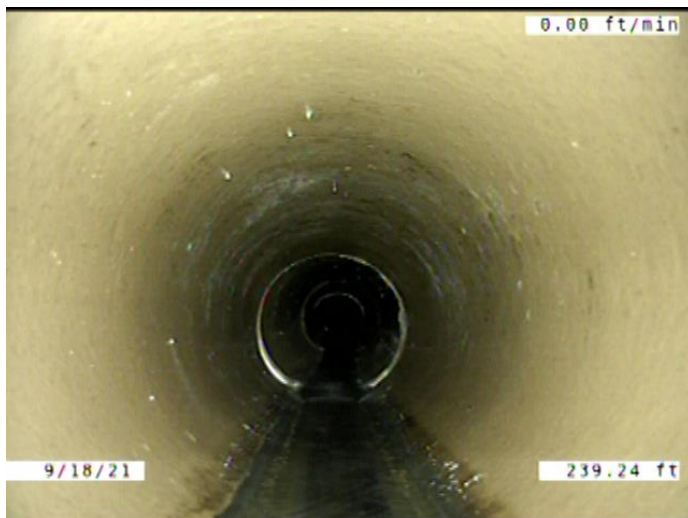
Code: **MWLS**
Description: **Miscellaneous Water Level Sag**

Distance (ft): **239.2**
Structural Grade: **2**
O&M Grade: **0**
Clock Start/From:
Clock To:
1st Value:
2nd Value:
Value Percent: **5.000**
Continuous Index: **F03**
Within 8" of Joint: **NO**
Remarks:

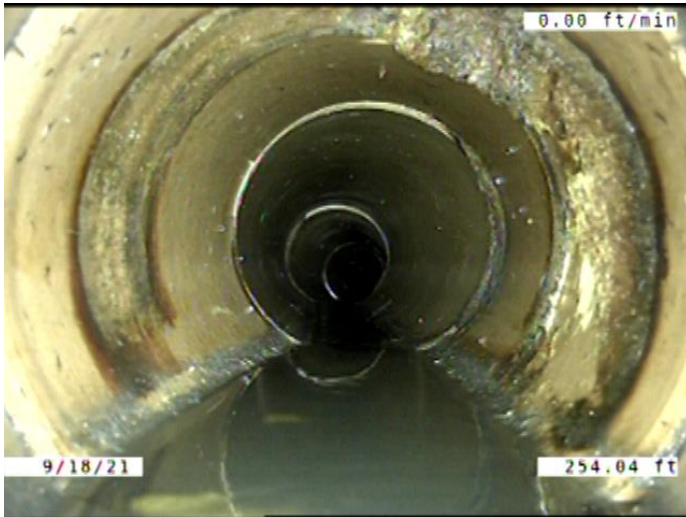
Code: **MWLS**
Description: **Miscellaneous Water Level Sag**

Distance (ft): **254.0**
Structural Grade: **2**
O&M Grade: **0**
Clock Start/From:
Clock To:
1st Value:
2nd Value:
Value Percent: **5.000**
Continuous Index:
Within 8" of Joint: **NO**
Remarks:

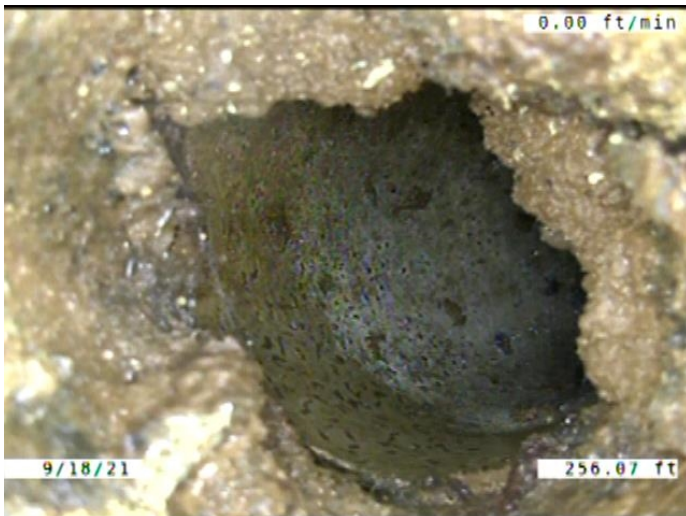
Code: **TFD**
Description: **Tap Factory Defective**

Distance (ft): **256.1**
Structural Grade: **0**
O&M Grade: **3**
Clock Start/From: **1**
Clock To:
1st Value: **4.000**
2nd Value:
Value Percent:
Continuous Index:
Within 8" of Joint: **YES**
Remarks: **ENCRUSTATION ALL AROUND THE TAP CONNECTION**

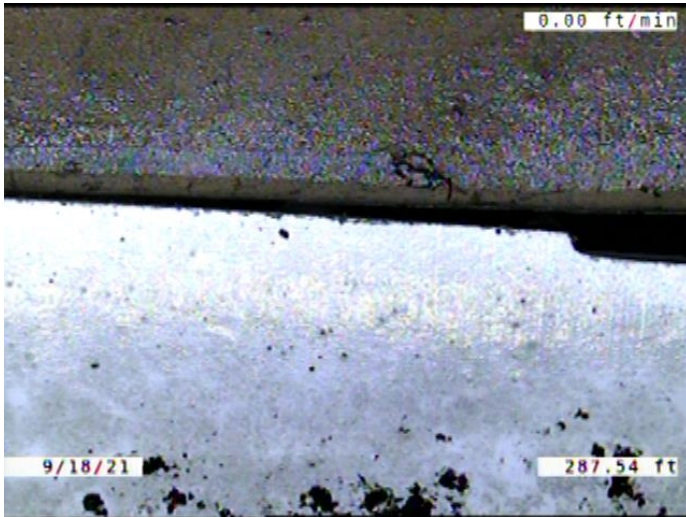
Code: **MMC**
 Description: **Miscellaneous Material Change**

Distance (ft): **287.5**
 Structural Grade: **0**
 O&M Grade: **0**
 Clock Start/From:
 Clock To:
 1st Value:
 2nd Value:
 Value Percent:
 Continuous Index:
 Within 8" of Joint: **NO**
 Remarks: **VCP TO PVC**

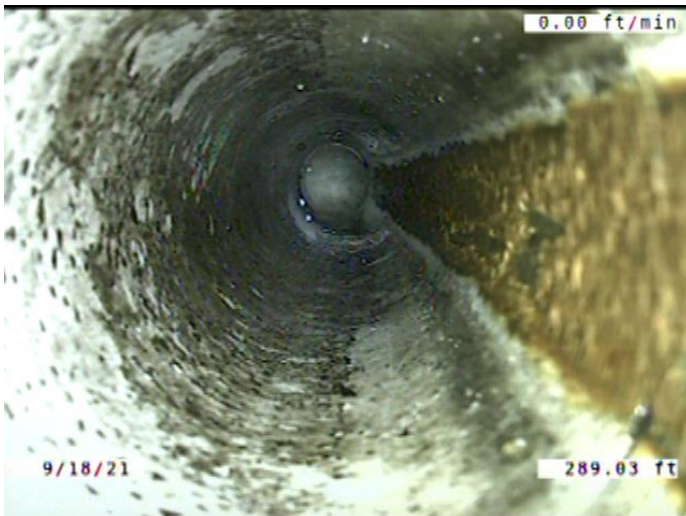
Code: **TF**
 Description: **Tap Factory**

Distance (ft): **289.0**
 Structural Grade: **0**
 O&M Grade: **0**
 Clock Start/From: **2**
 Clock To:
 1st Value: **4.000**
 2nd Value:
 Value Percent:
 Continuous Index:
 Within 8" of Joint: **YES**
 Remarks:

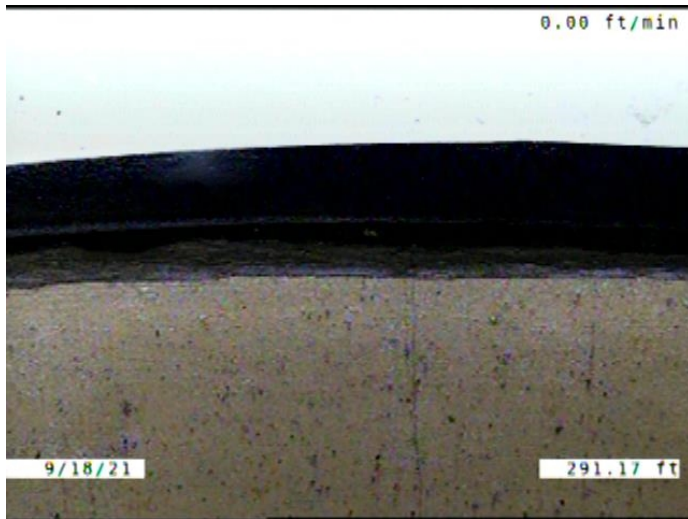
Code: **MMC**
Description: **Miscellaneous Material Change**

Distance (ft): **291.2**
Structural Grade: **0**
O&M Grade: **0**
Clock Start/From:
Clock To:
1st Value:
2nd Value:
Value Percent:
Continuous Index:
Within 8" of Joint: **NO**
Remarks: **PVC TO VCP**

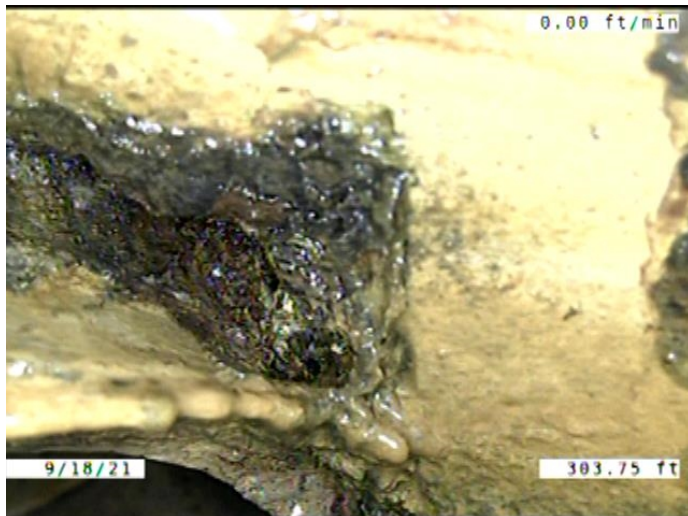
Code: **B**
Description: **Broken**

Distance (ft): **303.7**
Structural Grade: **4**
O&M Grade: **0**
Clock Start/From: **12**
Clock To: **2**
1st Value:
2nd Value:
Value Percent:
Continuous Index:
Within 8" of Joint: **NO**
Remarks:

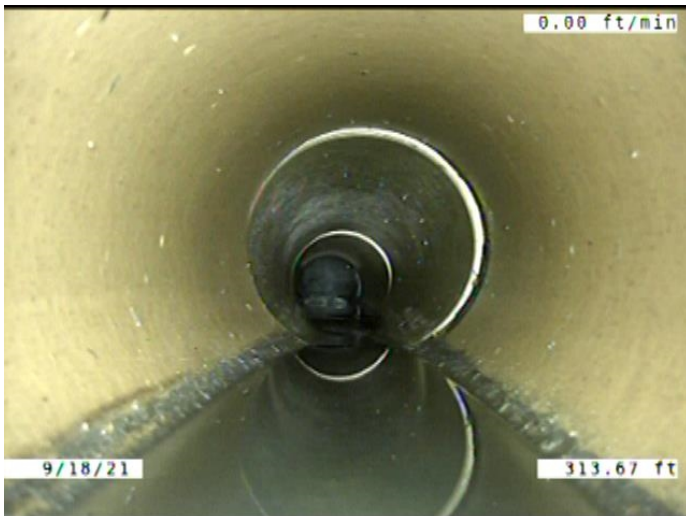
Code: **MWLS**
 Description: **Miscellaneous Water Level Sag**

Distance (ft): **313.7**
 Structural Grade: **2**
 O&M Grade: **0**
 Clock Start/From:
 Clock To:
 1st Value:
 2nd Value:
 Value Percent: **5.000**
 Continuous Index:
 Within 8" of Joint: **NO**
 Remarks:

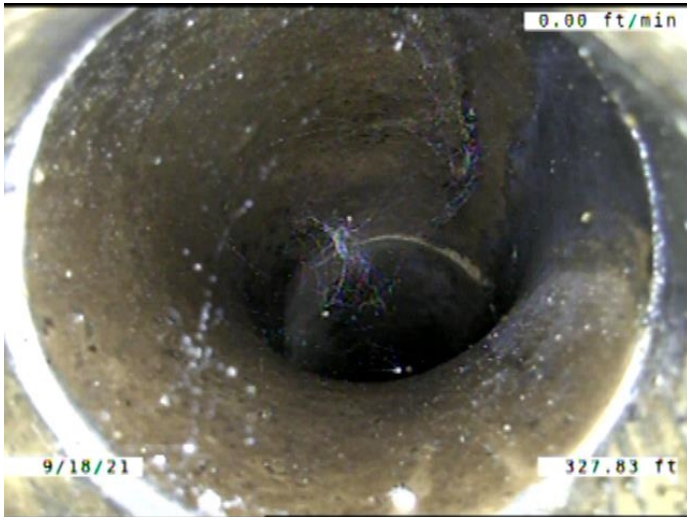
Code: **TFD**
Description: **Tap Factory Defective**

Distance (ft): **327.8**
Structural Grade: **0**
O&M Grade: **3**
Clock Start/From: **2**
Clock To:
1st Value: **4.000**
2nd Value:
Value Percent:
Continuous Index:
Within 8" of Joint: **YES**
Remarks: **Defective**

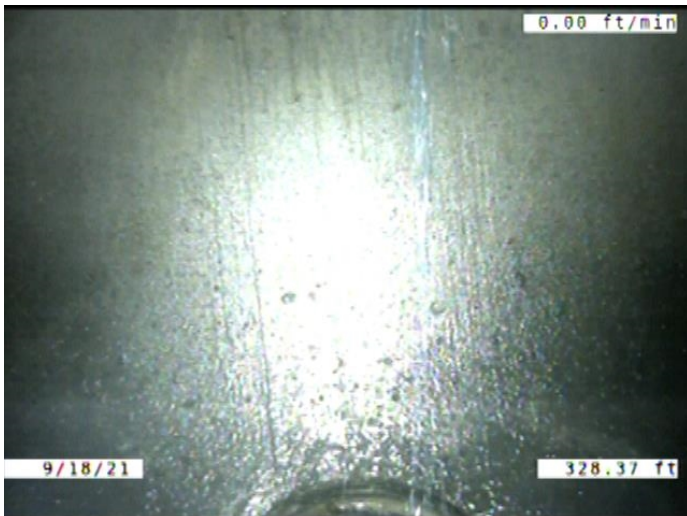
Code: **DAE**
Description: **Deposits Attached Encrustation**

Distance (ft): **328.4**
Structural Grade: **0**
O&M Grade: **2**
Clock Start/From: **7**
Clock To: **5**
1st Value:
2nd Value:
Value Percent: **5.000**
Continuous Index: **F01**
Within 8" of Joint: **YES**
Remarks:

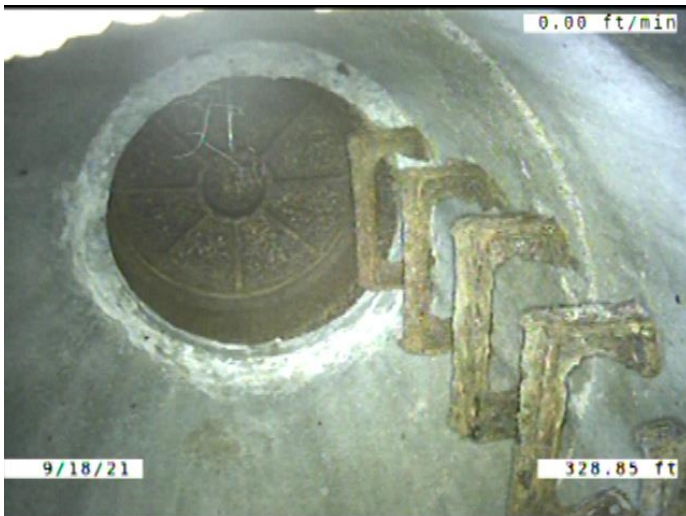
Code: **AMH**
 Description: **Manhole**

Distance (ft): **328.9**
 Structural Grade: **0**
 O&M Grade: **0**
 Clock Start/From:
 Clock To:
 1st Value:
 2nd Value:
 Value Percent:
 Continuous Index:
 Within 8" of Joint: **NO**
 Remarks: **M-503-045**
