## Profile/Photo Observation Report

Date:	<b>09/18/2021</b>	Weather:		Coding:	<b>PACP 7.0</b>
Pipe Length (ft):	<b>328.9</b>	Owner:	<b>City of Hobart</b>	Pre Clean:	<b>Light Cleaning</b>
P.O.#:	<b>YES502259</b>	Surveyor:	<b>S. Bucklin</b>	PSR:	<b>P-503-045-062</b>
Customer:	<b>City of Hobart</b>	Clean Date:	<b>08/25/2021</b>	Shape:	<b>C</b>

Street:	<b>North Wisconsin Street</b>	Flow Control:	<b>Not Controlled</b>
City:	<b>Hobart, IN</b>	Year Renewed:	
Location:	<b>Easement/Right of Way</b>	Tape/Media #:	
Purpose:	<b>Routine Assessment</b>	Dia/Height:	<b>10"</b>
Use:	<b>Sanitary Sewage Pipe</b>	Material:	<b>VCP</b>
Drain Area:		Lining:	<b>None</b>
Category:	<b>NA</b>		
Comment:

Location Details:	<b>JUST OFF THE SW CORNER OF THE C</b>	Direction of Survey:	<b>Downstream</b>
US MH:	<b>M-503-062</b>	DS MH:	<b>M-503-045</b>
		Total Length Surveyed (ft):	<b>328.9</b>

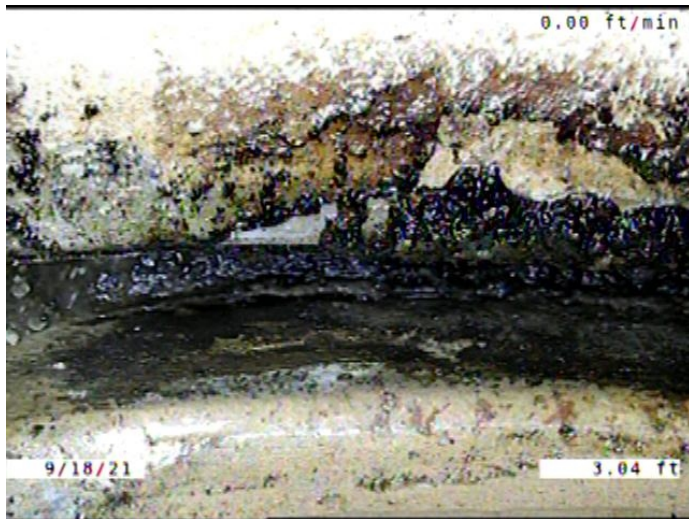
Code: **ISJ**  
 Description: **Infiltration Stain Joint**

Distance (ft): **3.0**  
 Structural Grade: **0**  
 O&M Grade: **1**  
 Clock Start/From: **8**  
 Clock To: **11**  
 1st Value:  
 2nd Value:  
 Value Percent:  
 Continuous Index:  
 Within 8" of Joint: **YES**  
 Remarks:

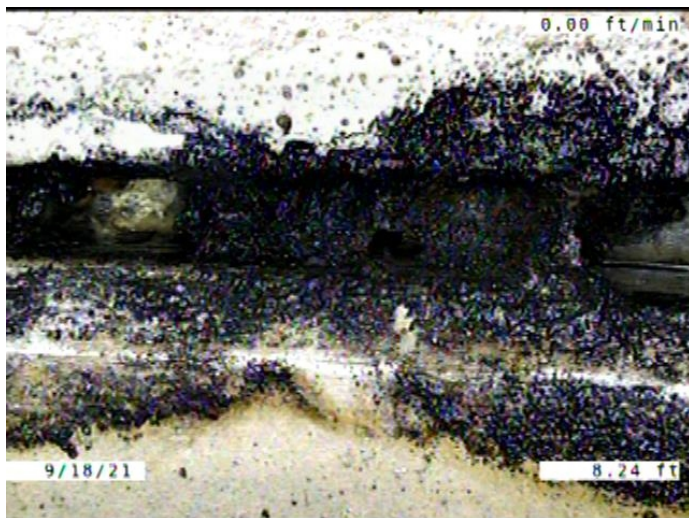
Code: **DAE**  
 Description: **Deposits Attached Encrustation**

Distance (ft): **8.2**  
 Structural Grade: **0**  
 O&M Grade: **2**  
 Clock Start/From: **7**  
 Clock To: **5**  
 1st Value:  
 2nd Value:  
 Value Percent: **5.000**  
 Continuous Index: **S01**  
 Within 8" of Joint: **YES**  
 Remarks:

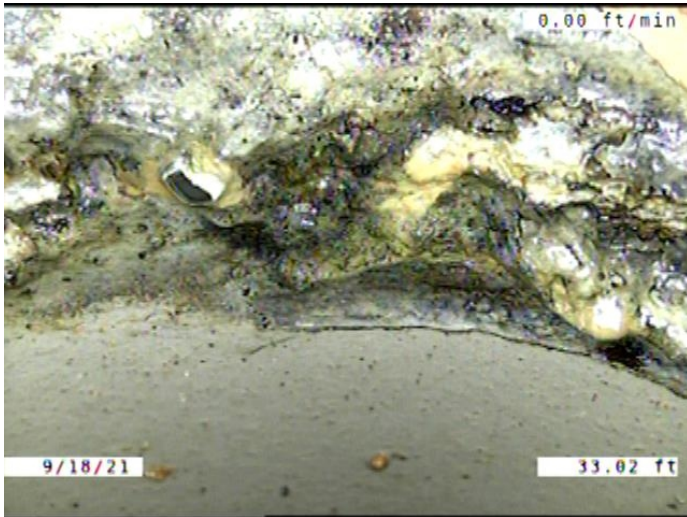
Code: **IWJ**  
 Description: **Infiltration Weeper Joint**

Distance (ft): **33.0**  
 Structural Grade: **0**  
 O&M Grade: **2**  
 Clock Start/From: **12**  
 Clock To:  
 1st Value:  
 2nd Value:  
 Value Percent:  
 Continuous Index:  
 Within 8" of Joint: **YES**  
 Remarks:

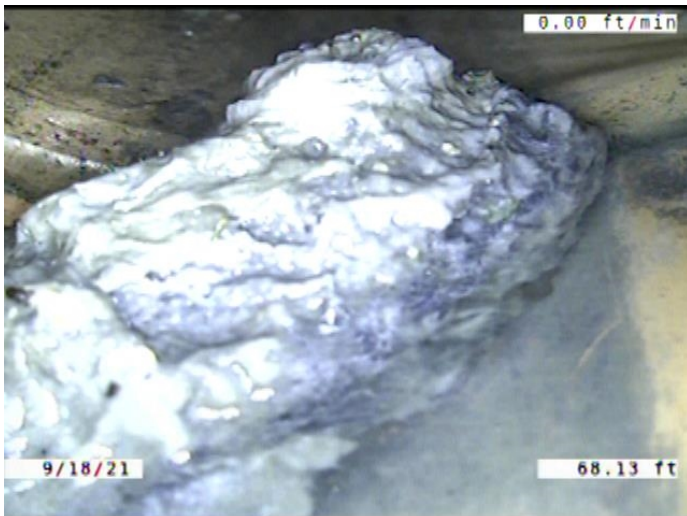
Code: **OBN**  
 Description: **Obstruction Construction Debris**

Distance (ft): **68.1**  
 Structural Grade: **0**  
 O&M Grade: **2**  
 Clock Start/From: **6**  
 Clock To: **7**  
 1st Value:  
 2nd Value:  
 Value Percent: **5.000**  
 Continuous Index:  
 Within 8" of Joint: **YES**  
 Remarks:

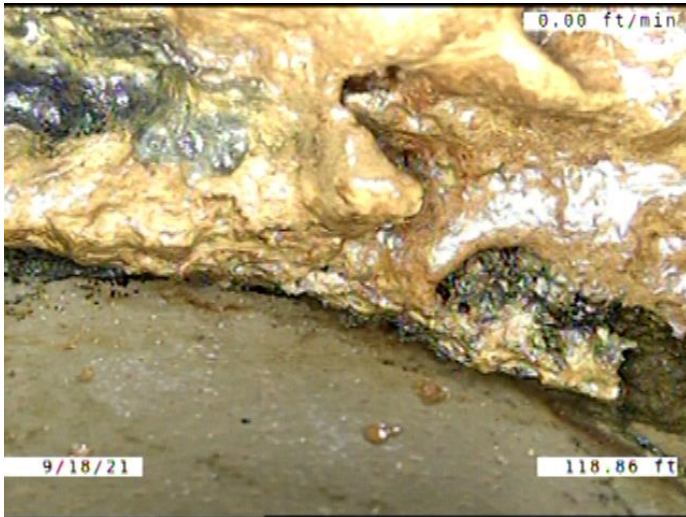
Code: **IDJ**  
 Description: **Infiltration Dripper Joint**

Distance (ft): **118.9**  
 Structural Grade: **0**  
 O&M Grade: **3**  
 Clock Start/From: **2**  
 Clock To: **3**  
 1st Value:  
 2nd Value:  
 Value Percent:  
 Continuous Index:  
 Within 8" of Joint: **YES**  
 Remarks:

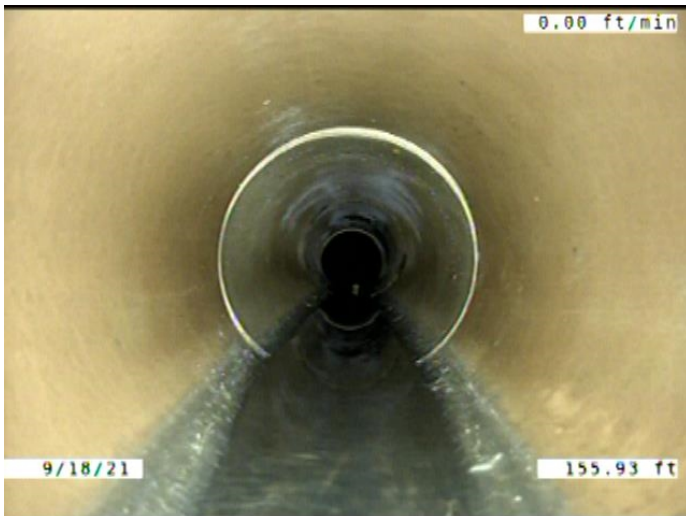
Code: **MWLS**  
 Description: **Miscellaneous Water Level Sag**

Distance (ft): **155.9**  
 Structural Grade: **2**  
 O&M Grade: **0**  
 Clock Start/From:  
 Clock To:  
 1st Value:  
 2nd Value:  
 Value Percent: **5.000**  
 Continuous Index: **S02**  
 Within 8" of Joint: **NO**  
 Remarks:

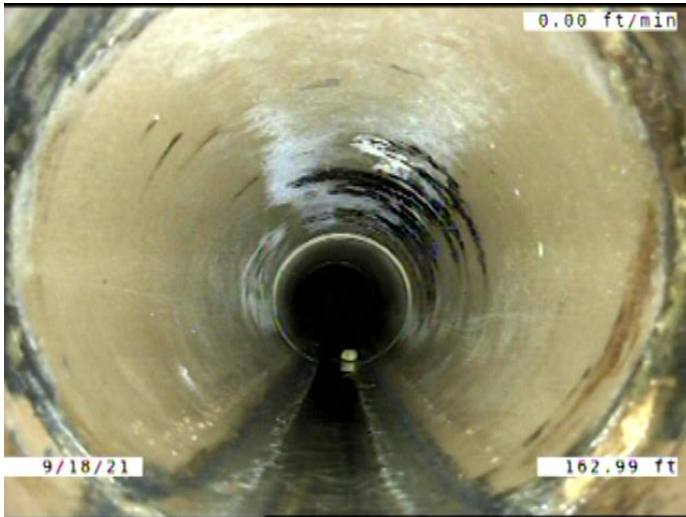
Code: **MWLS**  
Description: **Miscellaneous Water Level Sag**

Distance (ft): **163.0**  
Structural Grade: **2**  
O&M Grade: **0**  
Clock Start/From:  
Clock To:  
1st Value:  
2nd Value:  
Value Percent: **5.000**  
Continuous Index: **F02**  
Within 8" of Joint: **NO**  
Remarks:

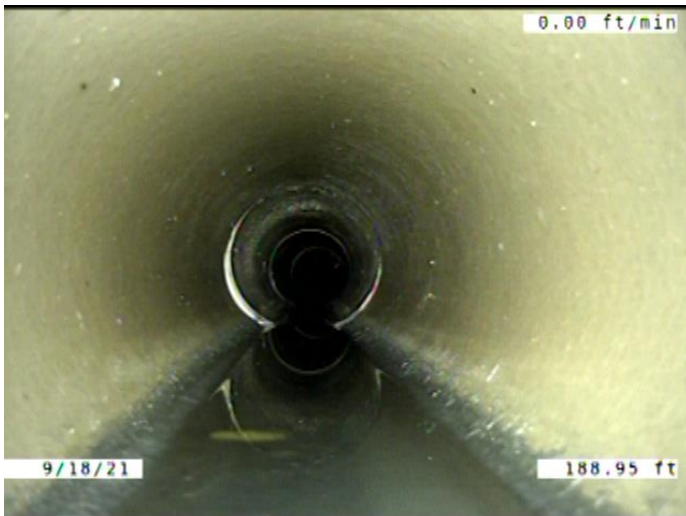
Code: **MWLS**  
Description: **Miscellaneous Water Level Sag**

Distance (ft): **189.0**  
Structural Grade: **2**  
O&M Grade: **0**  
Clock Start/From:  
Clock To:  
1st Value:  
2nd Value:  
Value Percent: **5.000**  
Continuous Index:  
Within 8" of Joint: **NO**  
Remarks:

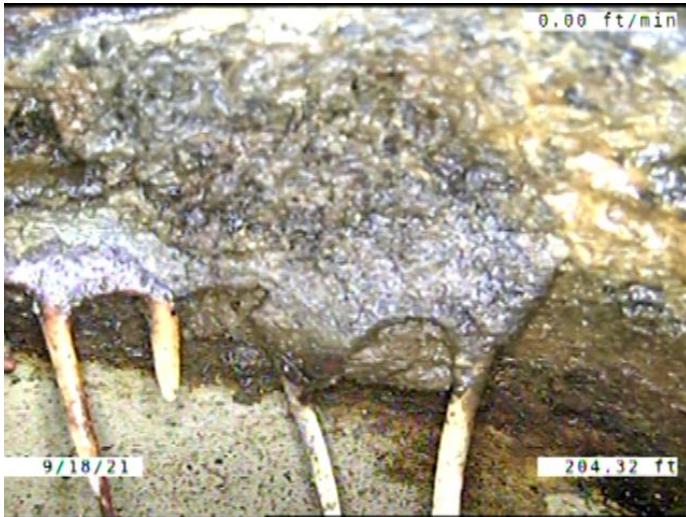
Code: **RFJ**  
 Description: **Roots Fine Joint**

Distance (ft): **204.3**  
 Structural Grade: **0**  
 O&M Grade: **1**  
 Clock Start/From: **1**  
 Clock To: **2**  
 1st Value:  
 2nd Value:  
 Value Percent:  
 Continuous Index:  
 Within 8" of Joint: **YES**  
 Remarks:

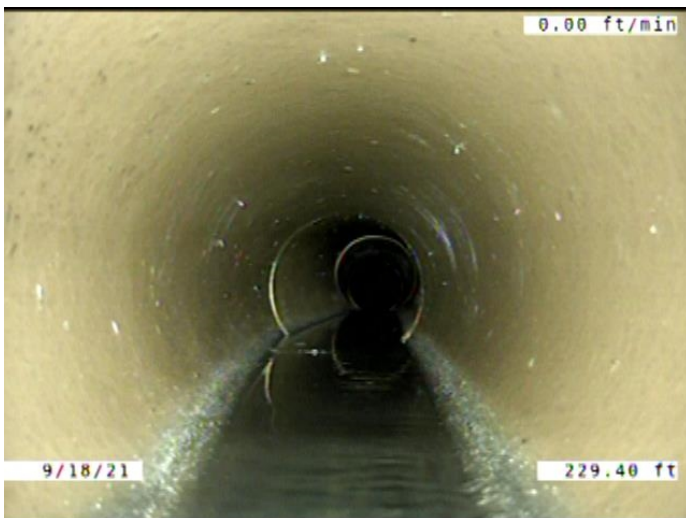
Code: **MWLS**  
 Description: **Miscellaneous Water Level Sag**

Distance (ft): **229.4**  
 Structural Grade: **2**  
 O&M Grade: **0**  
 Clock Start/From:  
 Clock To:  
 1st Value:  
 2nd Value:  
 Value Percent: **5.000**  
 Continuous Index: **S03**  
 Within 8" of Joint: **NO**  
 Remarks:

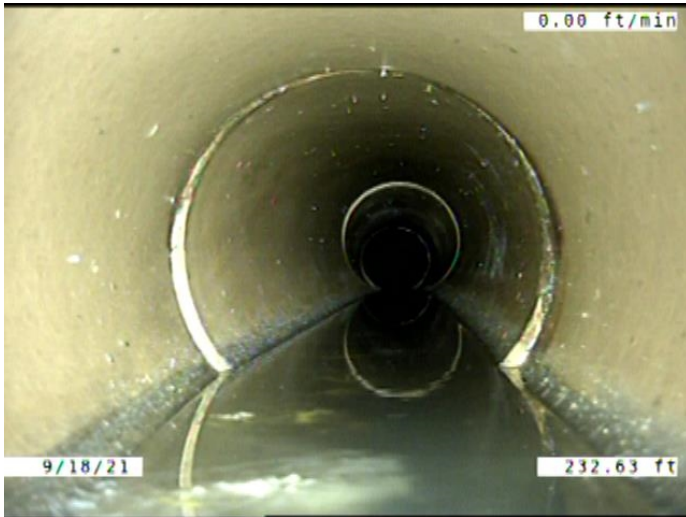
Code: **DSF**  
 Description: **Deposits Settled Fine**

Distance (ft): **232.6**  
 Structural Grade: **0**  
 O&M Grade: **2**  
 Clock Start/From: **5**  
 Clock To: **7**  
 1st Value:  
 2nd Value:  
 Value Percent: **5.000**  
 Continuous Index: **S04**  
 Within 8" of Joint: **YES**  
 Remarks:

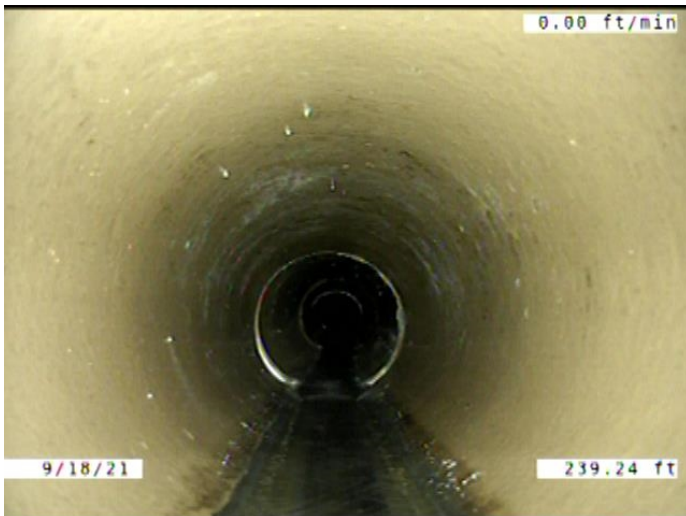
Code: **MWLS**  
 Description: **Miscellaneous Water Level Sag**

Distance (ft): **239.2**  
 Structural Grade: **2**  
 O&M Grade: **0**  
 Clock Start/From:  
 Clock To:  
 1st Value:  
 2nd Value:  
 Value Percent: **5.000**  
 Continuous Index: **F03**  
 Within 8" of Joint: **NO**  
 Remarks:

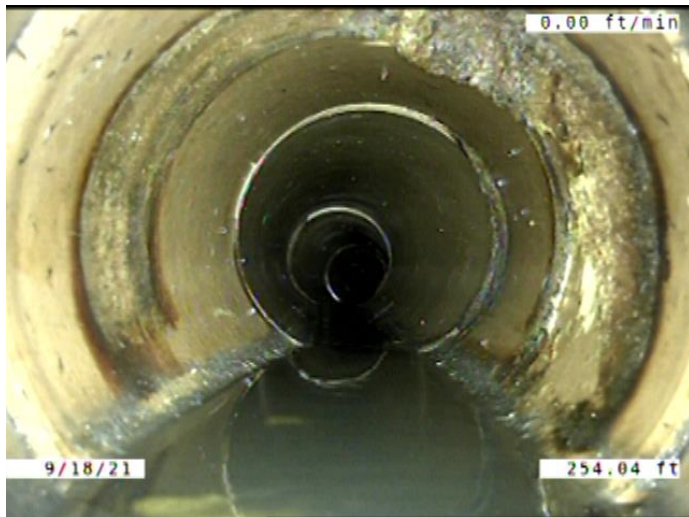
Code: **MWLS**  
 Description: **Miscellaneous Water Level Sag**

Distance (ft): **254.0**  
 Structural Grade: **2**  
 O&M Grade: **0**  
 Clock Start/From:  
 Clock To:  
 1st Value:  
 2nd Value:  
 Value Percent: **5.000**  
 Continuous Index:  
 Within 8" of Joint: **NO**  
 Remarks:

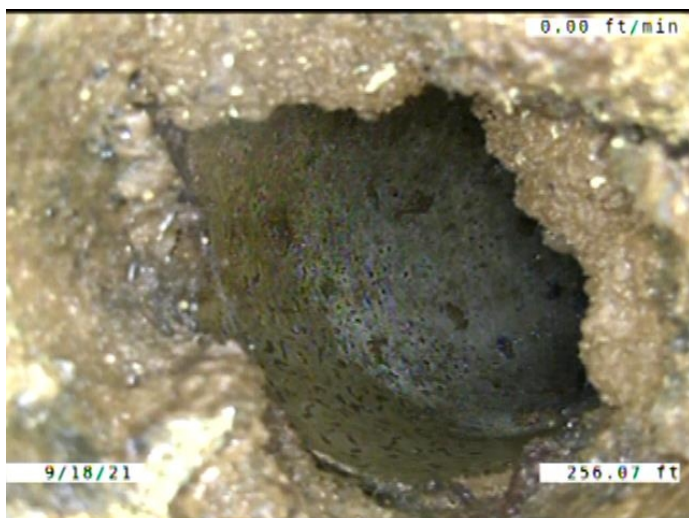
Code: **TFD**  
 Description: **Tap Factory Defective**

Distance (ft): **256.1**  
 Structural Grade: **0**  
 O&M Grade: **3**  
 Clock Start/From: **1**  
 Clock To:  
 1st Value: **4.000**  
 2nd Value:  
 Value Percent:  
 Continuous Index:  
 Within 8" of Joint: **YES**  
 Remarks: **ENCRUSTATION ALL AROUND THE TAP CONNECTION**

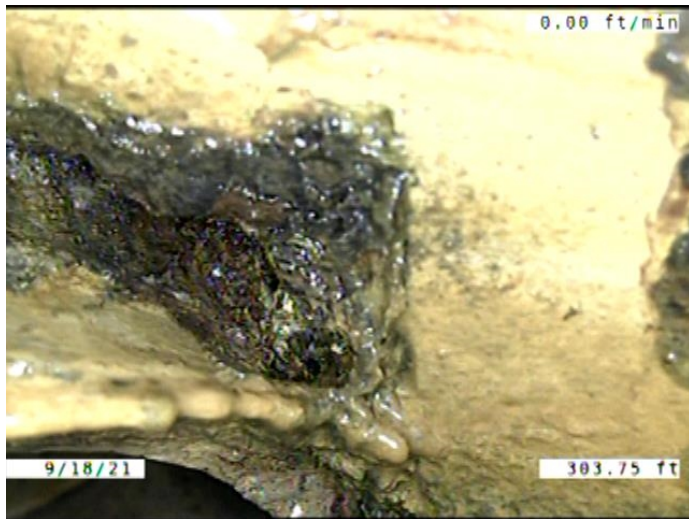
Code: **B**  
Description: **Broken**

Distance (ft): **303.7**  
Structural Grade: **4**  
O&M Grade: **0**  
Clock Start/From: **12**  
Clock To: **2**  
1st Value:  
2nd Value:  
Value Percent:  
Continuous Index:  
Within 8" of Joint: **NO**  
Remarks:

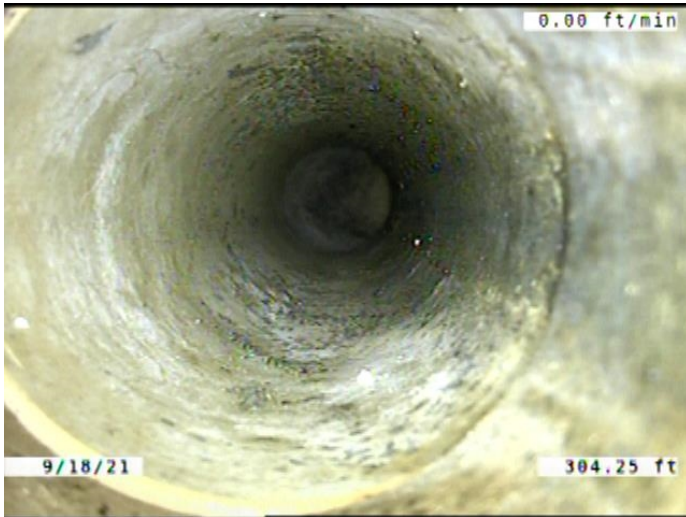
Code: **TBI**  
 Description: **Tap Break-in Intruding**

Distance (ft): **304.2**  
 Structural Grade: **0**  
 O&M Grade: **2**  
 Clock Start/From: **1**  
 Clock To:  
 1st Value: **4.000**  
 2nd Value: **2.000**  
 Value Percent:  
 Continuous Index:  
 Within 8" of Joint: **NO**  
 Remarks:

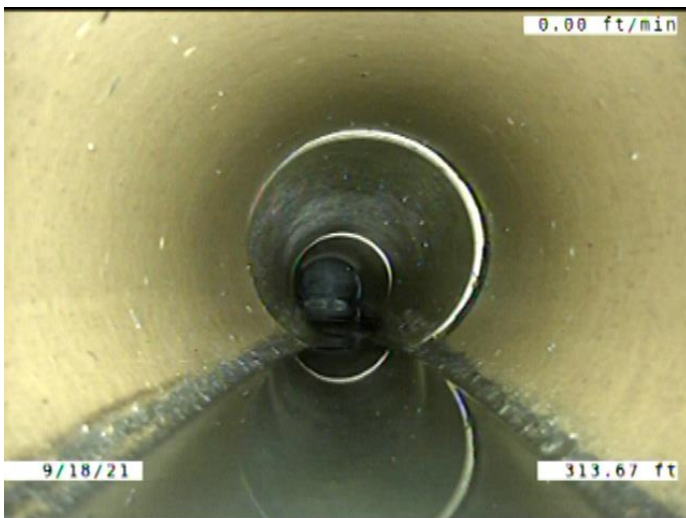
Code: **MWLS**  
 Description: **Miscellaneous Water Level Sag**

Distance (ft): **313.7**  
 Structural Grade: **2**  
 O&M Grade: **0**  
 Clock Start/From:  
 Clock To:  
 1st Value:  
 2nd Value:  
 Value Percent: **5.000**  
 Continuous Index:  
 Within 8" of Joint: **NO**  
 Remarks:

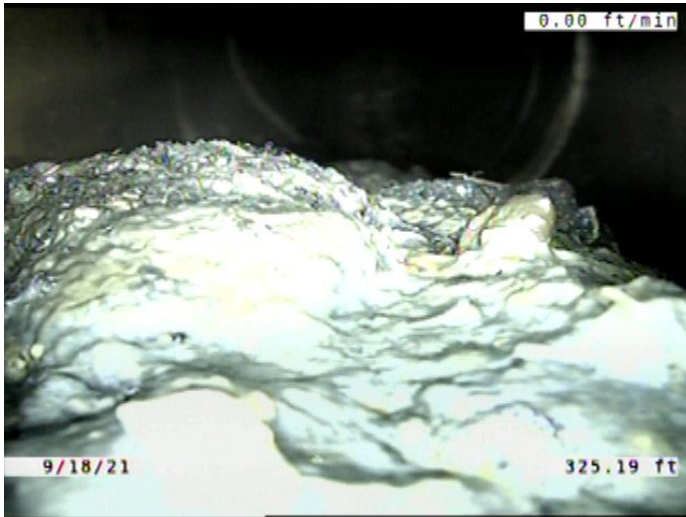
Code: **OBN**  
 Description: **Obstruction Construction Debris**

Distance (ft): **325.2**  
 Structural Grade: **0**  
 O&M Grade: **3**  
 Clock Start/From: **5**  
 Clock To: **7**  
 1st Value:  
 2nd Value:  
 Value Percent: **15.000**  
 Continuous Index:  
 Within 8" of Joint: **YES**  
 Remarks:

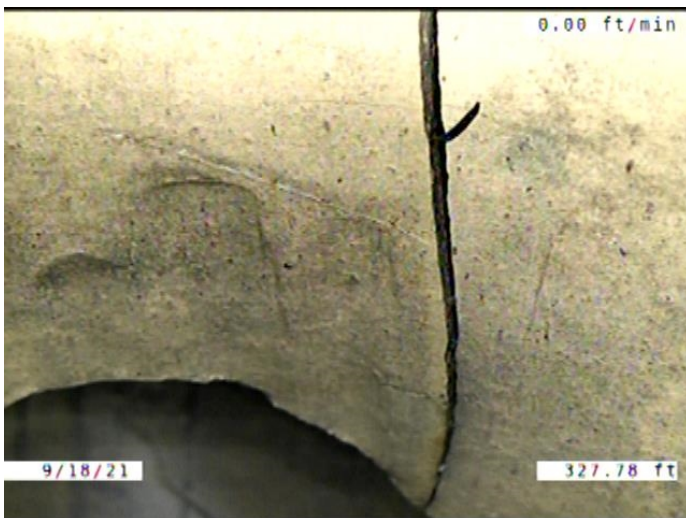
Code: **B**  
 Description: **Broken**

Distance (ft): **327.8**  
 Structural Grade: **4**  
 O&M Grade: **0**  
 Clock Start/From: **12**  
 Clock To: **12**  
 1st Value:  
 2nd Value:  
 Value Percent:  
 Continuous Index:  
 Within 8" of Joint: **YES**  
 Remarks:

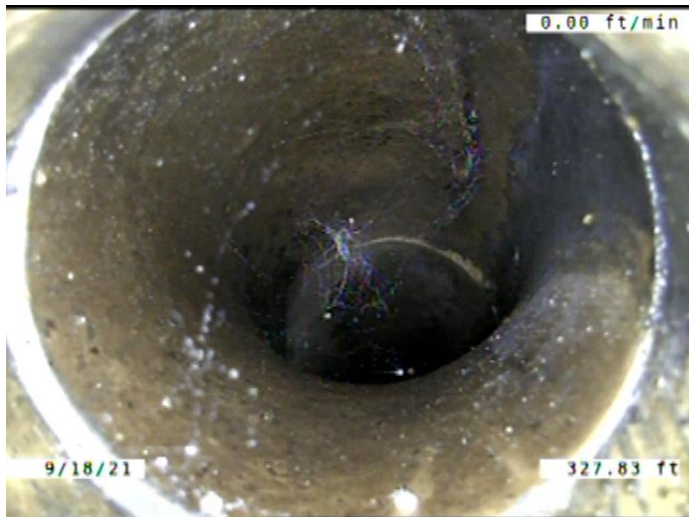
Code: **TFD**  
 Description: **Tap Factory Defective**

Distance (ft): **327.8**  
 Structural Grade: **0**  
 O&M Grade: **3**  
 Clock Start/From: **2**  
 Clock To:  
 1st Value: **4.000**  
 2nd Value:  
 Value Percent:  
 Continuous Index:  
 Within 8" of Joint: **YES**  
 Remarks: **Defective**

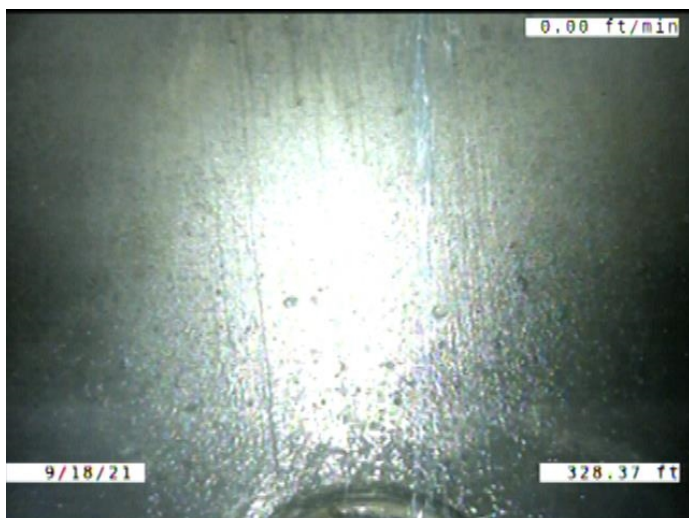
Code: **DAE**  
 Description: **Deposits Attached Encrustation**

Distance (ft): **328.4**  
 Structural Grade: **0**  
 O&M Grade: **2**  
 Clock Start/From: **7**  
 Clock To: **5**  
 1st Value:  
 2nd Value:  
 Value Percent: **5.000**  
 Continuous Index: **F01**  
 Within 8" of Joint: **YES**  
 Remarks:

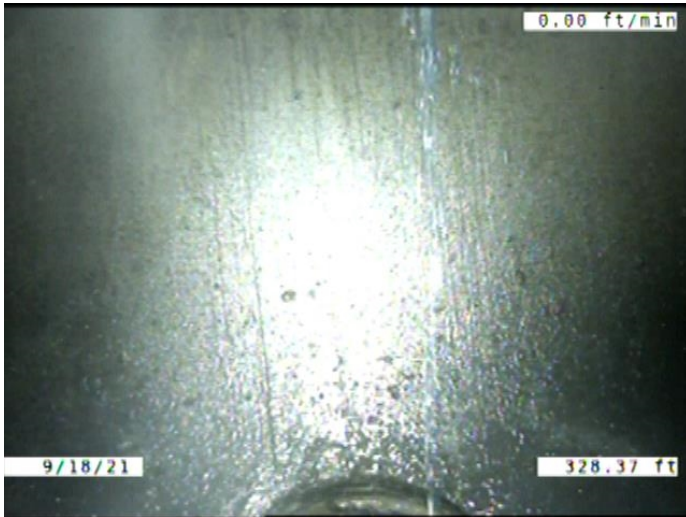
Code: **DSF**  
 Description: **Deposits Settled Fine**

Distance (ft): **328.4**  
 Structural Grade: **0**  
 O&M Grade: **2**  
 Clock Start/From: **5**  
 Clock To: **7**  
 1st Value:  
 2nd Value:  
 Value Percent: **5.000**  
 Continuous Index: **F04**  
 Within 8" of Joint: **YES**  
 Remarks:
