# Profile/Photo Observation Report

| Customer: | <b>City of Hobart</b> | Clean Date: | <b>05/07/2023</b> | Shape: | <b>C</b> |

| Street: | <b>East 34th Lane</b> | Flow Control: | <b>Not Controlled</b> |
| US MH: | <b>M-902-045</b> | DS MH: | <b>M-902-076</b> |

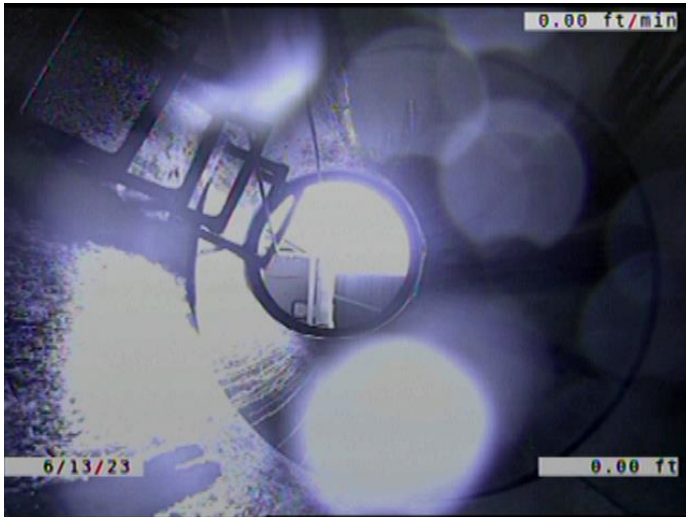
**M-902-045**

Code: **AMH**  
Description: **Manhole**

Distance (ft): **.0**  
Structural Grade: **0**  
O&M Grade: **0**  
Clock Start/From:  
Clock To:  
1st Value:  
2nd Value:  
Value Percent:  
Continuous Index:  
Within 8" of Joint: **NO**  
Remarks: **M-902-076**

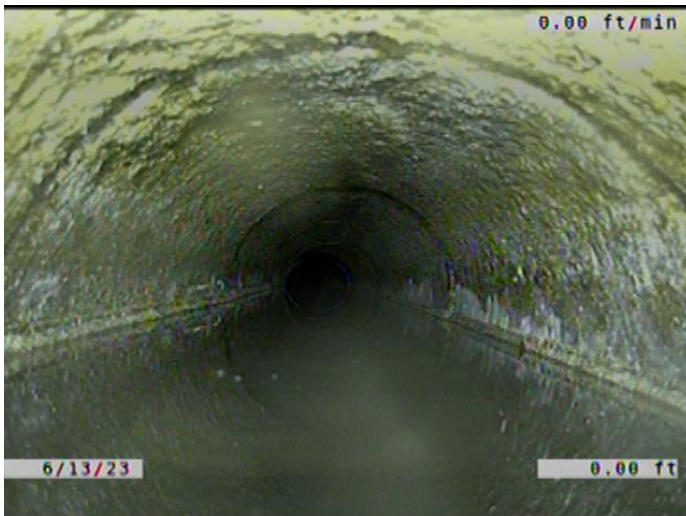
Code: **MWL**  
Description: **Miscellaneous Water Level**

Distance (ft): **.0**  
Structural Grade: **0**  
O&M Grade: **0**  
Clock Start/From:  
Clock To:  
1st Value:  
2nd Value:  
Value Percent: **50.000**  
Continuous Index:  
Within 8" of Joint: **NO**  
Remarks:

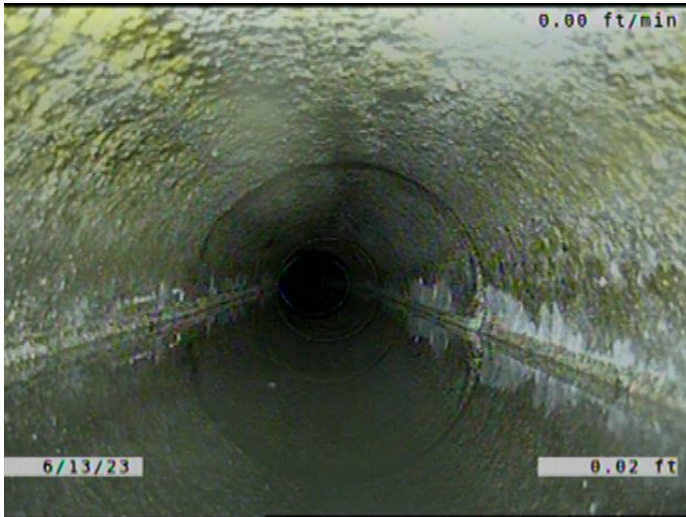
Code: **SAP**  
Description: **Surface Damage Aggregate Projecting**

Distance (ft): **.0**  
Structural Grade: **3**  
O&M Grade: **0**  
Clock Start/From: **9**  
Clock To: **3**  
1st Value:  
2nd Value:  
Value Percent:  
Continuous Index: **S01**  
Within 8" of Joint: **YES**  
Remarks:

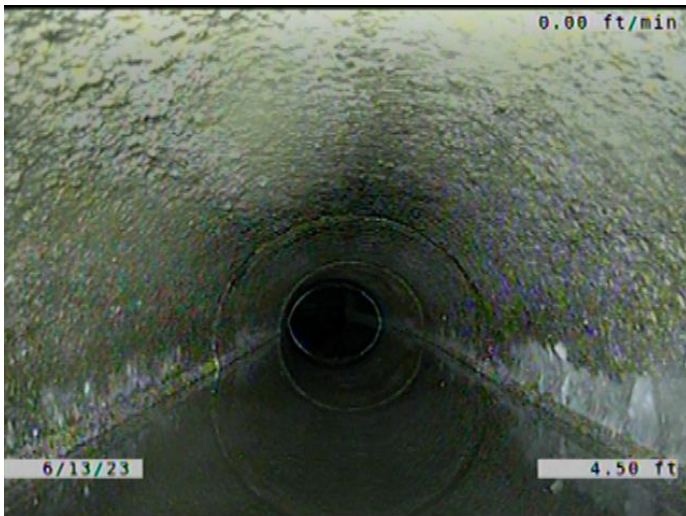
Code: **MWLS**  
Description: **Miscellaneous Water Level Sag**

Distance (ft): **4.5**  
Structural Grade: **4**  
O&M Grade: **0**  
Clock Start/From:  
Clock To:  
1st Value:  
2nd Value:  
Value Percent: **65.000**  
Continuous Index: **S02**  
Within 8" of Joint: **NO**  
Remarks:

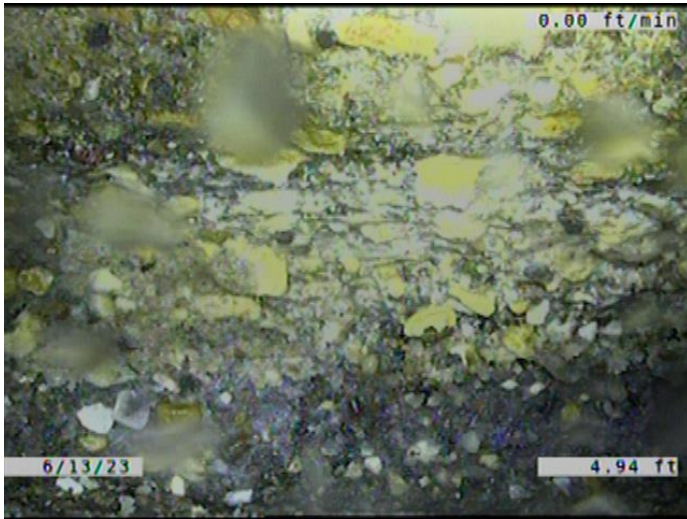
Code: **JOMD**  
Description: **Joint Offset Medium Defective**

Distance (ft): **4.9**  
Structural Grade: **3**  
O&M Grade: **0**  
Clock Start/From:  
Clock To:  
1st Value:  
2nd Value:  
Value Percent:  
Continuous Index:  
Within 8" of Joint: **NO**  
Remarks:

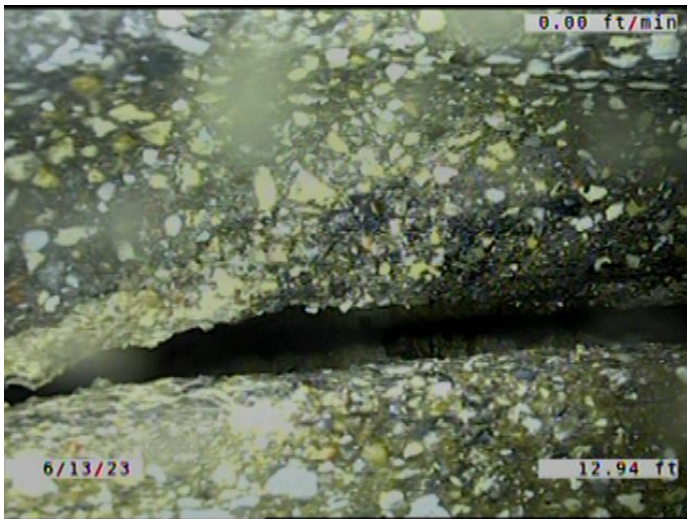
Code: **JSL**  
Description: **Joint Separated Large**

Distance (ft): **12.9**  
Structural Grade: **4**  
O&M Grade: **0**  
Clock Start/From:  
Clock To:  
1st Value:  
2nd Value:  
Value Percent:  
Continuous Index:  
Within 8" of Joint: **NO**  
Remarks: **SOIL AND VOID VISIBLE.**

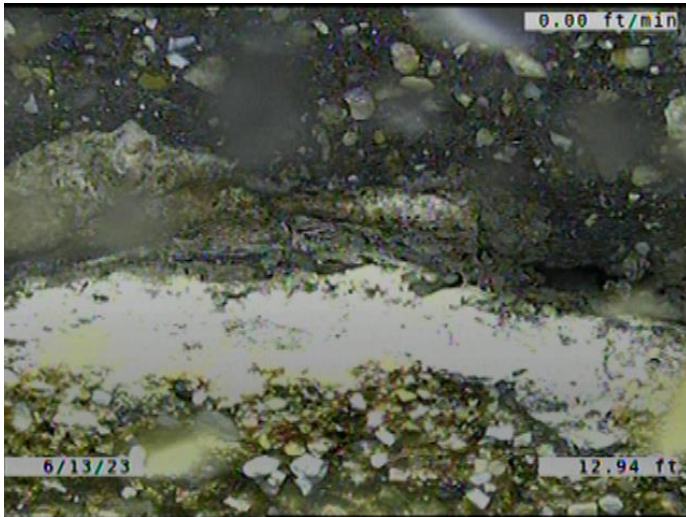
Code: **DAE**  
Description: **Deposits Attached Encrustation**

Distance (ft): **12.9**  
Structural Grade: **0**  
O&M Grade: **2**  
Clock Start/From: **9**  
Clock To: **3**  
1st Value:  
2nd Value:  
Value Percent: **5.000**  
Continuous Index: **S03**  
Within 8" of Joint: **YES**  
Remarks:

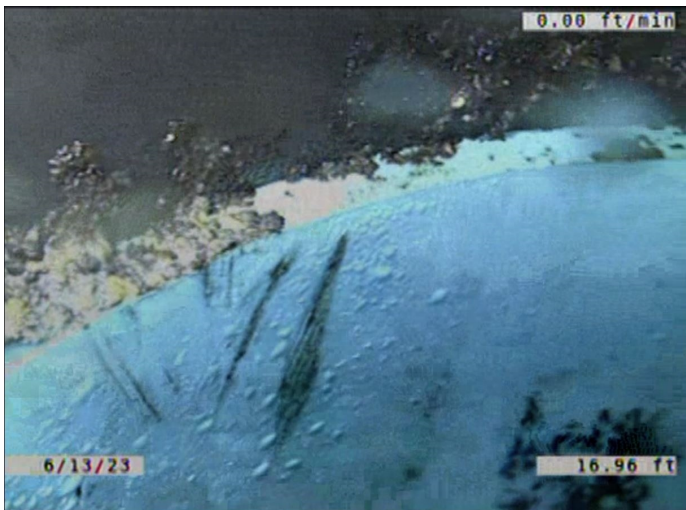
Code: **SAM**  
Description: **Surface Damage Aggregate Missing**

Distance (ft): **16.7**  
Structural Grade: **4**  
O&M Grade: **0**  
Clock Start/From: **9**  
Clock To: **3**  
1st Value:  
2nd Value:  
Value Percent:  
Continuous Index: **F01**  
Within 8" of Joint: **YES**  
Remarks:

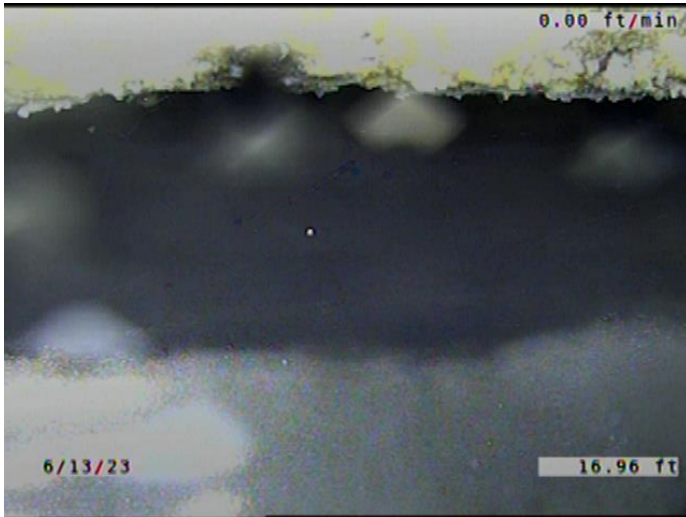
Code: **RPR**  
Description: **Point Repair Replacement**

Distance (ft): **17.0**  
Structural Grade: **0**  
O&M Grade: **0**  
Clock Start/From:  
Clock To:  
1st Value:  
2nd Value:  
Value Percent:  
Continuous Index: **S04**  
Within 8" of Joint: **YES**  
Remarks: **REPLACED WITH PVC.**

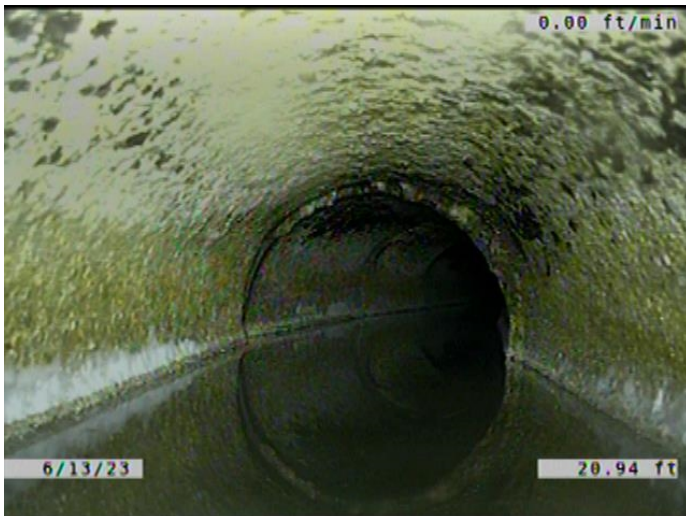
Code: **MWLS**  
Description: **Miscellaneous Water Level Sag**

Distance (ft): **20.9**  
Structural Grade: **4**  
O&M Grade: **0**  
Clock Start/From:  
Clock To:  
1st Value:  
2nd Value:  
Value Percent: **65.000**  
Continuous Index: **F02**  
Within 8" of Joint: **NO**  
Remarks:

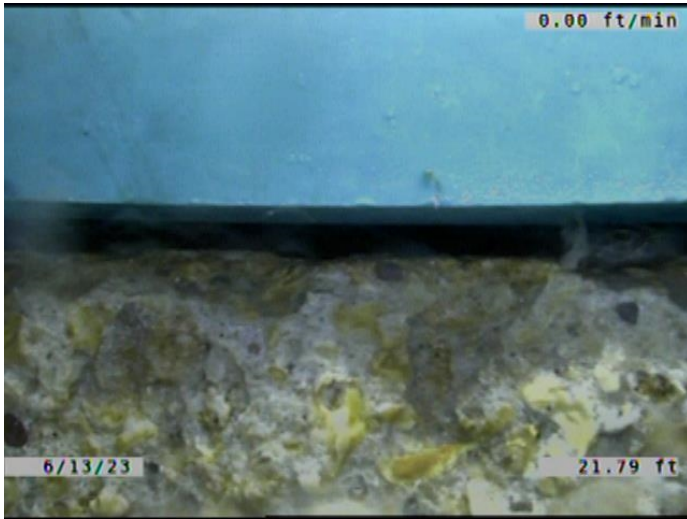
Code: **RPR**  
Description: **Point Repair Replacement**

Distance (ft): **21.8**  
Structural Grade: **0**  
O&M Grade: **0**  
Clock Start/From:  
Clock To:  
1st Value:  
2nd Value:  
Value Percent:  
Continuous Index: **F04**  
Within 8" of Joint: **YES**  
Remarks: **REPLACED WITH PVC.**

Code: **SRI**  
Description: **Surface Damage Roughness Increased**

Distance (ft): **21.8**  
Structural Grade: **1**  
O&M Grade: **0**  
Clock Start/From: **8**  
Clock To: **4**  
1st Value:  
2nd Value:  
Value Percent:  
Continuous Index: **S13**  
Within 8" of Joint: **NO**  
Remarks:

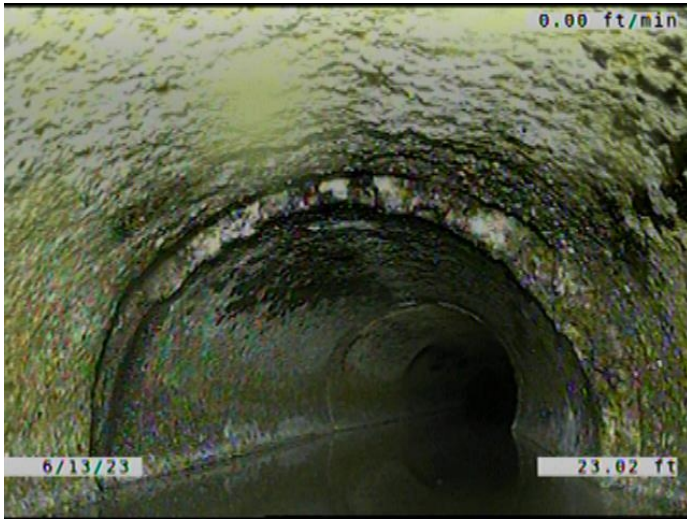
Code: **MWLS**  
Description: **Miscellaneous Water Level Sag**

Distance (ft): **23.0**  
Structural Grade: **3**  
O&M Grade: **0**  
Clock Start/From:  
Clock To:  
1st Value:  
2nd Value:  
Value Percent: **50.000**  
Continuous Index: **S05**  
Within 8" of Joint: **NO**  
Remarks:

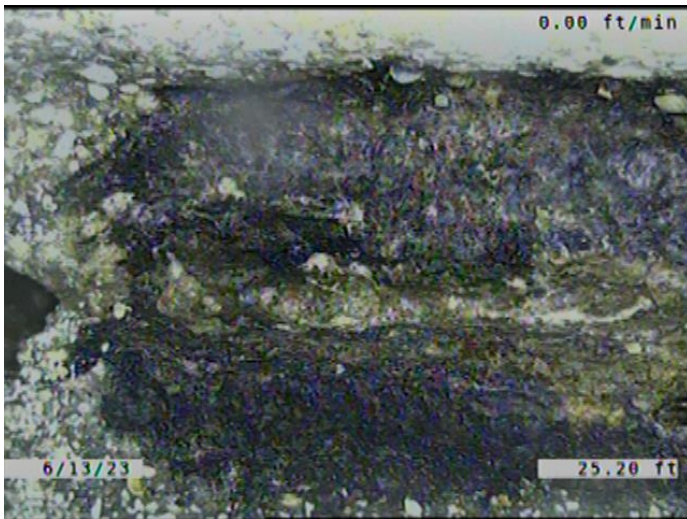
Code: **JAL**  
Description: **Joint Angular Large**

Distance (ft): **25.2**  
Structural Grade: **4**  
O&M Grade: **0**  
Clock Start/From:  
Clock To:  
1st Value:  
2nd Value:  
Value Percent:  
Continuous Index:  
Within 8" of Joint: **NO**  
Remarks:

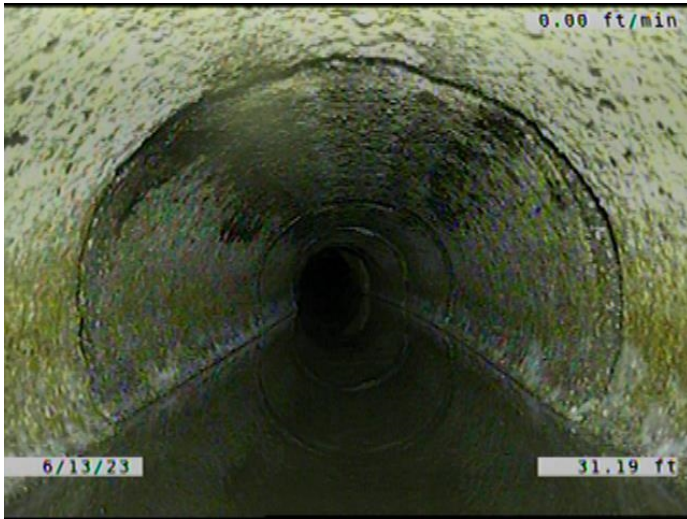
Code: **MWLS**  
Description: **Miscellaneous Water Level Sag**

Distance (ft): **31.2**  
Structural Grade: **3**  
O&M Grade: **0**  
Clock Start/From:  
Clock To:  
1st Value:  
2nd Value:  
Value Percent: **50.000**  
Continuous Index: **F05**  
Within 8" of Joint: **NO**  
Remarks:

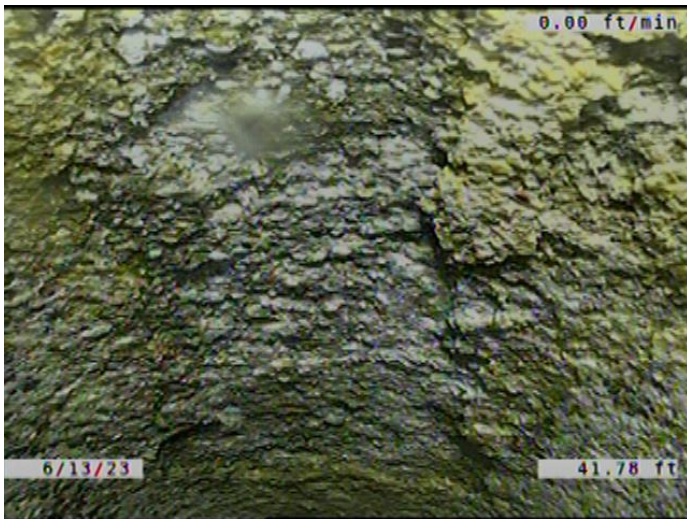
Code: **SAM**  
Description: **Surface Damage Aggregate Missing**

Distance (ft): **41.8**  
Structural Grade: **4**  
O&M Grade: **0**  
Clock Start/From: **11**  
Clock To: **1**  
1st Value:  
2nd Value:  
Value Percent:  
Continuous Index:  
Within 8" of Joint: **NO**  
Remarks:

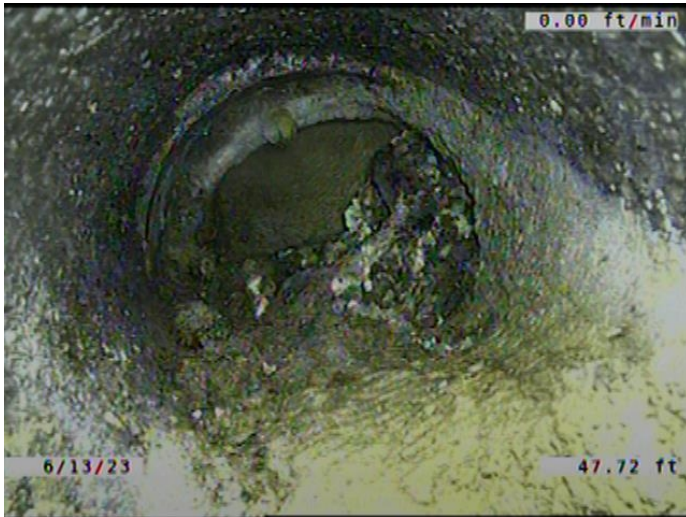
| Description: | <b>Tap Factory Defective</b> |
| O&M Grade: | <b>3</b> |
| Remarks: | <b>SERVICE OFFSET. ENCRUSTATION<br/>COMING FROM THE SERVICE INTO T</b> |

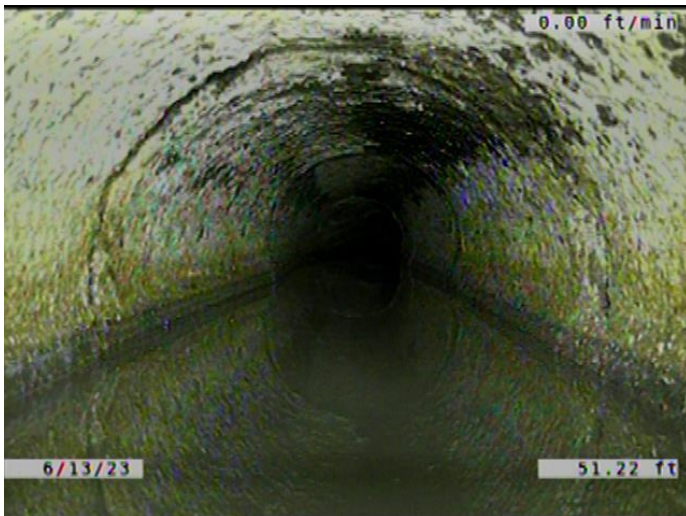
| Description: | <b>Miscellaneous Water Level Sag</b> |
| Structural Grade: | <b>3</b> |

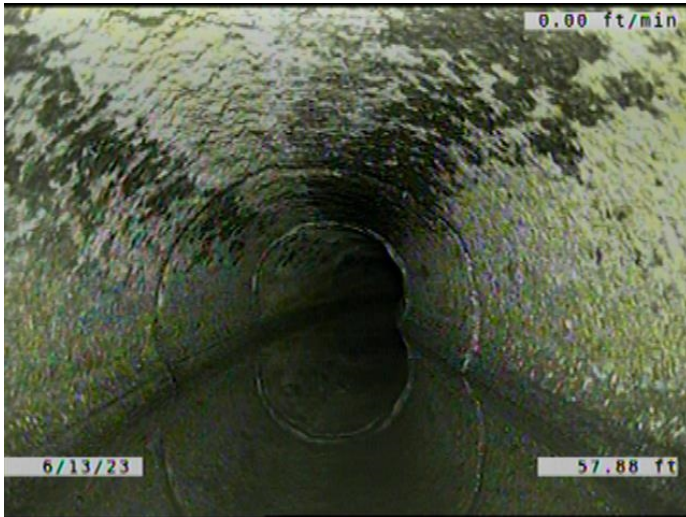
Code: **MWLS**  
Description: **Miscellaneous Water Level Sag**

Distance (ft): **57.9**  
Structural Grade: **3**  
O&M Grade: **0**  
Clock Start/From:  
Clock To:  
1st Value:  
2nd Value:  
Value Percent: **50.000**  
Continuous Index: **F06**  
Within 8" of Joint: **NO**  
Remarks:

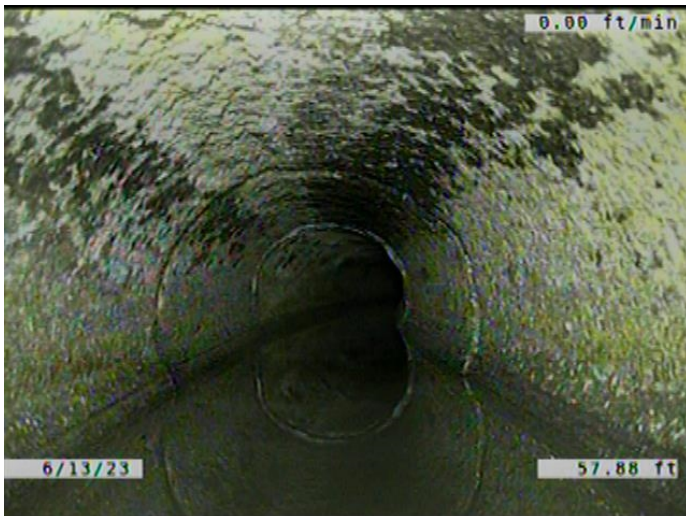
Code: **MWL**  
Description: **Miscellaneous Water Level**

Distance (ft): **57.9**  
Structural Grade: **0**  
O&M Grade: **0**  
Clock Start/From:  
Clock To:  
1st Value:  
2nd Value:  
Value Percent: **30.000**  
Continuous Index:  
Within 8" of Joint: **NO**  
Remarks:

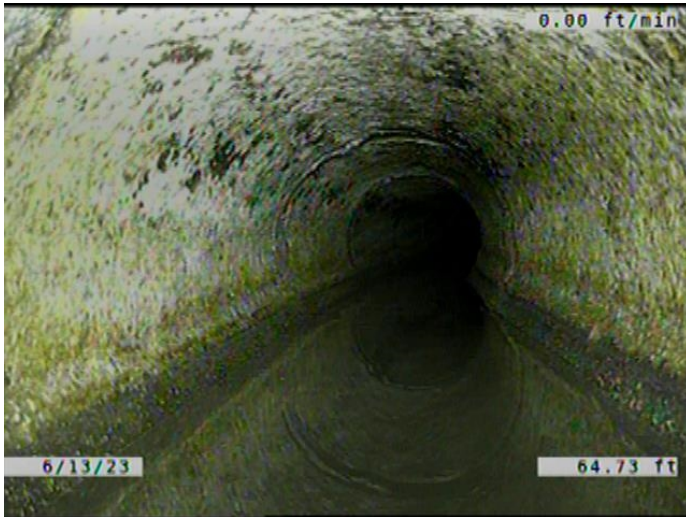
Code: **LR**  
Description: **Line Right**

Distance (ft): **64.7**  
Structural Grade: **0**  
O&M Grade: **2**  
Clock Start/From:  
Clock To:  
1st Value:  
2nd Value:  
Value Percent: **15.000**  
Continuous Index:  
Within 8" of Joint: **NO**  
Remarks:

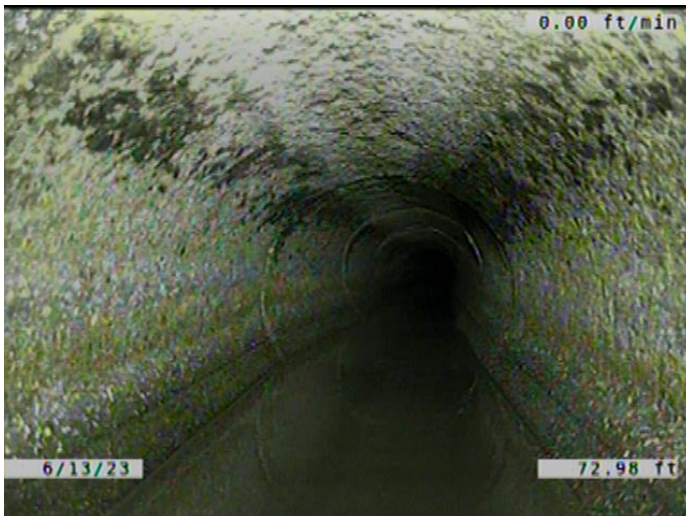
Code: **LR**  
Description: **Line Right**

Distance (ft): **73.0**  
Structural Grade: **0**  
O&M Grade: **1**  
Clock Start/From:  
Clock To:  
1st Value:  
2nd Value:  
Value Percent: **5.000**  
Continuous Index:  
Within 8" of Joint: **NO**  
Remarks:

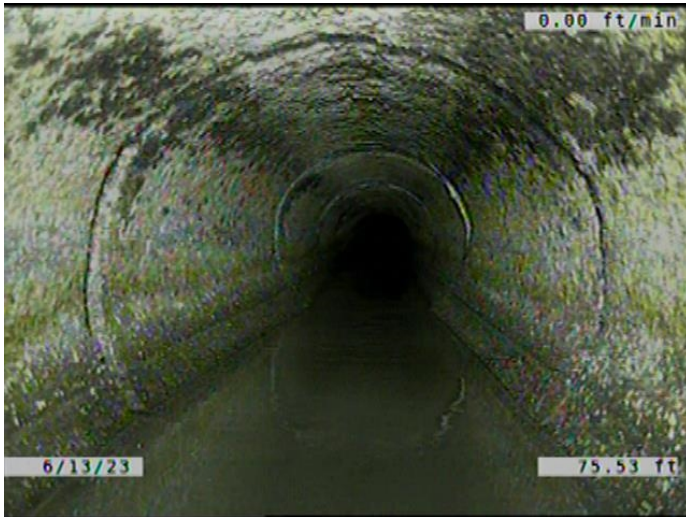
Code: **MWLS**  
Description: **Miscellaneous Water Level Sag**

Distance (ft): **75.5**  
Structural Grade: **2**  
O&M Grade: **0**  
Clock Start/From:  
Clock To:  
1st Value:  
2nd Value:  
Value Percent: **20.000**  
Continuous Index: **S07**  
Within 8" of Joint: **NO**  
Remarks:

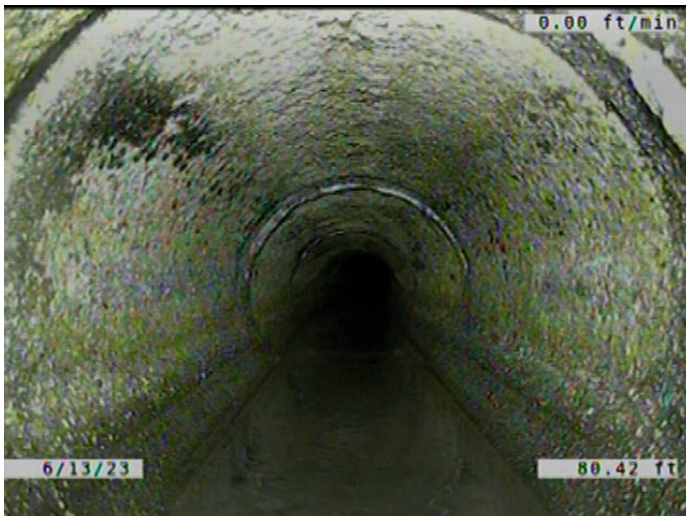
Code: **MWLS**  
Description: **Miscellaneous Water Level Sag**

Distance (ft): **80.4**  
Structural Grade: **2**  
O&M Grade: **0**  
Clock Start/From:  
Clock To:  
1st Value:  
2nd Value:  
Value Percent: **20.000**  
Continuous Index: **F07**  
Within 8" of Joint: **NO**  
Remarks:

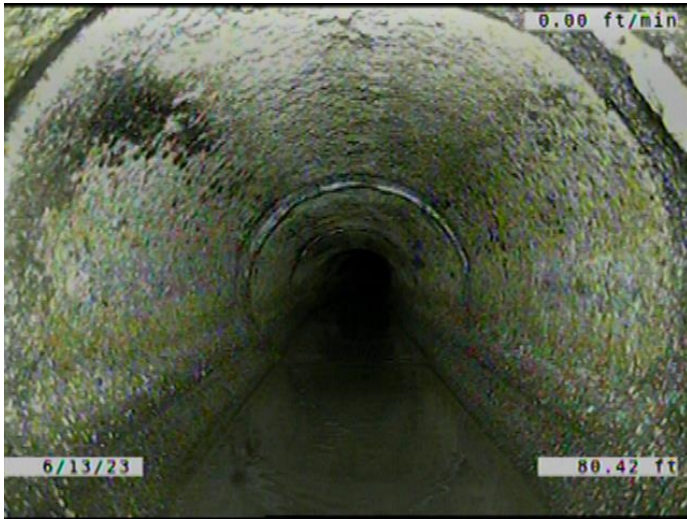
Code: **MWL**  
Description: **Miscellaneous Water Level**

Distance (ft): **80.4**  
Structural Grade: **0**  
O&M Grade: **0**  
Clock Start/From:  
Clock To:  
1st Value:  
2nd Value:  
Value Percent: **15.000**  
Continuous Index:  
Within 8" of Joint: **NO**  
Remarks:

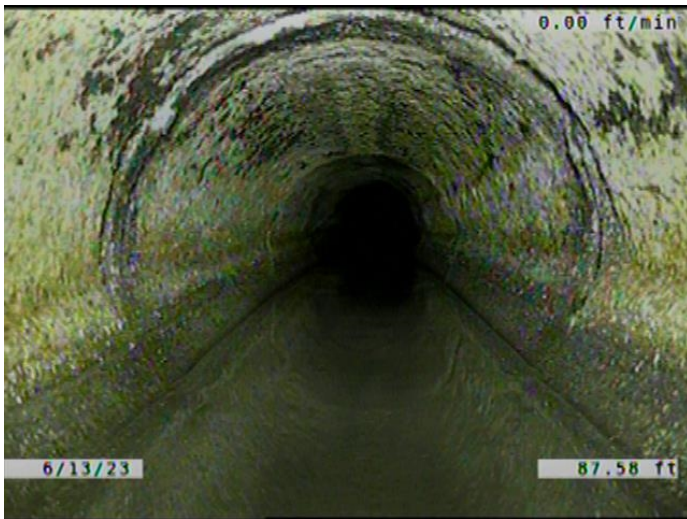
Code: **MWLS**  
Description: **Miscellaneous Water Level Sag**

Distance (ft): **87.6**  
Structural Grade: **2**  
O&M Grade: **0**  
Clock Start/From:  
Clock To:  
1st Value:  
2nd Value:  
Value Percent: **20.000**  
Continuous Index: **S08**  
Within 8" of Joint: **NO**  
Remarks:

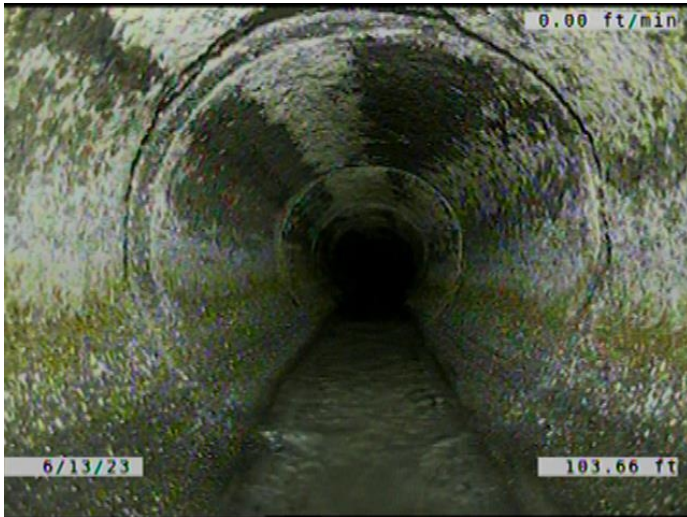
Code: **MWLS**  
Description: **Miscellaneous Water Level Sag**

Distance (ft): **103.7**  
Structural Grade: **2**  
O&M Grade: **0**  
Clock Start/From:  
Clock To:  
1st Value:  
2nd Value:  
Value Percent: **20.000**  
Continuous Index: **F08**  
Within 8" of Joint: **NO**  
Remarks:

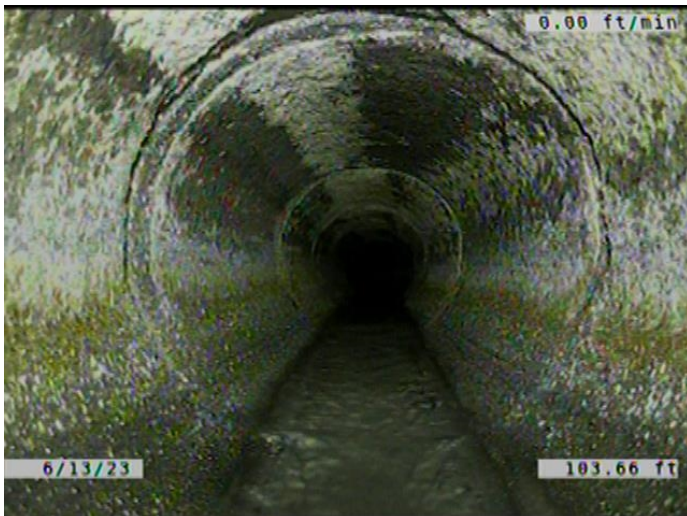
Code: **MWL**  
Description: **Miscellaneous Water Level**

Distance (ft): **103.7**  
Structural Grade: **0**  
O&M Grade: **0**  
Clock Start/From:  
Clock To:  
1st Value:  
2nd Value:  
Value Percent: **5.000**  
Continuous Index:  
Within 8" of Joint: **NO**  
Remarks:

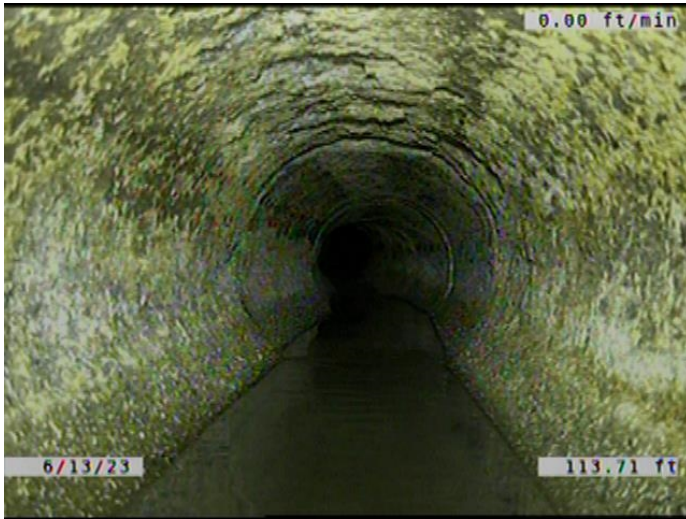
| Description: | <b>Surface Damage Aggregate Missing</b> |
| Structural Grade: | <b>4</b> |

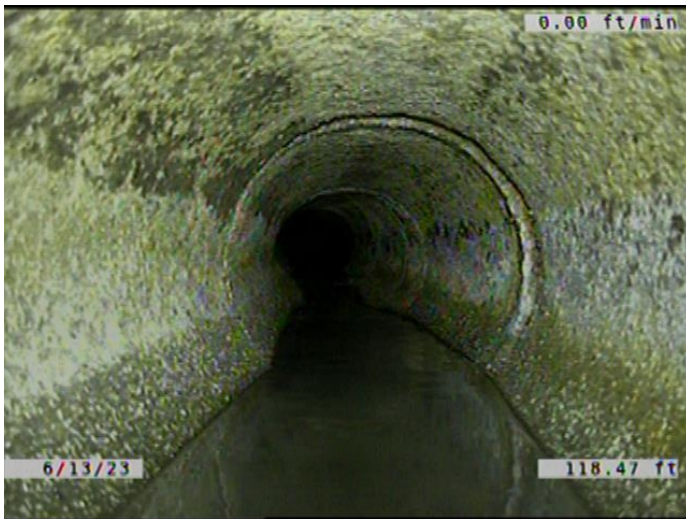
| Description: | <b>Surface Damage Aggregate Missing</b> |
| Structural Grade: | <b>4</b> |

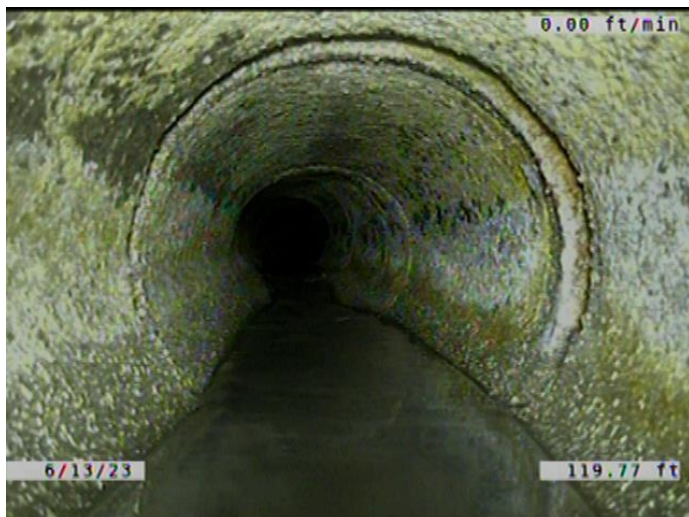
Code: **MWLS**  
Description: **Miscellaneous Water Level Sag**

Distance (ft): **119.8**  
Structural Grade: **2**  
O&M Grade: **0**  
Clock Start/From:  
Clock To:  
1st Value:  
2nd Value:  
Value Percent: **15.000**  
Continuous Index: **S10**  
Within 8" of Joint: **NO**  
Remarks:

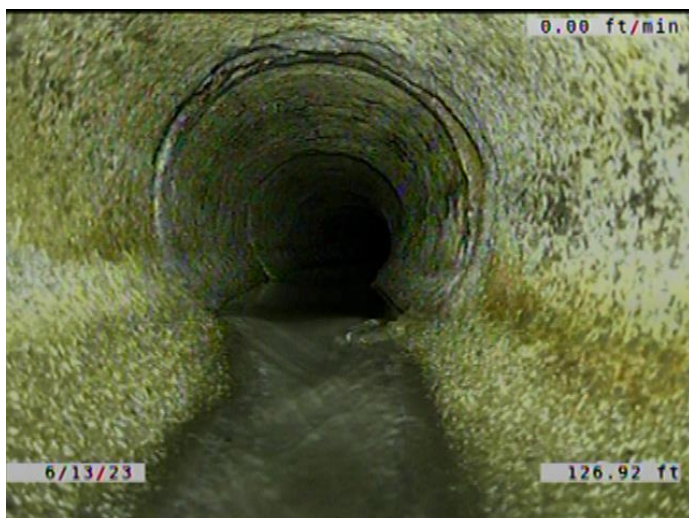
Code: **MWLS**  
Description: **Miscellaneous Water Level Sag**

Distance (ft): **126.9**  
Structural Grade: **2**  
O&M Grade: **0**  
Clock Start/From:  
Clock To:  
1st Value:  
2nd Value:  
Value Percent: **15.000**  
Continuous Index: **F10**  
Within 8" of Joint: **NO**  
Remarks:

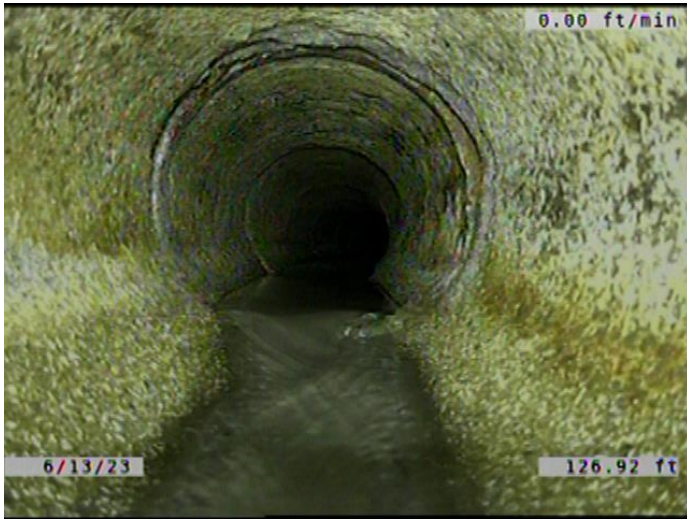
Code: **LU**  
Description: **Line Up**

Distance (ft): **126.9**  
Structural Grade: **0**  
O&M Grade: **1**  
Clock Start/From:  
Clock To:  
1st Value:  
2nd Value:  
Value Percent: **5.000**  
Continuous Index:  
Within 8" of Joint: **NO**  
Remarks:

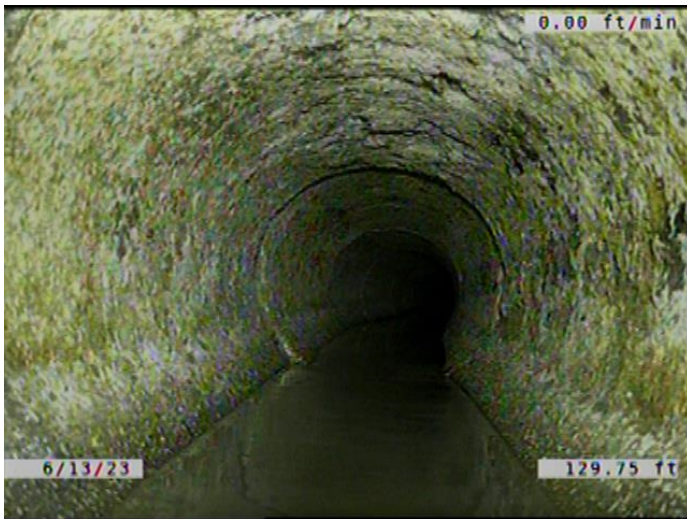
Code: **SAM**  
Description: **Surface Damage Aggregate Missing**

Distance (ft): **129.8**  
Structural Grade: **4**  
O&M Grade: **0**  
Clock Start/From: **10**  
Clock To: **3**  
1st Value:  
2nd Value:  
Value Percent:  
Continuous Index: **S11**  
Within 8" of Joint: **YES**  
Remarks:

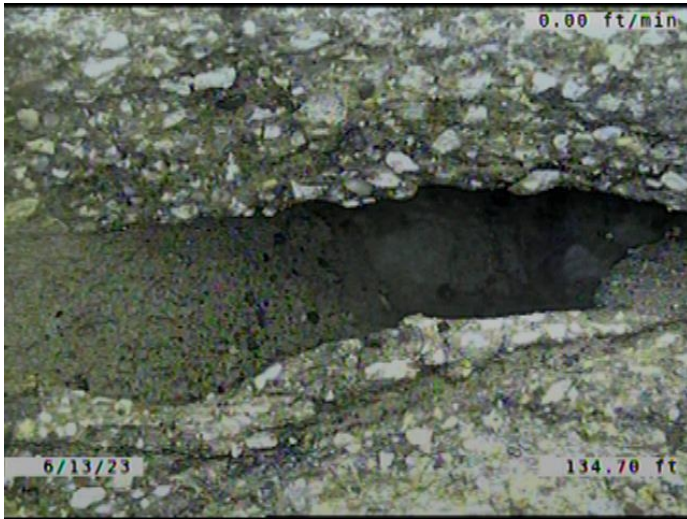
Code: **SMW**  
Description: **Surface Damage Missing Wall**

Distance (ft): **134.7**  
Structural Grade: **5**  
O&M Grade: **0**  
Clock Start/From: **8**  
Clock To: **4**  
1st Value:  
2nd Value:  
Value Percent:  
Continuous Index:  
Within 8" of Joint: **YES**  
Remarks: **SOIL AND VOID VISIBLE.**

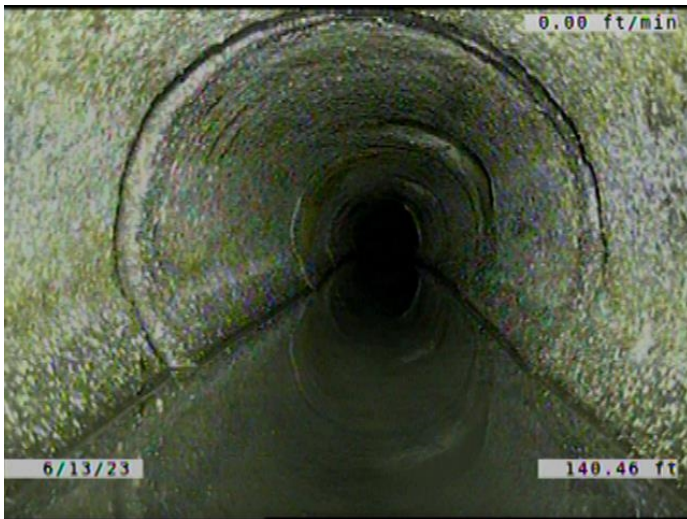
Code: **SAM**  
Description: **Surface Damage Aggregate Missing**

Distance (ft): **140.5**  
Structural Grade: **4**  
O&M Grade: **0**  
Clock Start/From: **10**  
Clock To: **3**  
1st Value:  
2nd Value:  
Value Percent:  
Continuous Index: **F11**  
Within 8" of Joint: **YES**  
Remarks:

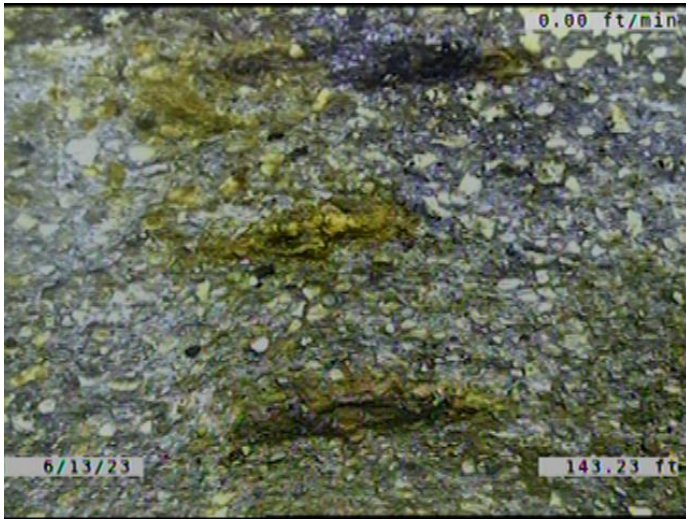
Code: **SRC**  
Description: **Surface Damage Reinforcement Corroded**

Distance (ft): **143.2**  
Structural Grade: **5**  
O&M Grade: **0**  
Clock Start/From: **10**  
Clock To: **11**  
1st Value:  
2nd Value:  
Value Percent:  
Continuous Index:  
Within 8" of Joint: **YES**  
Remarks:

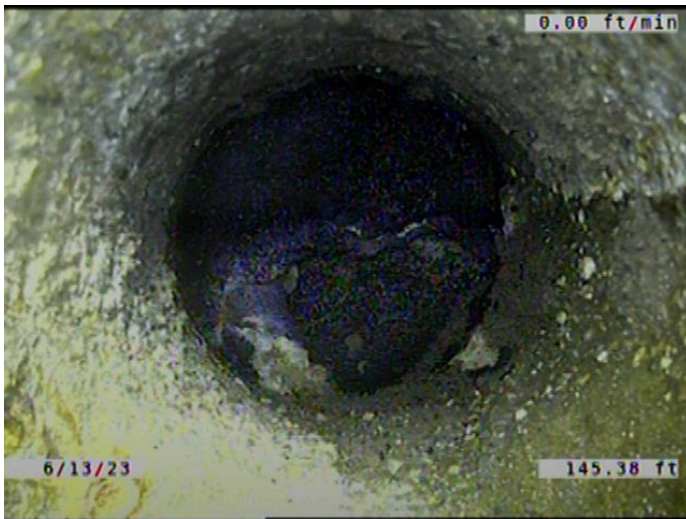
Code: **TFD**  
Description: **Tap Factory Defective**

Distance (ft): **145.4**  
Structural Grade: **0**  
O&M Grade: **3**  
Clock Start/From: **1**  
Clock To:  
1st Value: **6.000**  
2nd Value:  
Value Percent:  
Continuous Index:  
Within 8" of Joint: **YES**  
Remarks: **LOOKS LIKE IT MIGHT BE PLUGGED.**

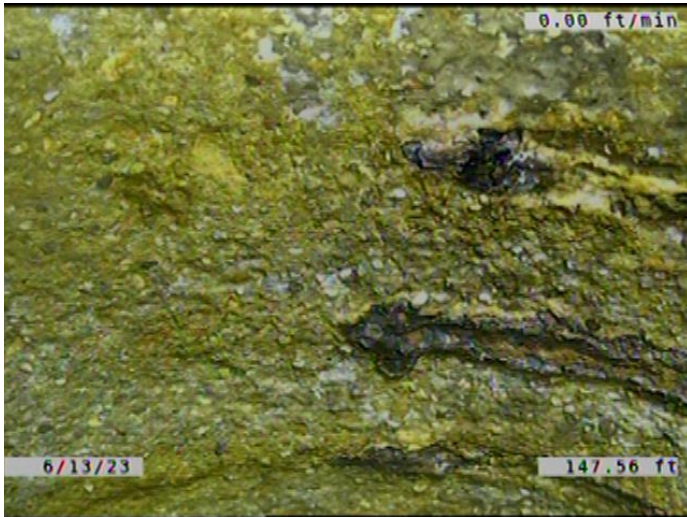
| Description: | <b>Surface Damage Reinforcement Corroded</b> |
| Structural Grade: | <b>5</b> |

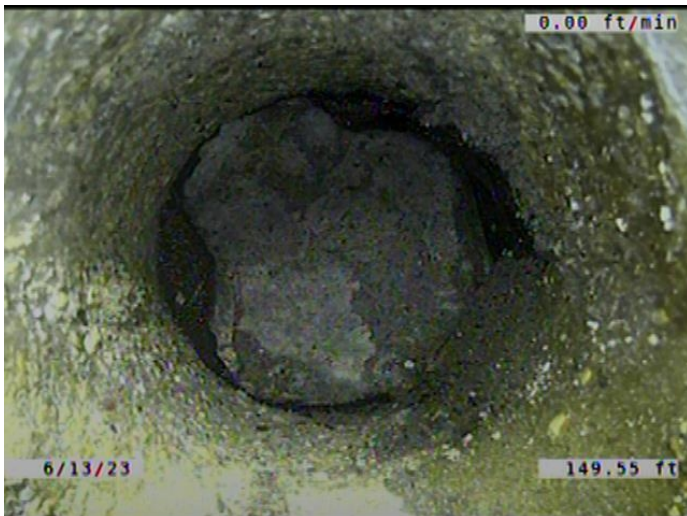
| Description: | <b>Tap Factory Capped</b> |

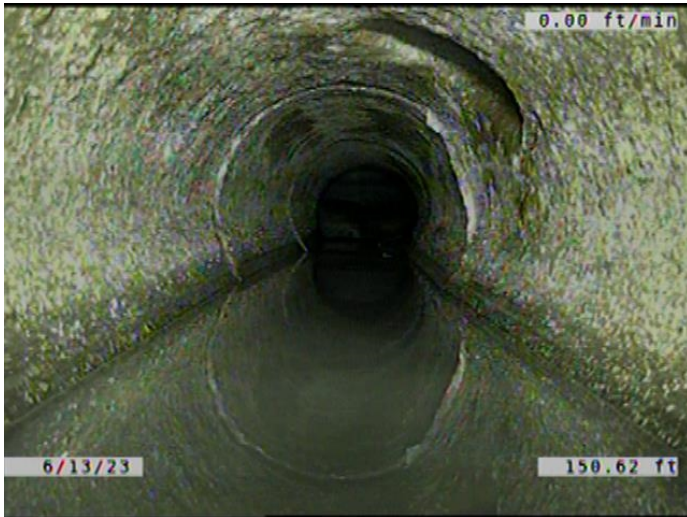
Code: **SRC**  
Description: **Surface Damage Reinforcement Corroded**

Distance (ft): **150.6**  
Structural Grade: **5**  
O&M Grade: **0**  
Clock Start/From: **10**  
Clock To: **12**  
1st Value:  
2nd Value:  
Value Percent:  
Continuous Index: **F12**  
Within 8" of Joint: **YES**  
Remarks:

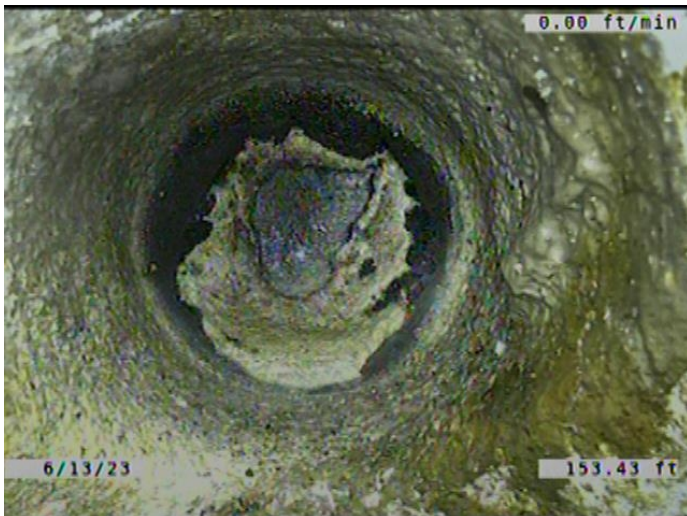
Code: **TFD**  
Description: **Tap Factory Defective**

Distance (ft): **153.4**  
Structural Grade: **0**  
O&M Grade: **3**  
Clock Start/From: **1**  
Clock To:  
1st Value: **6.000**  
2nd Value:  
Value Percent:  
Continuous Index:  
Within 8" of Joint: **YES**  
Remarks: **PLUGGED OFF. SOIL VISIBLE THROUGH THE CAP. ENCRUSTATION**

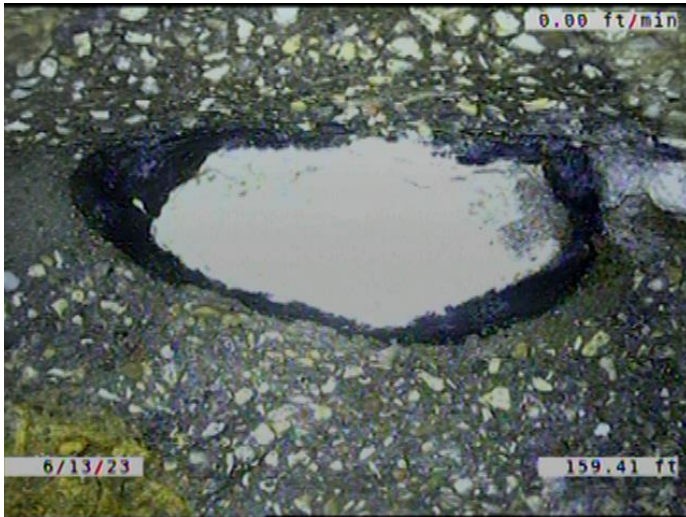
Code: **RPP**  
Description: **Point Repair Patch**

Distance (ft): **159.4**  
Structural Grade: **0**  
O&M Grade: **0**  
Clock Start/From: **12**  
Clock To: **1**  
1st Value:  
2nd Value:  
Value Percent:  
Continuous Index:  
Within 8" of Joint: **YES**  
Remarks: **SEALANT VISIBLE.**

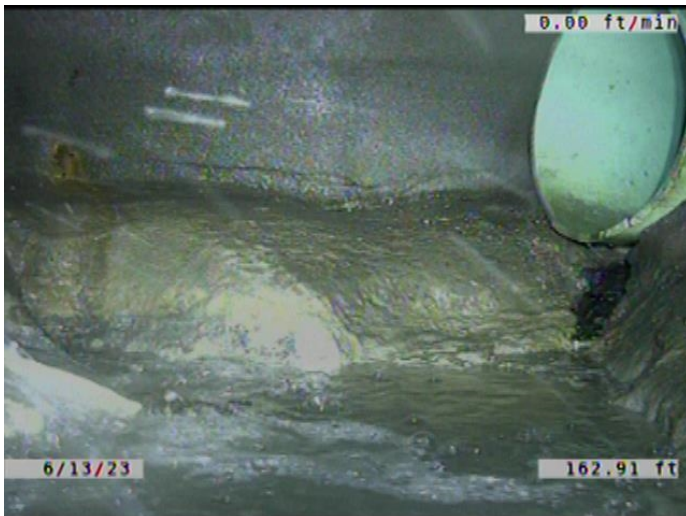
Code: **SRI**  
Description: **Surface Damage Roughness Increased**

Distance (ft): **162.9**  
Structural Grade: **1**  
O&M Grade: **0**  
Clock Start/From: **8**  
Clock To: **4**  
1st Value:  
2nd Value:  
Value Percent:  
Continuous Index: **F13**  
Within 8" of Joint: **YES**  
Remarks:

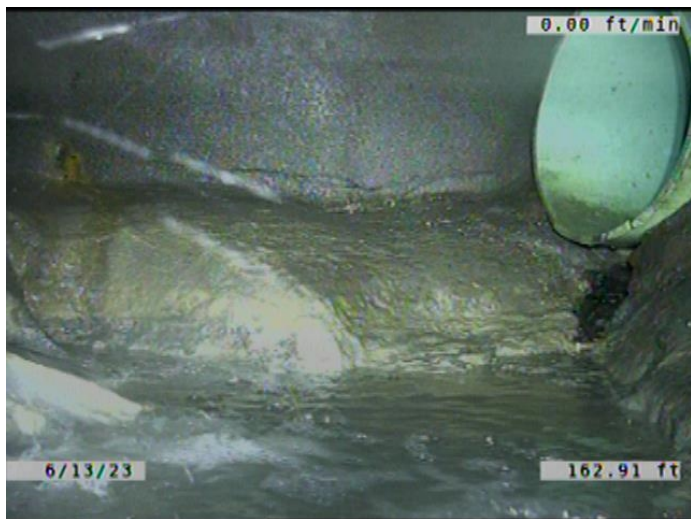
| Description: | <b>Deposits Attached Encrustation</b> |
| O&M Grade: | <b>2</b> |

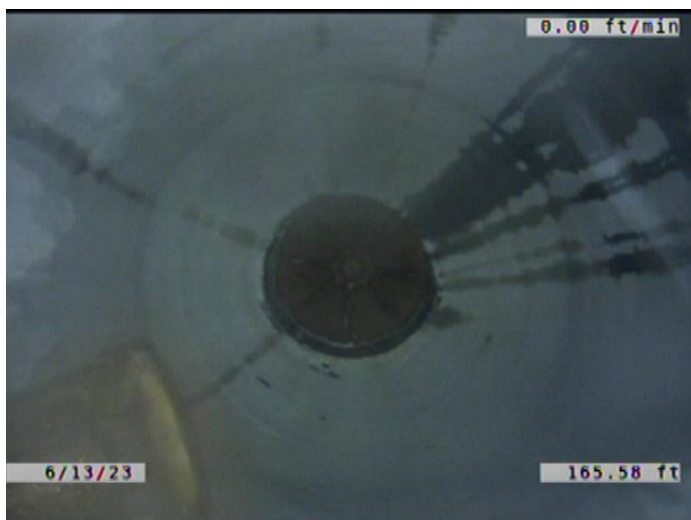
| Remarks: | <b>M-902-045</b> |

| Description: | <b>Manhole</b> |
