## Profile/Photo Observation Report

Date:	<b>09/10/2021</b>	Weather:		Coding:	<b>PACP 7.0</b>
Pipe Length (ft):	<b>50.0</b>	Owner:	<b>City of Hobart</b>	Pre Clean:	<b>No Pre-Cleaning</b>
P.O.#:	<b>YES502259</b>	Surveyor:	<b>S. Bucklin</b>	PSR:	<b>M-504-104.R_M-504-104</b>
Customer:	<b>City of Hobart</b>	Clean Date:		Shape:	<b>C</b>

Street:	<b>North Colorado Street</b>	Flow Control:	<b>Not Controlled</b>
City:	<b>Hobart, IN</b>	Year Renewed:	
Location:	<b>Alley</b>	Tape/Media #:	
Purpose:	<b>Routine Assessment</b>	Dia/Height:	<b>8"</b>
Use:	<b>Sanitary Sewage Pipe</b>	Material:	<b>CP</b>
Drain Area:		Lining:	<b>None</b>
Category:	<b>NA</b>		
Comment:			
Location Details:		Direction of Survey:	<b>Upstream</b>
US MH:	<b>M-504-104.R</b>	DS MH:	<b>M-504-104</b>
		Total Length Surveyed (ft):	<b>1.6</b>

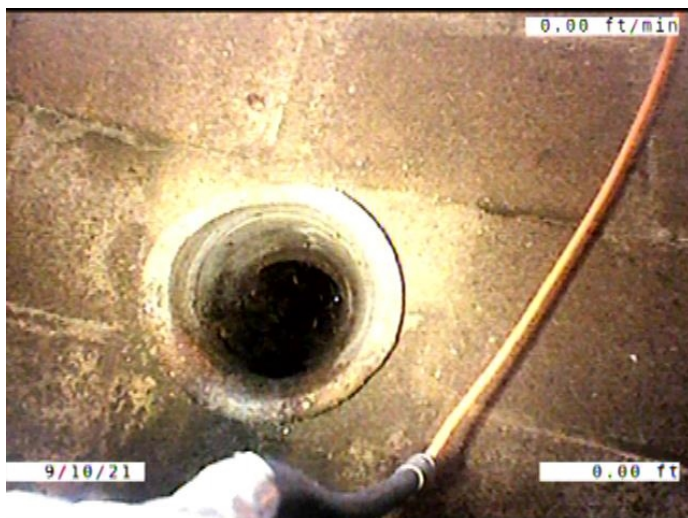
Code: **AMH**  
Description: **Manhole**

Distance (ft): **.0**  
Structural Grade: **0**  
O&M Grade: **0**  
Clock Start/From:  
Clock To:  
1st Value:  
2nd Value:  
Value Percent:  
Continuous Index:  
Within 8" of Joint: **NO**  
Remarks: **M-504-104**

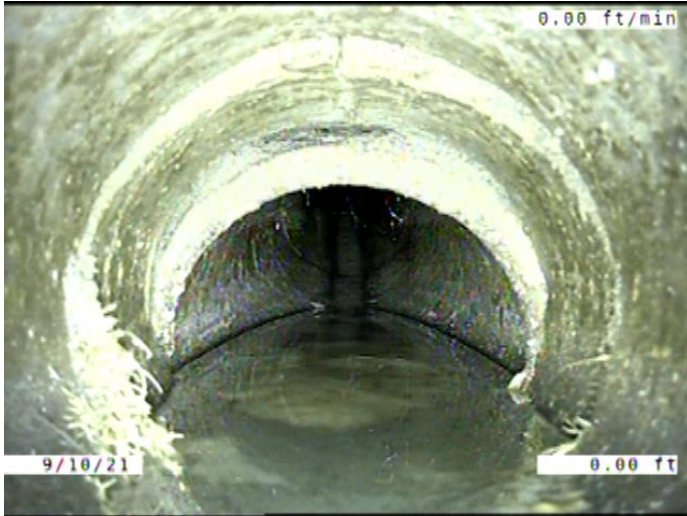
Code: **MWL**  
Description: **Miscellaneous Water Level**

Distance (ft): **.0**  
Structural Grade: **0**  
O&M Grade: **0**  
Clock Start/From:  
Clock To:  
1st Value:  
2nd Value:  
Value Percent: **5.000**  
Continuous Index:  
Within 8" of Joint: **NO**  
Remarks:

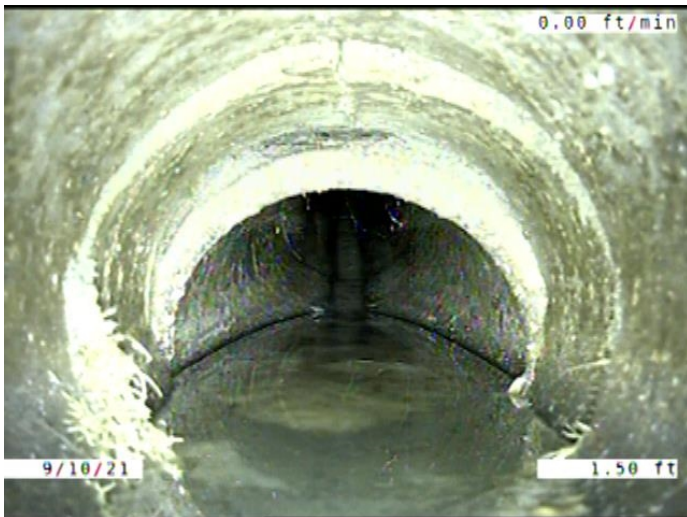
Code: **MGO**  
Description: **Miscellaneous General Observation**

Distance (ft): **1.5**  
Structural Grade: **0**  
O&M Grade: **0**  
Clock Start/From:  
Clock To:  
1st Value:  
2nd Value:  
Value Percent:  
Continuous Index:  
Within 8" of Joint: **NO**  
Remarks: **DROP INTO THE MANHOLE. HAD TO START IN THE PIPE.**

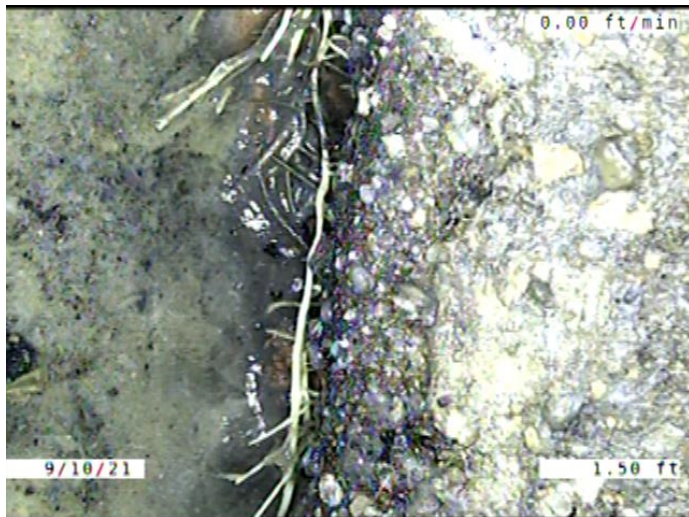
Code: **HSV**  
 Description: **Hole Soil Visible**

Distance (ft): **1.5**  
 Structural Grade: **5**  
 O&M Grade: **0**  
 Clock Start/From: **4**  
 Clock To: **5**  
 1st Value:  
 2nd Value:  
 Value Percent:  
 Continuous Index:  
 Within 8" of Joint: **YES**  
 Remarks:

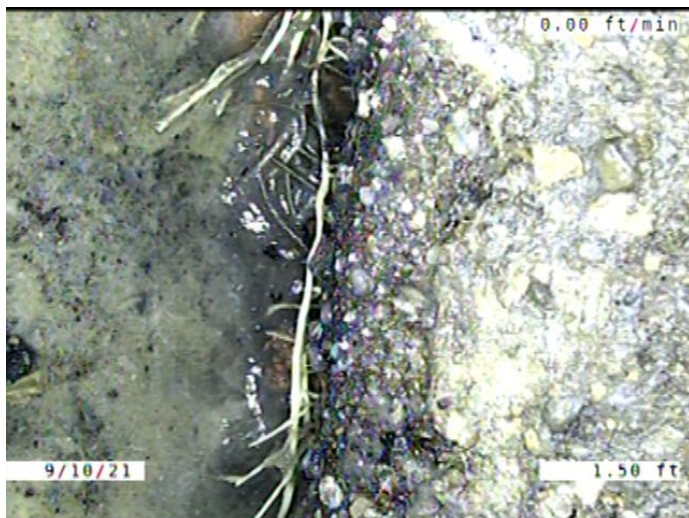
Code: **RFB**  
 Description: **Roots Fine Barrel**

Distance (ft): **1.5**  
 Structural Grade: **0**  
 O&M Grade: **2**  
 Clock Start/From: **4**  
 Clock To:  
 1st Value:  
 2nd Value:  
 Value Percent:  
 Continuous Index:  
 Within 8" of Joint: **NO**  
 Remarks:

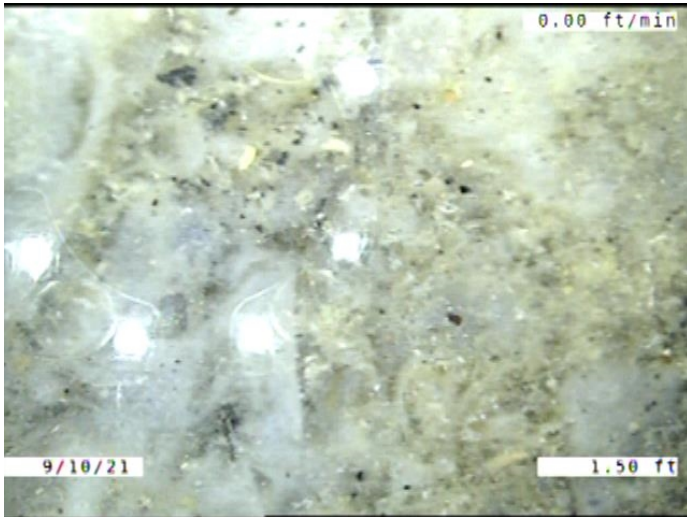
Code: **DSF**  
 Description: **Deposits Settled Fine**

Distance (ft): **1.5**  
 Structural Grade: **0**  
 O&M Grade: **2**  
 Clock Start/From: **5**  
 Clock To: **7**  
 1st Value:  
 2nd Value:  
 Value Percent: **5.000**  
 Continuous Index:  
 Within 8" of Joint: **YES**  
 Remarks:

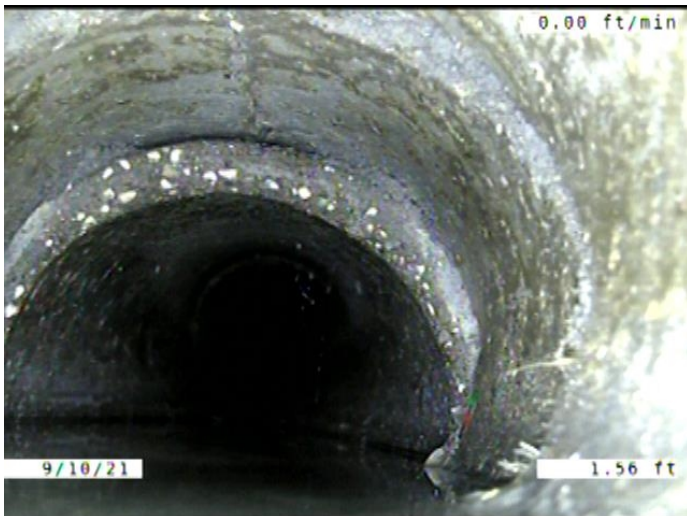
Code: **MSA**  
 Description: **Miscellaneous Survey Abandoned**

Distance (ft): **1.6**  
 Structural Grade: **0**  
 O&M Grade: **0**  
 Clock Start/From:  
 Clock To:  
 1st Value:  
 2nd Value:  
 Value Percent:  
 Continuous Index:  
 Within 8" of Joint: **NO**  
 Remarks: **LOOKS TO BE A DROP CONNECTION**
