Profile/Photo Observation Report

Date:	01/29/2025	Weather:		Coding:	PACP 7.0
Pipe Length (ft):		Owner:	City of Hobart	Pre Clean:	No Pre-Cleaning
P.O.#:	YES502259	Surveyor:	S. Bucklin	PSR:	M-507-004.1-LS007
Customer:	City of Hobart	Clean Date:		Shape:	C

Street:	Delaware St.	Flow Control:	Not Controlled
City:	Hobart, IN	Year Renewed:	
Location:	Easement/Right of Way	Tape/Media #:	
Purpose:	Sewer System Evaluation Survey (SS	Dia/Height:	15"
Use:	Sanitary Sewage Pipe	Material:	DIP
Drain Area:		Lining:	None
Category:	NA		
Comment:

Location Details:		Direction of Survey:	Downstream
US MH:	M-507-004.1	DS MH:	LS007
		Total Length Surveyed (ft):	73.0

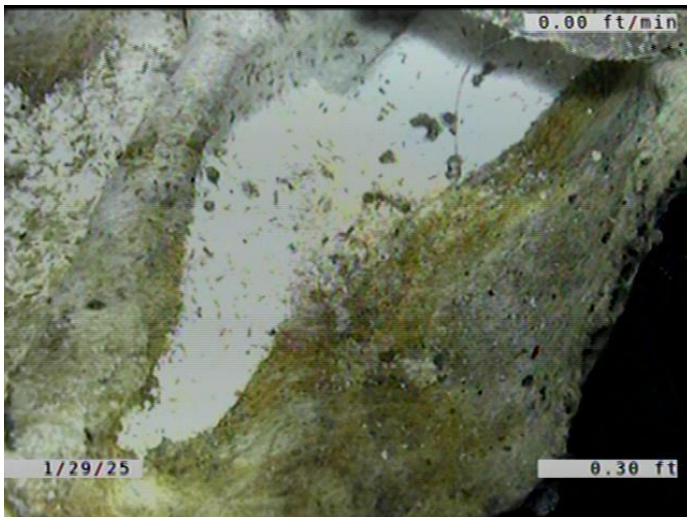
Code:	DAR
Description:	Deposits Attached Ragging
Distance (ft):	.3
Structural Grade:	0
O&M Grade:	2
Clock Start/From:	11
Clock To:	1
1st Value:	
2nd Value:	
Value Percent:	5.000
Continuous Index:	
Within 8" of Joint:	YES
Remarks:

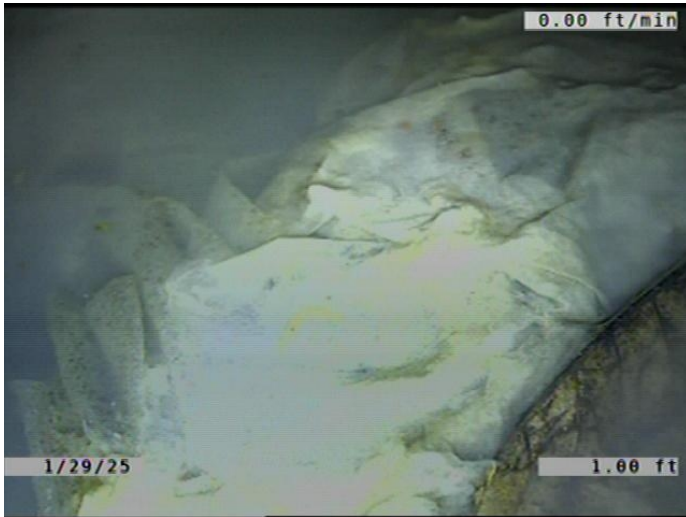
Code: **DAR**
 Description: **Deposits Attached Ragging**

Distance (ft): **1.0**
 Structural Grade: **0**
 O&M Grade: **3**
 Clock Start/From: **5**
 Clock To: **7**
 1st Value:
 2nd Value:
 Value Percent: **15.000**
 Continuous Index:
 Within 8" of Joint: **YES**
 Remarks:

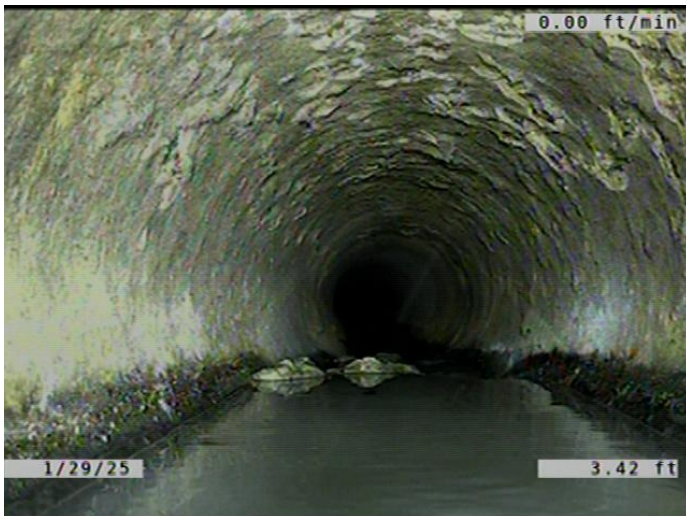
Code: **SSC**
 Description: **Surface Spalling of Damage Coating**

Distance (ft): **3.4**
 Structural Grade: **1**
 O&M Grade: **0**
 Clock Start/From: **8**
 Clock To: **4**
 1st Value:
 2nd Value:
 Value Percent:
 Continuous Index: **S01**
 Within 8" of Joint: **YES**
 Remarks:

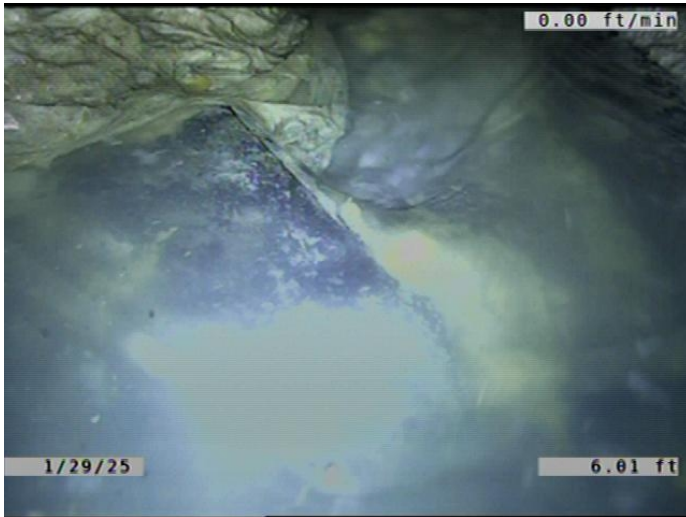
Code: **OBB**
Description: **Obstruction Brick or Masonry**

Distance (ft): **6.0**
Structural Grade: **0**
O&M Grade: **2**
Clock Start/From: **5**
Clock To: **7**
1st Value:
2nd Value:
Value Percent: **10.000**
Continuous Index:
Within 8" of Joint: **NO**
Remarks:

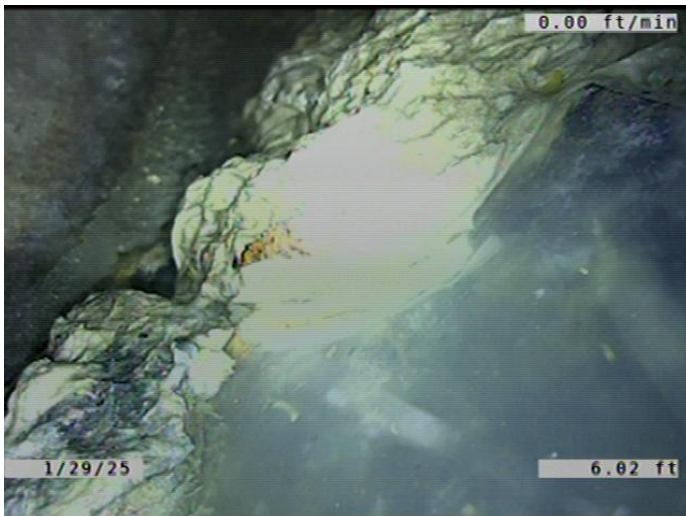
Code: **OBM**
Description: **Obstruction Pipe Material in Invert**

Distance (ft): **6.0**
Structural Grade: **0**
O&M Grade: **2**
Clock Start/From: **7**
Clock To:
1st Value:
2nd Value:
Value Percent: **5.000**
Continuous Index:
Within 8" of Joint: **NO**
Remarks:

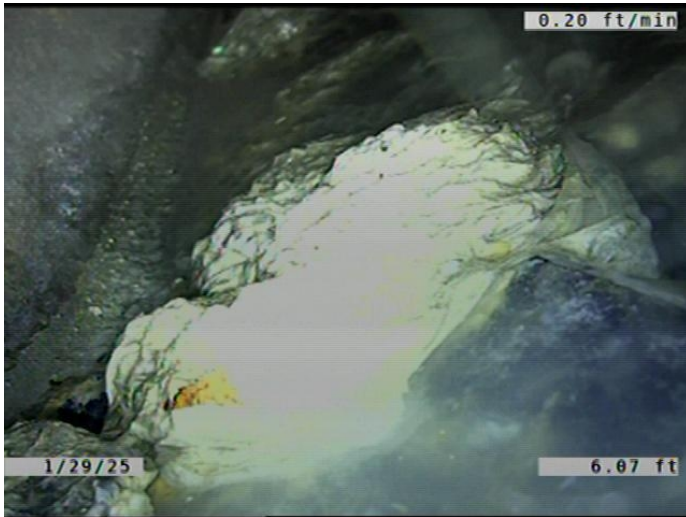
Code:	DAR
Description:	Deposits Attached Ragging
Distance (ft):	6.1
Structural Grade:	0
O&M Grade:	2
Clock Start/From:	5
Clock To:	8
1st Value:	
2nd Value:	
Value Percent:	5.000
Continuous Index:	
Within 8" of Joint:	YES
Remarks:

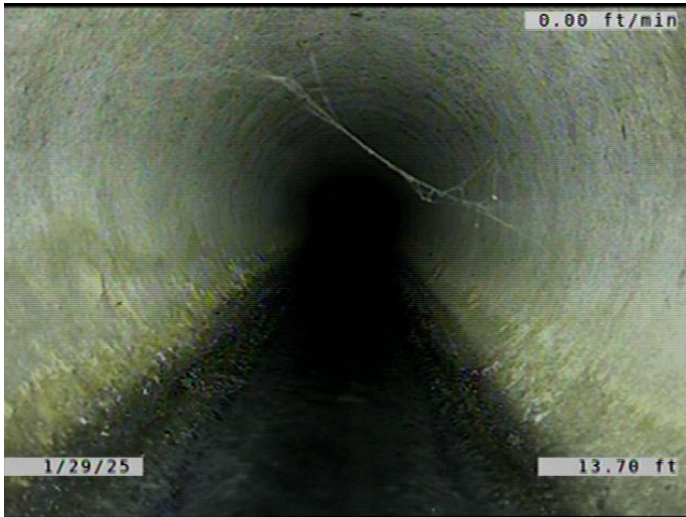
Code: **SSC**
Description: **Surface Spalling of Damage Coating**

Distance (ft): **13.7**
Structural Grade: **1**
O&M Grade: **0**
Clock Start/From: **8**
Clock To: **4**
1st Value:
2nd Value:
Value Percent:
Continuous Index: **F01**
Within 8" of Joint: **YES**
Remarks:

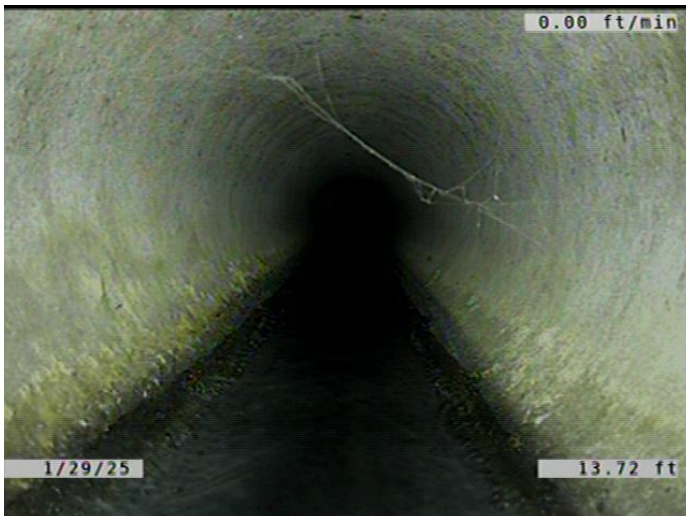
Code: **SSC**
Description: **Surface Spalling of Damage Coating**

Distance (ft): **13.7**
Structural Grade: **1**
O&M Grade: **0**
Clock Start/From: **7**
Clock To: **8**
1st Value:
2nd Value:
Value Percent:
Continuous Index: **S02**
Within 8" of Joint: **NO**
Remarks:

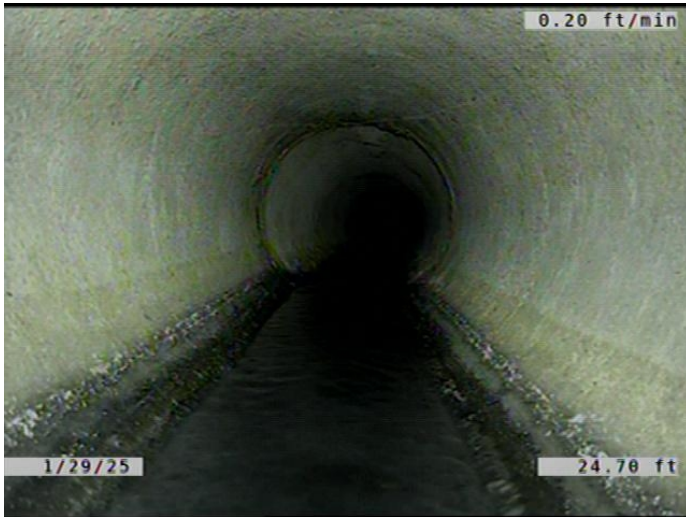
Code: **SSC**
Description: **Surface Spalling of Damage Coating**

Distance (ft): **24.7**
Structural Grade: **1**
O&M Grade: **0**
Clock Start/From: **7**
Clock To: **8**
1st Value:
2nd Value:
Value Percent:
Continuous Index: **F02**
Within 8" of Joint: **NO**
Remarks:

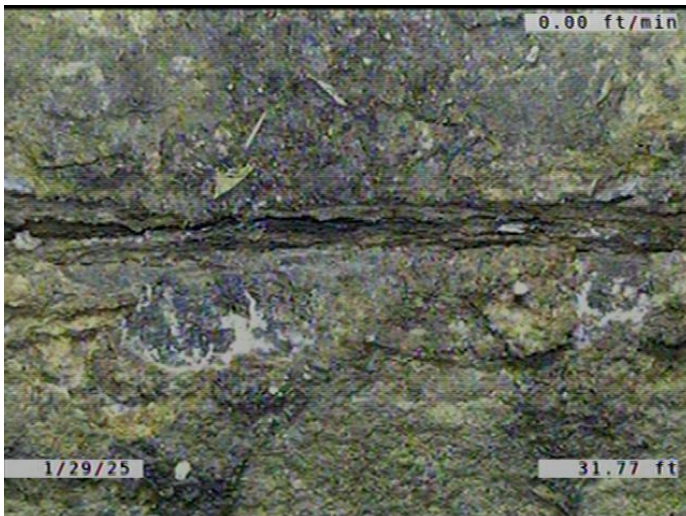
Code: **SSC**
Description: **Surface Spalling of Damage Coating**

Distance (ft): **31.8**
Structural Grade: **1**
O&M Grade: **0**
Clock Start/From: **7**
Clock To: **5**
1st Value:
2nd Value:
Value Percent:
Continuous Index:
Within 8" of Joint: **YES**
Remarks:

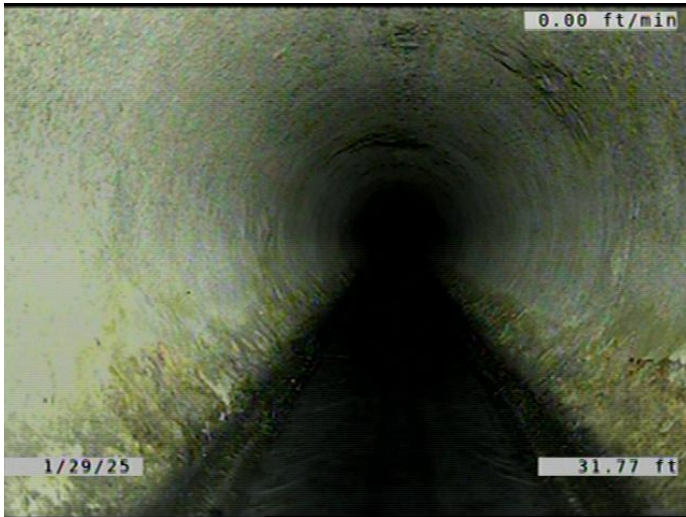
Code:	SSC
Description:	Surface Spalling of Damage Coating
Distance (ft):	31.8
Structural Grade:	1
O&M Grade:	0
Clock Start/From:	4
Clock To:	8
1st Value:	
2nd Value:	
Value Percent:	
Continuous Index:	S03
Within 8" of Joint:	YES
Remarks:

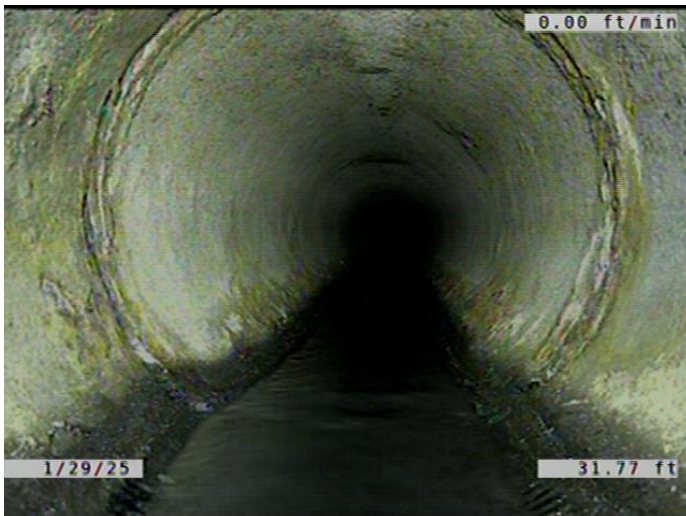
Code:	LR
Description:	Line Right
Distance (ft):	31.8
Structural Grade:	0
O&M Grade:	1
Clock Start/From:	
Clock To:	
1st Value:	
2nd Value:	
Value Percent:	5.000
Continuous Index:	
Within 8" of Joint:	NO
Remarks:

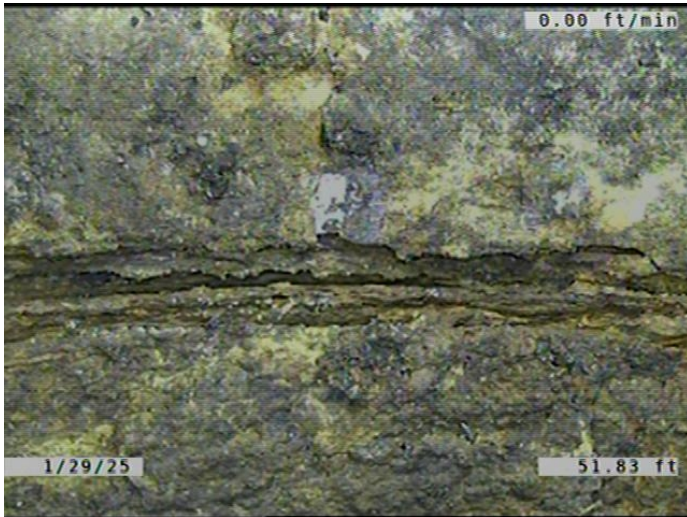
Code: **SSC**
Description: **Surface Spalling of Damage Coating**

Distance (ft): **51.8**
Structural Grade: **1**
O&M Grade: **0**
Clock Start/From: **7**
Clock To: **5**
1st Value:
2nd Value:
Value Percent:
Continuous Index:
Within 8" of Joint: **YES**
Remarks:

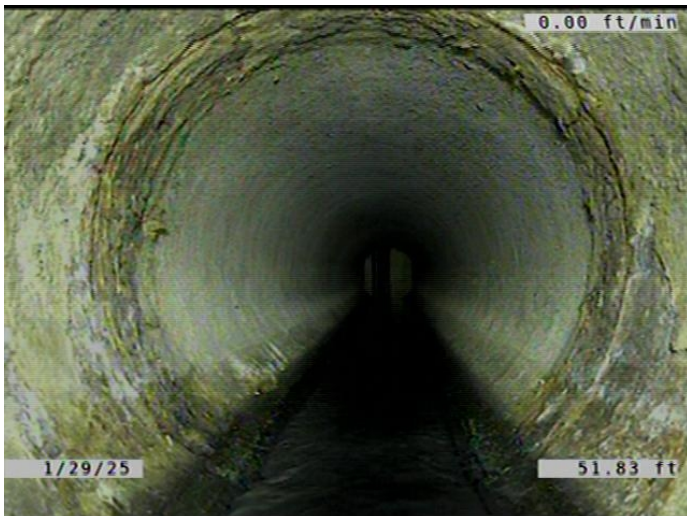
Code: **LR**
Description: **Line Right**

Distance (ft): **51.8**
Structural Grade: **0**
O&M Grade: **1**
Clock Start/From:
Clock To:
1st Value:
2nd Value:
Value Percent: **5.000**
Continuous Index:
Within 8" of Joint: **NO**
Remarks:

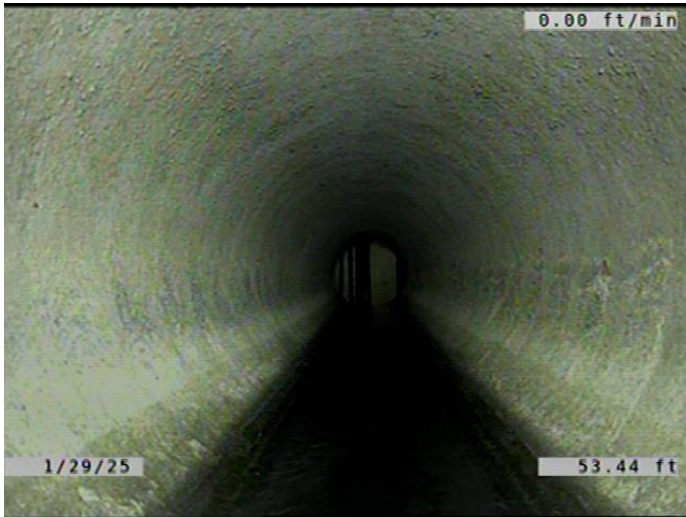
Code:	SSC
Description:	Surface Spalling of Damage Coating
Distance (ft):	53.4
Structural Grade:	1
O&M Grade:	0
Clock Start/From:	4
Clock To:	8
1st Value:	
2nd Value:	
Value Percent:	
Continuous Index:	F03
Within 8" of Joint:	YES
Remarks:

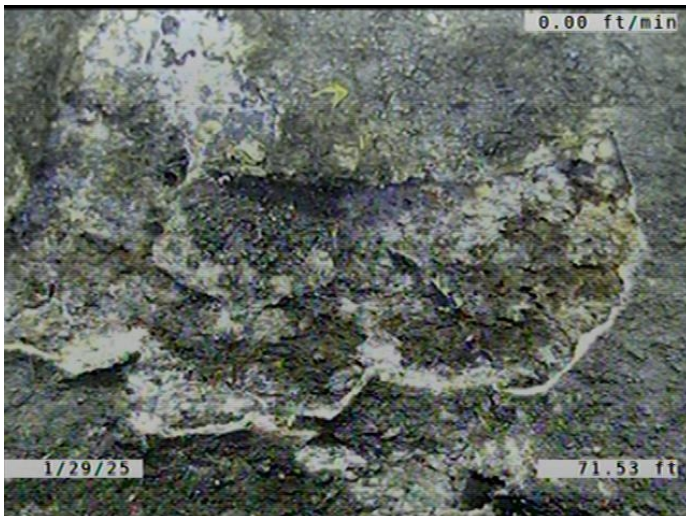
Code:	SSC
Description:	Surface Spalling of Damage Coating
Distance (ft):	71.5
Structural Grade:	1
O&M Grade:	0
Clock Start/From:	10
Clock To:	1
1st Value:	
2nd Value:	
Value Percent:	
Continuous Index:	
Within 8" of Joint:	YES
Remarks:
