Profile/Photo Observation Report

Street:	FOXCROFT STREET	Flow Control:	Not Controlled
City:	Hobart, IN	Year Renewed:	
Location:	Light Highway	Tape/Media #:	
Purpose:	Routine Assessment	Dia/Height:	12"
Use:	Sanitary	Material:	VCP
Drain Area:	NA	Lining:	
Category:	NA		
Comment:	R_M at 16 ft debris		
Location Details:		Direction of Survey:	Downstream
US MH:	M-507-006	DS MH:	M-507-019A
		Total Length Surveyed (ft):	28.0

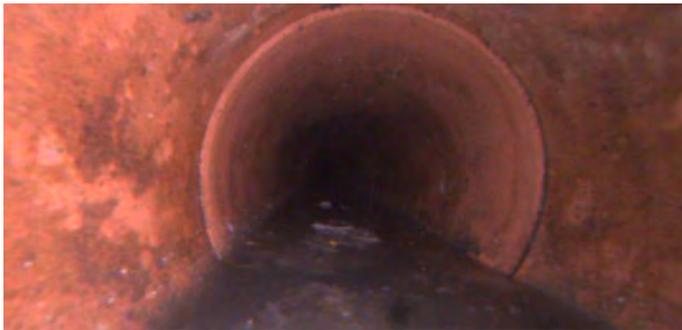
Code: **AMH**
 Description: **Manhole**

Distance (ft): **.0**
 Structural Grade: **0**
 O&M Grade: **0**
 Clock Start/From:
 Clock To:
 1st Value:
 2nd Value:
 Value Percent:
 Continuous Index:
 Within 8" of Joint: **NO**
 Remarks: **M-507-006**

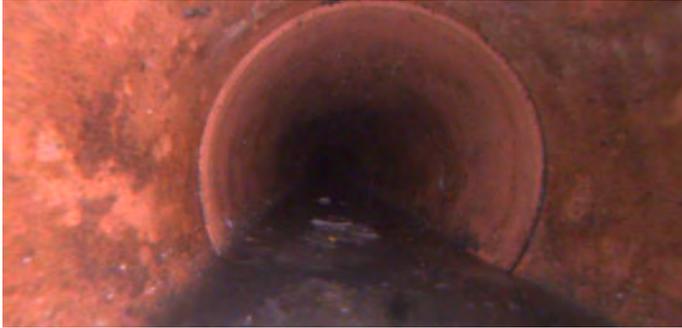
Code: **MWL**
Description: **Water Level**

Distance (ft): **.0**
Structural Grade: **0**
O&M Grade: **0**
Clock Start/From:
Clock To:
1st Value:
2nd Value:
Value Percent: **10.000**
Continuous Index:
Within 8" of Joint: **NO**
Remarks:

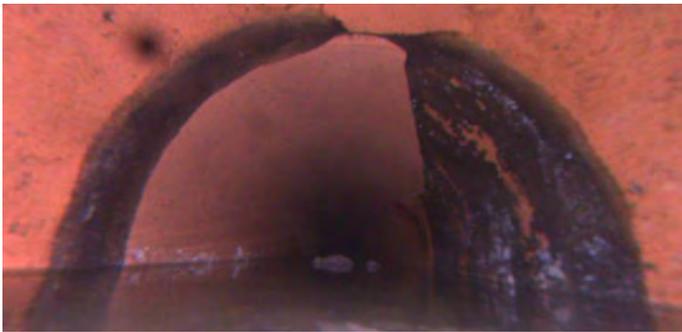
Code: **IW**
Description: **Infil Weeper**

Distance (ft): **25.2**
Structural Grade: **0**
O&M Grade: **2**
Clock Start/From: **8**
Clock To: **4**
1st Value:
2nd Value:
Value Percent:
Continuous Index:
Within 8" of Joint: **YES**
Remarks:

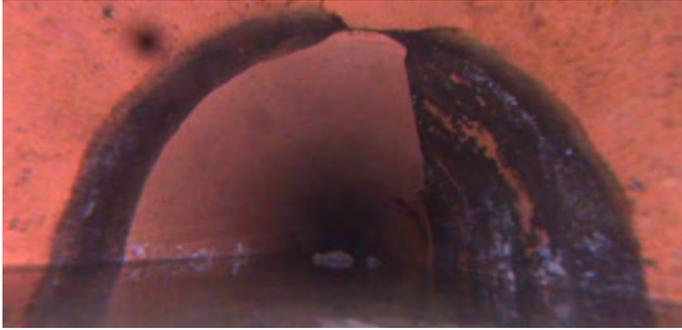
Code: **FS**
Description: **Fracture Spiral**

Distance (ft): **25.2**
Structural Grade: **3**
O&M Grade: **0**
Clock Start/From: **1**
Clock To: **3**
1st Value:
2nd Value:
Value Percent:
Continuous Index:
Within 8" of Joint: **YES**
Remarks:

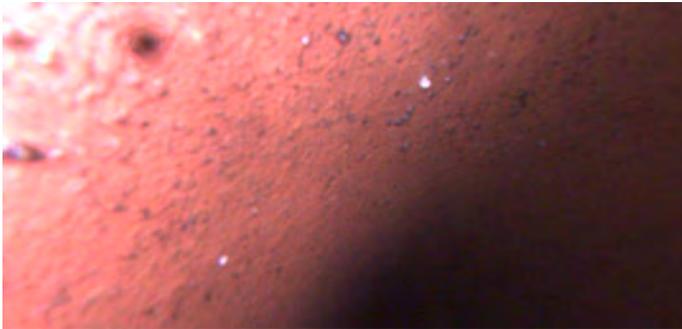
Code: **MSA**
Description: **Abandoned Survey**

Distance (ft): **28.0**
Structural Grade: **0**
O&M Grade: **0**
Clock Start/From:
Clock To:
1st Value:
2nd Value:
Value Percent:
Continuous Index:
Within 8" of Joint: **NO**
Remarks: **DEBRIS UNDER WATER**
