Profile/Photo Observation Report

Street:	FOXCROFT STREET	Flow Control:	Not Controlled		
City:	Hobart, IN	Year Renewed:			
Location:	Woods	Tape/Media #:			
Purpose:	Routine Assessment	Dia/Height:	12"		
Use:	Sanitary	Material:	VCP		
Drain Area:	NA	Lining:			
Category:	NA				
Comment:	P_C at 108 ft debris				
Location Details:		Direction of Survey:	Downstream		
US MH:	M-507-019	DS MH:	M-507-019A	Total Length Surveyed (ft):	109.9

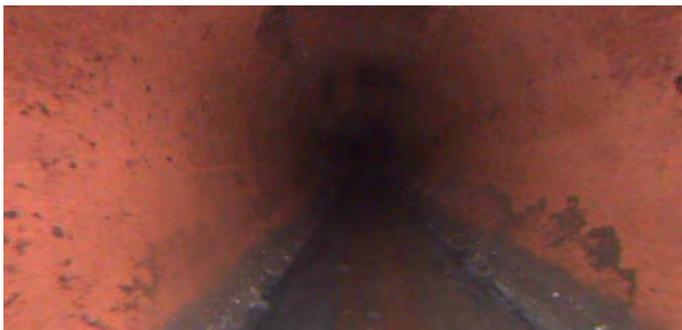
Code: **AMH**
 Description: **Manhole**

Distance (ft): **.0**
 Structural Grade: **0**
 O&M Grade: **0**
 Clock Start/From:
 Clock To:
 1st Value:
 2nd Value:
 Value Percent:
 Continuous Index:
 Within 8" of Joint: **NO**
 Remarks: **M-507-019**

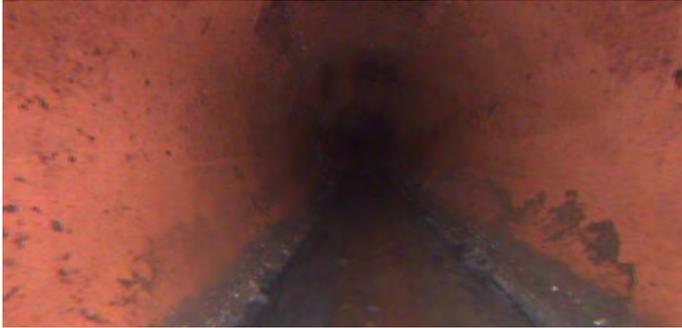
Code: **MWL**
Description: **Water Level**

Distance (ft): **.0**
Structural Grade: **0**
O&M Grade: **0**
Clock Start/From:
Clock To:
1st Value:
2nd Value:
Value Percent: **5.000**
Continuous Index:
Within 8" of Joint: **NO**
Remarks:

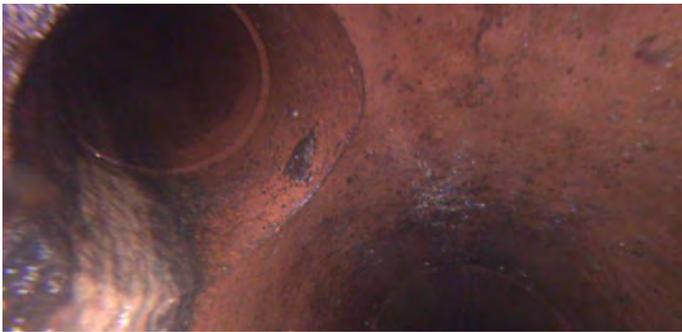
Code: **TFA**
Description: **Tap Factory Active**

Distance (ft): **83.1**
Structural Grade: **0**
O&M Grade: **0**
Clock Start/From: **10**
Clock To:
1st Value: **4.000**
2nd Value:
Value Percent:
Continuous Index:
Within 8" of Joint:
Remarks:

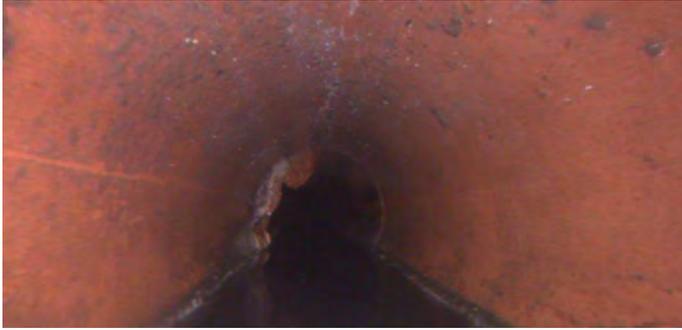
Code: **DAE**
Description: **Deposits Attached Encrustation**

Distance (ft): **94.6**
Structural Grade: **0**
O&M Grade: **3**
Clock Start/From: **7**
Clock To: **12**
1st Value:
2nd Value:
Value Percent: **15.000**
Continuous Index:
Within 8" of Joint: **YES**
Remarks:

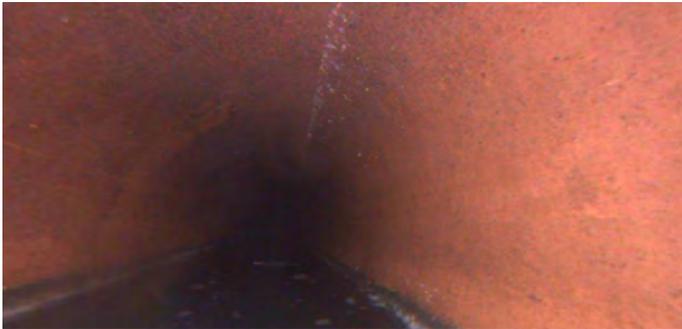
Code: **MSA**
Description: **Abandoned Survey**

Distance (ft): **109.9**
Structural Grade: **0**
O&M Grade: **0**
Clock Start/From:
Clock To:
1st Value:
2nd Value:
Value Percent:
Continuous Index:
Within 8" of Joint: **NO**
Remarks: **camera stopped**
