Profile/Photo Observation Report

Date:	11/10/2021	Weather:		Coding:	PACP 7.0
Pipe Length (ft):	219.1	Owner:	City of Hobart	Pre Clean:	No Pre-Cleaning
P.O.#:	YES502259	Surveyor:	Steven Bucklin	PSR:	M-604-057.1-M-604-057
Customer:	City of Hobart, IN (Red	Clean Date:		Shape:	C

Street:	North Connection Street	Flow Control:	Not Controlled
City:	City of Hobart	Year Renewed:	
Location:	Alley	Tape/Media #:	
Purpose:	Routine Assessment	Dia/Height:	8"
Use:	Sanitary Sewage Pipe	Material:	CP
Drain Area:		Lining:	None
Category:	NA		
Comment:			
Location Details:		Direction of Survey:	Upstream
US MH:	M-604-057.1	DS MH:	M-604-057
		Total Length Surveyed (ft):	219.1

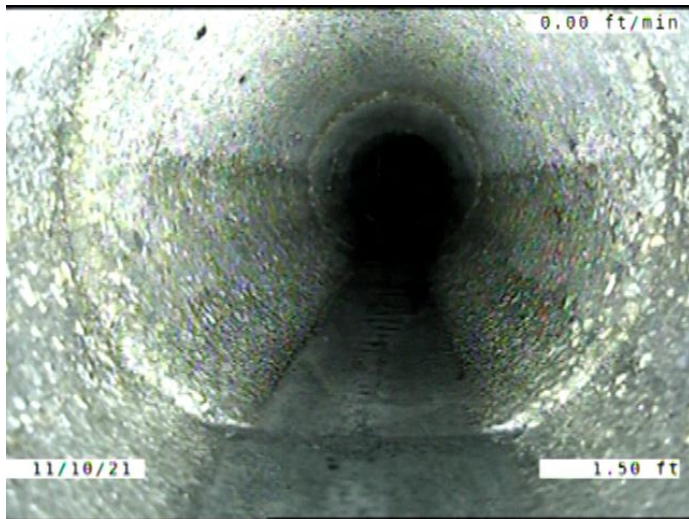
Code: **MGO**
 Description: **Miscellaneous General Observation**

Distance (ft): **1.5**
 Structural Grade: **0**
 O&M Grade: **0**
 Clock Start/From:
 Clock To:
 1st Value:
 2nd Value:
 Value Percent:
 Continuous Index:
 Within 8" of Joint: **NO**
 Remarks: **DROP INTO THE MANHOLE. HAD TO START IN THE PIPE.**

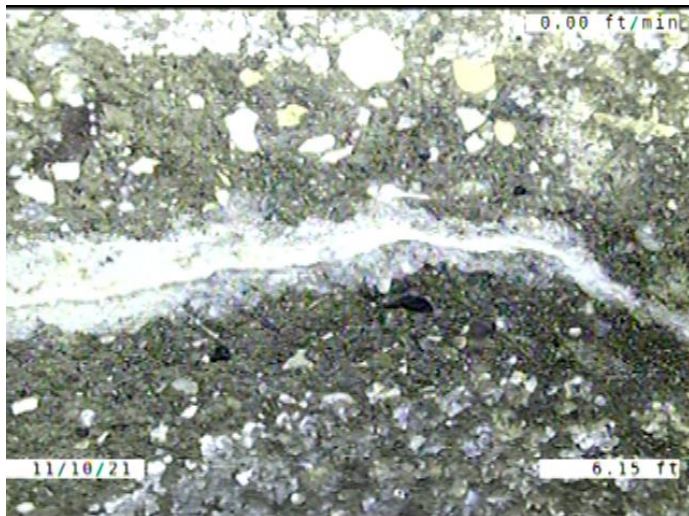
Code: **DAE**
 Description: **Deposits Attached Encrustation**

Distance (ft): **6.2**
 Structural Grade: **0**
 O&M Grade: **2**
 Clock Start/From: **9**
 Clock To: **11**
 1st Value:
 2nd Value:
 Value Percent: **5.000**
 Continuous Index:
 Within 8" of Joint: **NO**
 Remarks:

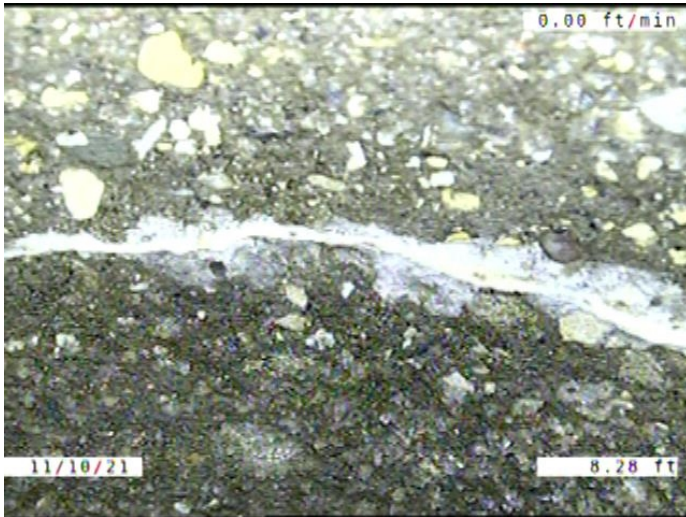
Code: **DAE**
Description: **Deposits Attached Encrustation**

Distance (ft): **8.3**
Structural Grade: **0**
O&M Grade: **2**
Clock Start/From: **12**
Clock To: **3**
1st Value:
2nd Value:
Value Percent: **5.000**
Continuous Index:
Within 8" of Joint: **NO**
Remarks:

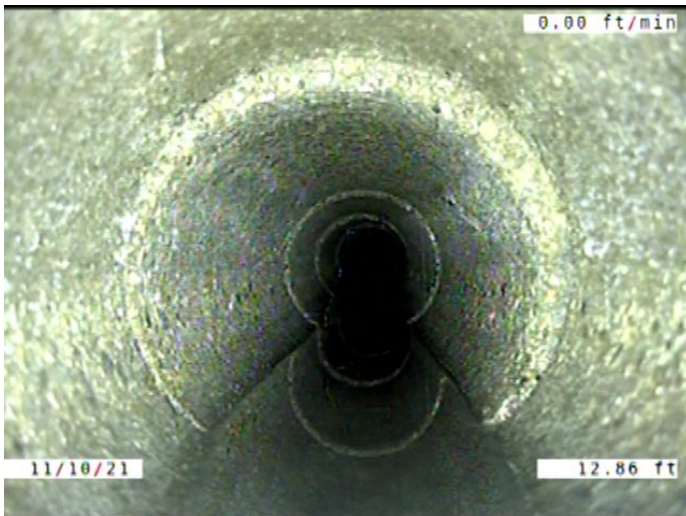
Code: **MWLS**
Description: **Miscellaneous Water Level Sag**

Distance (ft): **12.9**
Structural Grade: **2**
O&M Grade: **0**
Clock Start/From:
Clock To:
1st Value:
2nd Value:
Value Percent: **5.000**
Continuous Index: **S01**
Within 8" of Joint: **NO**
Remarks:

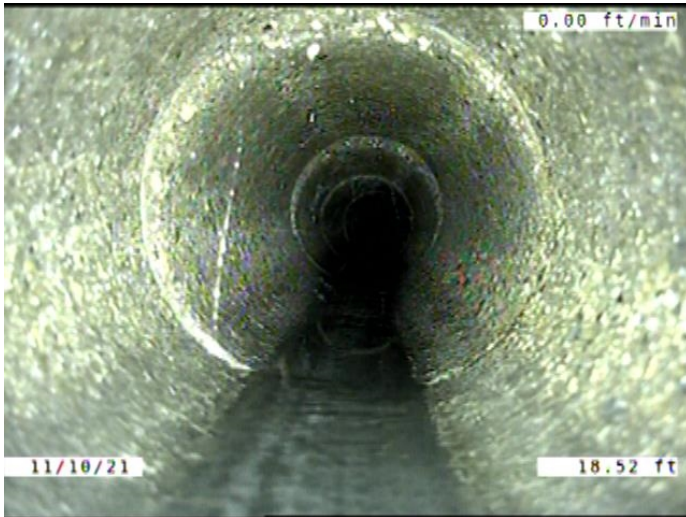
Code: **MWLS**
Description: **Miscellaneous Water Level Sag**

Distance (ft): **18.5**
Structural Grade: **2**
O&M Grade: **0**
Clock Start/From:
Clock To:
1st Value:
2nd Value:
Value Percent: **5.000**
Continuous Index: **F01**
Within 8" of Joint: **NO**
Remarks:

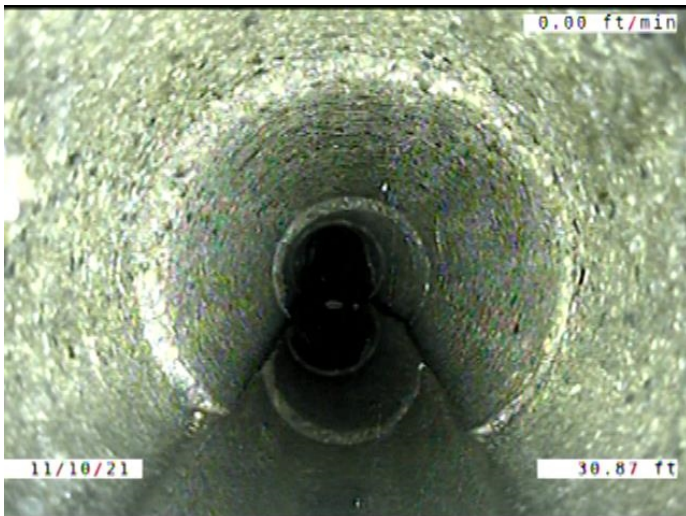
Code: **MWLS**
Description: **Miscellaneous Water Level Sag**

Distance (ft): **30.9**
Structural Grade: **2**
O&M Grade: **0**
Clock Start/From:
Clock To:
1st Value:
2nd Value:
Value Percent: **5.000**
Continuous Index: **S02**
Within 8" of Joint: **NO**
Remarks:

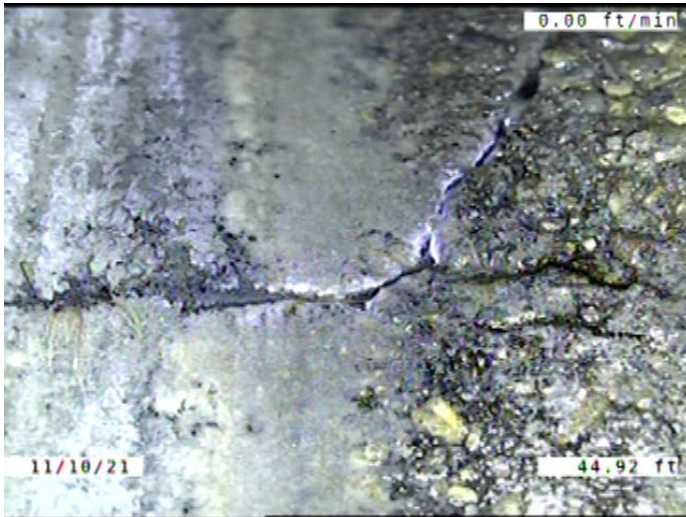
Code: **FM**
 Description: **Fracture Multiple**

Distance (ft): **44.9**
 Structural Grade: **4**
 O&M Grade: **0**
 Clock Start/From: **12**
 Clock To: **12**
 1st Value:
 2nd Value:
 Value Percent:
 Continuous Index:
 Within 8" of Joint: **YES**
 Remarks:

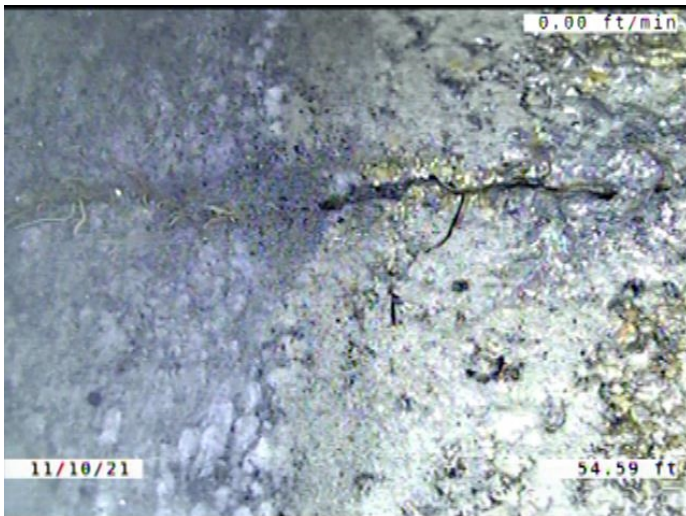
Code: **FM**
 Description: **Fracture Multiple**

Distance (ft): **54.6**
 Structural Grade: **4**
 O&M Grade: **0**
 Clock Start/From: **12**
 Clock To: **12**
 1st Value:
 2nd Value:
 Value Percent:
 Continuous Index:
 Within 8" of Joint: **YES**
 Remarks:

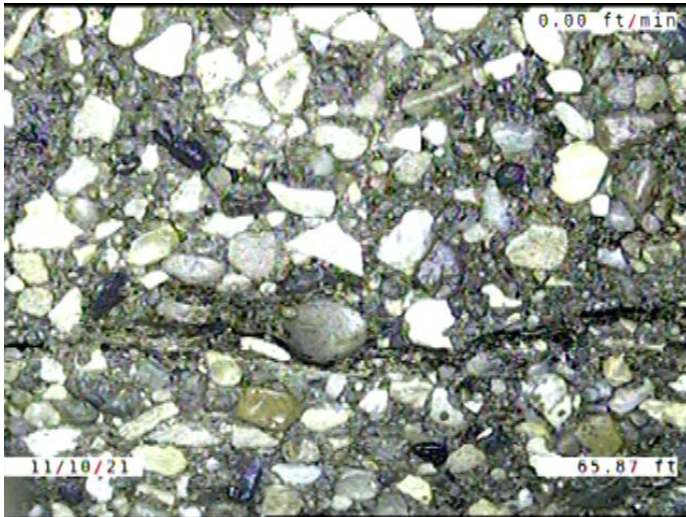
Code: **FC**
 Description: **Fracture Circumferential**

Distance (ft): **65.9**
 Structural Grade: **2**
 O&M Grade: **0**
 Clock Start/From: **8**
 Clock To: **12**
 1st Value:
 2nd Value:
 Value Percent:
 Continuous Index:
 Within 8" of Joint: **NO**
 Remarks:

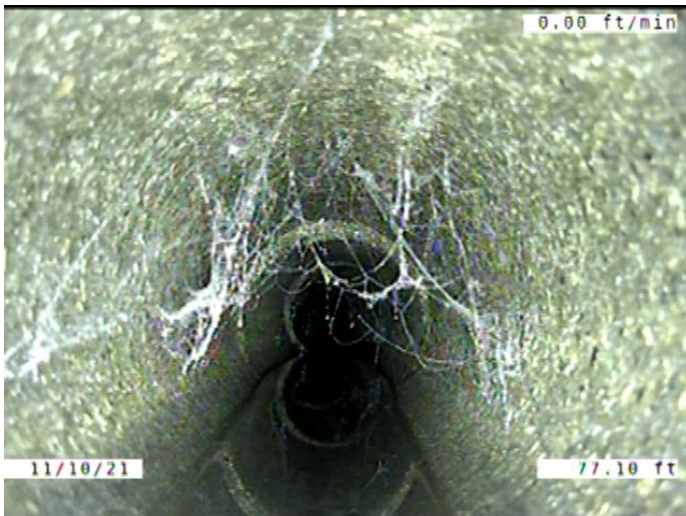
Code: **MWLS**
 Description: **Miscellaneous Water Level Sag**

Distance (ft): **77.1**
 Structural Grade: **2**
 O&M Grade: **0**
 Clock Start/From:
 Clock To:
 1st Value:
 2nd Value:
 Value Percent: **5.000**
 Continuous Index: **F02**
 Within 8" of Joint: **NO**
 Remarks:

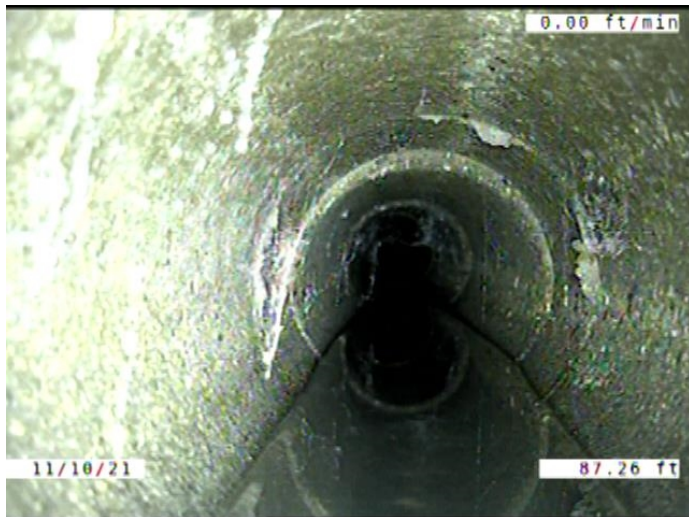
Code: **MWLS**
 Description: **Miscellaneous Water Level Sag**

Distance (ft): **87.3**
 Structural Grade: **2**
 O&M Grade: **0**
 Clock Start/From:
 Clock To:
 1st Value:
 2nd Value:
 Value Percent: **10.000**
 Continuous Index: **S03**
 Within 8" of Joint: **NO**
 Remarks:

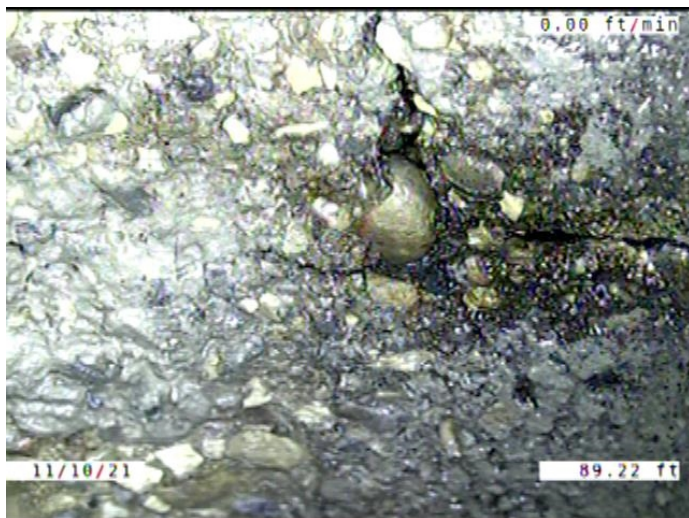
Code: **FM**
 Description: **Fracture Multiple**

Distance (ft): **89.2**
 Structural Grade: **4**
 O&M Grade: **0**
 Clock Start/From: **12**
 Clock To: **12**
 1st Value:
 2nd Value:
 Value Percent:
 Continuous Index:
 Within 8" of Joint: **YES**
 Remarks:

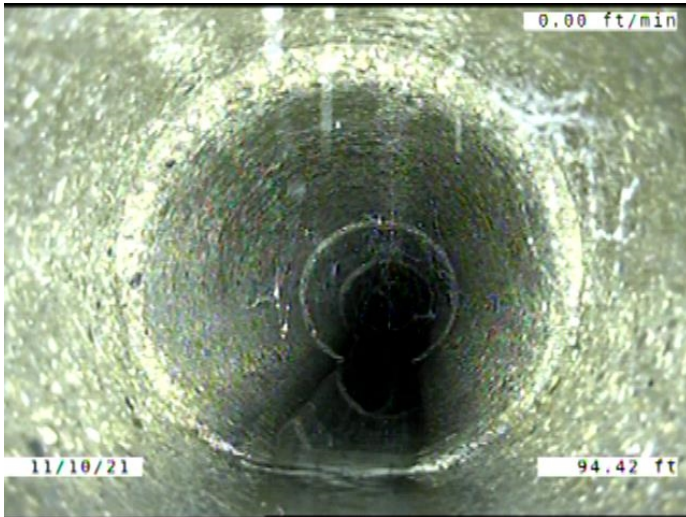
Code: **MWLS**
Description: **Miscellaneous Water Level Sag**

Distance (ft): **94.4**
Structural Grade: **2**
O&M Grade: **0**
Clock Start/From:
Clock To:
1st Value:
2nd Value:
Value Percent: **10.000**
Continuous Index: **F03**
Within 8" of Joint: **NO**
Remarks:

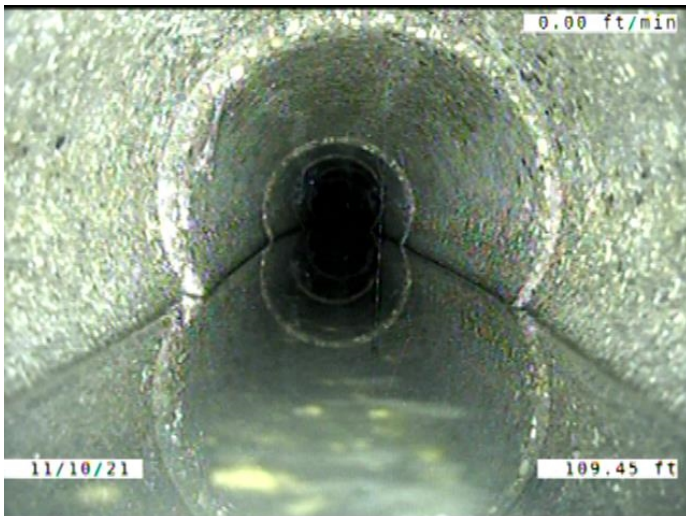
Code: **MWLS**
Description: **Miscellaneous Water Level Sag**

Distance (ft): **109.4**
Structural Grade: **2**
O&M Grade: **0**
Clock Start/From:
Clock To:
1st Value:
2nd Value:
Value Percent: **10.000**
Continuous Index: **S04**
Within 8" of Joint: **NO**
Remarks:

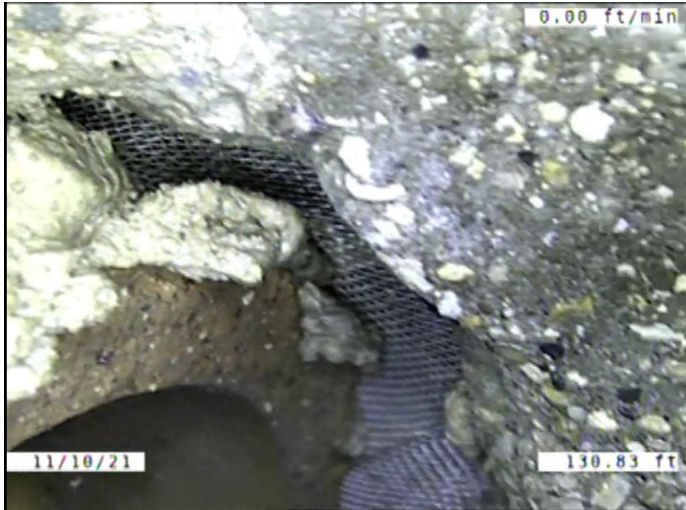
Code: **RPP**
Description: **Point Repair Patch**

Distance (ft): **130.8**
Structural Grade: **0**
O&M Grade: **0**
Clock Start/From: **11**
Clock To: **12**
1st Value:
2nd Value:
Value Percent:
Continuous Index:
Within 8" of Joint: **NO**
Remarks: **Steel mesh**

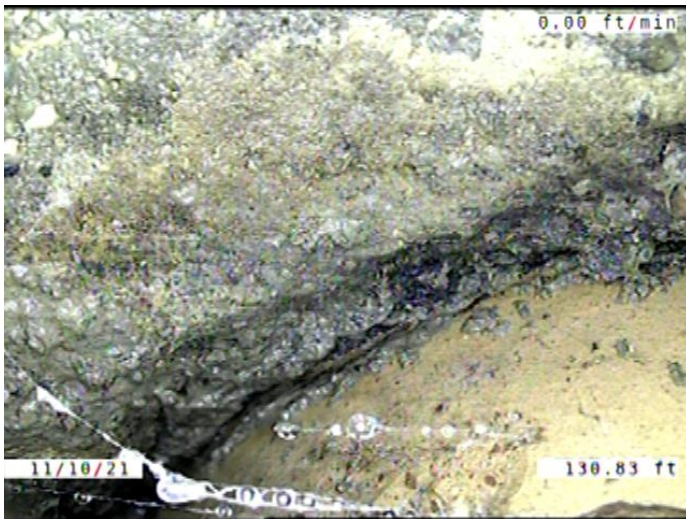
Code: **SSS**
Description: **Surface Damage Surface Spalling**

Distance (ft): **130.8**
Structural Grade: **2**
O&M Grade: **0**
Clock Start/From: **8**
Clock To: **12**
1st Value:
2nd Value:
Value Percent:
Continuous Index:
Within 8" of Joint: **NO**
Remarks:

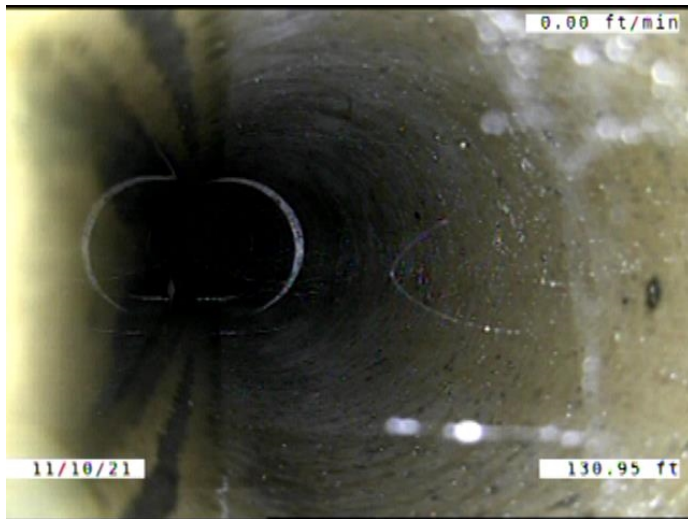
Code: **TBI**
 Description: **Tap Break-in Intruding**

Distance (ft): **131.0**
 Structural Grade: **0**
 O&M Grade: **2**
 Clock Start/From: **10**
 Clock To:
 1st Value: **4.000**
 2nd Value: **2.000**
 Value Percent:
 Continuous Index:
 Within 8" of Joint: **YES**
 Remarks:

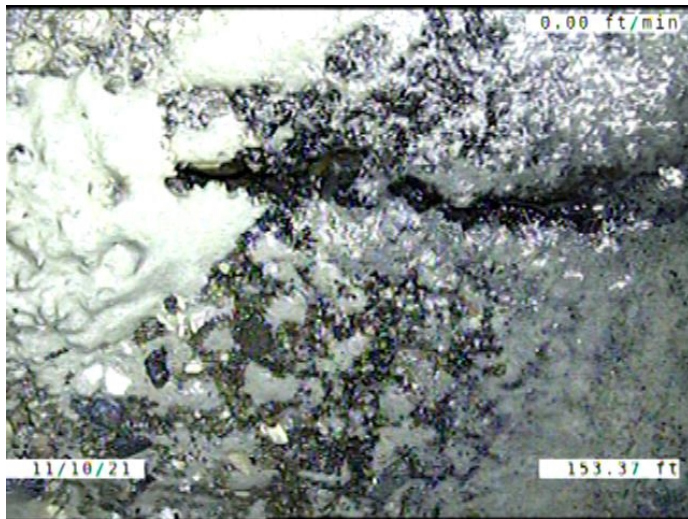
Code: **FC**
 Description: **Fracture Circumferential**

Distance (ft): **153.4**
 Structural Grade: **2**
 O&M Grade: **0**
 Clock Start/From: **2**
 Clock To: **10**
 1st Value:
 2nd Value:
 Value Percent:
 Continuous Index:
 Within 8" of Joint: **YES**
 Remarks:

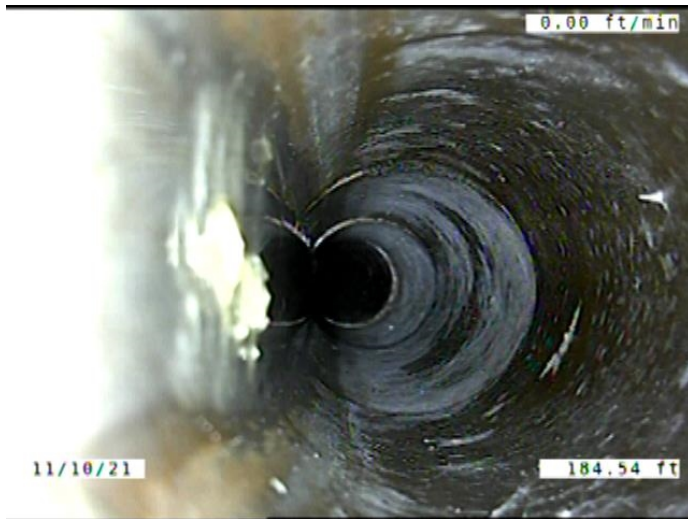
Code: **TBI**
Description: **Tap Break-in Intruding**

Distance (ft): **184.5**
Structural Grade: **0**
O&M Grade: **2**
Clock Start/From: **10**
Clock To:
1st Value: **4.000**
2nd Value: **1.000**
Value Percent:
Continuous Index:
Within 8" of Joint: **YES**
Remarks:

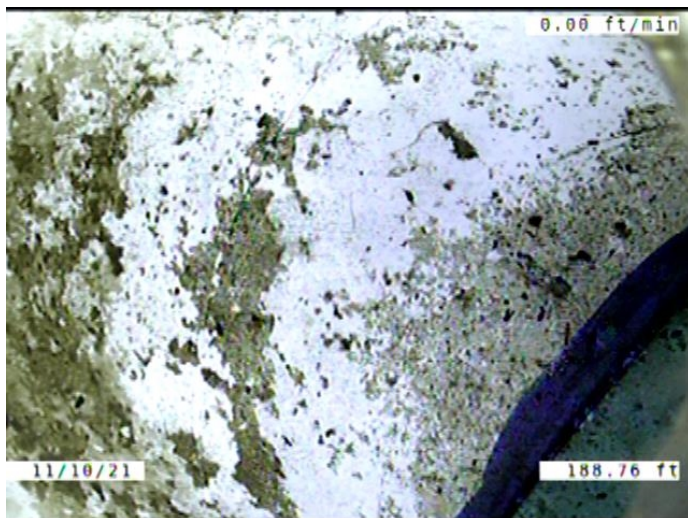
Code: **TBI**
Description: **Tap Break-in Intruding**

Distance (ft): **187.6**
Structural Grade: **0**
O&M Grade: **2**
Clock Start/From: **12**
Clock To:
1st Value: **4.000**
2nd Value: **2.000**
Value Percent:
Continuous Index:
Within 8" of Joint: **YES**
Remarks:

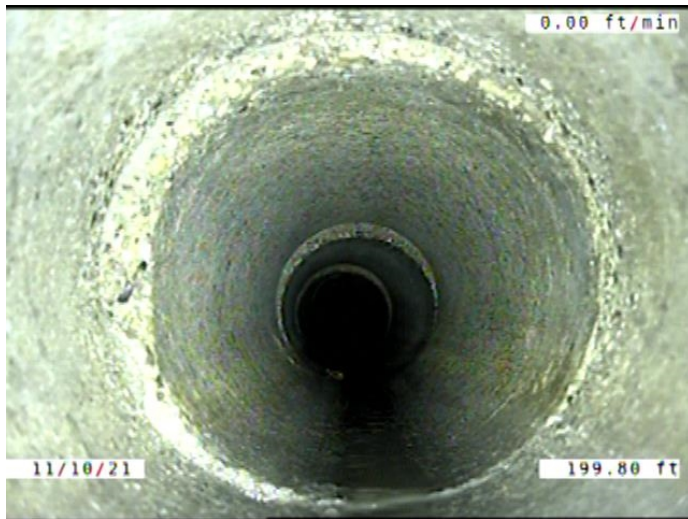
Code: **MWLS**
 Description: **Miscellaneous Water Level Sag**

Distance (ft): **199.8**
 Structural Grade: **2**
 O&M Grade: **0**
 Clock Start/From:
 Clock To:
 1st Value:
 2nd Value:
 Value Percent: **10.000**
 Continuous Index: **F04**
 Within 8" of Joint: **NO**
 Remarks:

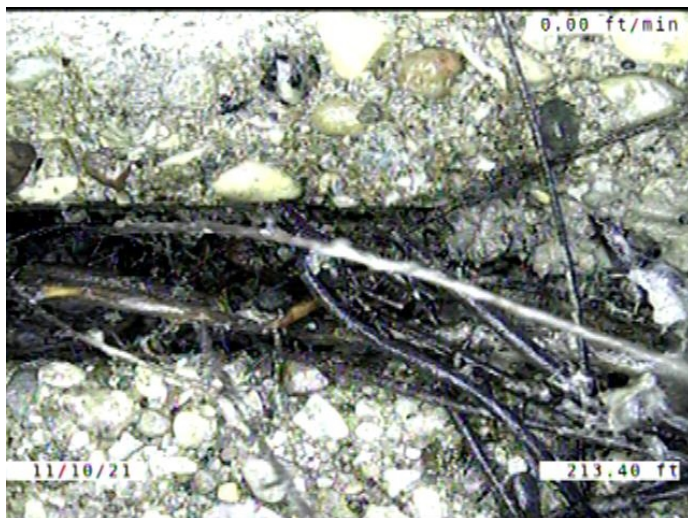
Code: **RFJ**
 Description: **Roots Fine Joint**

Distance (ft): **213.4**
 Structural Grade: **0**
 O&M Grade: **1**
 Clock Start/From: **7**
 Clock To: **11**
 1st Value:
 2nd Value:
 Value Percent:
 Continuous Index:
 Within 8" of Joint: **YES**
 Remarks:

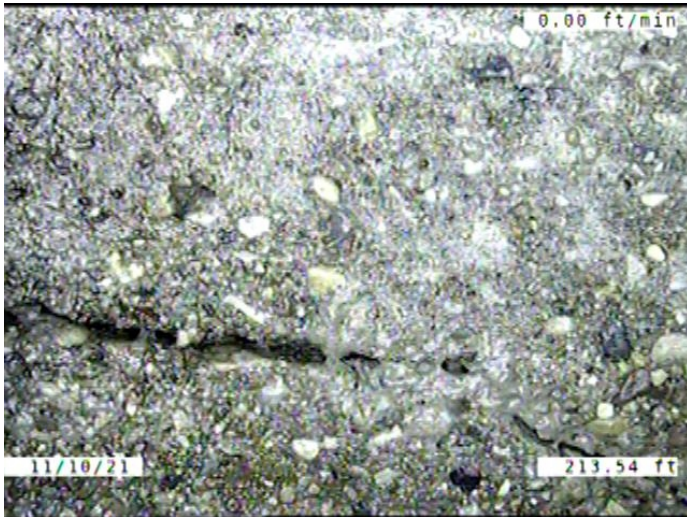
Code: **FM**
 Description: **Fracture Multiple**

Distance (ft): **213.5**
 Structural Grade: **4**
 O&M Grade: **0**
 Clock Start/From: **3**
 Clock To: **12**
 1st Value:
 2nd Value:
 Value Percent:
 Continuous Index:
 Within 8" of Joint: **YES**
 Remarks:

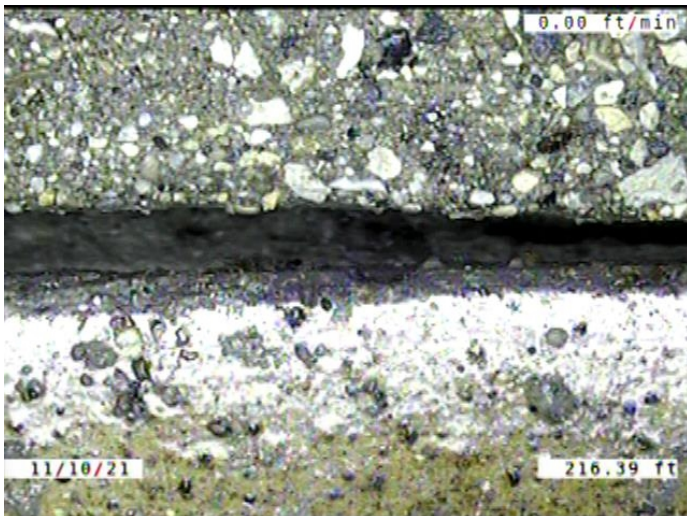
Code: **MMC**
 Description: **Miscellaneous Material Change**

Distance (ft): **216.4**
 Structural Grade: **0**
 O&M Grade: **0**
 Clock Start/From:
 Clock To:
 1st Value:
 2nd Value:
 Value Percent:
 Continuous Index:
 Within 8" of Joint: **NO**
 Remarks: **CONCRETE TO VCP**

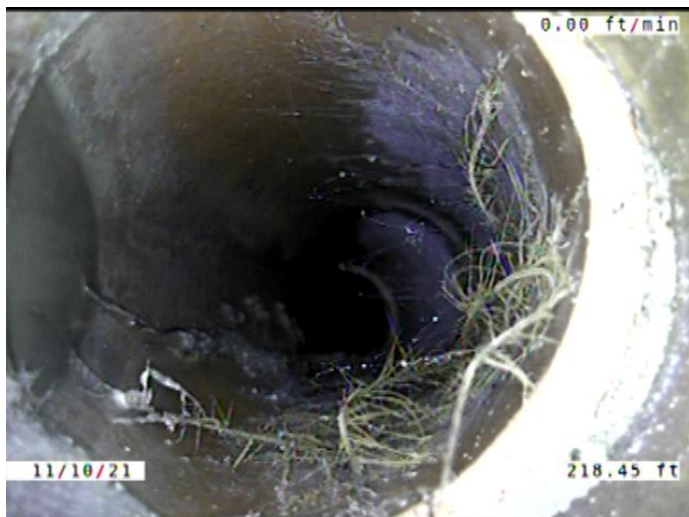
Code:	TFD
Description:	Tap Factory Defective
Distance (ft):	218.5
Structural Grade:	0
O&M Grade:	3
Clock Start/From:	9
Clock To:	
1st Value:	4.000
2nd Value:	
Value Percent:	
Continuous Index:	
Within 8" of Joint:	YES
Remarks:	OFFSET. SOIL VISIBLE. ROOTS GROWING IN THE TAP
