Profile/Photo Observation Report

Date:	03/30/2018	Weather:		Coding:	PACP 6.0
Pipe Length (ft):	361.0	Owner:	NA	Pre Clean:	No Pre-Cleaning
P.O.#:		Surveyor:	JUSTIN GONZALES	PSR:	
Customer:		Clean Date:	01/01/1900	Shape:	C

Street:	FOXCROFT STREET	Flow Control:	Not Controlled
City:	Hobart, IN	Year Renewed:	
Location:	Yard	Tape/Media #:	
Purpose:	Routine Assessment	Dia/Height:	10"
Use:	Sanitary	Material:	PVC
Drain Area:	NA	Lining:	
Category:	NA		
Comment:	M_T_P_C at 425 ft . O_C at 341 ft		
Location Details:		Direction of Survey:	Upstream
US MH:	M-607-075A	DS MH:	M-607-075
		Total Length Surveyed (ft):	426.8

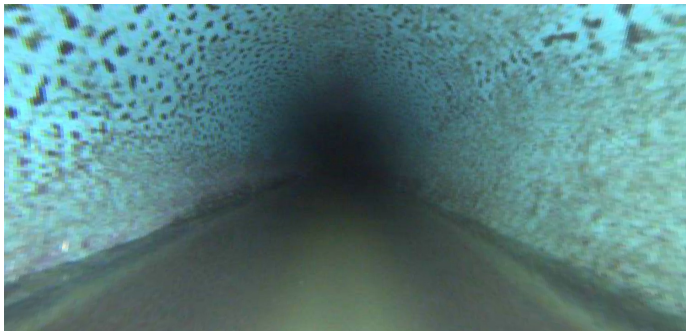
Code: **AMH**
Description: **Manhole**

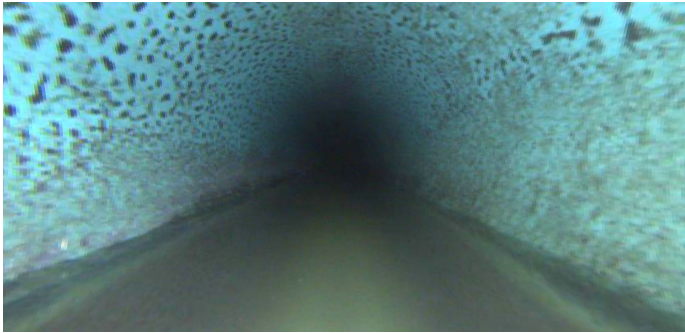
Code:	MWL
Description:	Water Level

Distance (ft):	.0
Structural Grade:	0
O&M Grade:	0
Clock Start/From:	
Clock To:	
1st Value:	
2nd Value:	
Value Percent:	15.000
Continuous Index:	
Within 8" of Joint:	NO
Remarks:

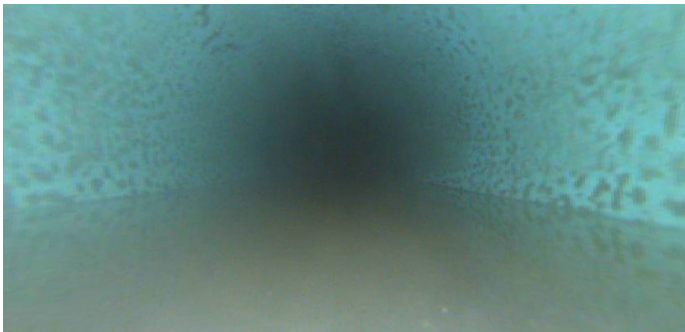
Code:	MGO
Description:	General Observation

Distance (ft):	13.1
Structural Grade:	0
O&M Grade:	0
Clock Start/From:	
Clock To:	
1st Value:	
2nd Value:	
Value Percent:	
Continuous Index:	
Within 8" of Joint:	NO
Remarks:	FOG

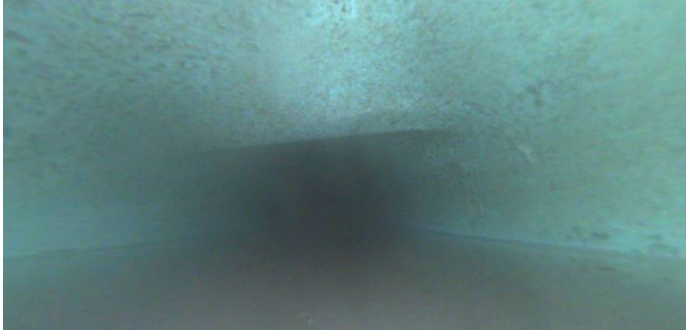
Code: **D**
Description: **Deformed**

Distance (ft): **26.4**
Structural Grade: **4**
O&M Grade: **0**
Clock Start/From:
Clock To:
1st Value:
2nd Value:
Value Percent: **10.000**
Continuous Index:
Within 8" of Joint: **NO**
Remarks:

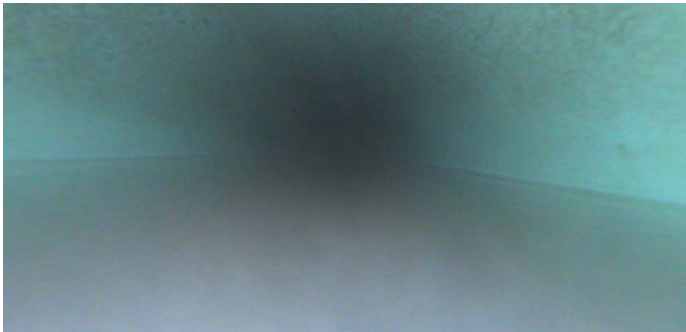
Code: **MWLS**
Description: **Water Level Sag**

Distance (ft): **28.3**
Structural Grade: **2**
O&M Grade: **3**
Clock Start/From:
Clock To:
1st Value:
2nd Value:
Value Percent: **20.000**
Continuous Index:
Within 8" of Joint: **NO**
Remarks:

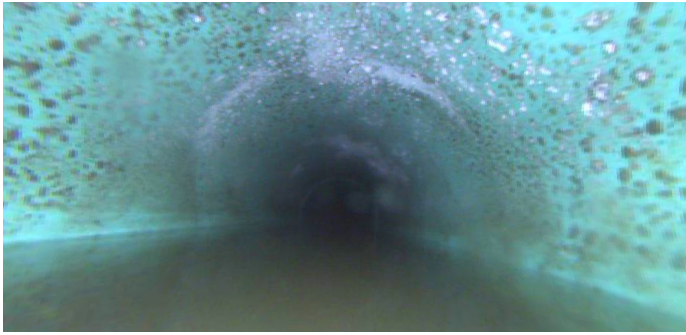
Code: **DAGS**
Description: **Deposits Attached Grease**

Distance (ft): **178.5**
Structural Grade: **0**
O&M Grade: **2**
Clock Start/From: **7**
Clock To: **5**
1st Value:
2nd Value:
Value Percent: **5.000**
Continuous Index:
Within 8" of Joint: **NO**
Remarks:

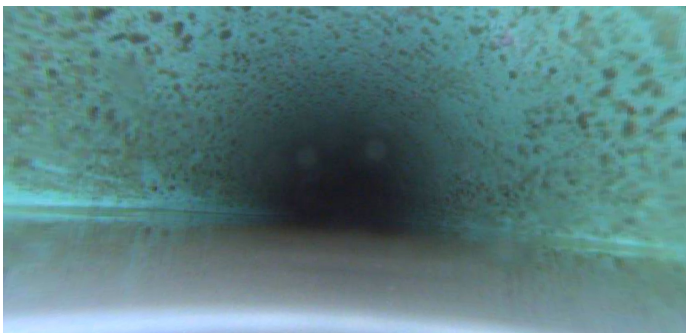
Code: **MWLS**
Description: **Water Level Sag**

Distance (ft): **222.0**
Structural Grade: **3**
O&M Grade: **3**
Clock Start/From:
Clock To:
1st Value:
2nd Value:
Value Percent: **40.000**
Continuous Index: **S01**
Within 8" of Joint: **NO**
Remarks:

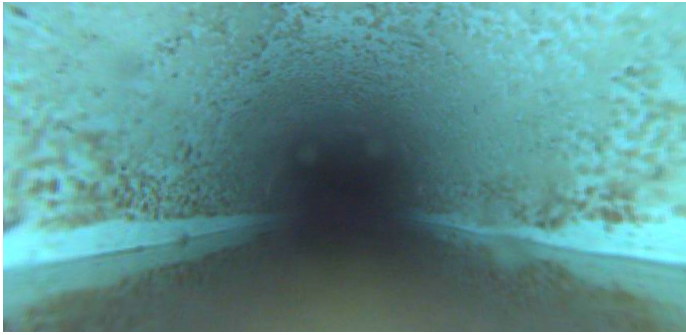
Code: **MWLS**
Description: **Water Level Sag**

Distance (ft): **243.8**
Structural Grade: **3**
O&M Grade: **3**
Clock Start/From:
Clock To:
1st Value:
2nd Value:
Value Percent: **40.000**
Continuous Index: **F01**
Within 8" of Joint: **NO**
Remarks:

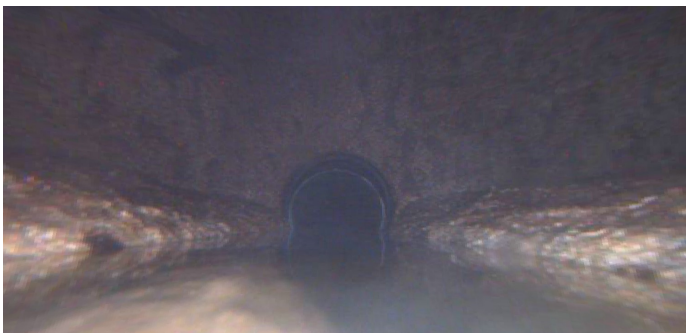
Code: **MGO**
Description: **General Observation**

Distance (ft): **341.3**
Structural Grade: **0**
O&M Grade: **0**
Clock Start/From:
Clock To:
1st Value:
2nd Value:
Value Percent:
Continuous Index:
Within 8" of Joint: **NO**
Remarks: **DSMH**

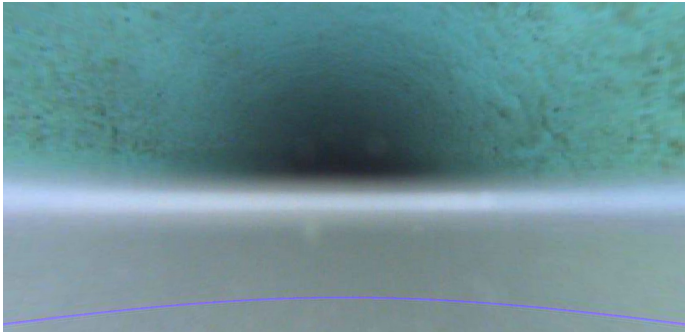
Code: **MWLS**
Description: **Water Level Sag**

Distance (ft): **406.5**
Structural Grade: **3**
O&M Grade: **3**
Clock Start/From:
Clock To:
1st Value:
2nd Value:
Value Percent: **50.000**
Continuous Index:
Within 8" of Joint: **NO**
Remarks:

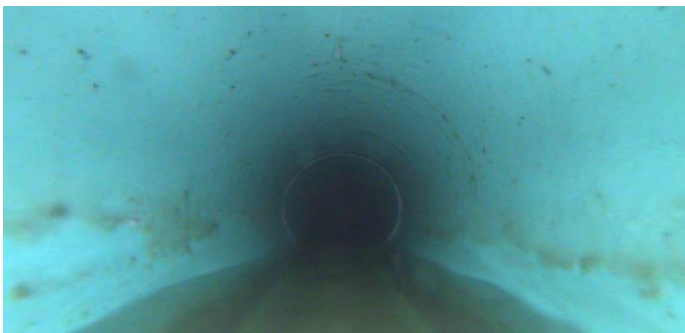
Code: **MSA**
Description: **Abandoned Survey**

Distance (ft): **426.8**
Structural Grade: **0**
O&M Grade: **0**
Clock Start/From:
Clock To:
1st Value:
2nd Value:
Value Percent:
Continuous Index:
Within 8" of Joint: **NO**
Remarks: **ROBOT HAS STOPPED**
