Profile/Photo Observation Report

Street:	FOXCROFT STREET	Flow Control:	Not Controlled
City:	Hobart, IN	Year Renewed:	
Location:	Yard	Tape/Media #:	
Purpose:	Routine Assessment	Dia/Height:	10"
Use:	Sanitary	Material:	PVC
Drain Area:	NA	Lining:	
Category:	NA		
Comment:	Flow direction

Location Details:		Direction of Survey:	Upstream
US MH:	M-607-075A	DS MH:	M-608-015
		Total Length Surveyed (ft):	128.0

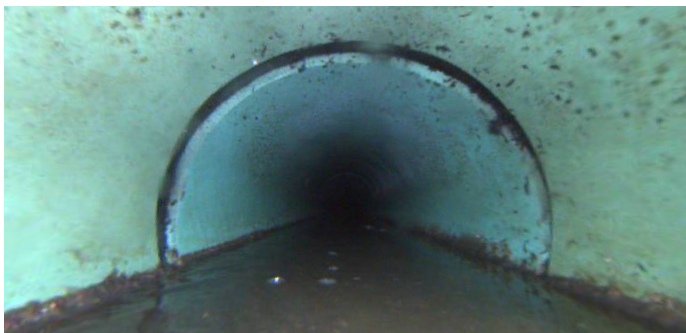
Code: **AMH**
Description: **Manhole**

Distance (ft): **.0**
Structural Grade: **0**
O&M Grade: **0**
Clock Start/From:
Clock To:
1st Value:
2nd Value:
Value Percent:
Continuous Index:
Within 8" of Joint: **NO**
Remarks: **M-608-015**

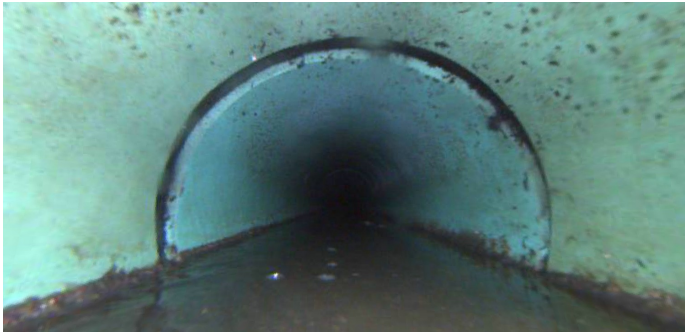
Code:	MWL
Description:	Water Level

Distance (ft):	.0
Structural Grade:	0
O&M Grade:	0
Clock Start/From:	
Clock To:	
1st Value:	
2nd Value:	
Value Percent:	30.000
Continuous Index:	
Within 8" of Joint:	NO
Remarks:

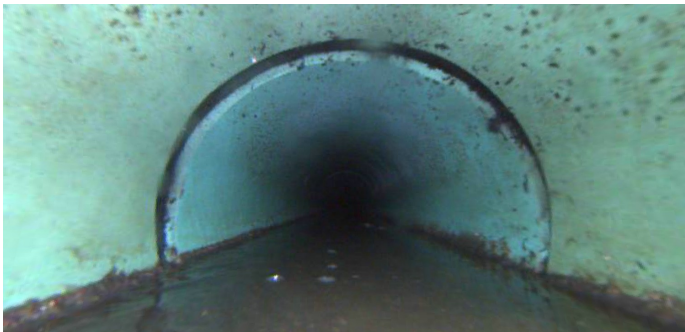
Code:	JOM
Description:	Joint Offset Medium

Distance (ft):	.0
Structural Grade:	1
O&M Grade:	0
Clock Start/From:	
Clock To:	
1st Value:	
2nd Value:	
Value Percent:	
Continuous Index:	
Within 8" of Joint:	NO
Remarks:

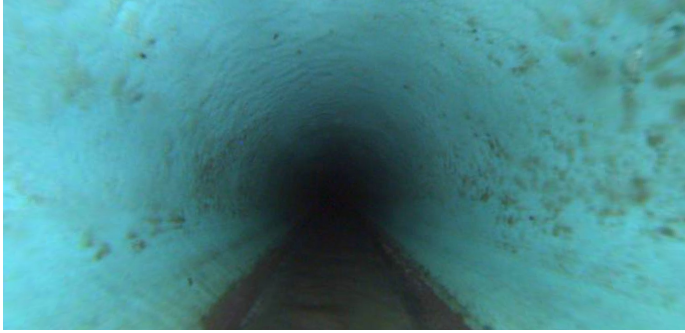
Code: **MWL**
Description: **Water Level**

Distance (ft): **7.0**
Structural Grade: **0**
O&M Grade: **0**
Clock Start/From:
Clock To:
1st Value:
2nd Value:
Value Percent: **5.000**
Continuous Index:
Within 8" of Joint: **NO**
Remarks:

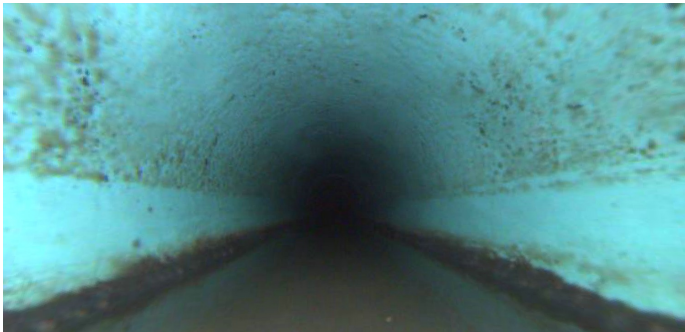
Code: **MWL**
Description: **Water Level**

Distance (ft): **37.6**
Structural Grade: **0**
O&M Grade: **0**
Clock Start/From:
Clock To:
1st Value:
2nd Value:
Value Percent: **20.000**
Continuous Index:
Within 8" of Joint: **NO**
Remarks:

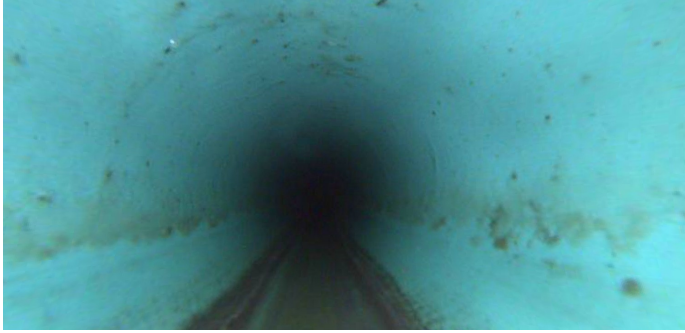
Code: **MWL**
Description: **Water Level**

Distance (ft): **44.0**
Structural Grade: **0**
O&M Grade: **0**
Clock Start/From:
Clock To:
1st Value:
2nd Value:
Value Percent: **5.000**
Continuous Index:
Within 8" of Joint: **NO**
Remarks:

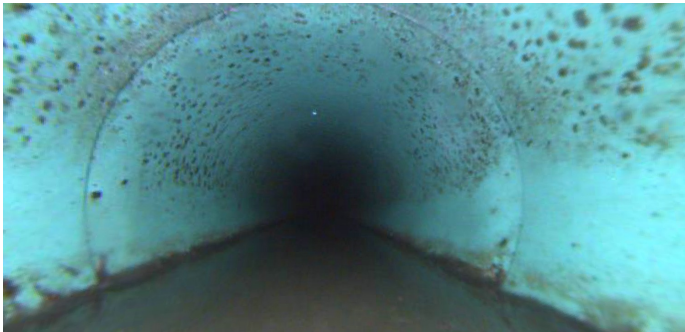
Code: **MWL**
Description: **Water Level**

Distance (ft): **66.3**
Structural Grade: **0**
O&M Grade: **0**
Clock Start/From:
Clock To:
1st Value:
2nd Value:
Value Percent: **20.000**
Continuous Index:
Within 8" of Joint: **NO**
Remarks:

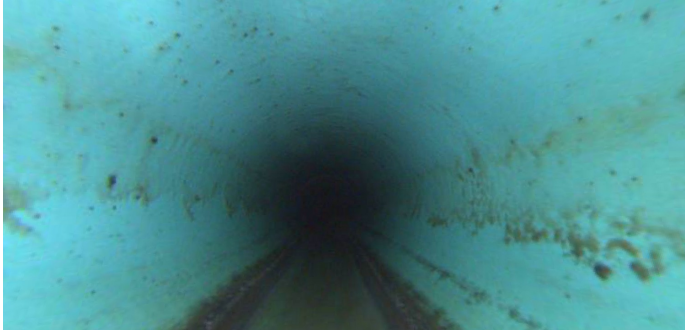
Code: **MWL**
Description: **Water Level**

Distance (ft): **111.5**
Structural Grade: **0**
O&M Grade: **0**
Clock Start/From:
Clock To:
1st Value:
2nd Value:
Value Percent: **5.000**
Continuous Index:
Within 8" of Joint: **NO**
Remarks:

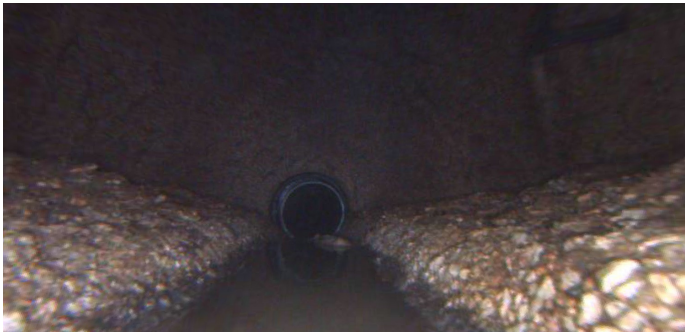
Code: **AMH**
Description: **Manhole**

Distance (ft): **127.8**
Structural Grade: **0**
O&M Grade: **0**
Clock Start/From:
Clock To:
1st Value:
2nd Value:
Value Percent:
Continuous Index:
Within 8" of Joint: **NO**
Remarks: **M-607-075A**
