Profile/Photo Observation Report

Date:	04/19/2018	Weather:		Coding:	PACP 6.0
Pipe Length (ft):	279.0	Owner:	NA	Pre Clean:	Not Known
P.O.#:		Surveyor:	Justin Gonzales	PSR:	
Customer:		Clean Date:	01/01/1900	Shape:	C

Street:	Capitol	Flow Control:	Not Controlled
City:	Hobart, IN	Year Renewed:	
Location:	Light Highway	Tape/Media #:	
Purpose:	Maintenance Related	Dia/Height:	12"
Use:	Sanitary	Material:	PVC
Drain Area:	NA	Lining:	Cured in Place
Category:	NA		
Comment:	new segment-706-039 doesn't exist.		
Location Details:		Direction of Survey:	Upstream
US MH:	M-705-021	DS MH:	M-706-040
		Total Length Surveyed (ft):	280.9

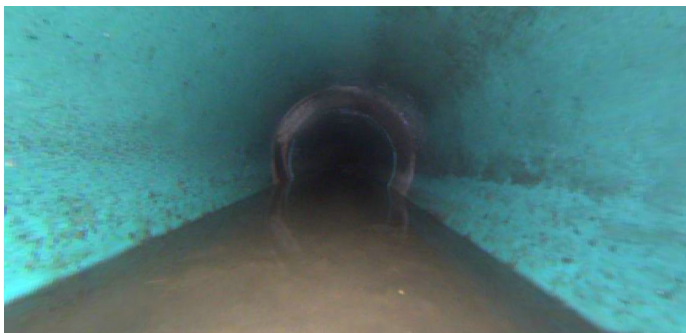
Code: **AMH**
Description: **Manhole**

Distance (ft): **.0**
Structural Grade: **0**
O&M Grade: **0**
Clock Start/From:
Clock To:
1st Value:
2nd Value:
Value Percent:
Continuous Index:
Within 8" of Joint: **NO**
Remarks: **M-706-040**

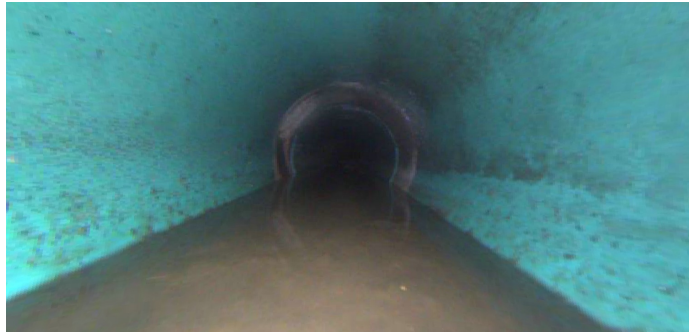
Code:	MWL
Description:	Water Level
Distance (ft):	.0
Structural Grade:	0
O&M Grade:	0
Clock Start/From:	
Clock To:	
1st Value:	
2nd Value:	
Value Percent:	10.000
Continuous Index:	
Within 8" of Joint:	NO
Remarks:

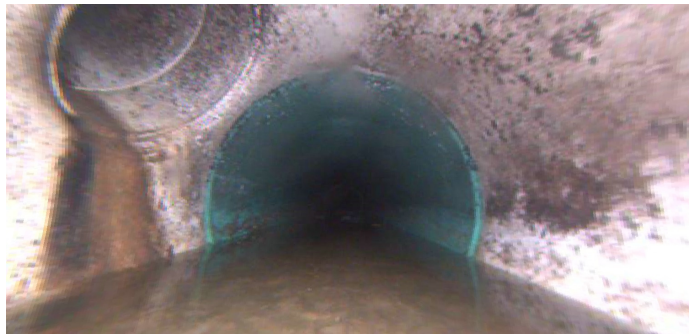
Code:	TF
Description:	Tap Factory
Distance (ft):	2.5
Structural Grade:	0
O&M Grade:	0
Clock Start/From:	10
Clock To:	
1st Value:	4.000
2nd Value:	
Value Percent:	
Continuous Index:	
Within 8" of Joint:	
Remarks:

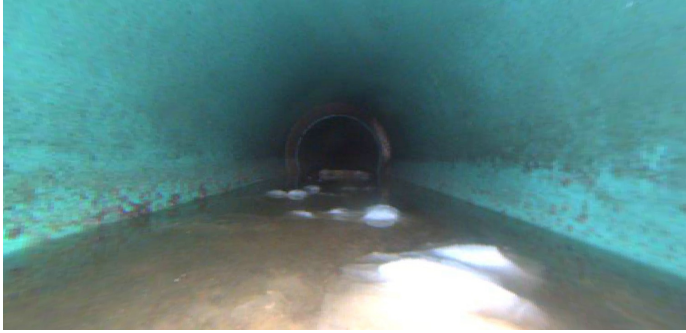
Code: **MGO**
Description: **General Observation**

Distance (ft): **6.6**
Structural Grade: **0**
O&M Grade: **0**
Clock Start/From:
Clock To:
1st Value:
2nd Value:
Value Percent:
Continuous Index:
Within 8" of Joint: **NO**
Remarks: **TOILET TISSUE**

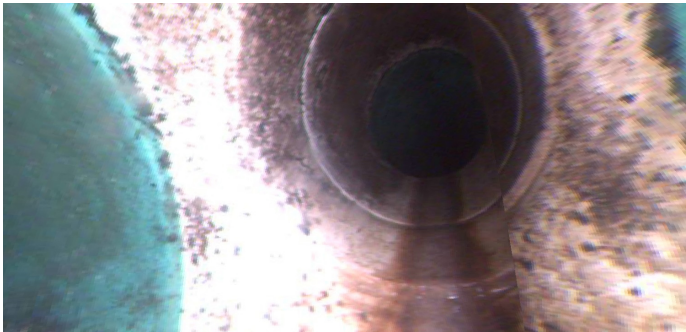
Code: **TF**
Description: **Tap Factory**

Distance (ft): **9.4**
Structural Grade: **0**
O&M Grade: **0**
Clock Start/From: **3**
Clock To:
1st Value: **4.000**
2nd Value:
Value Percent:
Continuous Index:
Within 8" of Joint:
Remarks:

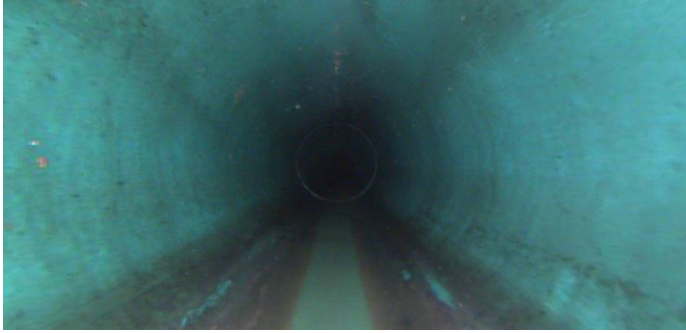
Code: **MWL**
Description: **Water Level**

Distance (ft): **20.0**
Structural Grade: **0**
O&M Grade: **0**
Clock Start/From:
Clock To:
1st Value:
2nd Value:
Value Percent: **5.000**
Continuous Index:
Within 8" of Joint: **NO**
Remarks:

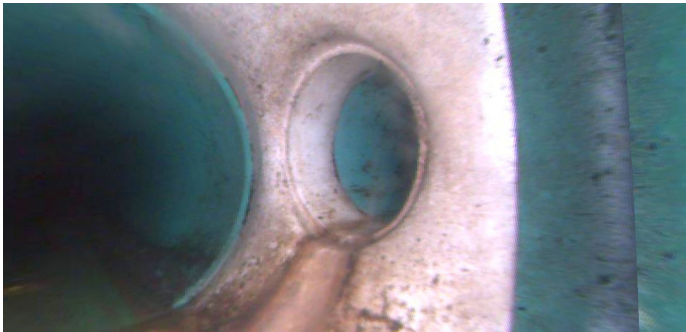
Code: **TF**
Description: **Tap Factory**

Distance (ft): **52.4**
Structural Grade: **0**
O&M Grade: **0**
Clock Start/From: **3**
Clock To:
1st Value: **4.000**
2nd Value:
Value Percent:
Continuous Index:
Within 8" of Joint:
Remarks:

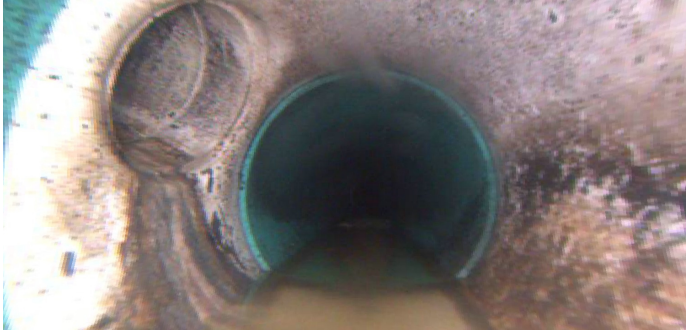
Code: **TF**
Description: **Tap Factory**

Distance (ft): **65.5**
Structural Grade: **0**
O&M Grade: **0**
Clock Start/From: **10**
Clock To:
1st Value: **4.000**
2nd Value:
Value Percent:
Continuous Index:
Within 8" of Joint:
Remarks:

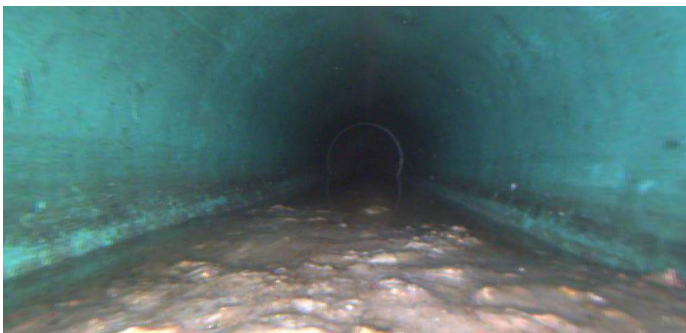
Code: **MGO**
Description: **General Observation**

Distance (ft): **98.5**
Structural Grade: **0**
O&M Grade: **0**
Clock Start/From:
Clock To:
1st Value:
2nd Value:
Value Percent:
Continuous Index:
Within 8" of Joint: **NO**
Remarks: **TOILET TISSUE**

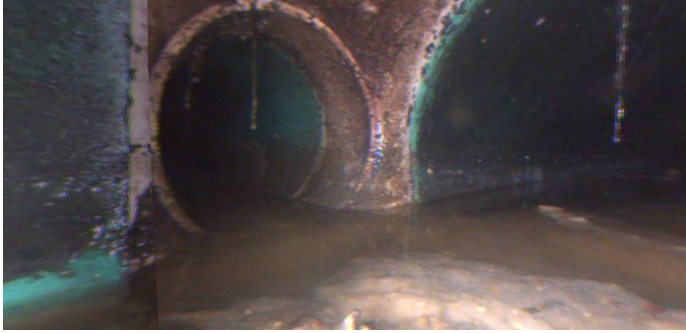
Code: **TF**
Description: **Tap Factory**

Distance (ft): **116.1**
Structural Grade: **0**
O&M Grade: **0**
Clock Start/From: **9**
Clock To:
1st Value: **4.000**
2nd Value:
Value Percent:
Continuous Index:
Within 8" of Joint:
Remarks:

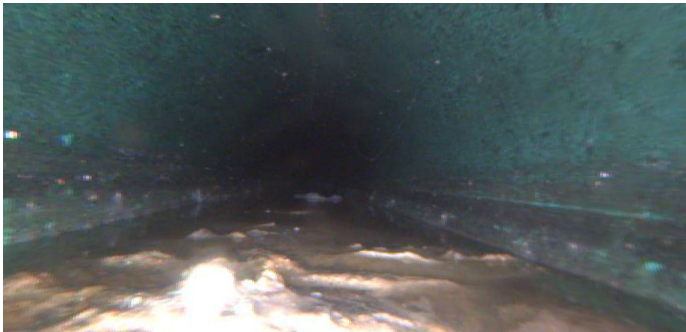
Code: **MGO**
Description: **General Observation**

Distance (ft): **121.8**
Structural Grade: **0**
O&M Grade: **0**
Clock Start/From:
Clock To:
1st Value:
2nd Value:
Value Percent:
Continuous Index:
Within 8" of Joint: **NO**
Remarks: **TOILET TISSUE**

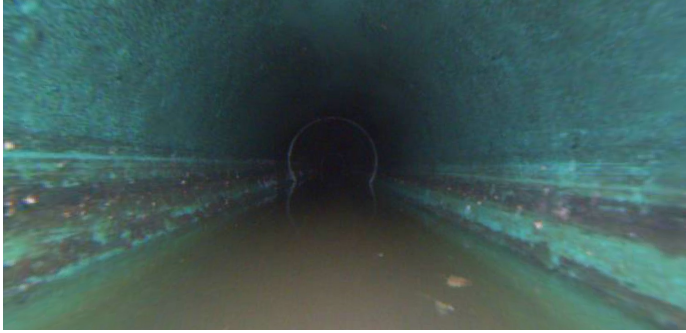
Code: **MWL**
Description: **Water Level**

Distance (ft): **127.3**
Structural Grade: **0**
O&M Grade: **0**
Clock Start/From:
Clock To:
1st Value:
2nd Value:
Value Percent: **30.000**
Continuous Index:
Within 8" of Joint: **NO**
Remarks:

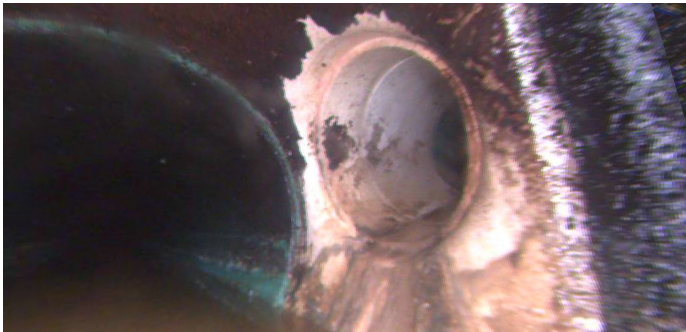
Code: **TF**
Description: **Tap Factory**

Distance (ft): **138.4**
Structural Grade: **0**
O&M Grade: **0**
Clock Start/From: **3**
Clock To:
1st Value: **4.000**
2nd Value:
Value Percent:
Continuous Index:
Within 8" of Joint:
Remarks:

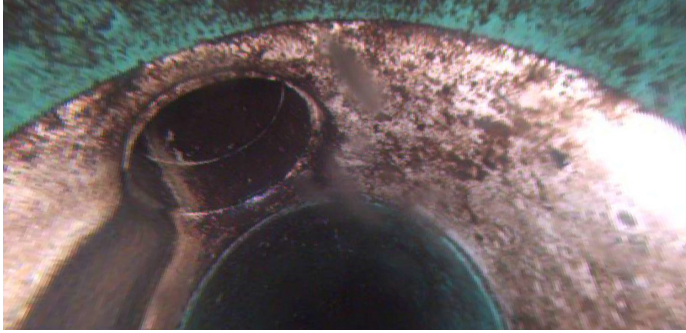
Code: **TF**
Description: **Tap Factory**

Distance (ft): **160.7**
Structural Grade: **0**
O&M Grade: **0**
Clock Start/From: **11**
Clock To:
1st Value: **4.000**
2nd Value:
Value Percent:
Continuous Index:
Within 8" of Joint:
Remarks:

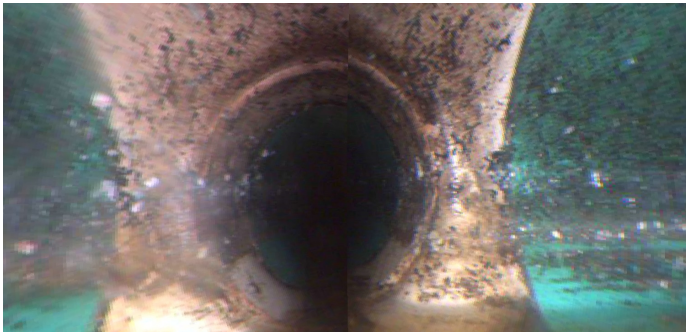
Code: **TF**
Description: **Tap Factory**

Distance (ft): **204.8**
Structural Grade: **0**
O&M Grade: **0**
Clock Start/From: **9**
Clock To:
1st Value: **4.000**
2nd Value:
Value Percent:
Continuous Index:
Within 8" of Joint:
Remarks:

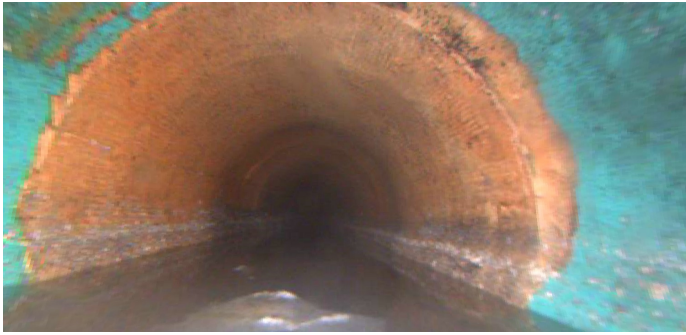
Code: **MLC**
Description: **Lining Change**

Distance (ft): **262.9**
Structural Grade: **0**
O&M Grade: **0**
Clock Start/From:
Clock To:
1st Value:
2nd Value:
Value Percent:
Continuous Index:
Within 8" of Joint: **NO**
Remarks: **cip**

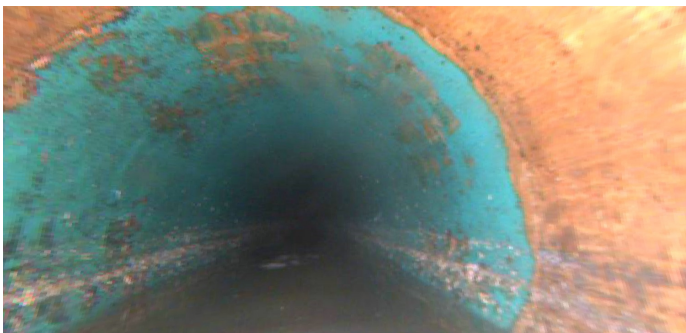
Code: **MLC**
Description: **Lining Change**

Distance (ft): **266.9**
Structural Grade: **0**
O&M Grade: **0**
Clock Start/From:
Clock To:
1st Value:
2nd Value:
Value Percent:
Continuous Index:
Within 8" of Joint: **NO**
Remarks: **end cip**

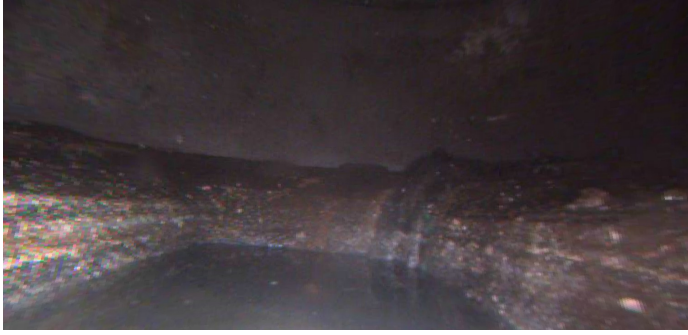
Code:	AMH
Description:	Manhole
Distance (ft):	280.9
Structural Grade:	0
O&M Grade:	0
Clock Start/From:	
Clock To:	
1st Value:	
2nd Value:	
Value Percent:	
Continuous Index:	
Within 8" of Joint:	NO
Remarks:	M-705-021
