## Profile/Photo Observation Report

Street:	<b>Capitol</b>	Flow Control:	<b>Not Controlled</b>
City:	<b>Hobart, IN</b>	Year Renewed:	
Location:	<b>Light Highway</b>	Tape/Media #:	
Purpose:	<b>Maintenance Related</b>	Dia/Height:	<b>12"</b>
Use:	<b>Sanitary</b>	Material:	<b>PVC</b>
Drain Area:	<b>NA</b>	Lining:	<b>Cured in Place</b>
Category:	<b>NA</b>		
Comment:	<b>706-036 doesn't exist.</b>

Location Details:		Direction of Survey:	<b>Downstream</b>
US MH:	<b>M-706-035.5</b>	DS MH:	<b>M-706-037</b>
		Total Length Surveyed (ft):	<b>158.6</b>

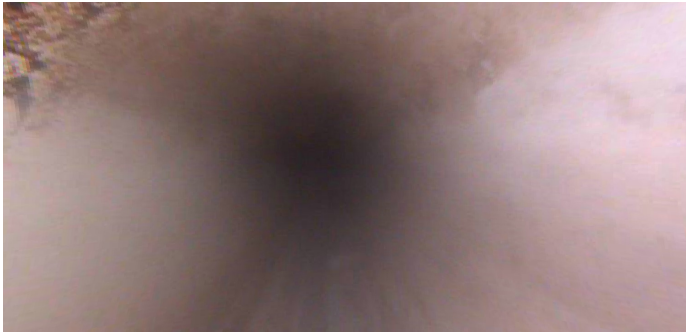
Code:	<b>MWL</b>
Description:	<b>Water Level</b>

Distance (ft):	<b>.0</b>
Structural Grade:	<b>0</b>
O&M Grade:	<b>0</b>
Clock Start/From:	
Clock To:	
1st Value:	
2nd Value:	
Value Percent:	<b>5.000</b>
Continuous Index:	
Within 8" of Joint:	<b>NO</b>
Remarks:

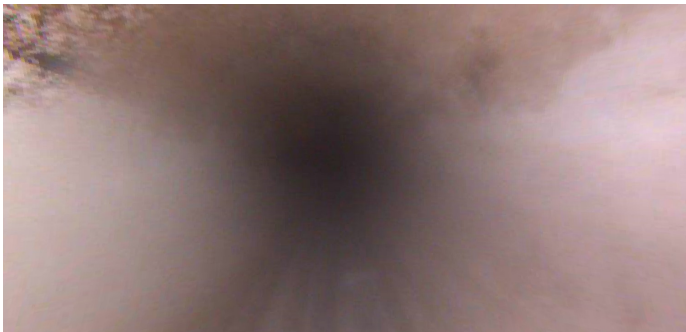
Code:	<b>MGO</b>
Description:	<b>General Observation</b>

Distance (ft):	<b>.5</b>
Structural Grade:	<b>0</b>
O&M Grade:	<b>0</b>
Clock Start/From:	
Clock To:	
1st Value:	
2nd Value:	
Value Percent:	
Continuous Index:	
Within 8" of Joint:	<b>NO</b>
Remarks:	<b>steam in line</b>

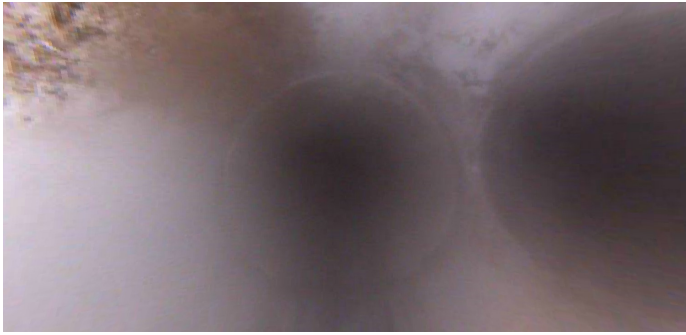
Code: **TF**  
Description: **Tap Factory**

Distance (ft): **7.3**  
Structural Grade: **0**  
O&M Grade: **0**  
Clock Start/From: **3**  
Clock To:  
1st Value: **4.000**  
2nd Value:  
Value Percent:  
Continuous Index:  
Within 8" of Joint: **YES**  
Remarks:

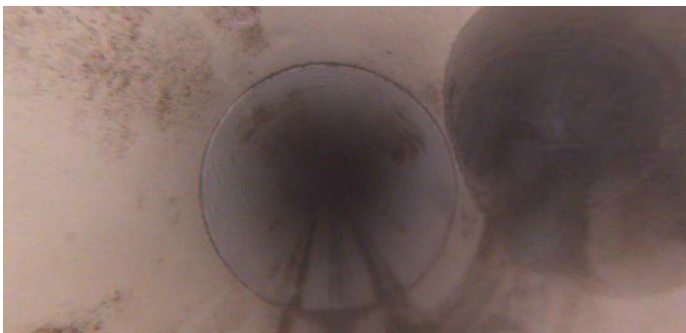
Code: **TF**  
Description: **Tap Factory**

Distance (ft): **62.4**  
Structural Grade: **0**  
O&M Grade: **0**  
Clock Start/From: **2**  
Clock To:  
1st Value: **4.000**  
2nd Value:  
Value Percent:  
Continuous Index:  
Within 8" of Joint: **YES**  
Remarks:

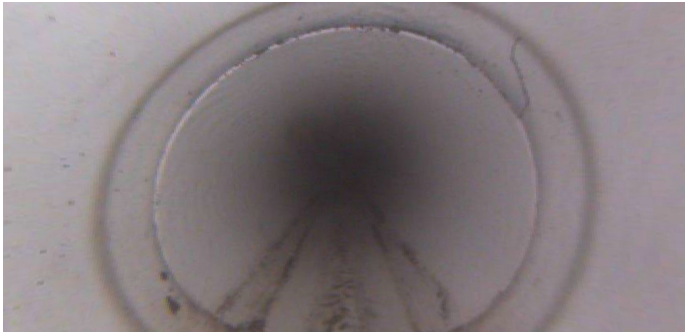
Code: **D**  
Description: **Deformed**

Distance (ft): **97.2**  
Structural Grade: **4**  
O&M Grade: **0**  
Clock Start/From:  
Clock To:  
1st Value:  
2nd Value:  
Value Percent: **5.000**  
Continuous Index:  
Within 8" of Joint: **NO**  
Remarks:

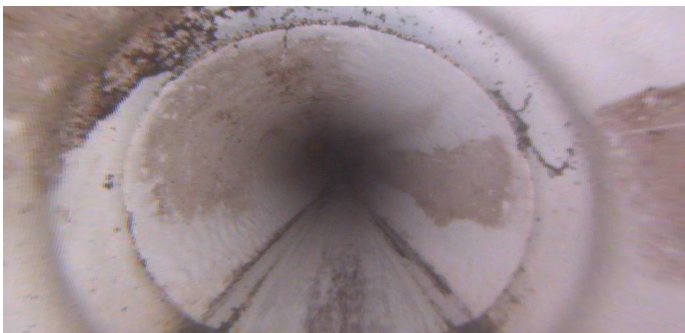
Code: **D**  
Description: **Deformed**

Distance (ft): **123.1**  
Structural Grade: **4**  
O&M Grade: **0**  
Clock Start/From:  
Clock To:  
1st Value:  
2nd Value:  
Value Percent: **5.000**  
Continuous Index:  
Within 8" of Joint: **NO**  
Remarks:

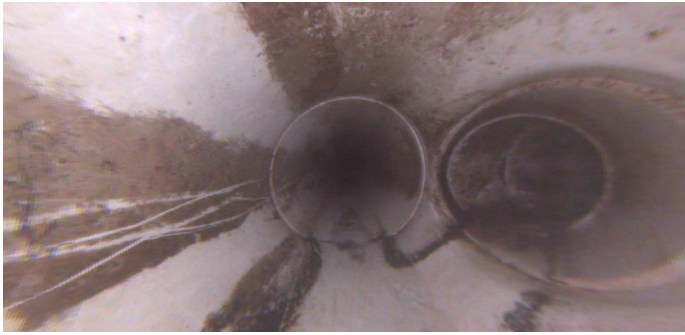
Code: **TF**  
Description: **Tap Factory**

Distance (ft): **145.9**  
Structural Grade: **0**  
O&M Grade: **0**  
Clock Start/From: **3**  
Clock To:  
1st Value: **4.000**  
2nd Value:  
Value Percent:  
Continuous Index:  
Within 8" of Joint: **YES**  
Remarks:

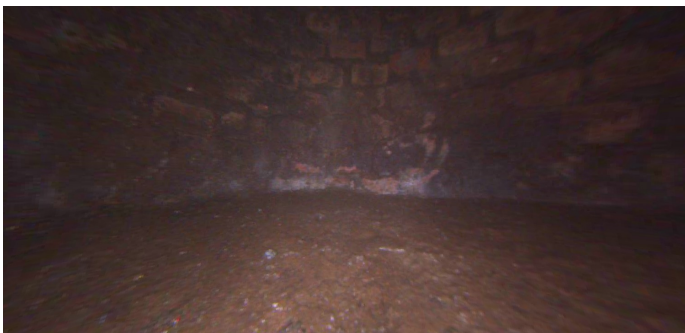
Code: **AMH**  
Description: **Manhole**

Distance (ft): **158.6**  
Structural Grade: **0**  
O&M Grade: **0**  
Clock Start/From:  
Clock To:  
1st Value:  
2nd Value:  
Value Percent:  
Continuous Index:  
Within 8" of Joint: **NO**  
Remarks: **M-706-037**
