Profile/Photo Observation Report

Profile/Photo Observation Report								
Date:	04/28/2018	Weather:			Coding:	PACP 6.0		
Pipe Length (ft	t):	Owner:	City of Hob	art	Pre Clean:	Not Known		
P.O.#:	256	Surveyor:	B. Helbling		PSR:			
Customer:	City of Hobart	Clean Date:			Shape:	С		
Street:	East 10th Street		Flow Control:		Not Controlled			
City:	Hobart, IN		Year Renewe	d:				
Location:	Sidewalk		Tape/Media	# :	DEP256			
Purpose:	Routine Assessment		Dia/Height:		12"			
Use:	Sanitary		Material:		PVC			
Drain Area:			Lining:					
Category:	NA							
Comment:	5-21-2018							
Location Detai	ls:		Direction of S	urvey:	Downstream			
US MH:	M-806-045	DS MH:	M-806-061		Total Length Surveyed (ft):	347.9		
O&M Index:	0.00	O&M Quick:	(0000	O&M Rating:	0.00		
Structural Index	0.00	Structural Qu	uick:	0000	Structural Rating:	0.00		
Overall Index:	0.00	Overall Quicl		0000	Overall Rating:	0.00

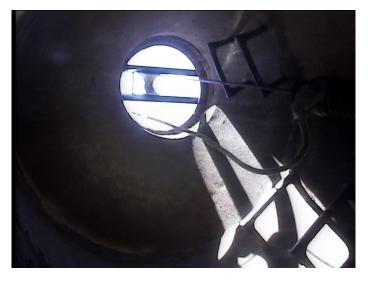
Description:	Manhole		
Distance (ft):	.0		
Structural Grade:	0		
O&M Grade:	0		
Clock Start/From:			
Clock To:			
1st Value:			
2nd Value:			
Value Percent:			
Continuous Index:			
Within 8" of Joint:	NO		
Remarks:	M-806-045

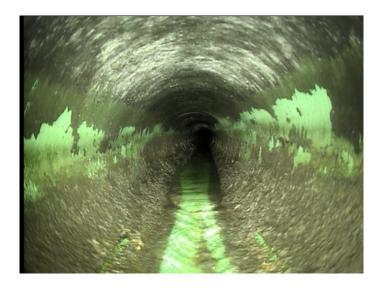
Code: MWL

Description: Water Level

Distance (ft): .0
Structural Grade: 0
O&M Grade: 0

Value Percent: 5.000

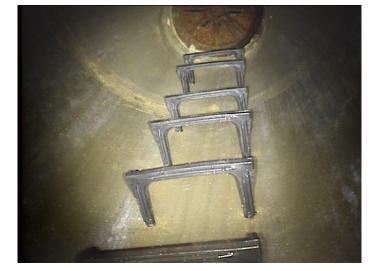
Code: AMH
Description: Manhole

Distance (ft): 347.9
Structural Grade: 0
O&M Grade: 0

Remarks: M-806-061
