## Profile/Photo Observation Report

Date:	<b>10/22/2021</b>	Weather:		Coding:	<b>PACP 6.0</b>
Pipe Length (ft):		Owner:	<b>Hobart, IN</b>	Pre Clean:	<b>Not Known</b>
P.O.#:	<b>964_1</b>	Surveyor:	<b>M. Pielacha</b>	PSR:	<b>M-806-045_M-806-061</b>
Customer:	<b>Hobart, IN</b>	Clean Date:		Shape:	<b>C</b>

Street:	<b>10th Street</b>	Flow Control:	
City:	<b>Hobart, IN</b>	Year Renewed:	
Location:	<b>Light Highway</b>	Tape/Media #:	<b>964</b>
Purpose:	<b>Routine Assessment</b>	Dia/Height:	<b>15"</b>
Use:	<b>Sanitary</b>	Material:	<b>PVC</b>
Drain Area:		Lining:	
Category:	<b>NA</b>		
Comment:

Location Details:		Direction of Survey:	<b>Downstream</b>
US MH:	<b>M-806-045</b>	DS MH:	<b>M-806-061</b>
		Total Length Surveyed (ft):	<b>344.0</b>

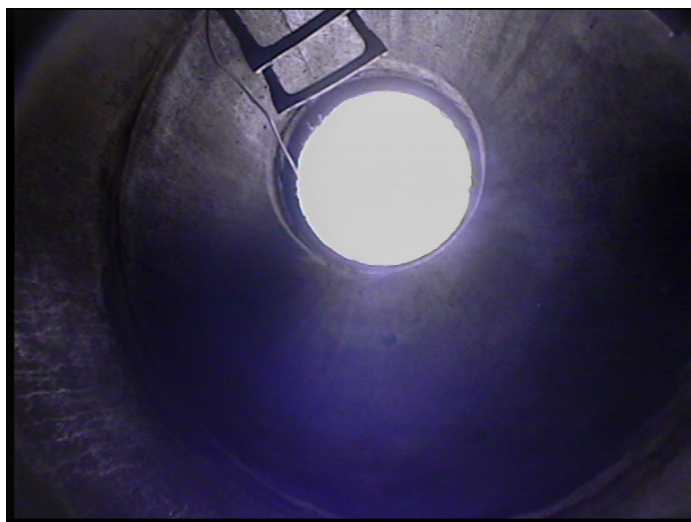
Code: **AMH**  
Description: **Manhole**

Distance (ft): **.0**  
Structural Grade: **0**  
O&M Grade: **0**  
Clock Start/From:  
Clock To:  
1st Value:  
2nd Value:  
Value Percent:  
Continuous Index:  
Within 8" of Joint: **NO**  
Remarks: **M-806-045**

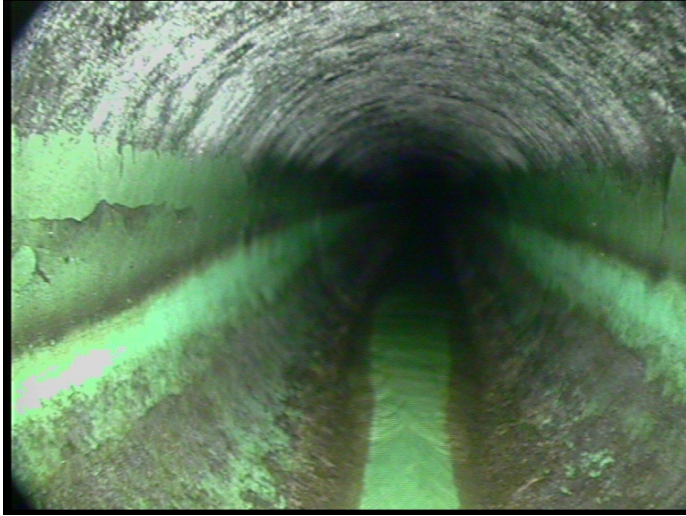
Code:	<b>MWL</b>
Description:	<b>Water Level</b>
Distance (ft):	<b>.0</b>
Structural Grade:	<b>0</b>
O&M Grade:	<b>0</b>
Clock Start/From:	
Clock To:	
1st Value:	
2nd Value:	
Value Percent:	<b>5.000</b>
Continuous Index:	
Within 8" of Joint:	<b>NO</b>
Remarks:

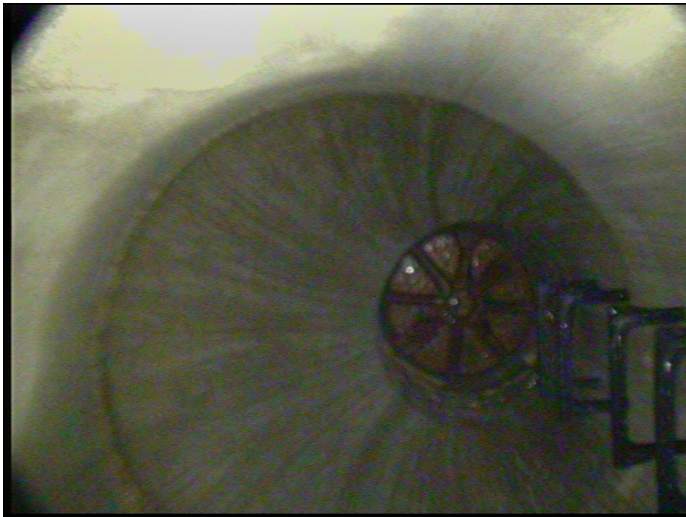
Code:	<b>AMH</b>
Description:	<b>Manhole</b>
Distance (ft):	<b>344.0</b>
Structural Grade:	<b>0</b>
O&M Grade:	<b>0</b>
Clock Start/From:	
Clock To:	
1st Value:	
2nd Value:	
Value Percent:	
Continuous Index:	
Within 8" of Joint:	<b>NO</b>
Remarks:	<b>M-806-061</b>
