# Profile/Photo Observation Report

Date:	<b>02/01/2025</b>	Weather:		Coding:	<b>PACP 7.0</b>
Pipe Length (ft):		Owner:	<b>City of Hobart</b>	Pre Clean:	<b>Heavy Cleaning</b>
P.O.#:	<b>YES502259</b>	Surveyor:	<b>S. Bucklin</b>	PSR:	<b>M-902-008-M-902-008.1</b>
Customer:	<b>City of Hobart</b>	Clean Date:	<b>08/22/2023</b>	Shape:	<b>C</b>

Street:	<b>East 34th Lane</b>	Flow Control:	<b>Not Controlled</b>
City:	<b>Hobart, IN</b>	Year Renewed:	
Location:	<b>Local rural streets with light traffic, t</b>	Tape/Media #:	
Purpose:	<b>Sewer System Evaluation Survey (SS</b>	Dia/Height:	<b>10"</b>
Use:	<b>Sanitary Sewage Pipe</b>	Material:	<b>VCP</b>
Drain Area:		Lining:	<b>None</b>
Category:	<b>NA</b>		
Comment:			
Location Details:		Direction of Survey:	<b>Downstream</b>
US MH:	<b>M-902-008</b>	DS MH:	<b>M-902-008.1</b>
		Total Length Surveyed (ft):	<b>225.5</b>

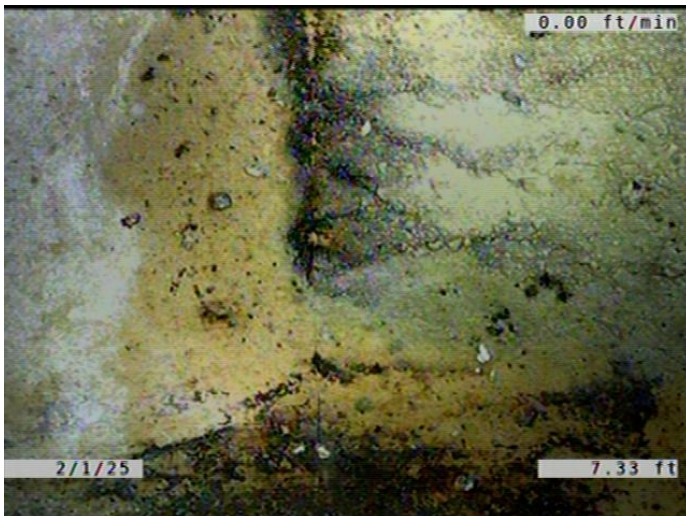
Code: **CL**  
Description: **Crack Longitudinal**

Distance (ft): **7.3**  
Structural Grade: **2**  
O&M Grade: **0**  
Clock Start/From: **2**  
Clock To:  
1st Value:  
2nd Value:  
Value Percent:  
Continuous Index:  
Within 8" of Joint: **YES**  
Remarks:

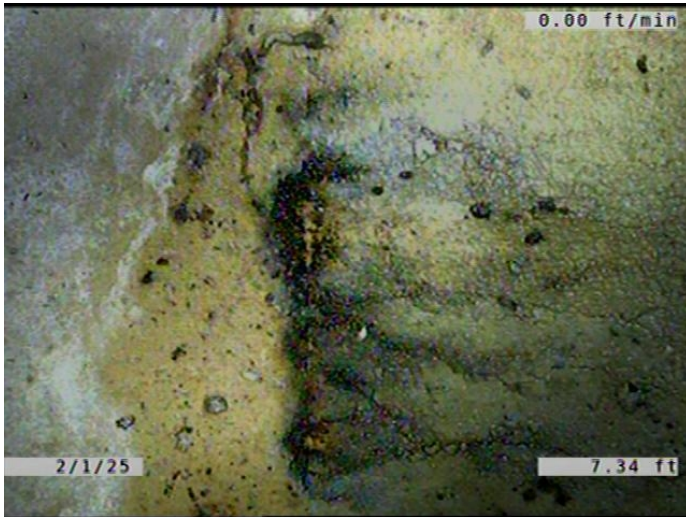
Code: **DAE**  
Description: **Deposits Attached Encrustation**

Distance (ft): **7.3**  
Structural Grade: **0**  
O&M Grade: **2**  
Clock Start/From: **2**  
Clock To: **5**  
1st Value:  
2nd Value:  
Value Percent: **5.000**  
Continuous Index:  
Within 8" of Joint: **YES**  
Remarks:

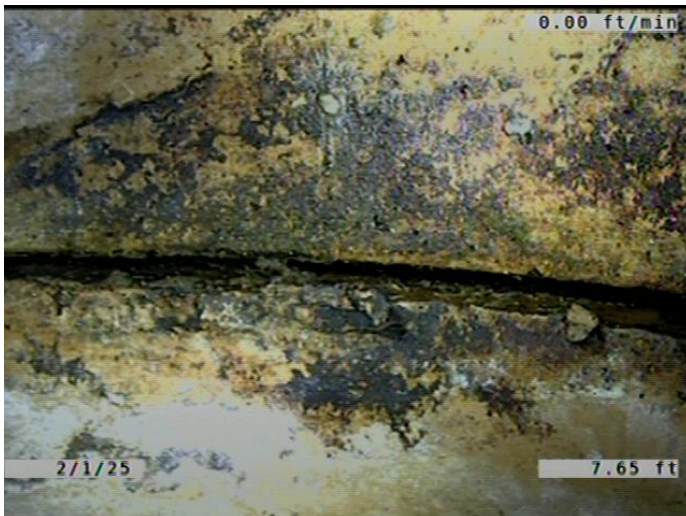
Code: **DAE**  
Description: **Deposits Attached Encrustation**

Distance (ft): **7.6**  
Structural Grade: **0**  
O&M Grade: **2**  
Clock Start/From: **7**  
Clock To: **5**  
1st Value:  
2nd Value:  
Value Percent: **5.000**  
Continuous Index:  
Within 8" of Joint: **YES**  
Remarks:

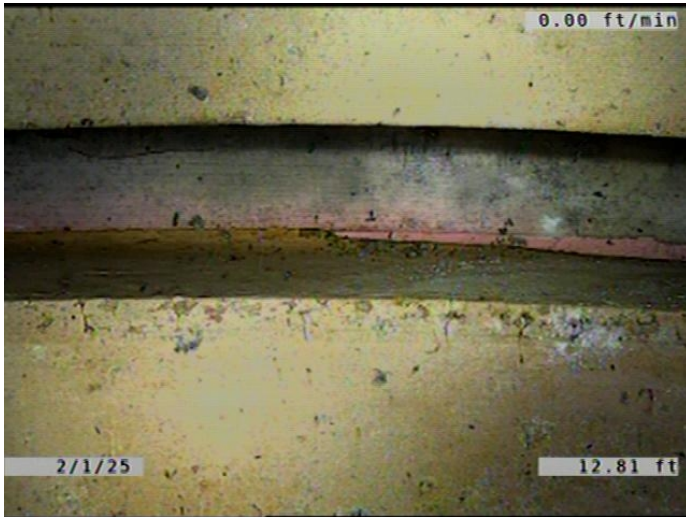
Code: **JAM**  
Description: **Joint Angular Medium**

Distance (ft): **12.8**  
Structural Grade: **3**  
O&M Grade: **0**  
Clock Start/From:  
Clock To:  
1st Value:  
2nd Value:  
Value Percent:  
Continuous Index:  
Within 8" of Joint: **NO**  
Remarks:

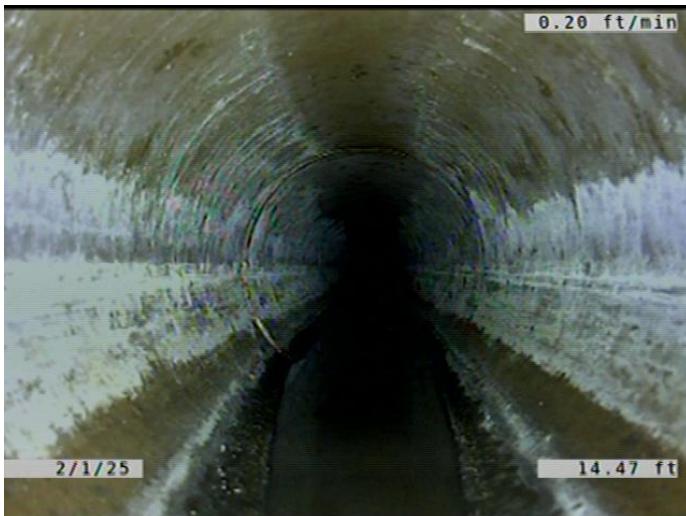
Code: **MWLS**  
Description: **Miscellaneous Water Level Sag**

Distance (ft): **14.4**  
Structural Grade: **2**  
O&M Grade: **0**  
Clock Start/From:  
Clock To:  
1st Value:  
2nd Value:  
Value Percent: **10.000**  
Continuous Index: **S01**  
Within 8" of Joint: **NO**  
Remarks:

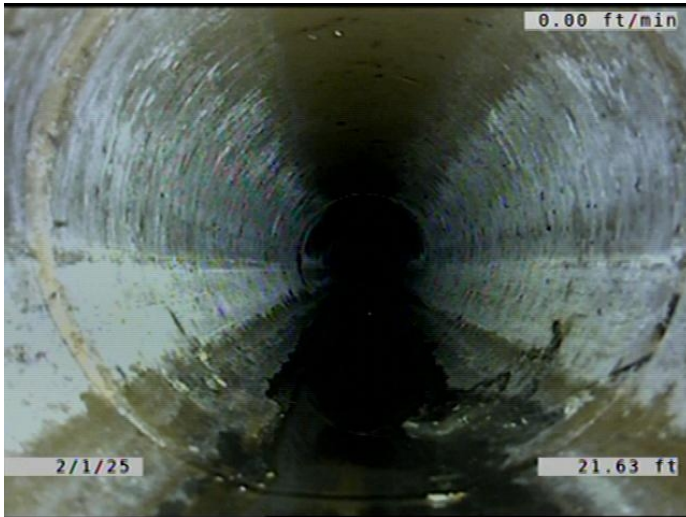
Code: **MWLS**  
Description: **Miscellaneous Water Level Sag**

Distance (ft): **21.6**  
Structural Grade: **2**  
O&M Grade: **0**  
Clock Start/From:  
Clock To:  
1st Value:  
2nd Value:  
Value Percent: **10.000**  
Continuous Index: **F01**  
Within 8" of Joint: **NO**  
Remarks:

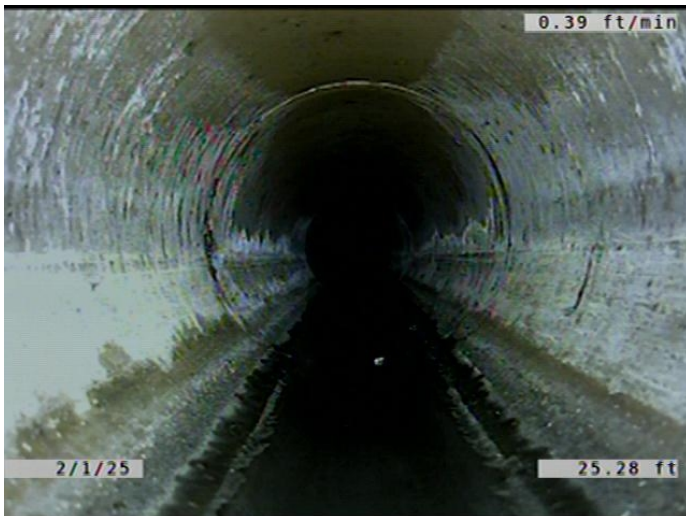
Code: **MWLS**  
Description: **Miscellaneous Water Level Sag**

Distance (ft): **25.2**  
Structural Grade: **2**  
O&M Grade: **0**  
Clock Start/From:  
Clock To:  
1st Value:  
2nd Value:  
Value Percent: **10.000**  
Continuous Index: **S02**  
Within 8" of Joint: **NO**  
Remarks:

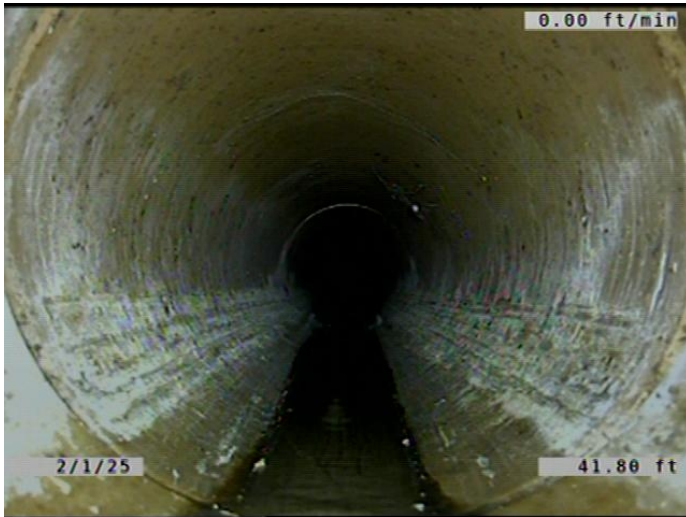
Code: **MWLS**  
Description: **Miscellaneous Water Level Sag**

Distance (ft): **41.8**  
Structural Grade: **2**  
O&M Grade: **0**  
Clock Start/From:  
Clock To:  
1st Value:  
2nd Value:  
Value Percent: **10.000**  
Continuous Index: **F02**  
Within 8" of Joint: **NO**  
Remarks:

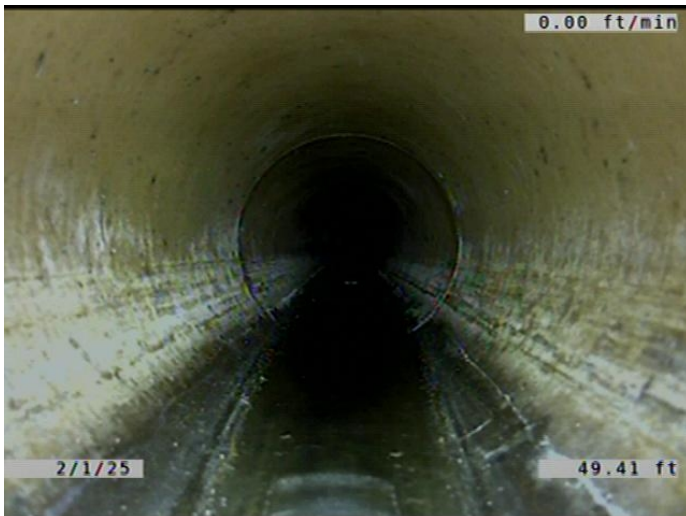
Code: **MWLS**  
Description: **Miscellaneous Water Level Sag**

Distance (ft): **49.4**  
Structural Grade: **2**  
O&M Grade: **0**  
Clock Start/From:  
Clock To:  
1st Value:  
2nd Value:  
Value Percent: **10.000**  
Continuous Index: **S03**  
Within 8" of Joint: **NO**  
Remarks:

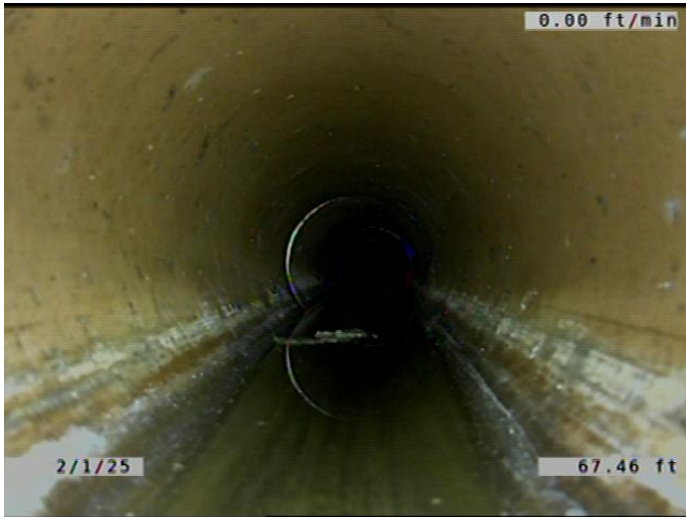
Code: **MWLS**  
Description: **Miscellaneous Water Level Sag**

Distance (ft): **67.4**  
Structural Grade: **2**  
O&M Grade: **0**  
Clock Start/From:  
Clock To:  
1st Value:  
2nd Value:  
Value Percent: **10.000**  
Continuous Index: **F03**  
Within 8" of Joint: **NO**  
Remarks:

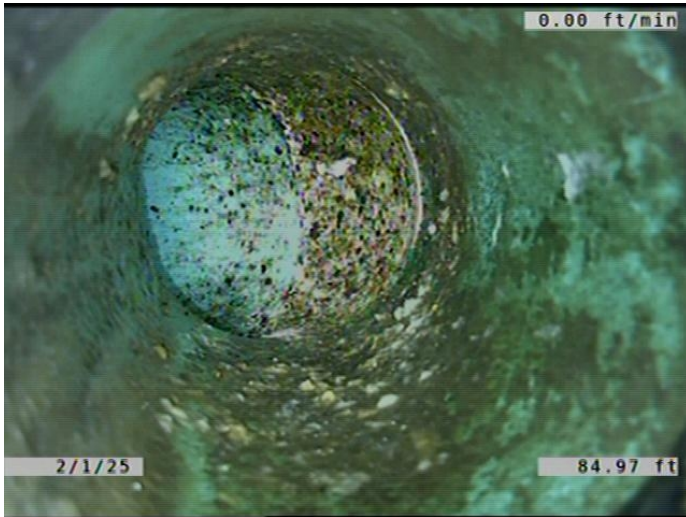
Code:	<b>TSD</b>
Description:	<b>Tap Saddle Defective</b>
Distance (ft):	<b>85.0</b>
Structural Grade:	<b>0</b>
O&M Grade:	<b>3</b>
Clock Start/From:	<b>12</b>
Clock To:	
1st Value:	<b>6.000</b>
2nd Value:	
Value Percent:	
Continuous Index:	
Within 8" of Joint:	<b>YES</b>
Remarks:	<b>SERVICE COMES FROM THE LEFT (SOUTH). SERVICE IS PVC.</b>

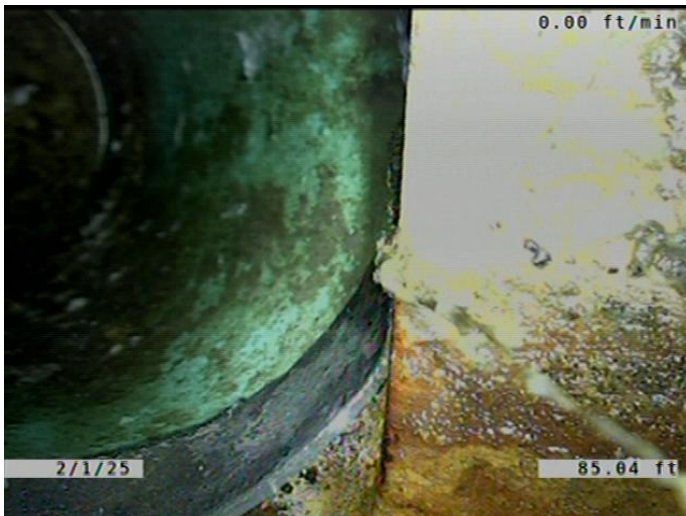
Code:	<b>RFB</b>
Description:	<b>Roots Fine Barrel</b>
Distance (ft):	<b>85.0</b>
Structural Grade:	<b>0</b>
O&M Grade:	<b>2</b>
Clock Start/From:	<b>12</b>
Clock To:	<b>1</b>
1st Value:	
2nd Value:	
Value Percent:	
Continuous Index:	
Within 8" of Joint:	<b>NO</b>
Remarks:

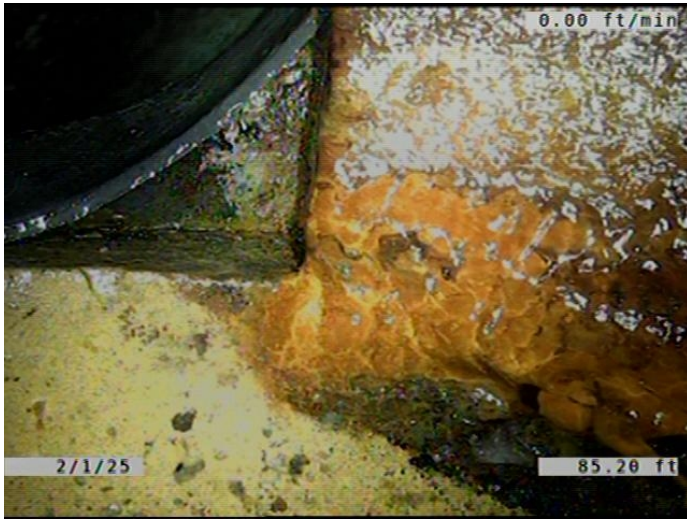
Code: **IDB**  
Description: **Infiltration Dripper Barrel**

Distance (ft): **85.2**  
Structural Grade: **0**  
O&M Grade: **3**  
Clock Start/From: **12**  
Clock To: **1**  
1st Value:  
2nd Value:  
Value Percent:  
Continuous Index:  
Within 8" of Joint: **YES**  
Remarks:

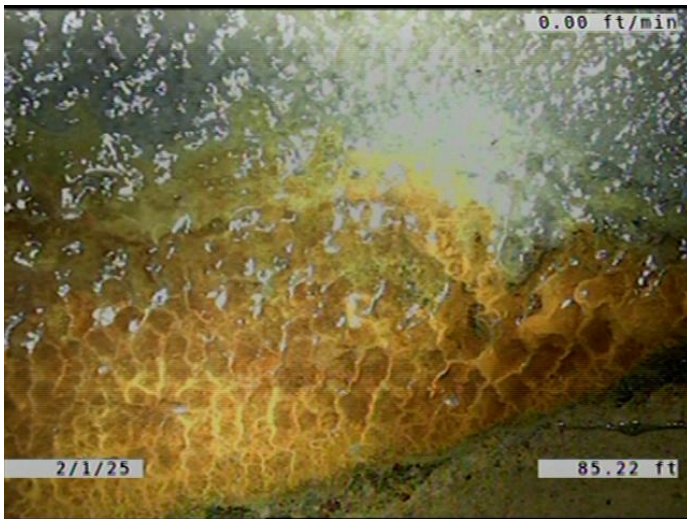
Code: **DAE**  
Description: **Deposits Attached Encrustation**

Distance (ft): **85.2**  
Structural Grade: **0**  
O&M Grade: **2**  
Clock Start/From: **7**  
Clock To: **5**  
1st Value:  
2nd Value:  
Value Percent: **5.000**  
Continuous Index:  
Within 8" of Joint: **YES**  
Remarks:

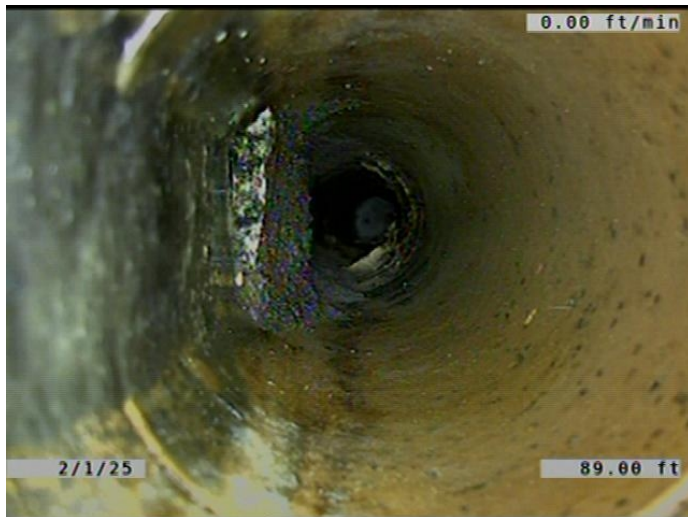
Code: **TFD**  
Description: **Tap Factory Defective**

Distance (ft): **89.0**  
Structural Grade: **0**  
O&M Grade: **3**  
Clock Start/From: **9**  
Clock To:  
1st Value: **6.000**  
2nd Value:  
Value Percent:  
Continuous Index:  
Within 8" of Joint: **YES**  
Remarks: **CAPPED. SOIL AND ENCRUSTATION IN THE SERVICE.**

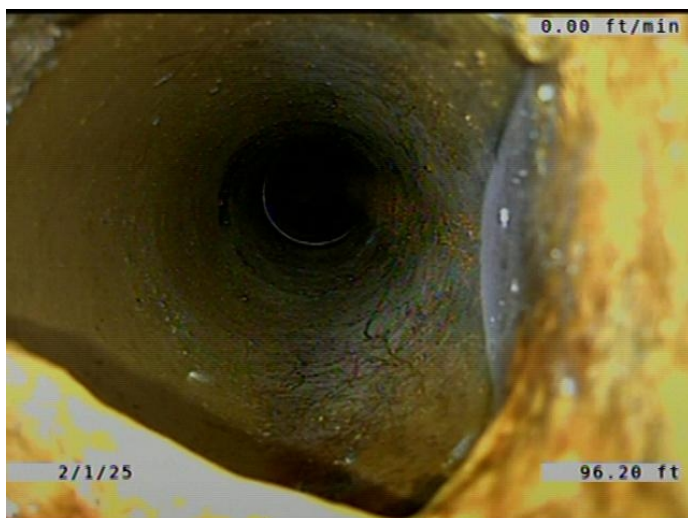
Code: **TFD**  
Description: **Tap Factory Defective**

Distance (ft): **96.2**  
Structural Grade: **0**  
O&M Grade: **3**  
Clock Start/From: **3**  
Clock To:  
1st Value: **6.000**  
2nd Value:  
Value Percent:  
Continuous Index:  
Within 8" of Joint: **YES**  
Remarks: **CAPPED. ENCRUSTATION COMING FROM THE JOINTS.**

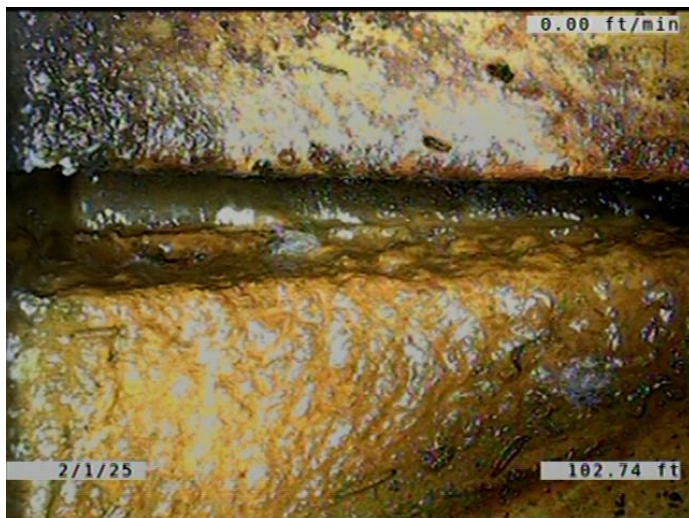
Code: **DAE**  
 Description: **Deposits Attached Encrustation**

Distance (ft): **102.7**  
 Structural Grade: **0**  
 O&M Grade: **2**  
 Clock Start/From: **8**  
 Clock To: **11**  
 1st Value:  
 2nd Value:  
 Value Percent: **5.000**  
 Continuous Index:  
 Within 8" of Joint: **YES**  
 Remarks:

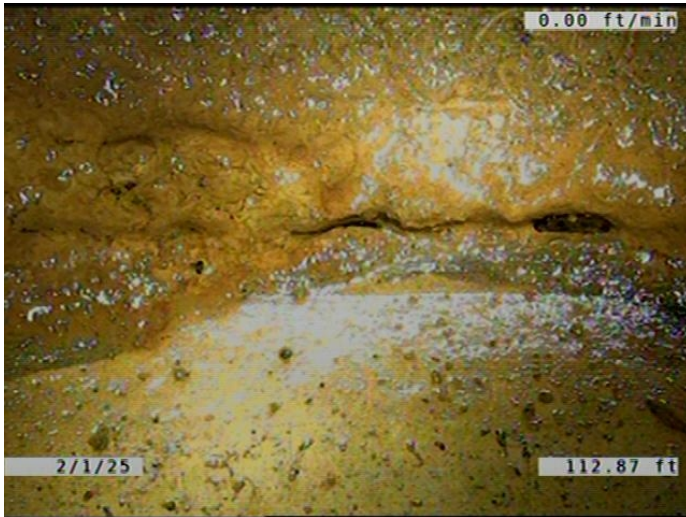
Code: **IWJ**  
 Description: **Infiltration Weeper Joint**

Distance (ft): **112.9**  
 Structural Grade: **0**  
 O&M Grade: **2**  
 Clock Start/From: **11**  
 Clock To: **1**  
 1st Value:  
 2nd Value:  
 Value Percent:  
 Continuous Index:  
 Within 8" of Joint: **YES**  
 Remarks:

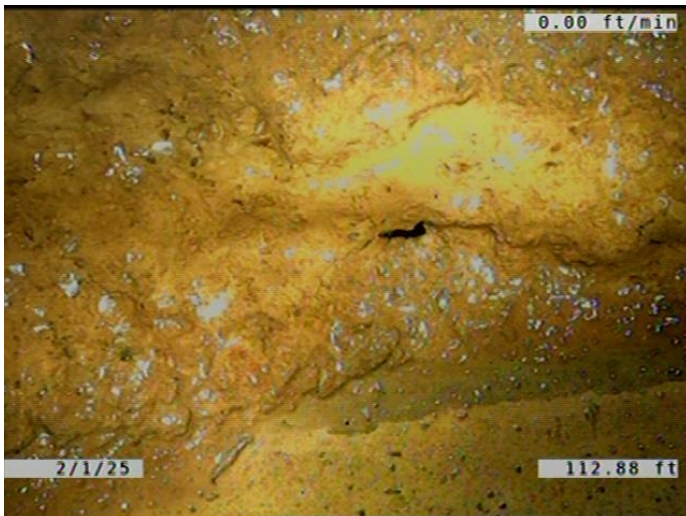
Code: **DAE**  
 Description: **Deposits Attached Encrustation**

Distance (ft): **112.9**  
 Structural Grade: **0**  
 O&M Grade: **2**  
 Clock Start/From: **8**  
 Clock To: **4**  
 1st Value:  
 2nd Value:  
 Value Percent: **5.000**  
 Continuous Index:  
 Within 8" of Joint: **YES**  
 Remarks:

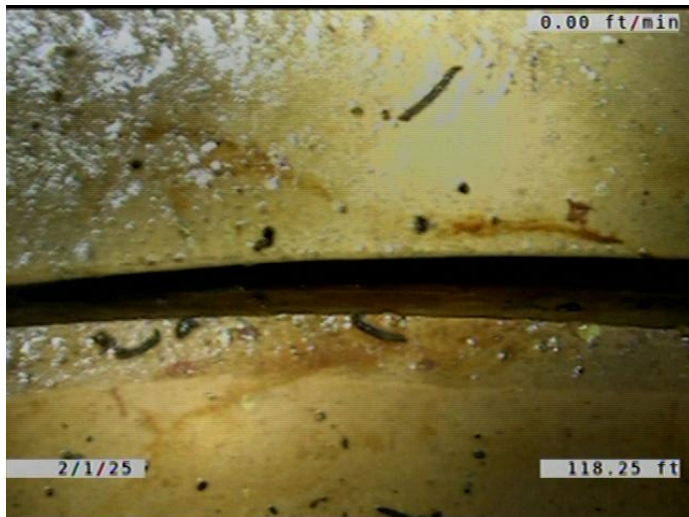
Code: **ISJ**  
Description: **Infiltration Stain Joint**

Distance (ft): **118.2**  
Structural Grade: **0**  
O&M Grade: **1**  
Clock Start/From: **8**  
Clock To: **10**  
1st Value:  
2nd Value:  
Value Percent:  
Continuous Index:  
Within 8" of Joint: **YES**  
Remarks:

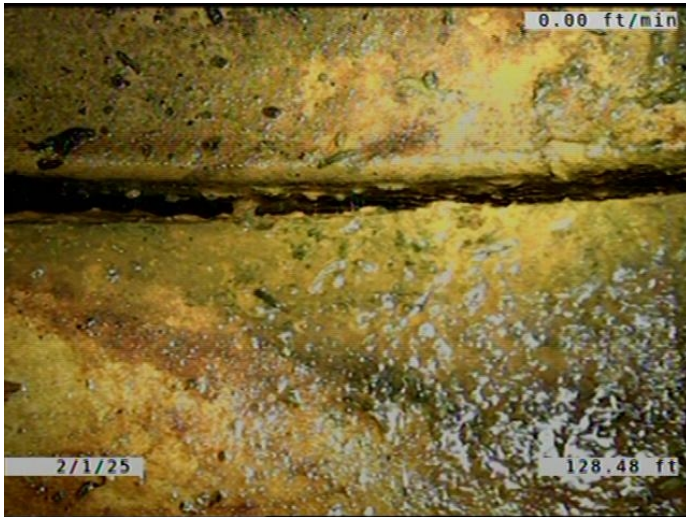
Code: **DAE**  
Description: **Deposits Attached Encrustation**

Distance (ft): **128.5**  
Structural Grade: **0**  
O&M Grade: **2**  
Clock Start/From: **12**  
Clock To: **4**  
1st Value:  
2nd Value:  
Value Percent: **5.000**  
Continuous Index:  
Within 8" of Joint: **YES**  
Remarks:

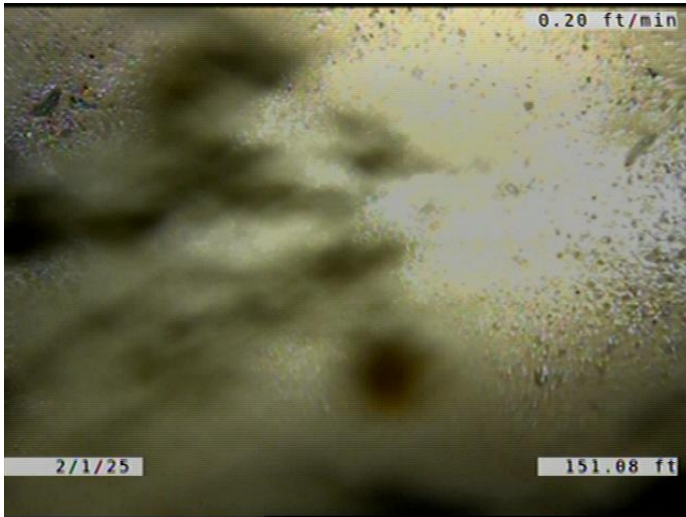
Code: **MCU**  
Description: **Miscellaneous Camera Underwater**

Distance (ft): **151.1**  
Structural Grade: **0**  
O&M Grade: **4**  
Clock Start/From:  
Clock To:  
1st Value:  
2nd Value:  
Value Percent:  
Continuous Index: **S04**  
Within 8" of Joint: **NO**  
Remarks:

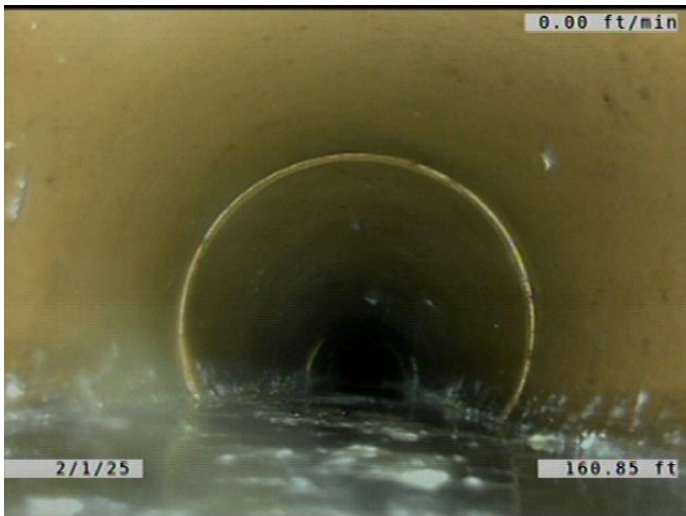
Code: **MCU**  
Description: **Miscellaneous Camera Underwater**

Distance (ft): **160.8**  
Structural Grade: **0**  
O&M Grade: **4**  
Clock Start/From:  
Clock To:  
1st Value:  
2nd Value:  
Value Percent:  
Continuous Index: **F04**  
Within 8" of Joint: **NO**  
Remarks:

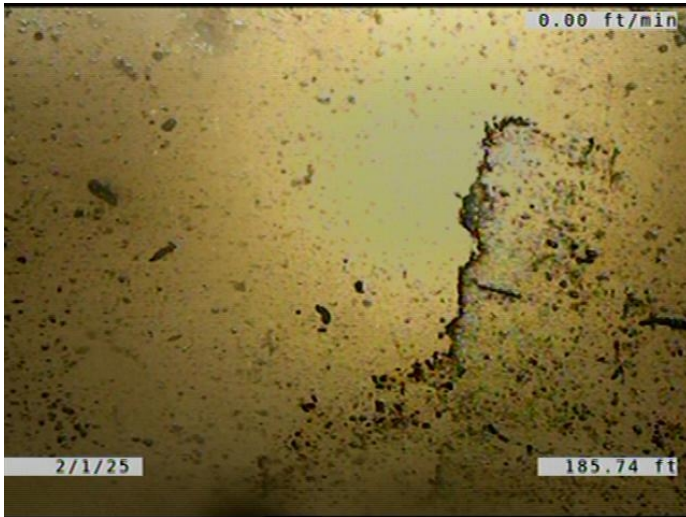
Code: **CL**  
Description: **Crack Longitudinal**

Distance (ft): **185.7**  
Structural Grade: **2**  
O&M Grade: **0**  
Clock Start/From: **1**  
Clock To:  
1st Value:  
2nd Value:  
Value Percent:  
Continuous Index:  
Within 8" of Joint: **YES**  
Remarks:

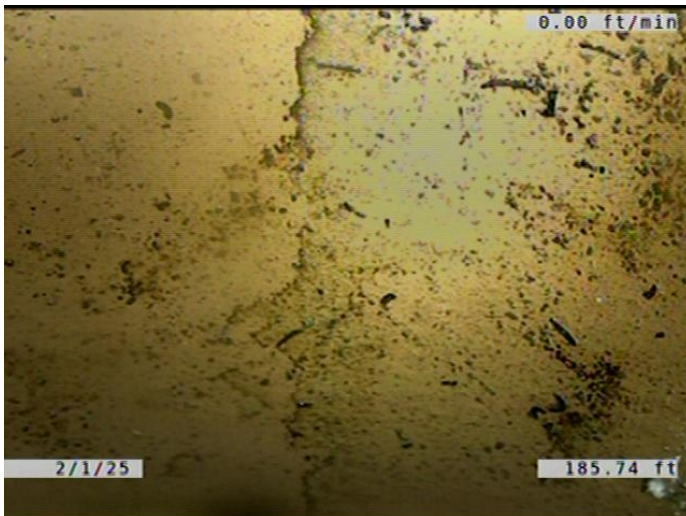
Code: **ISB**  
Description: **Infiltration Stain Barrel**

Distance (ft): **185.7**  
Structural Grade: **0**  
O&M Grade: **1**  
Clock Start/From: **1**  
Clock To: **4**  
1st Value:  
2nd Value:  
Value Percent:  
Continuous Index:  
Within 8" of Joint: **YES**  
Remarks:

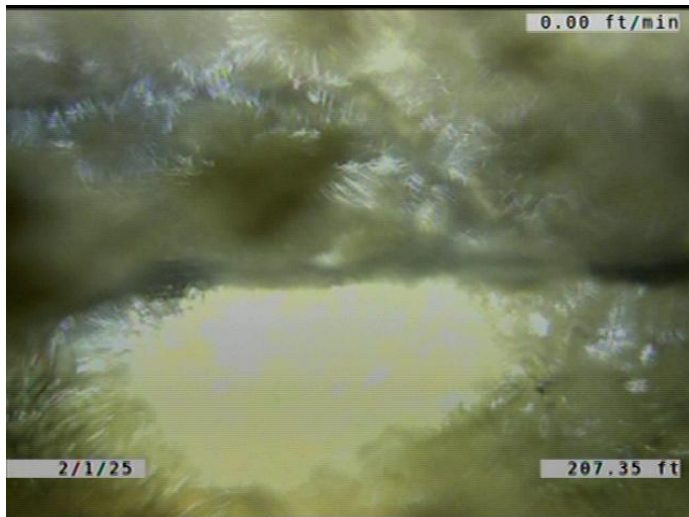
Code: **DAE**  
 Description: **Deposits Attached Encrustation**

Distance (ft): **207.4**  
 Structural Grade: **0**  
 O&M Grade: **2**  
 Clock Start/From: **10**  
 Clock To: **2**  
 1st Value:  
 2nd Value:  
 Value Percent: **5.000**  
 Continuous Index:  
 Within 8" of Joint: **YES**  
 Remarks:

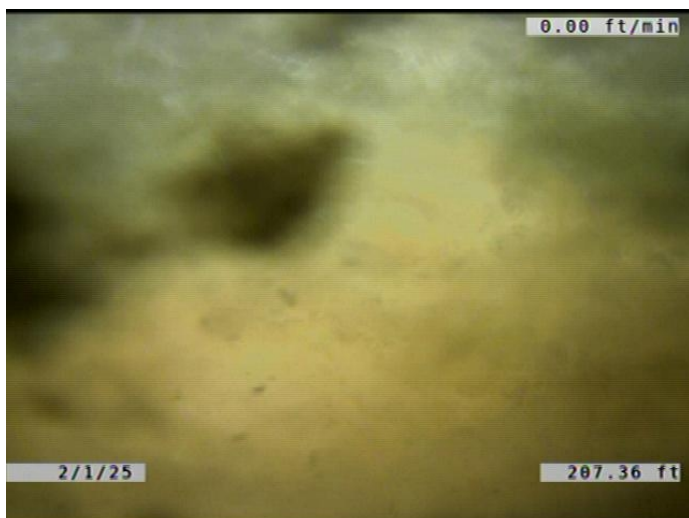
Code: **MCU**  
 Description: **Miscellaneous Camera Underwater**

Distance (ft): **207.4**  
 Structural Grade: **0**  
 O&M Grade: **4**  
 Clock Start/From:  
 Clock To:  
 1st Value:  
 2nd Value:  
 Value Percent:  
 Continuous Index: **F05**  
 Within 8" of Joint: **NO**  
 Remarks:

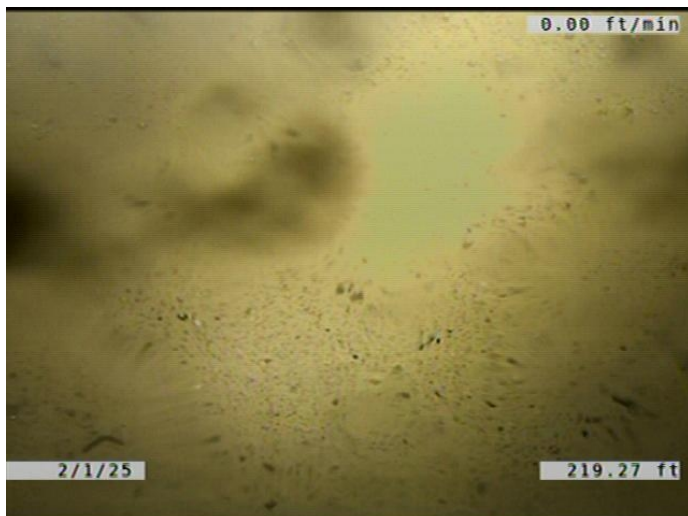
Code: **MCU**  
Description: **Miscellaneous Camera Underwater**

Distance (ft): **219.3**  
Structural Grade: **0**  
O&M Grade: **4**  
Clock Start/From:  
Clock To:  
1st Value:  
2nd Value:  
Value Percent:  
Continuous Index: **F06**  
Within 8" of Joint: **NO**  
Remarks:
