Profile/Photo Observation Report

Date:	02/01/2025	Weather:		Coding:	PACP 7.0
Pipe Length (ft):		Owner:	City of Hobart	Pre Clean:	Heavy Cleaning
P.O.#:	YES502259	Surveyor:	S. Bucklin	PSR:	M-902-008.1-M-902-009
Customer:	City of Hobart	Clean Date:	08/21/2023	Shape:	C

Street:	East 34th Lane	Flow Control:	Not Controlled
City:	Hobart, IN	Year Renewed:	
Location:	Easement/Right of Way	Tape/Media #:	
Purpose:	Sewer System Evaluation Survey (SS	Dia/Height:	10"
Use:	Sanitary Sewage Pipe	Material:	VCP
Drain Area:		Lining:	None
Category:	NA		
Comment:			
Location Details:		Direction of Survey:	Downstream
US MH:	M-902-008.1	DS MH:	M-902-009
		Total Length Surveyed (ft):	211.7

O&M Index:	3.93	O&M Quick:	4A31	O&M Rating:	55.00
Structural Index:	2.00	Structural Quick:	2A00	Structural Rating:	28.00
Overall Index:	2.96	Overall Quick:	4A31	Overall Rating:	83.00

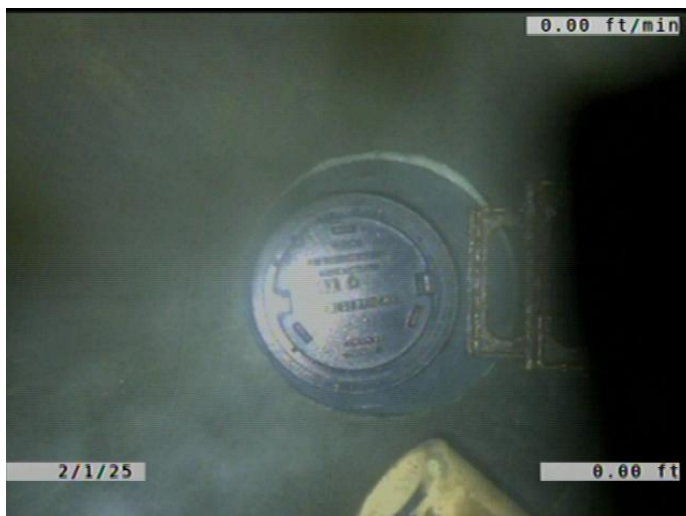
Code: **AMH**
 Description: **Manhole**

Distance (ft): **.0**
 Structural Grade: **0**
 O&M Grade: **0**
 Clock Start/From:
 Clock To:
 1st Value:
 2nd Value:
 Value Percent:
 Continuous Index:
 Within 8" of Joint: **NO**
 Remarks: **M-902-008.1**

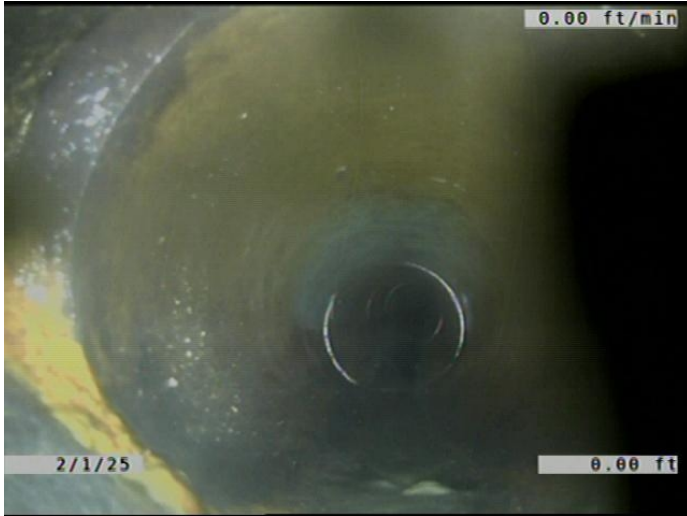
Code:	MWL
Description:	Miscellaneous Water Level
Distance (ft):	.0
Structural Grade:	0
O&M Grade:	0
Clock Start/From:	
Clock To:	
1st Value:	
2nd Value:	
Value Percent:	5.000
Continuous Index:	
Within 8" of Joint:	NO
Remarks:

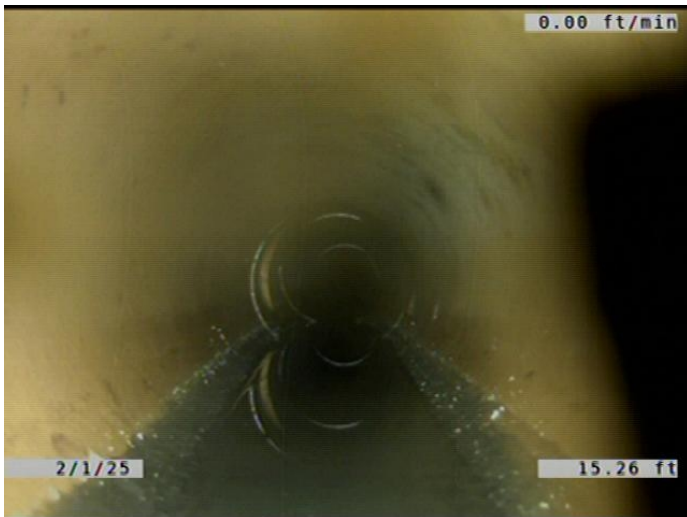
Code:	MWLS
Description:	Miscellaneous Water Level Sag
Distance (ft):	15.3
Structural Grade:	2
O&M Grade:	0
Clock Start/From:	
Clock To:	
1st Value:	
2nd Value:	
Value Percent:	10.000
Continuous Index:	S01
Within 8" of Joint:	NO
Remarks:

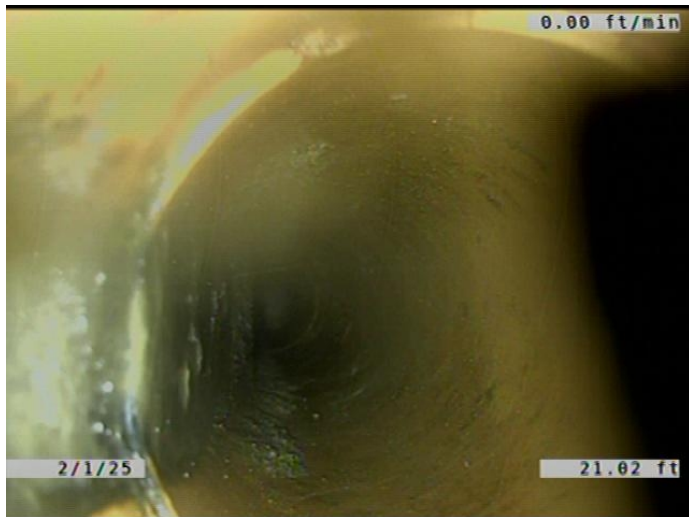
Code: **TFC**
 Description: **Tap Factory Capped**

Distance (ft): **21.0**
 Structural Grade: **0**
 O&M Grade: **0**
 Clock Start/From: **9**
 Clock To:
 1st Value: **6.000**
 2nd Value:
 Value Percent:
 Continuous Index:
 Within 8" of Joint: **YES**
 Remarks:

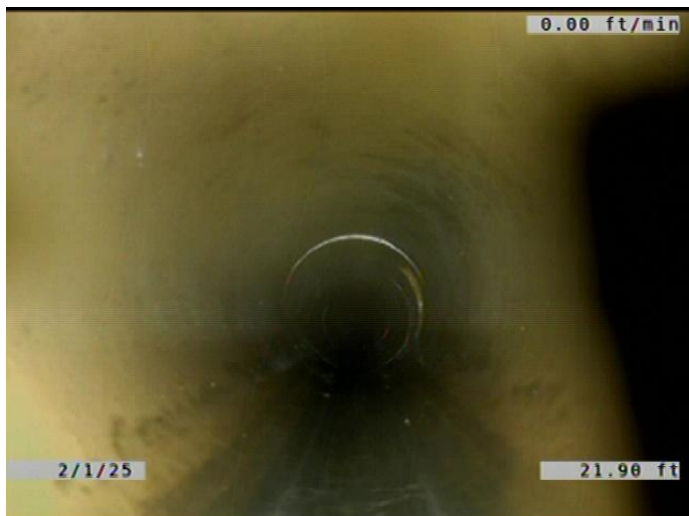
Code: **MWLS**
 Description: **Miscellaneous Water Level Sag**

Distance (ft): **21.9**
 Structural Grade: **2**
 O&M Grade: **0**
 Clock Start/From:
 Clock To:
 1st Value:
 2nd Value:
 Value Percent: **10.000**
 Continuous Index: **F01**
 Within 8" of Joint: **NO**
 Remarks:

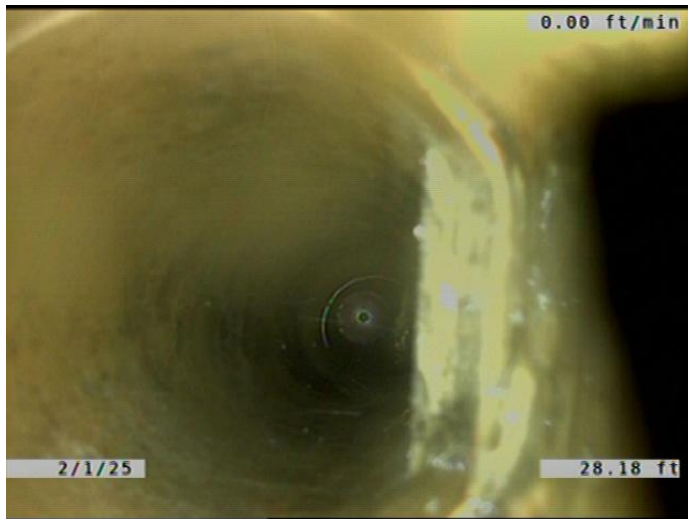
Code: **TFC**
Description: **Tap Factory Capped**

Distance (ft): **28.2**
Structural Grade: **0**
O&M Grade: **0**
Clock Start/From: **3**
Clock To:
1st Value: **6.000**
2nd Value:
Value Percent:
Continuous Index:
Within 8" of Joint: **YES**
Remarks:

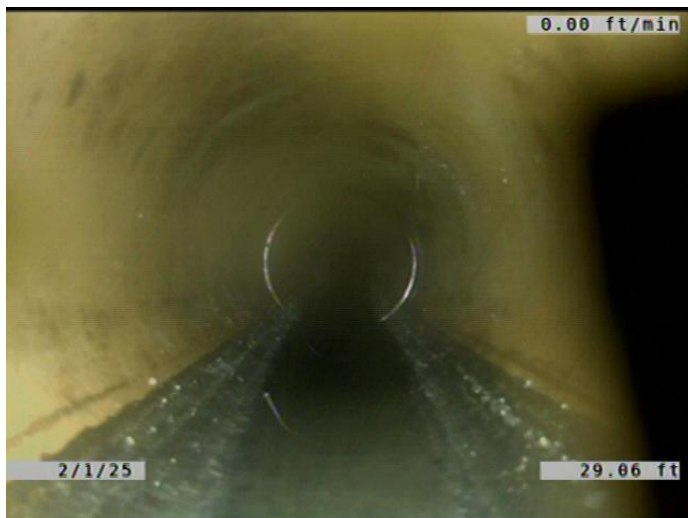
Code: **MWLS**
Description: **Miscellaneous Water Level Sag**

Distance (ft): **29.1**
Structural Grade: **2**
O&M Grade: **0**
Clock Start/From:
Clock To:
1st Value:
2nd Value:
Value Percent: **10.000**
Continuous Index: **S02**
Within 8" of Joint: **NO**
Remarks:

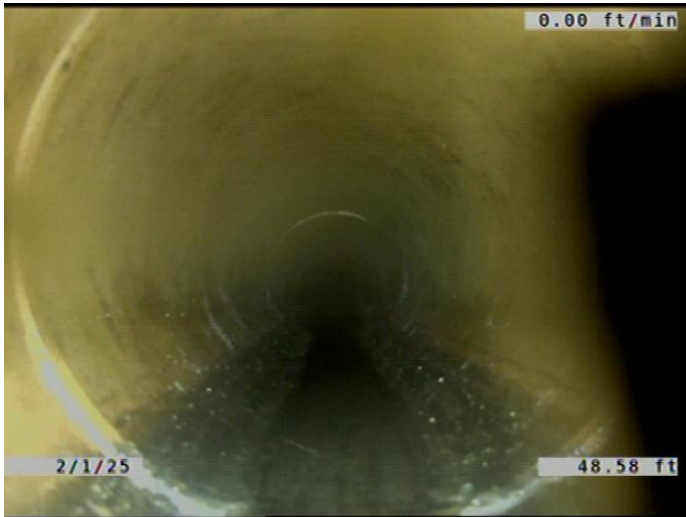
Code: **MWLS**
Description: **Miscellaneous Water Level Sag**

Distance (ft): **48.6**
Structural Grade: **2**
O&M Grade: **0**
Clock Start/From:
Clock To:
1st Value:
2nd Value:
Value Percent: **10.000**
Continuous Index: **F02**
Within 8" of Joint: **NO**
Remarks:

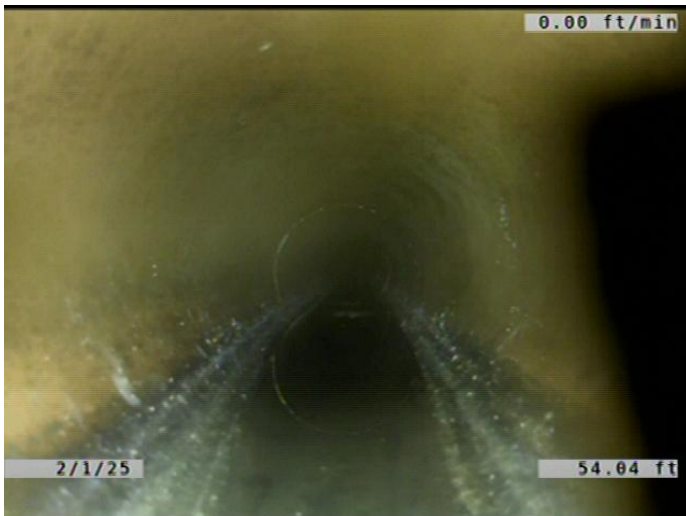
Code: **MWLS**
Description: **Miscellaneous Water Level Sag**

Distance (ft): **54.0**
Structural Grade: **2**
O&M Grade: **0**
Clock Start/From:
Clock To:
1st Value:
2nd Value:
Value Percent: **10.000**
Continuous Index: **S03**
Within 8" of Joint: **NO**
Remarks:

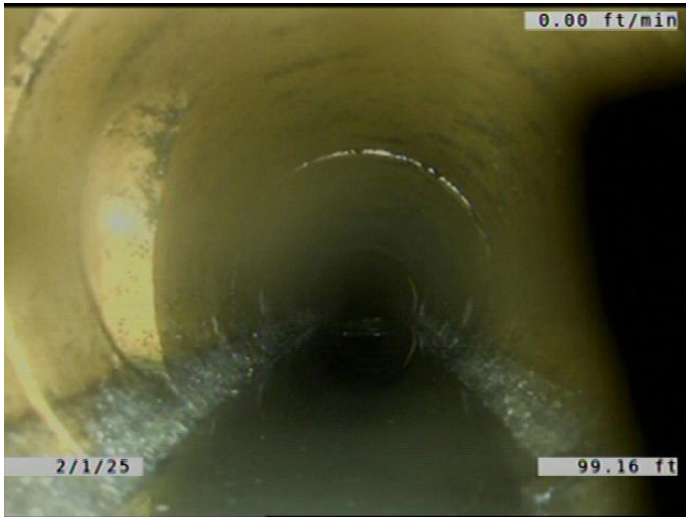
Code: **MWLS**
Description: **Miscellaneous Water Level Sag**

Distance (ft): **99.2**
Structural Grade: **2**
O&M Grade: **0**
Clock Start/From:
Clock To:
1st Value:
2nd Value:
Value Percent: **10.000**
Continuous Index: **F03**
Within 8" of Joint: **NO**
Remarks:

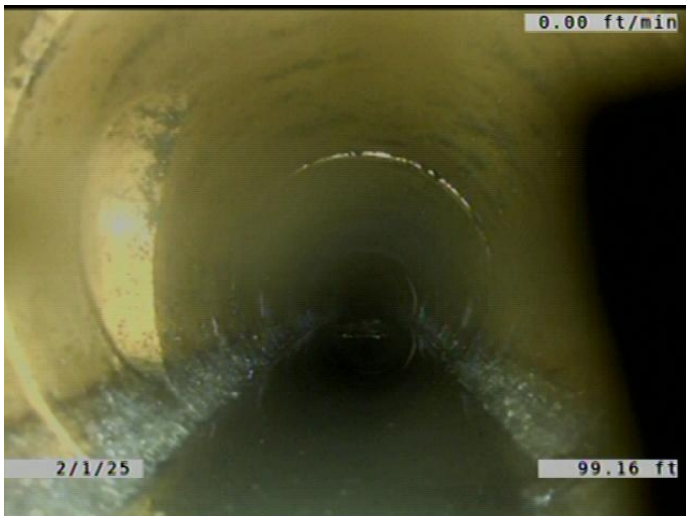
Code: **MWL**
Description: **Miscellaneous Water Level**

Distance (ft): **99.2**
Structural Grade: **0**
O&M Grade: **0**
Clock Start/From:
Clock To:
1st Value:
2nd Value:
Value Percent: **20.000**
Continuous Index:
Within 8" of Joint: **NO**
Remarks:

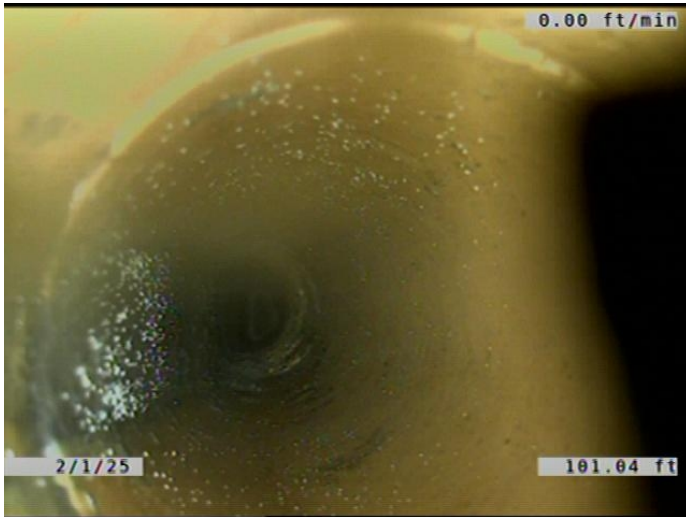
Code: **TFD**
Description: **Tap Factory Defective**

Distance (ft): **101.0**
Structural Grade: **0**
O&M Grade: **3**
Clock Start/From: **9**
Clock To:
1st Value: **6.000**
2nd Value:
Value Percent:
Continuous Index:
Within 8" of Joint: **YES**
Remarks: **CAPPED. ENCRUSTATION COMING FROM THE JOINTS.**

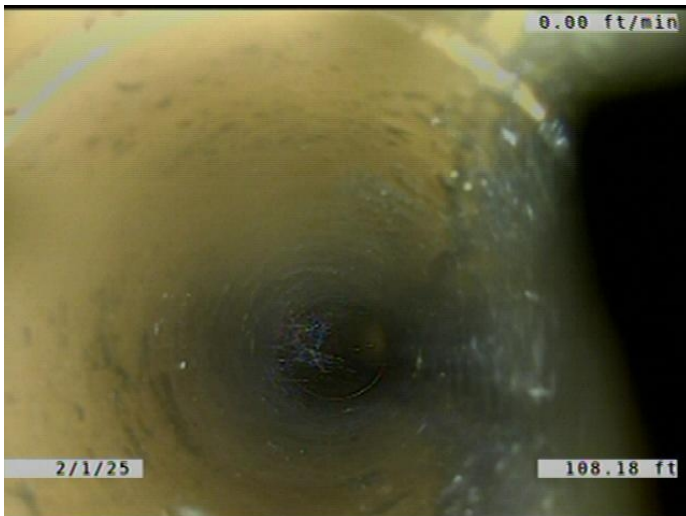
Code: **TF**
Description: **Tap Factory**

Distance (ft): **108.2**
Structural Grade: **0**
O&M Grade: **0**
Clock Start/From: **3**
Clock To:
1st Value: **6.000**
2nd Value:
Value Percent:
Continuous Index:
Within 8" of Joint: **YES**
Remarks: **CONSTANTLY RUNNING WATER.**

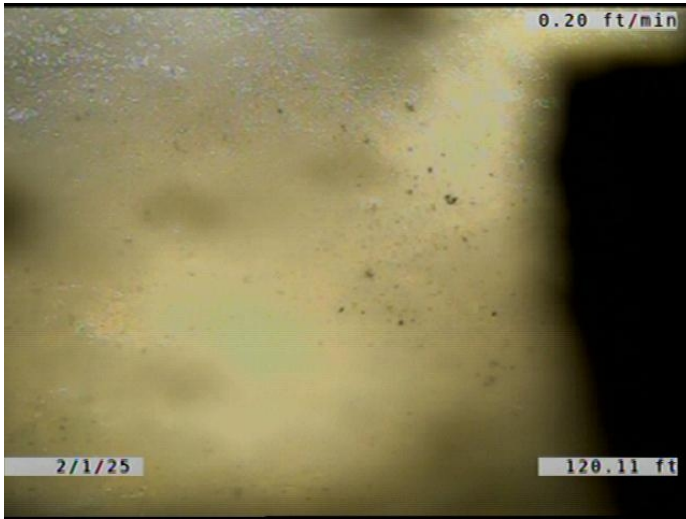
Code: **MWL**
Description: **Miscellaneous Water Level**

Distance (ft): **120.1**
Structural Grade: **0**
O&M Grade: **0**
Clock Start/From:
Clock To:
1st Value:
2nd Value:
Value Percent: **45.000**
Continuous Index:
Within 8" of Joint: **NO**
Remarks:
