Profile/Photo Observation Report

Date:	04/06/2018	Weather:		Coding:	PACP 6.0
Pipe Length (ft):	53.2	Owner:	NA	Pre Clean:	No Pre-Cleaning
P.O.#:		Surveyor:	Jen Costello	PSR:	P-506-026-011
Customer:		Clean Date:	01/01/1900	Shape:	C

Street:	FOXCROFT STREET	Flow Control:	Not Controlled
City:	Hobart, IN	Year Renewed:	
Location:	Yard	Tape/Media #:	
Purpose:	Routine Assessment	Dia/Height:	10"
Use:	Sanitary	Material:	VCP
Drain Area:	NA	Lining:	
Category:	NA		
Comment:	F_S_P_C debris, flow direction is marked wrong.		
Location Details:		Direction of Survey:	Downstream
US MH:	M-506-011	DS MH:	M-506-026
		Total Length Surveyed (ft):	13.2

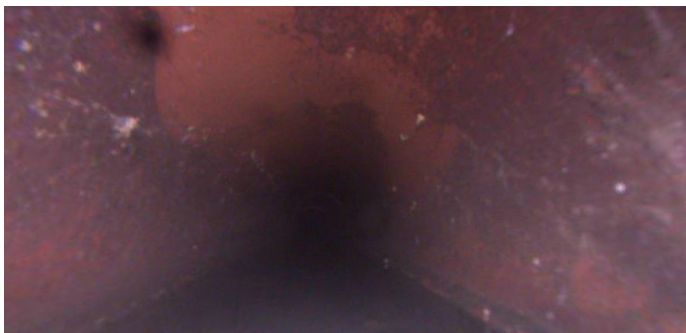
Code: **AMH**
Description: **Manhole**

Distance (ft): **.0**
Structural Grade: **0**
O&M Grade: **0**
Clock Start/From:
Clock To:
1st Value:
2nd Value:
Value Percent:
Continuous Index:
Within 8" of Joint: **NO**
Remarks: **M-506-011**

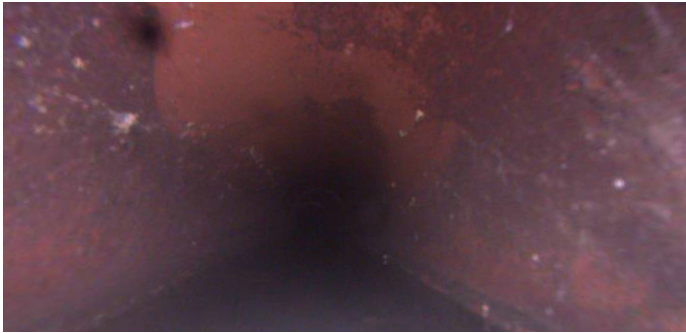
Code:	MWL
Description:	Water Level

Distance (ft):	.0
Structural Grade:	0
O&M Grade:	0
Clock Start/From:	
Clock To:	
1st Value:	
2nd Value:	
Value Percent:	10.000
Continuous Index:	
Within 8" of Joint:	NO
Remarks:

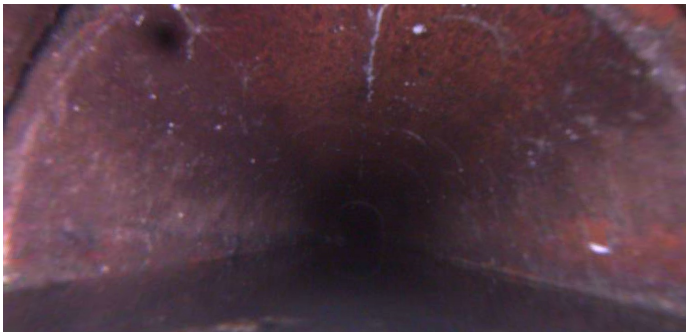
Code:	MSA
Description:	Abandoned Survey

Distance (ft):	13.2
Structural Grade:	0
O&M Grade:	0
Clock Start/From:	
Clock To:	
1st Value:	
2nd Value:	
Value Percent:	
Continuous Index:	
Within 8" of Joint:	NO
Remarks:	debris under water
