Profile/Photo Observation Report

Date:	02/22/2024	Weather:		Coding:	PACP 7.0
Pipe Length (ft):	8.0	Owner:	City of Hobart	Pre Clean:	Heavy Cleaning
P.O.#:	YES502259	Surveyor:	S. Bucklin	PSR:	P-604-116.1 (North)-116
Customer:	City of Hobart	Clean Date:	11/10/2021	Shape:	C

Street:	W CLEVELAND AVE	Flow Control:	Not Controlled
City:	Hobart, IN	Year Renewed:	
Location:	Local rural streets with light traffic, t	Tape/Media #:	
Purpose:	Sewer System Evaluation Survey (SS	Dia/Height:	12"
Use:	Sanitary Sewage Pipe	Material:	CP
Drain Area:		Lining:	None
Category:	NA		
Comment:			
Location Details:		Direction of Survey:	Upstream
US MH:	M-604-116.1 (NORTH)	DS MH:	M-604-116
		Total Length Surveyed (ft):	6.4

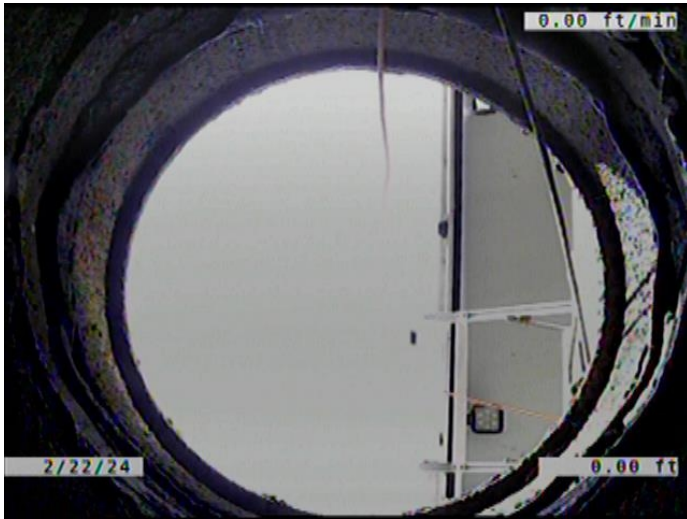
Code: **AMH**
Description: **Manhole**

Distance (ft): **.0**
Structural Grade: **0**
O&M Grade: **0**
Clock Start/From:
Clock To:
1st Value:
2nd Value:
Value Percent:
Continuous Index:
Within 8" of Joint: **NO**
Remarks: **M-604-116**

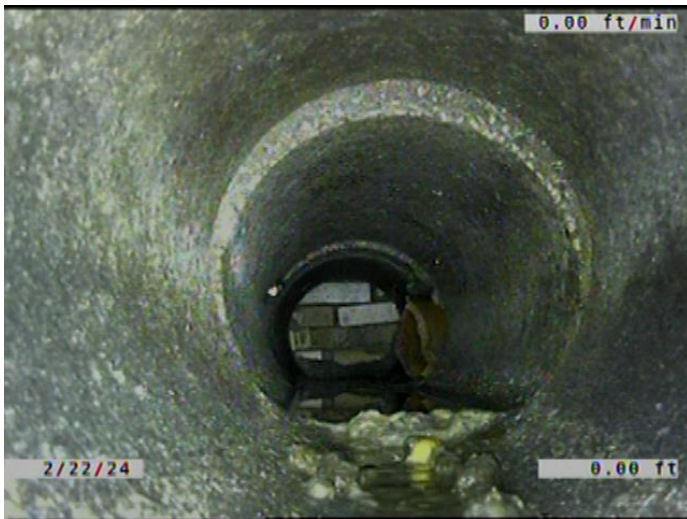
Code: **MWL**
Description: **Miscellaneous Water Level**

Distance (ft): **.0**
Structural Grade: **0**
O&M Grade: **0**
Clock Start/From:
Clock To:
1st Value:
2nd Value:
Value Percent: **5.000**
Continuous Index:
Within 8" of Joint: **NO**
Remarks:

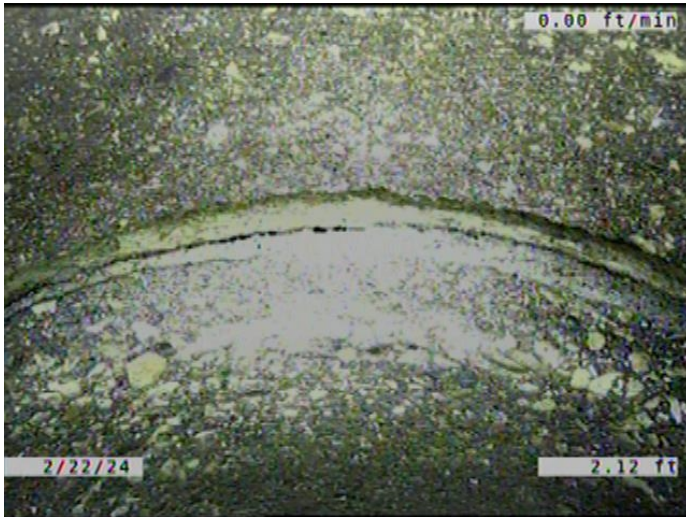
Code: **JOMD**
 Description: **Joint Offset Medium Defective**

Distance (ft): **2.1**
 Structural Grade: **3**
 O&M Grade: **0**
 Clock Start/From:
 Clock To:
 1st Value:
 2nd Value:
 Value Percent:
 Continuous Index:
 Within 8" of Joint: **NO**
 Remarks:

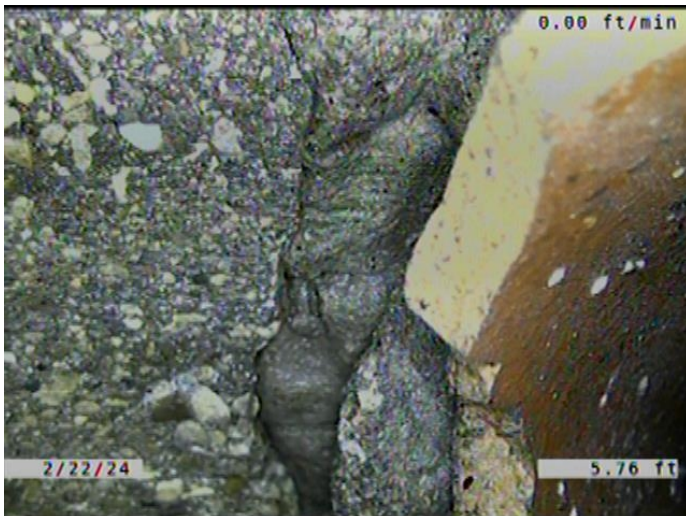
Code: **B**
 Description: **Broken**

Distance (ft): **5.8**
 Structural Grade: **4**
 O&M Grade: **0**
 Clock Start/From: **7**
 Clock To: **5**
 1st Value:
 2nd Value:
 Value Percent:
 Continuous Index:
 Within 8" of Joint: **YES**
 Remarks:

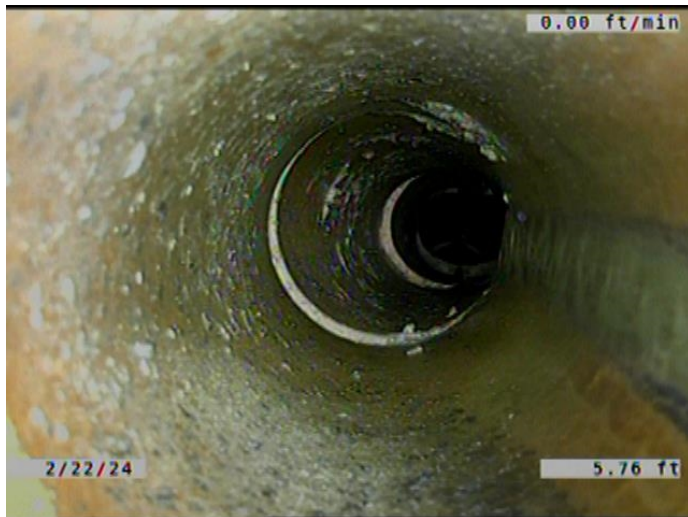
Code: **TBI**
Description: **Tap Break-in Intruding**

Distance (ft): **5.8**
Structural Grade: **0**
O&M Grade: **2**
Clock Start/From: **3**
Clock To:
1st Value: **6.000**
2nd Value: **3.000**
Value Percent:
Continuous Index:
Within 8" of Joint: **YES**
Remarks:

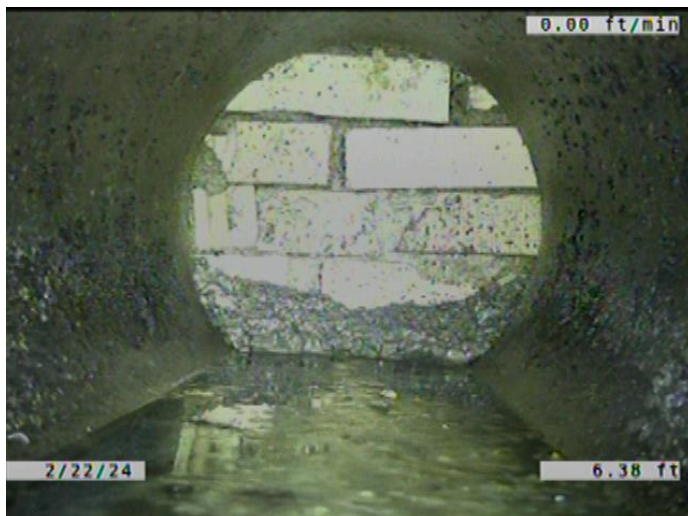
Code: **MGO**
Description: **Miscellaneous General Observation**

Distance (ft): **6.4**
Structural Grade: **0**
O&M Grade: **0**
Clock Start/From:
Clock To:
1st Value:
2nd Value:
Value Percent:
Continuous Index:
Within 8" of Joint: **NO**
Remarks: **CAN SEE THE END OF THE PIPE. IT HAS BEEN BRICKED OFF. LOOKS TO B**

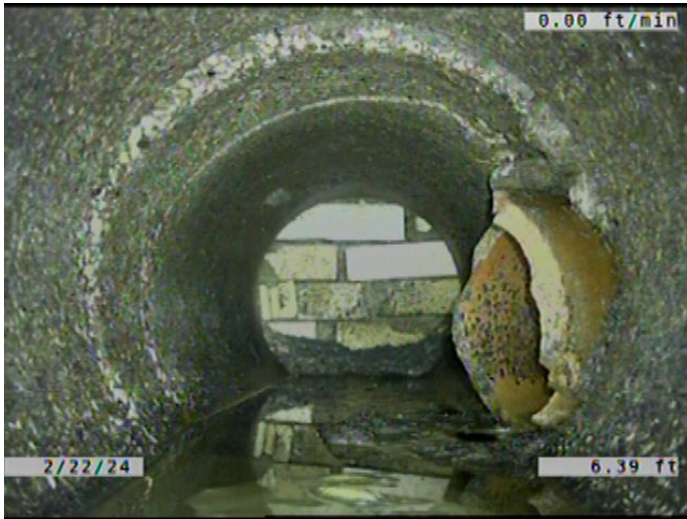
Code:	MSA
Description:	Miscellaneous Survey Abandoned
Distance (ft):	6.4
Structural Grade:	0
O&M Grade:	0
Clock Start/From:	
Clock To:	
1st Value:	
2nd Value:	
Value Percent:	
Continuous Index:	
Within 8" of Joint:	NO
Remarks:	CAMERA CANT MAKE IT PAST PROTRUDING TAP.
