Profile/Photo Observation Report

Date:	02/22/2024	Weather:		Coding:	PACP 7.0
Pipe Length (ft):	2.5	Owner:	City of Hobart	Pre Clean:	Heavy Cleaning
P.O.#:	YES502259	Surveyor:	S. Bucklin	PSR:	P-604-116.2 (East)-116
Customer:	City of Hobart	Clean Date:	02/22/2024	Shape:	C

Street:	W CLEVELAND AVE	Flow Control:	Not Controlled
City:	Hobart, IN	Year Renewed:	
Location:	Local rural streets with light traffic, t	Tape/Media #:	
Purpose:	Maintenance Related	Dia/Height:	10"
Use:	Sanitary Sewage Pipe	Material:	CP
Drain Area:		Lining:	None
Category:	NA		
Comment:			
Location Details:		Direction of Survey:	Upstream
US MH:	M-604-116.2 (EAST)	DS MH:	M-604-116
		Total Length Surveyed (ft):	2.1

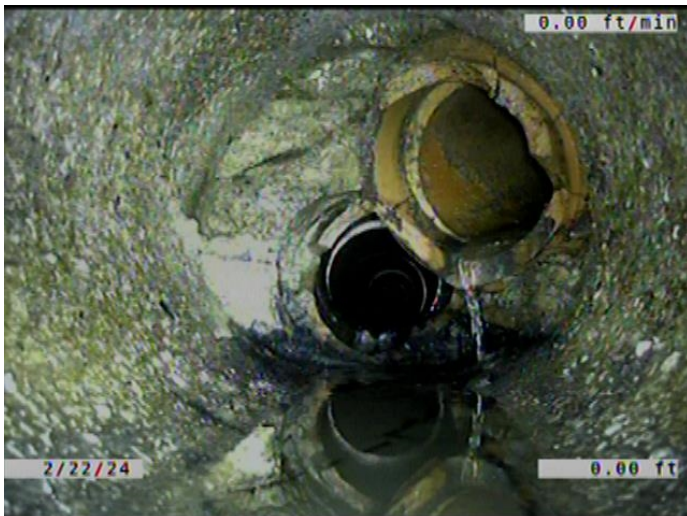
Code: **MWL**
Description: **Miscellaneous Water Level**

Distance (ft): **.0**
Structural Grade: **0**
O&M Grade: **0**
Clock Start/From:
Clock To:
1st Value:
2nd Value:
Value Percent: **5.000**
Continuous Index:
Within 8" of Joint: **NO**
Remarks:

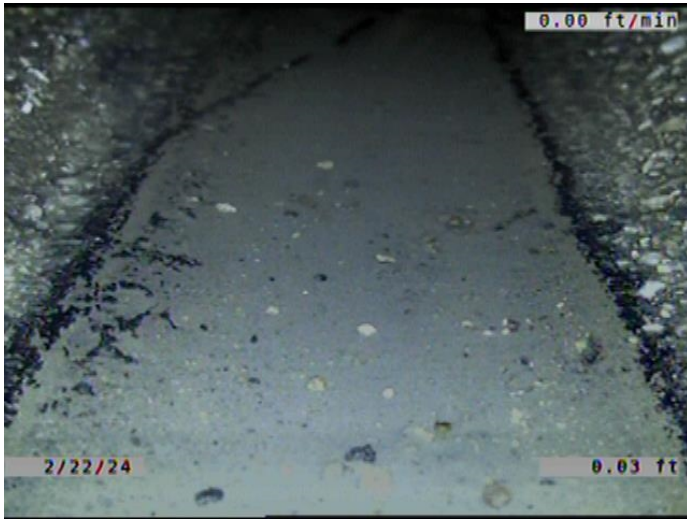
Code:	DSF
Description:	Deposits Settled Fine
Distance (ft):	.0
Structural Grade:	0
O&M Grade:	2
Clock Start/From:	5
Clock To:	7
1st Value:	
2nd Value:	
Value Percent:	5.000
Continuous Index:	
Within 8" of Joint:	YES
Remarks:

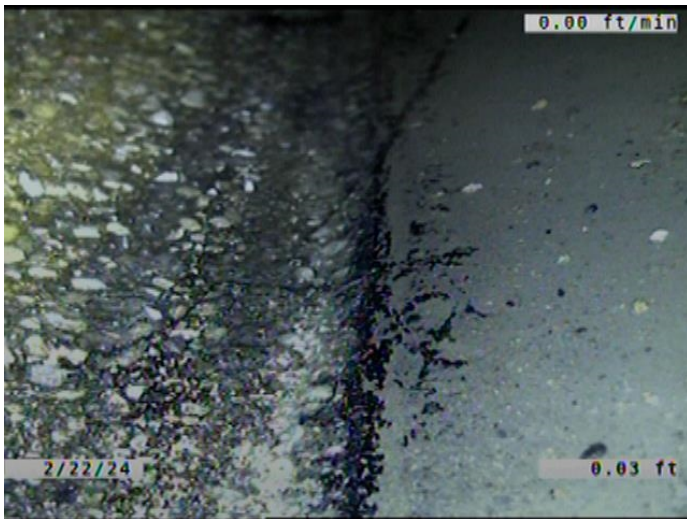
Code:	FM
Description:	Fracture Multiple
Distance (ft):	.0
Structural Grade:	4
O&M Grade:	0
Clock Start/From:	12
Clock To:	12
1st Value:	
2nd Value:	
Value Percent:	
Continuous Index:	
Within 8" of Joint:	YES
Remarks:

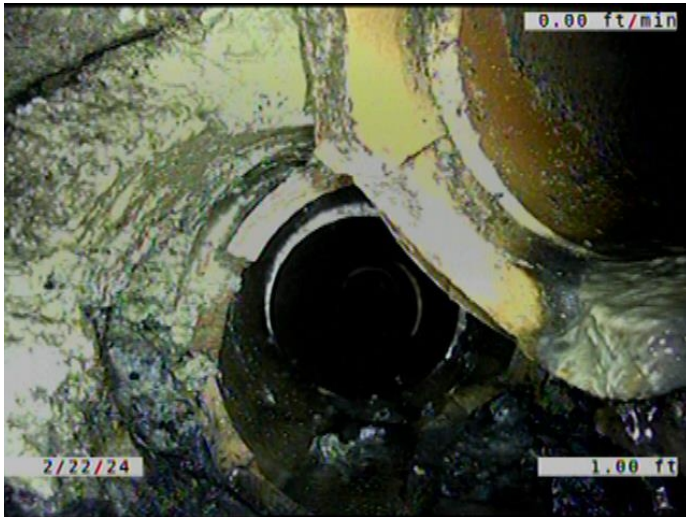
Code: **BSV**
Description: **Broken Soil Visible**

Distance (ft): **1.0**
Structural Grade: **5**
O&M Grade: **0**
Clock Start/From: **12**
Clock To: **12**
1st Value:
2nd Value:
Value Percent:
Continuous Index:
Within 8" of Joint: **YES**
Remarks:

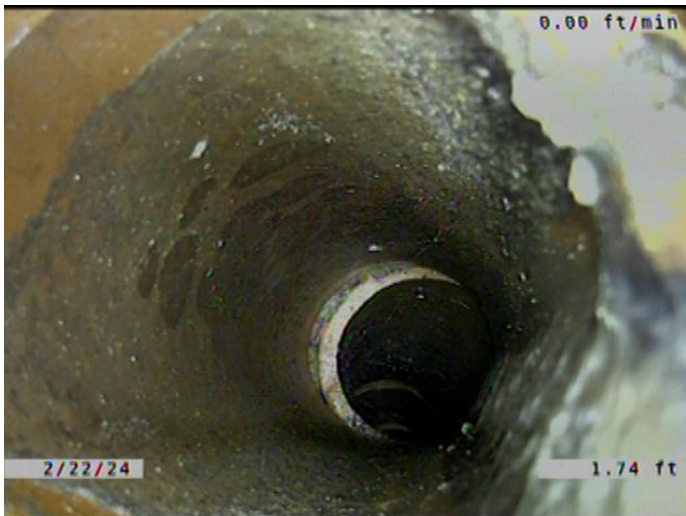
Code: **TBI**
Description: **Tap Break-in Intruding**

Distance (ft): **1.7**
Structural Grade: **0**
O&M Grade: **2**
Clock Start/From: **2**
Clock To:
1st Value: **6.000**
2nd Value: **3.000**
Value Percent:
Continuous Index:
Within 8" of Joint: **YES**
Remarks: **CONSTANTLY RUNNING WATER.
JOINTS IN THE SERVICE OFFSET. SOIL**

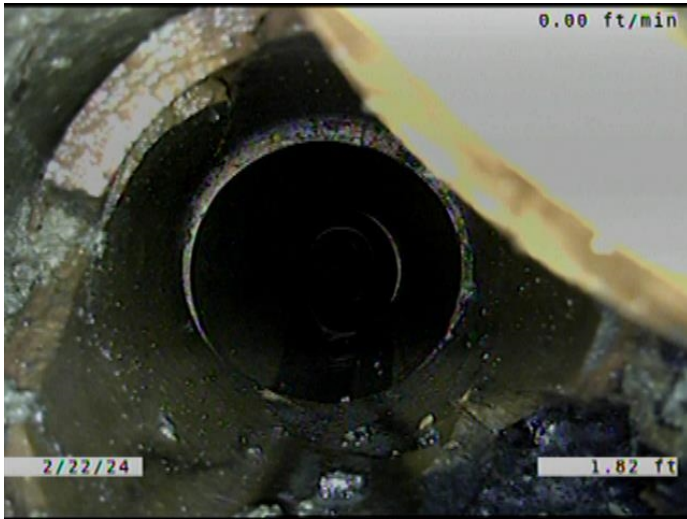
Code: **MSC**
Description: **Miscellaneous Shape/Size Change**

Distance (ft): **1.8**
Structural Grade: **0**
O&M Grade: **0**
Clock Start/From:
Clock To:
1st Value: **6.000**
2nd Value:
Value Percent:
Continuous Index:
Within 8" of Joint: **NO**
Remarks:

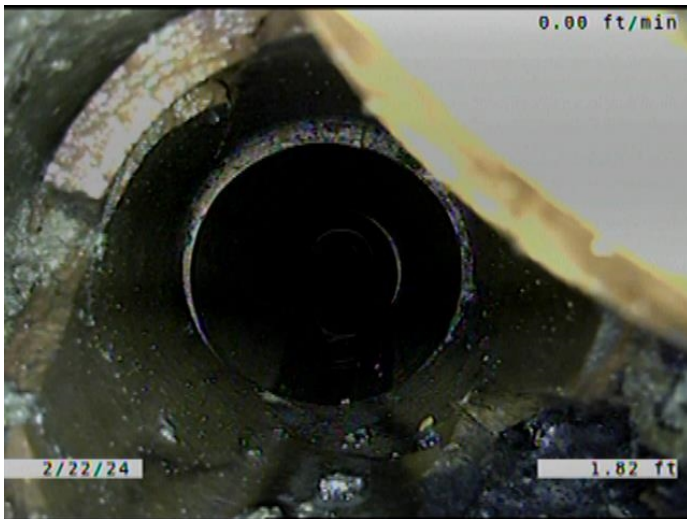
Code: **MGO**
Description: **Miscellaneous General Observation**

Distance (ft): **1.8**
Structural Grade: **0**
O&M Grade: **0**
Clock Start/From:
Clock To:
1st Value:
2nd Value:
Value Percent:
Continuous Index:
Within 8" of Joint: **NO**
Remarks: **12" CONCRETE TO 6" VCP. LINE LOOKS TO BE A LONG SERVICE.**

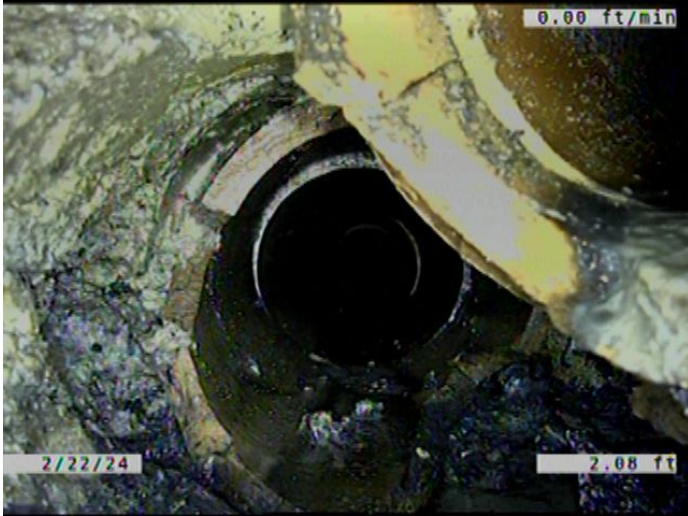
Code:	MSA
Description:	Miscellaneous Survey Abandoned
Distance (ft):	2.1
Structural Grade:	0
O&M Grade:	0
Clock Start/From:	
Clock To:	
1st Value:	
2nd Value:	
Value Percent:	
Continuous Index:	
Within 8" of Joint:	NO
Remarks:	CAMERA CANT MAKE IT PAST PROTRUDING TAP MISSING PIPE WA
