## Profile/Photo Observation Report

Date:	03/09/2024	Weather:		Coding:	PACP 7.0
Pipe Length (ft):	45.0	Owner:	City of Hobart	Pre Clean:	No Pre-Cleaning
P.O.#:		Surveyor:	S. Bucklin	PSR:	P-704-068.2-068.1
Customer:	City of Hobart	Clean Date:		Shape:	C

Street:	LAKEWOOD DR	Flow Control:	Not Controlled
City:	Hobart, IN	Year Renewed:	
Location:	Easement/Right of Way	Tape/Media #:	
Purpose:	Sewer System Evaluation Survey (SS	Dia/Height:	8"
Use:	Sanitary Sewage Pipe	Material:	PVC
Drain Area:		Lining:	None
Category:	NA		
Comment:			
Location Details:		Direction of Survey:	Downstream
US MH:	M-704-068.2	DS MH:	M-704-068.1
		Total Length Surveyed (ft):	45.9

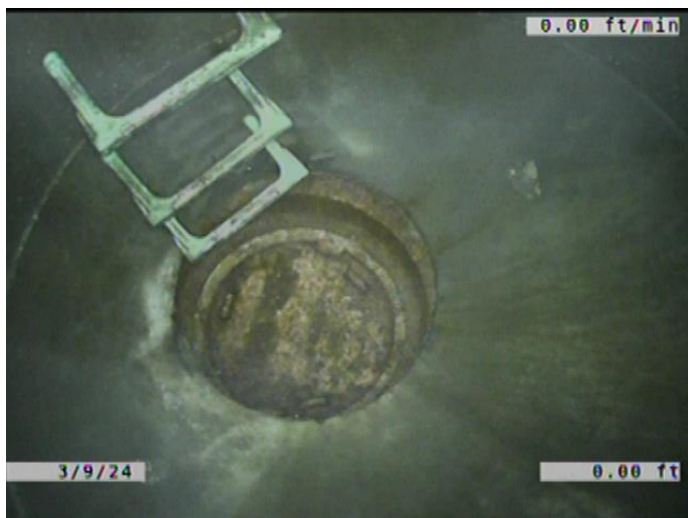
Code: **AMH**  
 Description: **Manhole**

Distance (ft): **.0**  
 Structural Grade: **0**  
 O&M Grade: **0**  
 Clock Start/From:  
 Clock To:  
 1st Value:  
 2nd Value:  
 Value Percent:  
 Continuous Index:  
 Within 8" of Joint: **NO**  
 Remarks: **M-704-068.2**

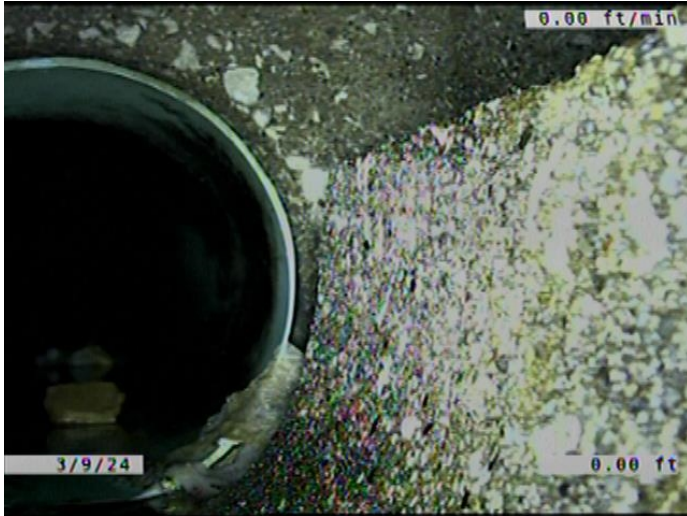
Code: **MWL**  
Description: **Miscellaneous Water Level**

Distance (ft): **.0**  
Structural Grade: **0**  
O&M Grade: **0**  
Clock Start/From:  
Clock To:  
1st Value:  
2nd Value:  
Value Percent: **5.000**  
Continuous Index:  
Within 8" of Joint: **NO**  
Remarks:

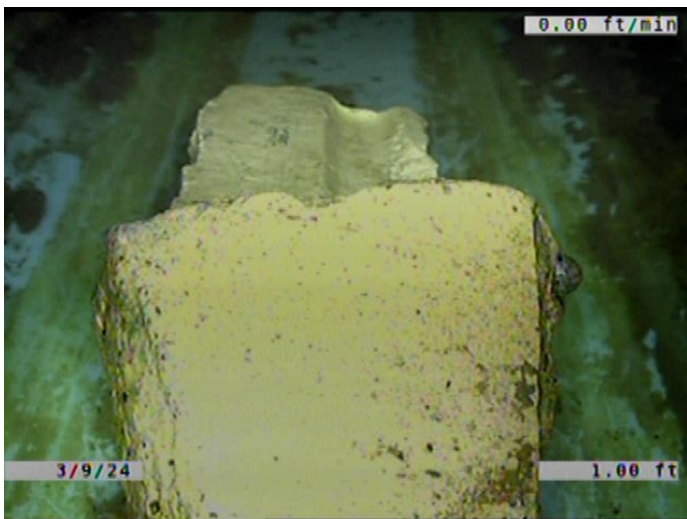
Code: **OBB**  
Description: **Obstruction Brick or Masonry**

Distance (ft): **1.0**  
Structural Grade: **0**  
O&M Grade: **2**  
Clock Start/From: **6**  
Clock To:  
1st Value:  
2nd Value:  
Value Percent: **5.000**  
Continuous Index:  
Within 8" of Joint: **NO**  
Remarks:

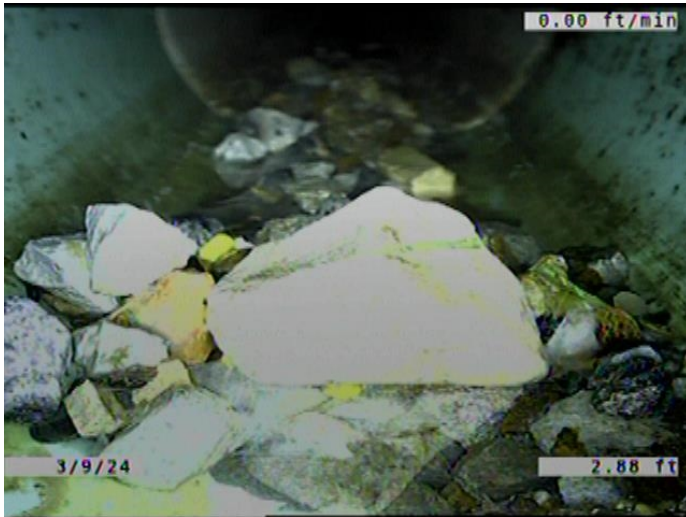
Code: **DSGV**  
Description: **Deposits Settled Gravel**

Distance (ft): **2.9**  
Structural Grade: **0**  
O&M Grade: **2**  
Clock Start/From: **5**  
Clock To: **7**  
1st Value:  
2nd Value:  
Value Percent: **5.000**  
Continuous Index: **S01**  
Within 8" of Joint: **YES**  
Remarks:

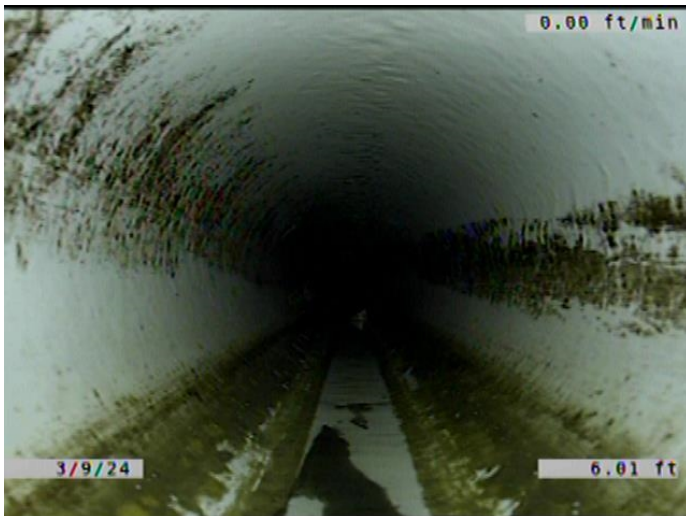
Code: **DSGV**  
Description: **Deposits Settled Gravel**

Distance (ft): **6.0**  
Structural Grade: **0**  
O&M Grade: **2**  
Clock Start/From: **5**  
Clock To: **7**  
1st Value:  
2nd Value:  
Value Percent: **5.000**  
Continuous Index: **F01**  
Within 8" of Joint: **YES**  
Remarks:

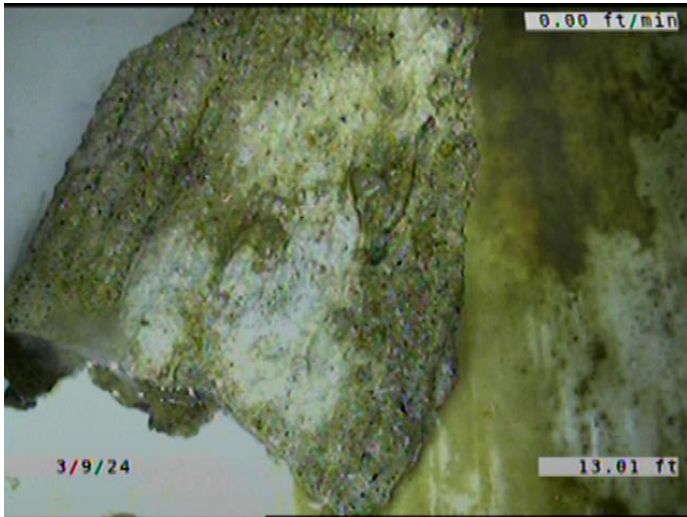
Code: **OBN**  
Description: **Obstruction Construction Debris**

Distance (ft): **13.0**  
Structural Grade: **0**  
O&M Grade: **2**  
Clock Start/From: **6**  
Clock To:  
1st Value:  
2nd Value:  
Value Percent: **5.000**  
Continuous Index:  
Within 8" of Joint: **NO**  
Remarks:

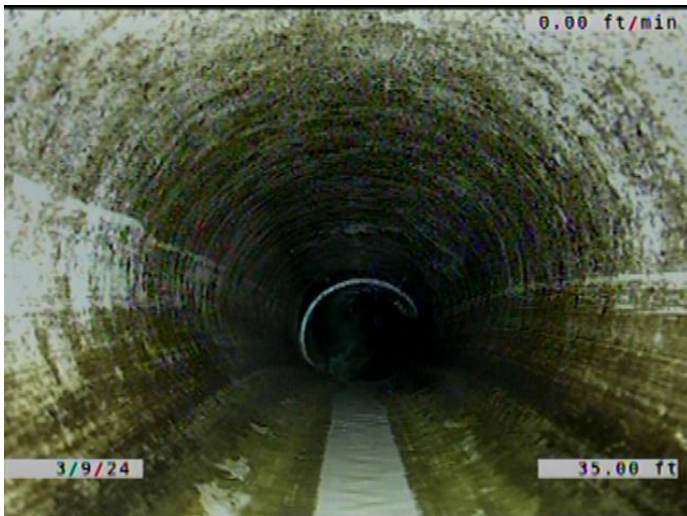
Code: **LD**  
Description: **Line Down**

Distance (ft): **35.0**  
Structural Grade: **0**  
O&M Grade: **2**  
Clock Start/From:  
Clock To:  
1st Value:  
2nd Value:  
Value Percent: **15.000**  
Continuous Index: **S02**  
Within 8" of Joint: **NO**  
Remarks:

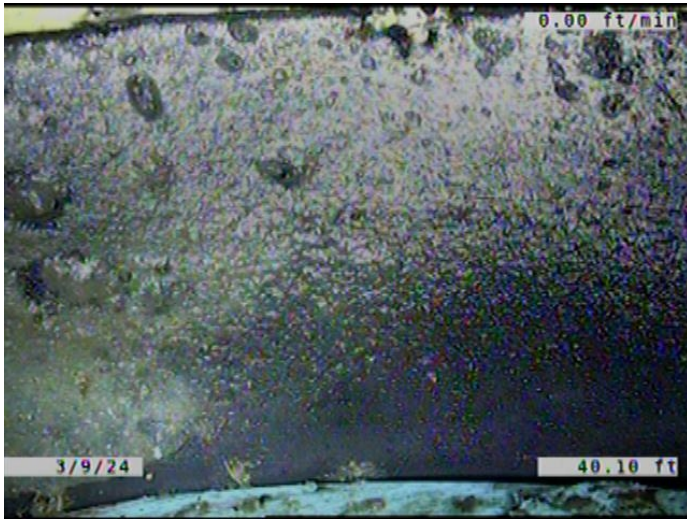
Code: **JAL**  
Description: **Joint Angular Large**

Distance (ft): **40.1**  
Structural Grade: **4**  
O&M Grade: **0**  
Clock Start/From:  
Clock To:  
1st Value:  
2nd Value:  
Value Percent:  
Continuous Index:  
Within 8" of Joint: **NO**  
Remarks:

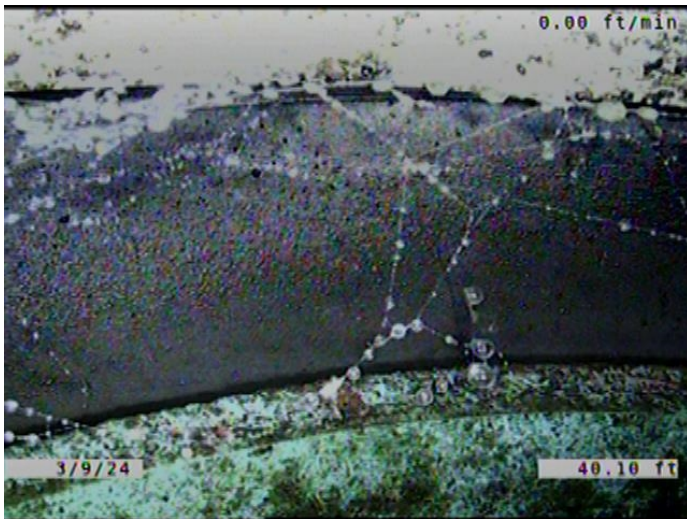
Code: **JSL**  
Description: **Joint Separated Large**

Distance (ft): **40.1**  
Structural Grade: **4**  
O&M Grade: **0**  
Clock Start/From:  
Clock To:  
1st Value:  
2nd Value:  
Value Percent:  
Continuous Index:  
Within 8" of Joint: **NO**  
Remarks:

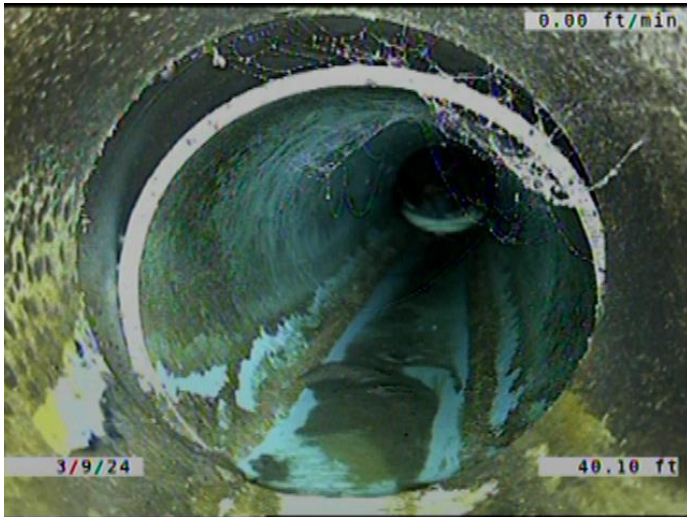
Code: **JOMD**  
Description: **Joint Offset Medium Defective**

Distance (ft): **40.1**  
Structural Grade: **3**  
O&M Grade: **0**  
Clock Start/From:  
Clock To:  
1st Value:  
2nd Value:  
Value Percent:  
Continuous Index:  
Within 8" of Joint: **NO**  
Remarks:

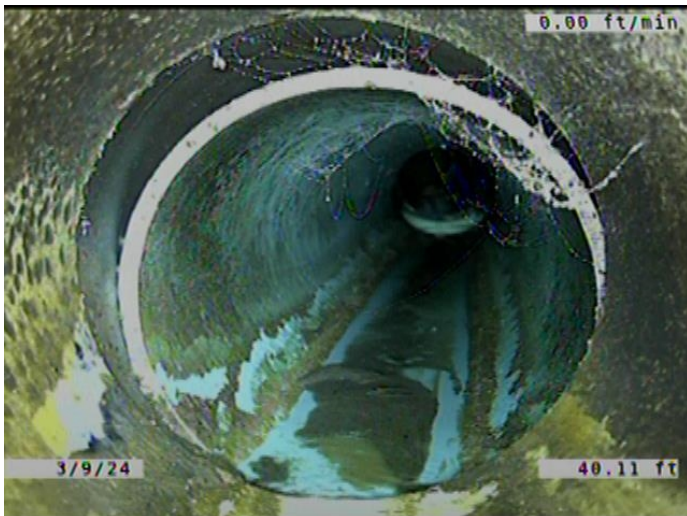
Code: **MGO**  
Description: **Miscellaneous General Observation**

Distance (ft): **40.1**  
Structural Grade: **0**  
O&M Grade: **0**  
Clock Start/From:  
Clock To:  
1st Value:  
2nd Value:  
Value Percent:  
Continuous Index:  
Within 8" of Joint: **NO**  
Remarks: **THIS IS WHERE BOWEN TIED ONTO THE EXISTING SEWER IN 2018.**

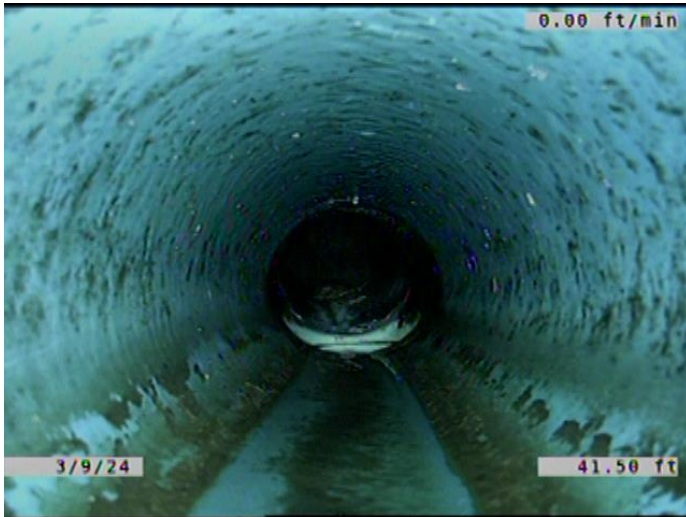
Code: **LD**  
 Description: **Line Down**

Distance (ft): **41.5**  
 Structural Grade: **0**  
 O&M Grade: **2**  
 Clock Start/From:  
 Clock To:  
 1st Value:  
 2nd Value:  
 Value Percent: **15.000**  
 Continuous Index: **F02**  
 Within 8" of Joint: **NO**  
 Remarks:

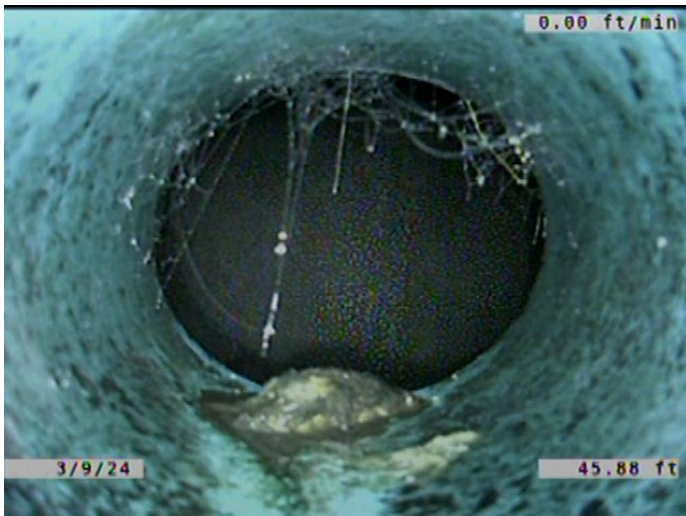
Code: **AMH**  
 Description: **Manhole**

Distance (ft): **45.9**  
 Structural Grade: **0**  
 O&M Grade: **0**  
 Clock Start/From:  
 Clock To:  
 1st Value:  
 2nd Value:  
 Value Percent:  
 Continuous Index:  
 Within 8" of Joint: **NO**  
 Remarks: **M-704-068.1**
