Profile/Photo Observation Report

Date:	04/13/2018	Weather:		Coding:	PACP 6.0
Pipe Length (ft):	99.0	Owner:	NA	Pre Clean:	Not Known
P.O.#:		Surveyor:	Jen Costello	PSR:	P-704-071-072
Customer:		Clean Date:	01/01/1900	Shape:	C

Street:	Lakewood Dr.	Flow Control:	Not Controlled
City:	Hobart, IN	Year Renewed:	
Location:	Other	Tape/Media #:	
Purpose:	Not Known	Dia/Height:	10"
Use:	Sanitary	Material:	VCP
Drain Area:	NA	Lining:	
Category:	NA		
Comment:

Location Details:		Direction of Survey:	Upstream
US MH:	M-704-071	DS MH:	M-704-072
		Total Length Surveyed (ft):	6.5

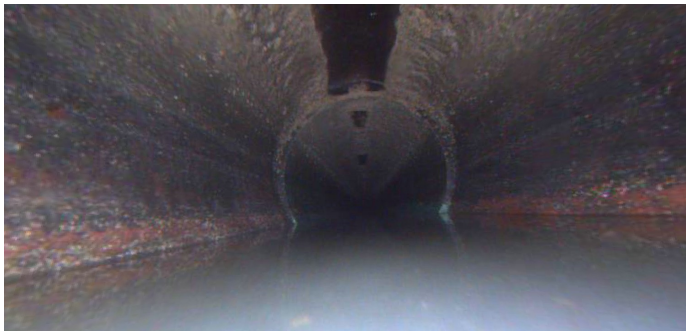
Code: **AMH**
Description: **Manhole**

Distance (ft): **.0**
Structural Grade: **0**
O&M Grade: **0**
Clock Start/From:
Clock To:
1st Value:
2nd Value:
Value Percent:
Continuous Index:
Within 8" of Joint: **NO**
Remarks: **M-704-072**

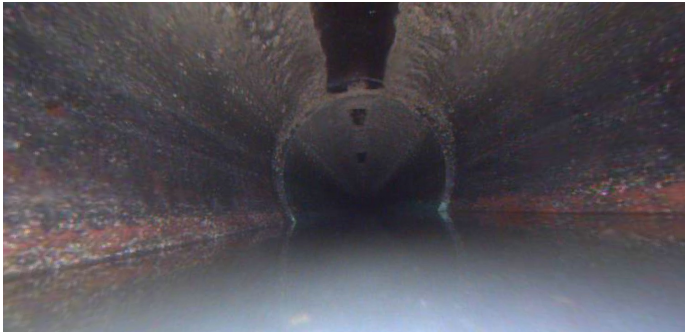
Code:	MWL
Description:	Water Level

Distance (ft):	.0
Structural Grade:	0
O&M Grade:	0
Clock Start/From:	
Clock To:	
1st Value:	
2nd Value:	
Value Percent:	30.000
Continuous Index:	
Within 8" of Joint:	NO
Remarks:

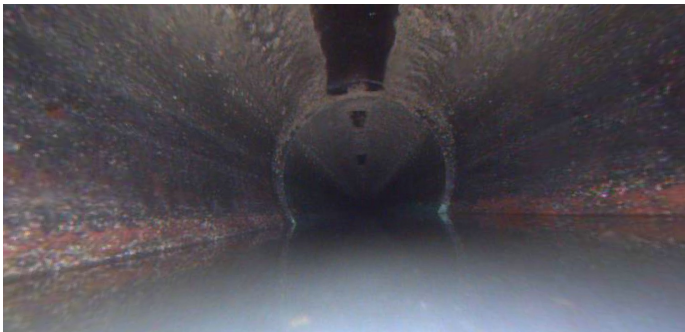
Code:	DAGS
Description:	Deposits Attached Grease

Distance (ft):	.0
Structural Grade:	0
O&M Grade:	2
Clock Start/From:	8
Clock To:	4
1st Value:	
2nd Value:	
Value Percent:	5.000
Continuous Index:	
Within 8" of Joint:	NO
Remarks:

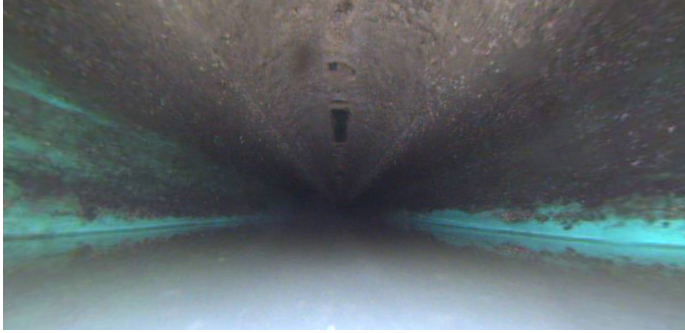
Code: **MMC**
Description: **Material Change**

Distance (ft): **2.9**
Structural Grade: **0**
O&M Grade: **0**
Clock Start/From:
Clock To:
1st Value:
2nd Value:
Value Percent:
Continuous Index:
Within 8" of Joint: **NO**
Remarks: **PVC**

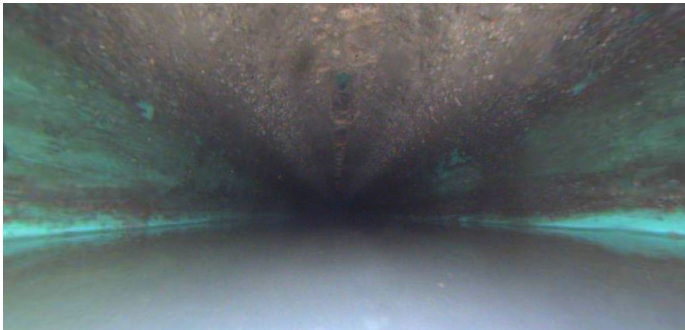
Code: **MSA**
Description: **Abandoned Survey**

Distance (ft): **6.5**
Structural Grade: **0**
O&M Grade: **0**
Clock Start/From:
Clock To:
1st Value:
2nd Value:
Value Percent:
Continuous Index:
Within 8" of Joint: **NO**
Remarks: **DEBRIS UNDER WATER**
