Profile/Photo Observation Report

Date:	03/09/2024	Weather:		Coding:	PACP 7.0
Pipe Length (ft):	91.0	Owner:	City of Hobart	Pre Clean:	Light Cleaning
P.O.#:		Surveyor:	S. Bucklin	PSR:	P-704-072.1-068.2
Customer:	City of Hobart	Clean Date:	03/09/2024	Shape:	C

Street:	LAKEWOOD DR	Flow Control:	Not Controlled
City:	Hobart, IN	Year Renewed:	
Location:	Easement/Right of Way	Tape/Media #:	
Purpose:	Sewer System Evaluation Survey (SS	Dia/Height:	8"
Use:	Sanitary Sewage Pipe	Material:	PVC
Drain Area:		Lining:	None
Category:	NA		
Comment:			
Location Details:		Direction of Survey:	Downstream
US MH:	M-704-072.1	DS MH:	M-704-068.2
		Total Length Surveyed (ft):	91.2

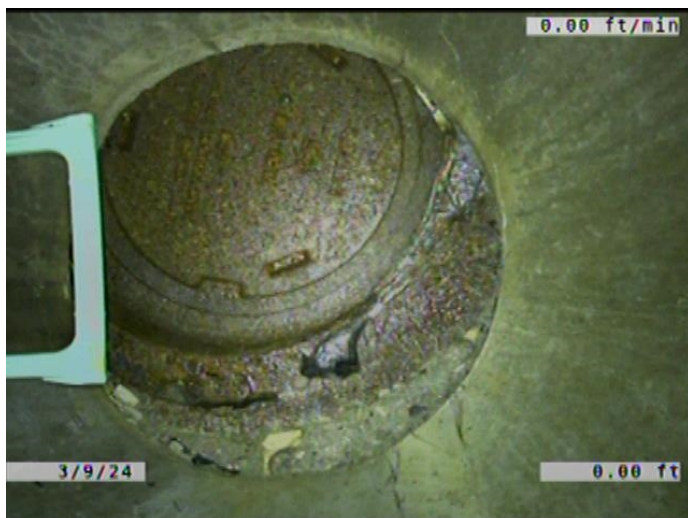
Code: **AMH**
Description: **Manhole**

Distance (ft): **.0**
Structural Grade: **0**
O&M Grade: **0**
Clock Start/From:
Clock To:
1st Value:
2nd Value:
Value Percent:
Continuous Index:
Within 8" of Joint: **NO**
Remarks: **M-704-072.1**

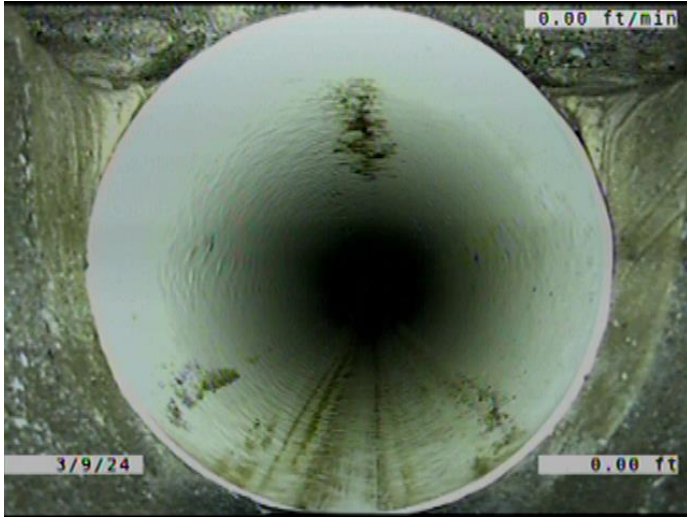
Code: **MWL**
Description: **Miscellaneous Water Level**

Distance (ft): **.0**
Structural Grade: **0**
O&M Grade: **0**
Clock Start/From:
Clock To:
1st Value:
2nd Value:
Value Percent: **5.000**
Continuous Index:
Within 8" of Joint: **NO**
Remarks:

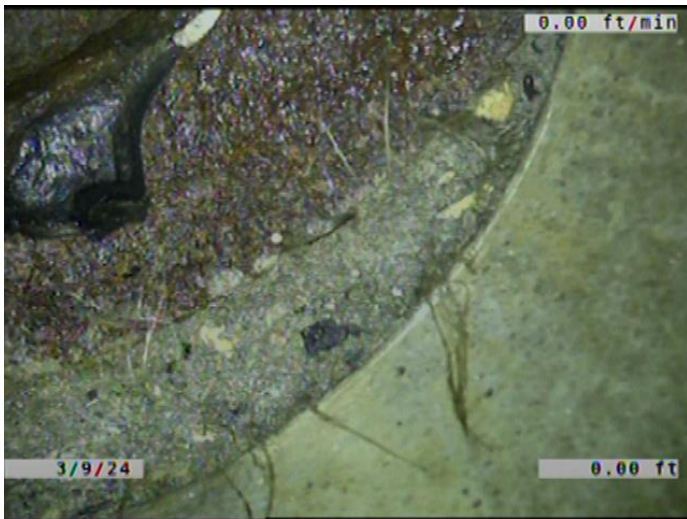
Code: **MGO**
Description: **Miscellaneous General Observation**

Distance (ft): **.0**
Structural Grade: **0**
O&M Grade: **0**
Clock Start/From:
Clock To:
1st Value:
2nd Value:
Value Percent:
Continuous Index:
Within 8" of Joint: **NO**
Remarks: **MANHOLE FROM HAS SHIFTED. SOIL VISIBLE.**

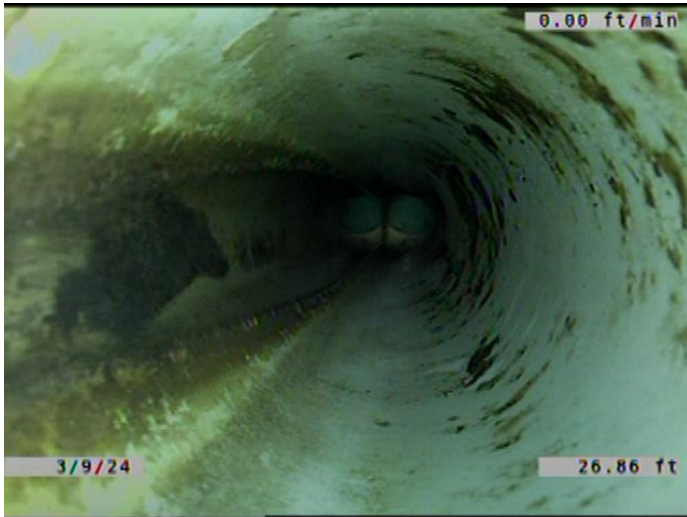
Code: **TF**
Description: **Tap Factory**

Distance (ft): **26.9**
Structural Grade: **0**
O&M Grade: **0**
Clock Start/From: **9**
Clock To:
1st Value: **6.000**
2nd Value:
Value Percent:
Continuous Index:
Within 8" of Joint: **YES**
Remarks:

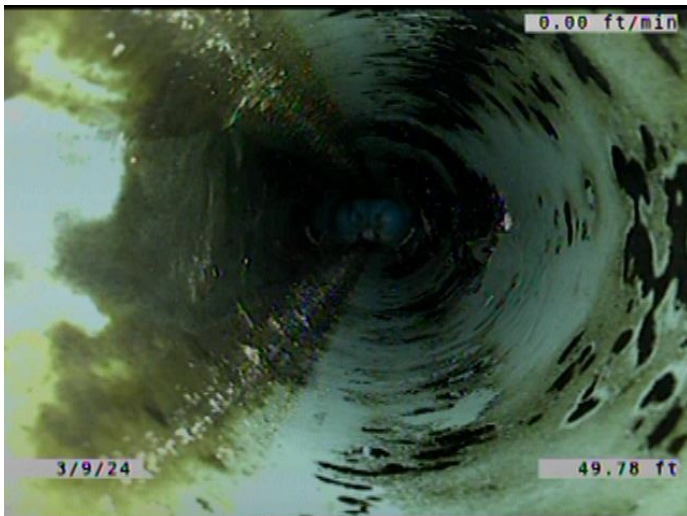
Code: **TF**
Description: **Tap Factory**

Distance (ft): **49.8**
Structural Grade: **0**
O&M Grade: **0**
Clock Start/From: **9**
Clock To:
1st Value: **6.000**
2nd Value:
Value Percent:
Continuous Index:
Within 8" of Joint: **YES**
Remarks:

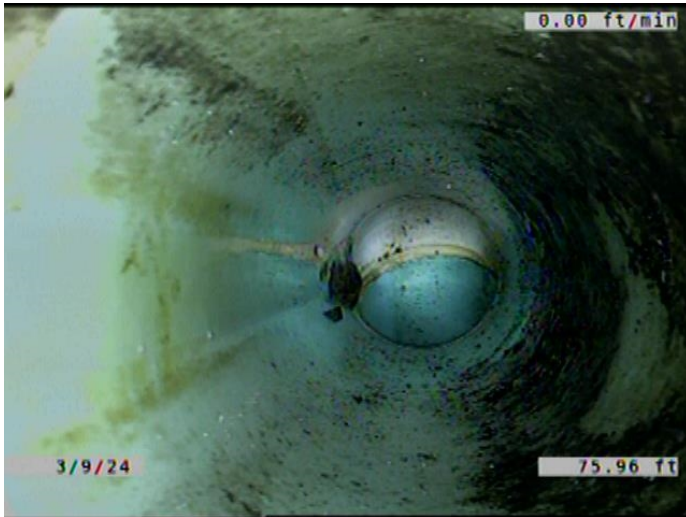
Code: **TF**
Description: **Tap Factory**

Distance (ft): **76.0**
Structural Grade: **0**
O&M Grade: **0**
Clock Start/From: **9**
Clock To:
1st Value: **6.000**
2nd Value:
Value Percent:
Continuous Index:
Within 8" of Joint: **YES**
Remarks:

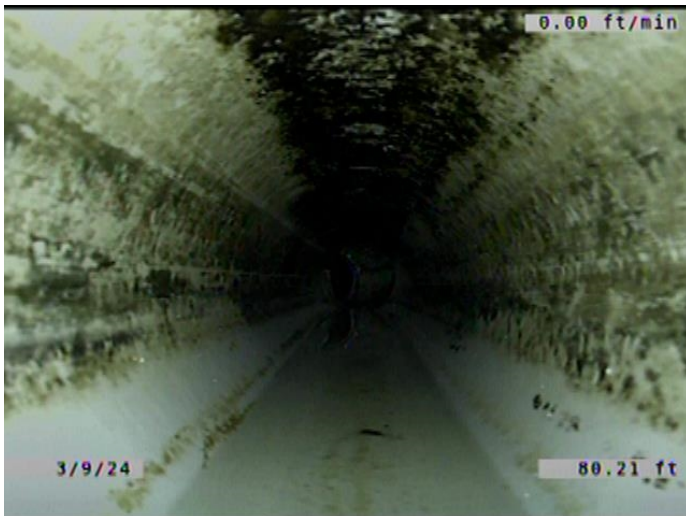
Code: **MWLS**
Description: **Miscellaneous Water Level Sag**

Distance (ft): **80.2**
Structural Grade: **2**
O&M Grade: **0**
Clock Start/From:
Clock To:
1st Value:
2nd Value:
Value Percent: **5.000**
Continuous Index: **S01**
Within 8" of Joint: **NO**
Remarks:

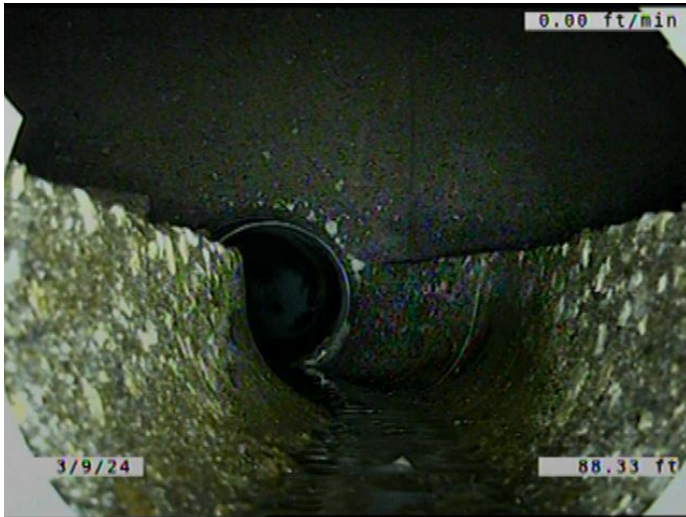
Code: **MWLS**
Description: **Miscellaneous Water Level Sag**

Distance (ft): **88.3**
Structural Grade: **2**
O&M Grade: **0**
Clock Start/From:
Clock To:
1st Value:
2nd Value:
Value Percent: **5.000**
Continuous Index: **F01**
Within 8" of Joint: **NO**
Remarks:

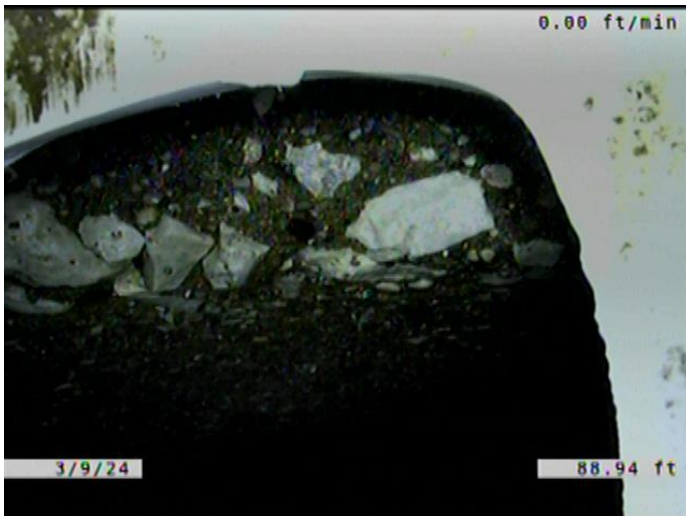
Code: **SMW**
Description: **Surface Damage Missing Wall**

Distance (ft): **88.9**
Structural Grade: **5**
O&M Grade: **0**
Clock Start/From: **10**
Clock To: **12**
1st Value:
2nd Value:
Value Percent:
Continuous Index:
Within 8" of Joint: **YES**
Remarks: **RIGHT AT THE MANHOLE.**

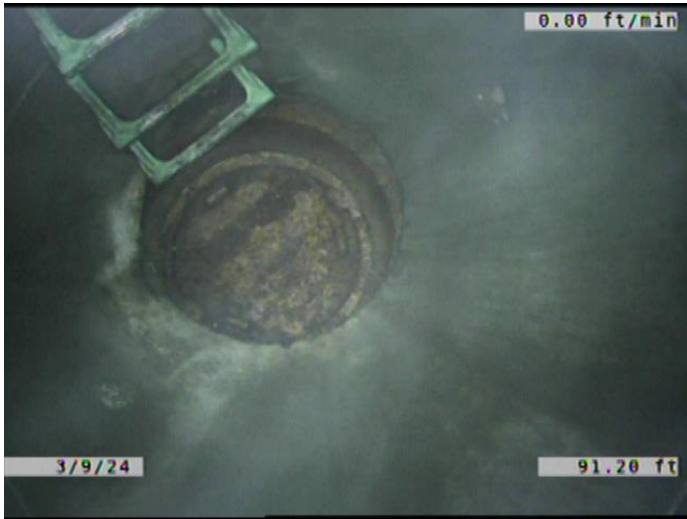
Code:	AMH
Description:	Manhole
Distance (ft):	91.2
Structural Grade:	0
O&M Grade:	0
Clock Start/From:	
Clock To:	
1st Value:	
2nd Value:	
Value Percent:	
Continuous Index:	
Within 8" of Joint:	NO
Remarks:	M-704-068.2
