## Profile/Photo Observation Report

Date:	02/20/2024	Weather:		Coding:	PACP 7.0
Pipe Length (ft):	46.0	Owner:	City of Hobart	Pre Clean:	Heavy Cleaning
P.O.#:	YES502259	Surveyor:	S. Bucklin	PSR:	P-708-009.1-009
Customer:	City of Hobart	Clean Date:	02/17/2024	Shape:	C

Street:	S LAKE PARK AVE	Flow Control:	Not Controlled
City:	Hobart, IN	Year Renewed:	
Location:	Parking Lot	Tape/Media #:	
Purpose:	Sewer System Evaluation Survey (SS	Dia/Height:	10"
Use:	Sanitary Sewage Pipe	Material:	PVC
Drain Area:		Lining:	None
Category:	NA		
Comment:			
Location Details:		Direction of Survey:	Downstream
US MH:	M-708-009.1	DS MH:	M-708-009
		Total Length Surveyed (ft):	46.0

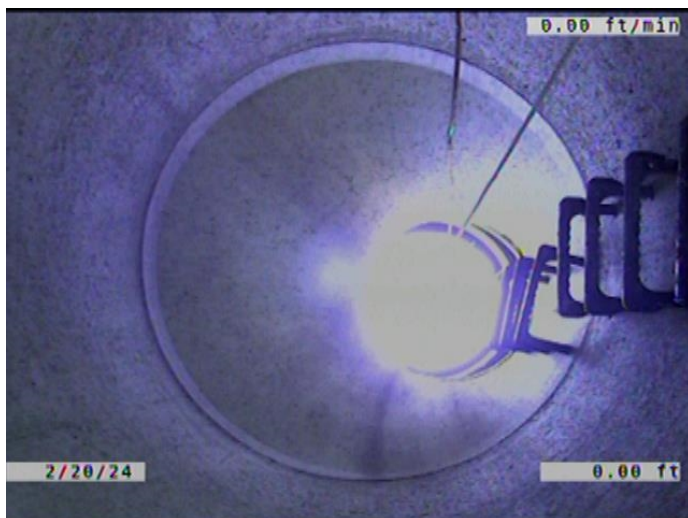
Code: **AMH**  
Description: **Manhole**

Distance (ft): **.0**  
Structural Grade: **0**  
O&M Grade: **0**  
Clock Start/From:  
Clock To:  
1st Value:  
2nd Value:  
Value Percent:  
Continuous Index:  
Within 8" of Joint: **NO**  
Remarks: **M-708-009.1**

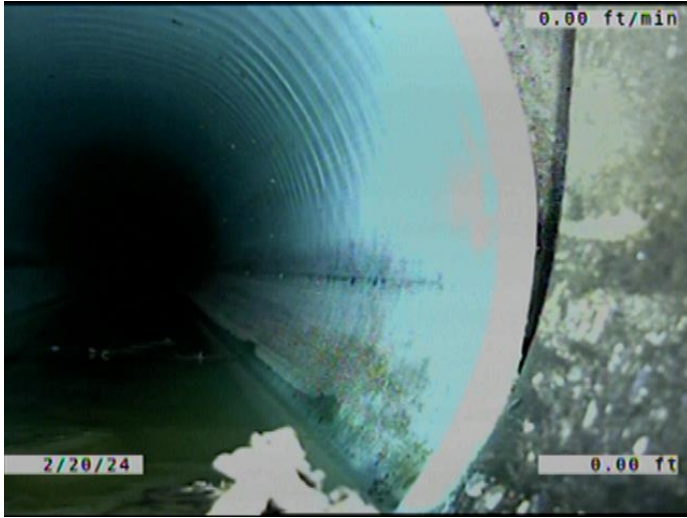
Code:	<b>MWL</b>
Description:	<b>Miscellaneous Water Level</b>
Distance (ft):	<b>.0</b>
Structural Grade:	<b>0</b>
O&M Grade:	<b>0</b>
Clock Start/From:	
Clock To:	
1st Value:	
2nd Value:	
Value Percent:	<b>5.000</b>
Continuous Index:	
Within 8" of Joint:	<b>NO</b>
Remarks:

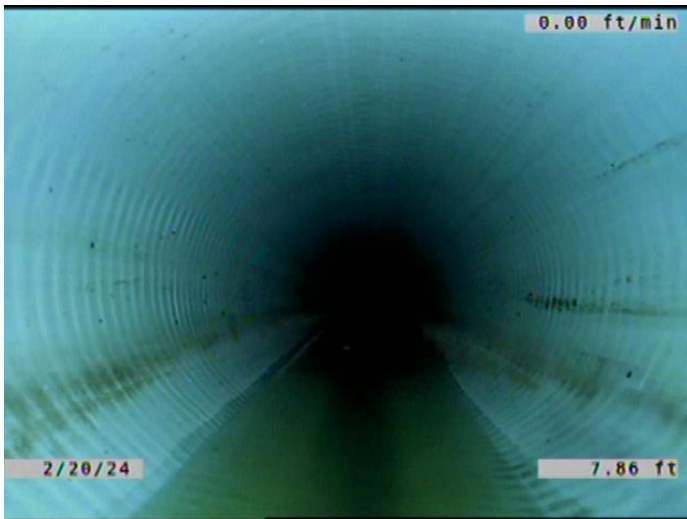
Code:	<b>LR</b>
Description:	<b>Line Right</b>
Distance (ft):	<b>7.9</b>
Structural Grade:	<b>0</b>
O&M Grade:	<b>1</b>
Clock Start/From:	
Clock To:	
1st Value:	
2nd Value:	
Value Percent:	<b>5.000</b>
Continuous Index:	
Within 8" of Joint:	<b>NO</b>
Remarks:

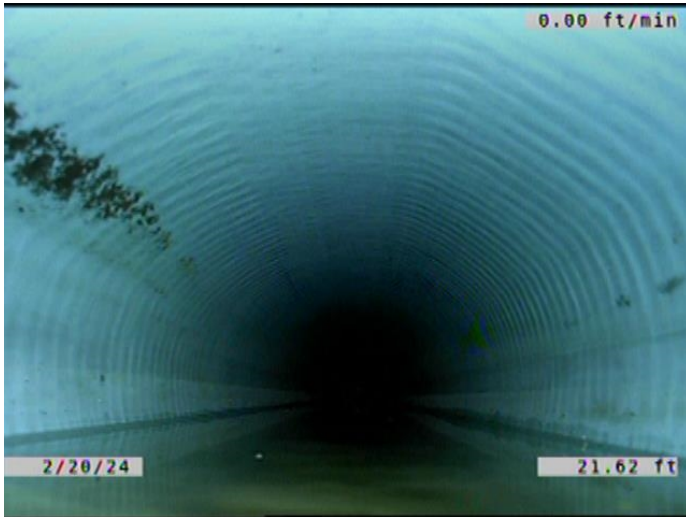
Code: **MWL**  
Description: **Miscellaneous Water Level**

Distance (ft): **21.6**  
Structural Grade: **0**  
O&M Grade: **0**  
Clock Start/From:  
Clock To:  
1st Value:  
2nd Value:  
Value Percent: **20.000**  
Continuous Index:  
Within 8" of Joint: **NO**  
Remarks:

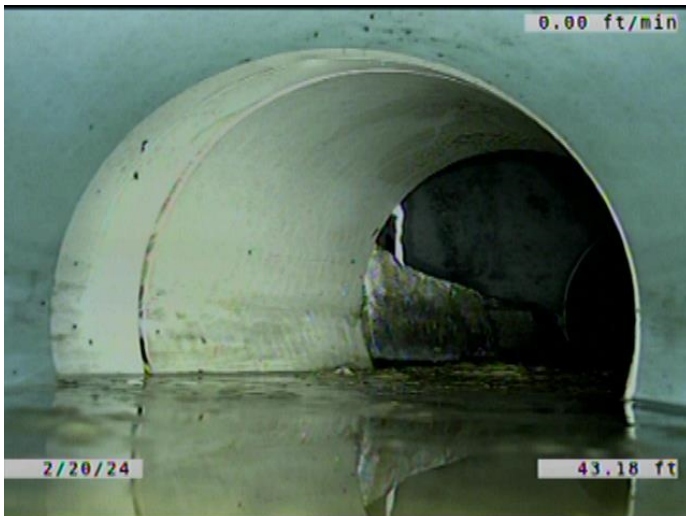
Code: **LR**  
Description: **Line Right**

Distance (ft): **43.2**  
Structural Grade: **0**  
O&M Grade: **4**  
Clock Start/From:  
Clock To:  
1st Value:  
2nd Value:  
Value Percent: **25.000**  
Continuous Index:  
Within 8" of Joint: **NO**  
Remarks:

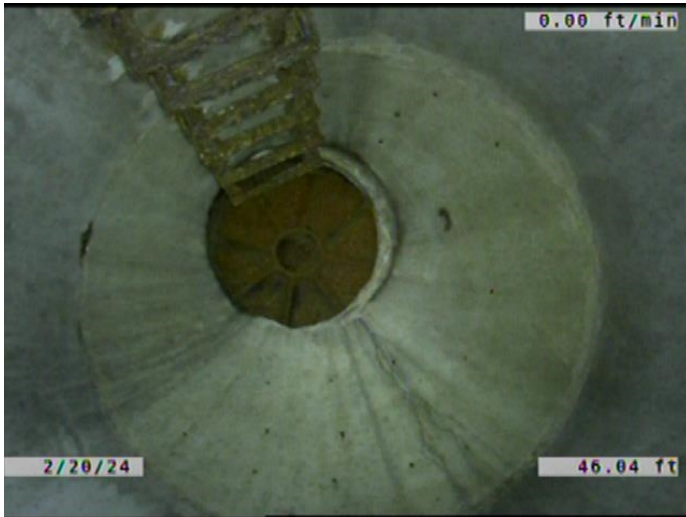
Code:	<b>AMH</b>
Description:	<b>Manhole</b>
Distance (ft):	<b>46.0</b>
Structural Grade:	<b>0</b>
O&M Grade:	<b>0</b>
Clock Start/From:	
Clock To:	
1st Value:	
2nd Value:	
Value Percent:	
Continuous Index:	
Within 8" of Joint:	<b>NO</b>
Remarks:	<b>M-708-009</b>
