Profile/Photo Observation Report

Profile/Prioto Observation Report								
Date:	02/20/2024	Weather:		Coding:	PACP 7.0			
Pipe Length (ft)): 211.0	Owner:	City of Hobart	Pre Clean:	Heavy Cleaning			
P.O.#:	YES502259	Surveyor:	S. Bucklin	PSR:	P-708-009.2-009.1			
Customer:	City of Hobart	Clean Date:	02/17/2024	Shape:	С			
Street:	S LAKE PARK AVE		Flow Control:	Not Controlled				
City:	Hobart, IN		Year Renewed:					
Location:	Parking Lot		Tape/Media #:					
Purpose:	Sewer System Eva	aluation Survey (SS	Dia/Height:	10"				
Use:	Sanitary Sewage F	Pipe	Material:	PVC				
Drain Area:			Lining:	None				
Category:	NA

Comment:								
Location Detail	s:		Direction of Survey	: Upstream				
US MH:	M-708-009.2	DS MH:	M-708.009.1	Total Length Surveyed (ft):	211.4			
O&M Index:	0.00	O&M Quick:	0000	O&M Rating:	0.00			
Structural Index:	0.00	Structural Qui	ick: 0000	Structural Rating:	0.00			
Overall Index:	0.00	Overall Quick		Overall Rating:	0.00

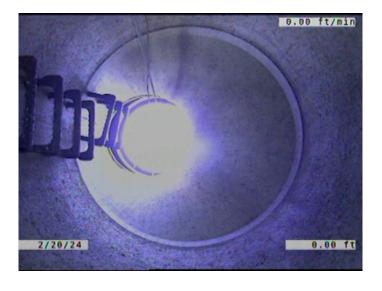
Code:	AMH
Description:	Manhole
Distance (ft):	.0
Structural Grade:	0
O&M Grade:	0
Clock Start/From:	
Clock To:	
1st Value:	
2nd Value:	
Value Percent:	
Continuous Index:	
Within 8" of Joint:	NO
Remarks:	M-708.009.1

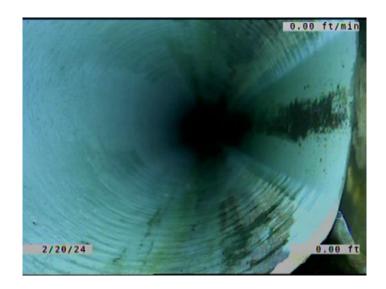
Code: MWL

Description: Miscellaneous Water Level

Distance (ft): .0
Structural Grade: 0
O&M Grade: 0

Value Percent: 5.000

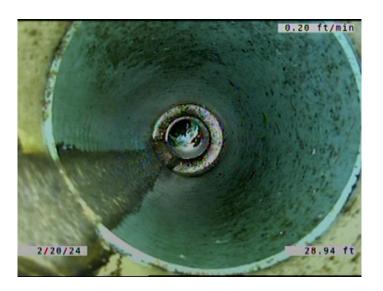
Code: **TF**

Description: Tap Factory

Distance (ft): 28.9
Structural Grade: 0
O&M Grade: 0
Clock Start/From: 11

1st Value: **6.000**

Within 8" of Joint: YES

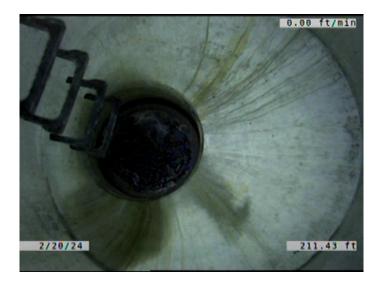
Code: AMH
Description: Manhole

Distance (ft): 211.4
Structural Grade: 0

Remarks: M-708-009.2
