## Profile/Photo Observation Report

Date:	<b>03/05/2024</b>	Weather:		Coding:	<b>PACP 7.0</b>
Pipe Length (ft):	<b>435.0</b>	Owner:	<b>City of Hobart</b>	Pre Clean:	<b>Heavy Cleaning</b>
P.O.#:		Surveyor:	<b>S. Bucklin</b>	PSR:	<b>P-805-066-036</b>
Customer:	<b>City of Hobart</b>	Clean Date:	<b>10/17/2022</b>	Shape:	<b>C</b>

Street:	<b>SR-130</b>	Flow Control:	<b>Not Controlled</b>
City:	<b>Hobart, IN</b>	Year Renewed:	
Location:	<b>Parking Lot</b>	Tape/Media #:	
Purpose:	<b>Sewer System Evaluation Survey (SS</b>	Dia/Height:	<b>6"</b>
Use:	<b>Sanitary Sewage Pipe</b>	Material:	<b>VCP</b>
Drain Area:		Lining:	<b>None</b>
Category:	<b>NA</b>		
Comment:			
Location Details:		Direction of Survey:	<b>Downstream</b>
US MH:	<b>M-805-066</b>	DS MH:	<b>M-805-036</b>
		Total Length Surveyed (ft):	<b>161.4</b>

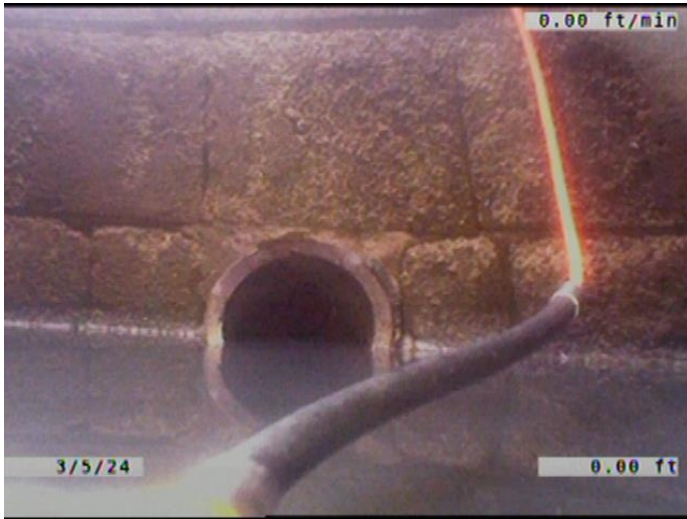
Code: **AMH**  
Description: **Manhole**

Distance (ft): **.0**  
Structural Grade: **0**  
O&M Grade: **0**  
Clock Start/From:  
Clock To:  
1st Value:  
2nd Value:  
Value Percent:  
Continuous Index:  
Within 8" of Joint: **NO**  
Remarks: **M-805-066**

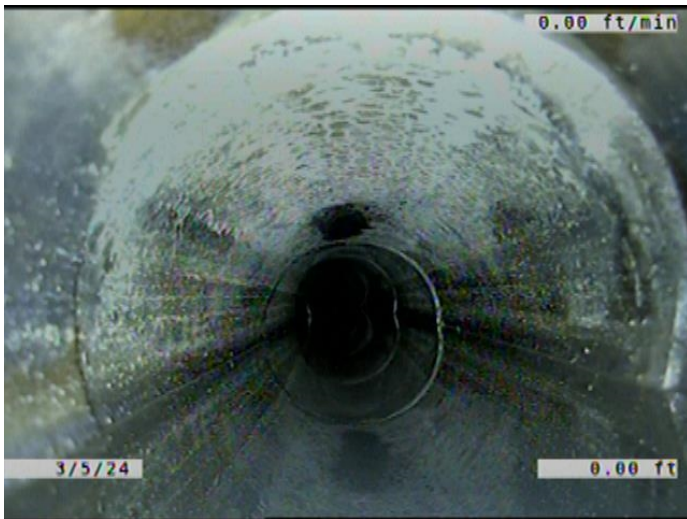
Code: **MWL**  
Description: **Miscellaneous Water Level**

Distance (ft): **.0**  
Structural Grade: **0**  
O&M Grade: **0**  
Clock Start/From:  
Clock To:  
1st Value:  
2nd Value:  
Value Percent: **5.000**  
Continuous Index:  
Within 8" of Joint: **NO**  
Remarks:

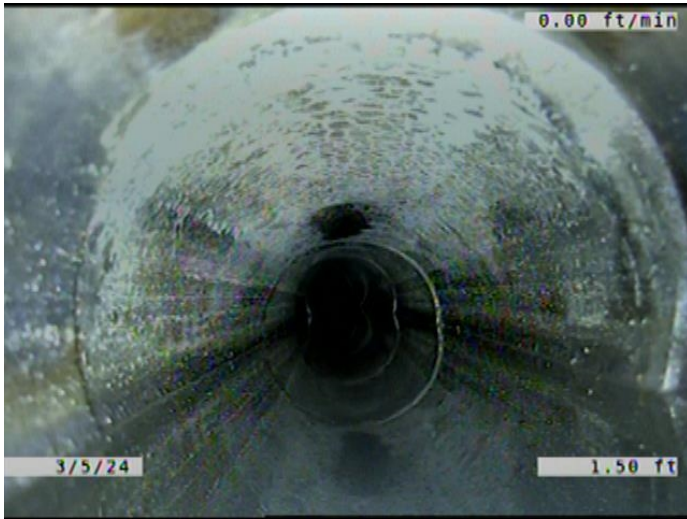
Code: **MGO**  
Description: **Miscellaneous General Observation**

Distance (ft): **1.5**  
Structural Grade: **0**  
O&M Grade: **0**  
Clock Start/From:  
Clock To:  
1st Value:  
2nd Value:  
Value Percent:  
Continuous Index:  
Within 8" of Joint: **NO**  
Remarks: **DROP INTO THE MANHOLE. HAD TO START IN THE PIPE.**

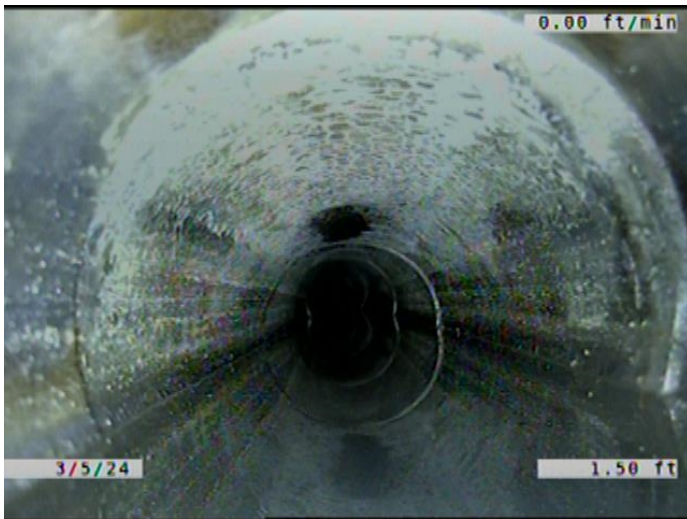
Code: **MWLS**  
Description: **Miscellaneous Water Level Sag**

Distance (ft): **1.5**  
Structural Grade: **2**  
O&M Grade: **0**  
Clock Start/From:  
Clock To:  
1st Value:  
2nd Value:  
Value Percent: **20.000**  
Continuous Index: **S01**  
Within 8" of Joint: **NO**  
Remarks:

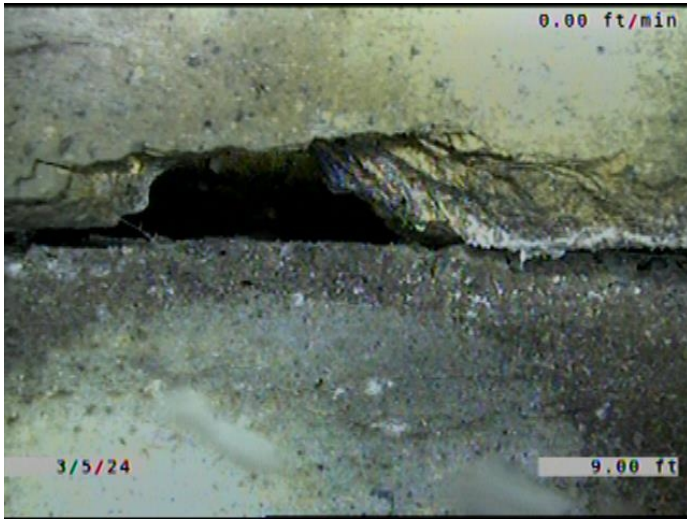
Code: **HVV**  
Description: **Hole Void Visible**

Distance (ft): **9.0**  
Structural Grade: **5**  
O&M Grade: **0**  
Clock Start/From: **12**  
Clock To:  
1st Value:  
2nd Value:  
Value Percent:  
Continuous Index:  
Within 8" of Joint: **YES**  
Remarks:

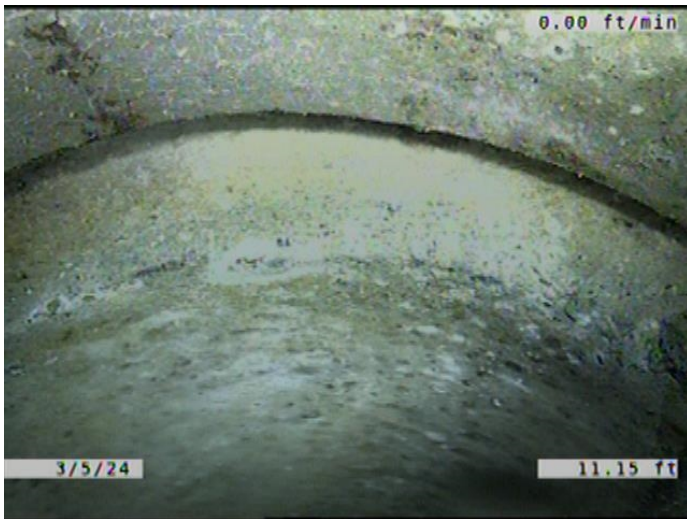
Code: **JOMD**  
Description: **Joint Offset Medium Defective**

Distance (ft): **11.2**  
Structural Grade: **3**  
O&M Grade: **0**  
Clock Start/From:  
Clock To:  
1st Value:  
2nd Value:  
Value Percent:  
Continuous Index:  
Within 8" of Joint: **NO**  
Remarks:

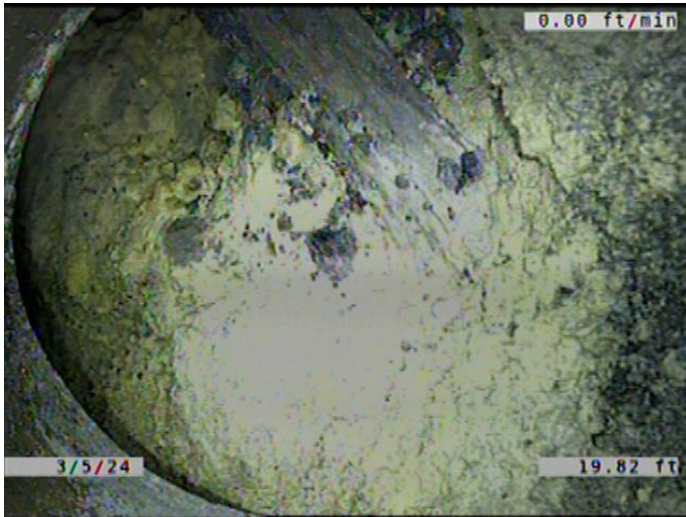
Code:	<b>TFD</b>
Description:	<b>Tap Factory Defective</b>
Distance (ft):	<b>19.8</b>
Structural Grade:	<b>0</b>
O&M Grade:	<b>3</b>
Clock Start/From:	<b>3</b>
Clock To:	
1st Value:	<b>6.000</b>
2nd Value:	
Value Percent:	
Continuous Index:	
Within 8" of Joint:	<b>YES</b>
Remarks:	<b>WOODEN CAP. MOST OF THE WOOD IS MISSING. SOIL AND VOID VISIBLE.</b>

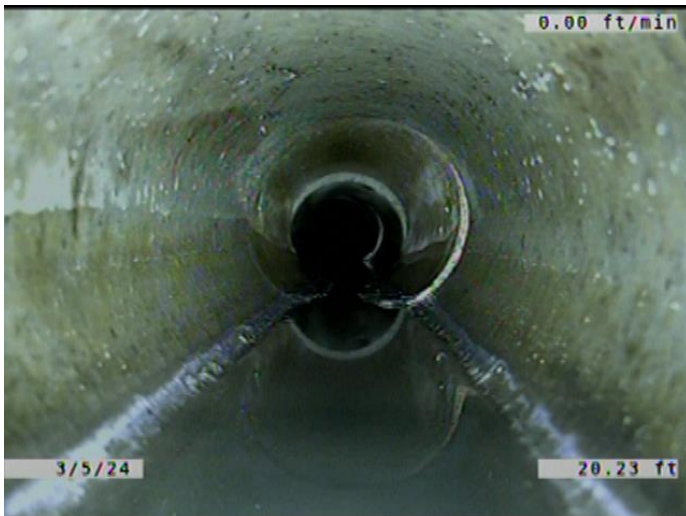
Code:	<b>MWLS</b>
Description:	<b>Miscellaneous Water Level Sag</b>
Distance (ft):	<b>20.2</b>
Structural Grade:	<b>2</b>
O&M Grade:	<b>0</b>
Clock Start/From:	
Clock To:	
1st Value:	
2nd Value:	
Value Percent:	<b>20.000</b>
Continuous Index:	<b>F01</b>
Within 8" of Joint:	<b>NO</b>
Remarks:

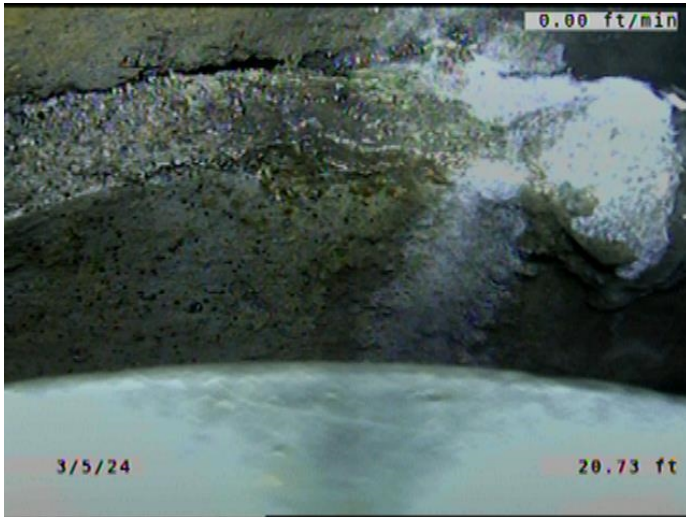
Code: **JOMD**  
Description: **Joint Offset Medium Defective**

Distance (ft): **20.7**  
Structural Grade: **3**  
O&M Grade: **0**  
Clock Start/From:  
Clock To:  
1st Value:  
2nd Value:  
Value Percent:  
Continuous Index:  
Within 8" of Joint: **NO**  
Remarks:

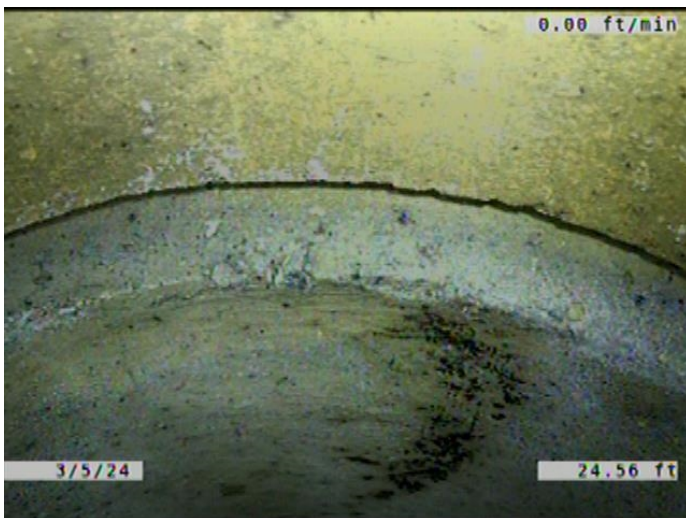
Code: **JOMD**  
Description: **Joint Offset Medium Defective**

Distance (ft): **24.6**  
Structural Grade: **3**  
O&M Grade: **0**  
Clock Start/From:  
Clock To:  
1st Value:  
2nd Value:  
Value Percent:  
Continuous Index: **S02**  
Within 8" of Joint: **NO**  
Remarks:

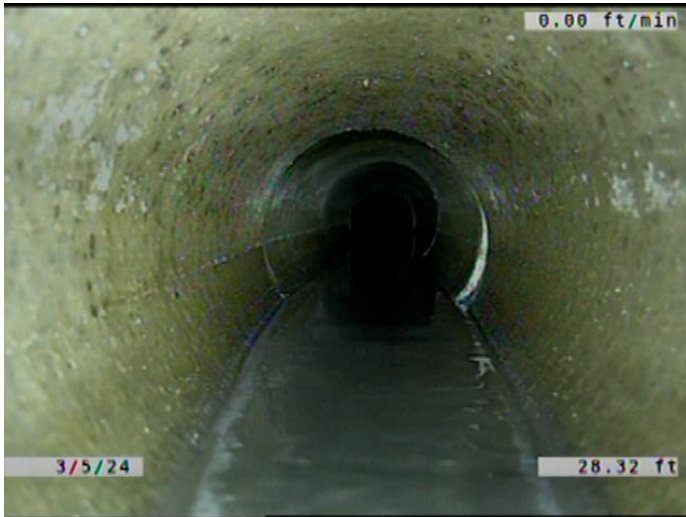
Code: **MWLS**  
Description: **Miscellaneous Water Level Sag**

Distance (ft): **28.3**  
Structural Grade: **2**  
O&M Grade: **0**  
Clock Start/From:  
Clock To:  
1st Value:  
2nd Value:  
Value Percent: **15.000**  
Continuous Index: **S03**  
Within 8" of Joint: **NO**  
Remarks:

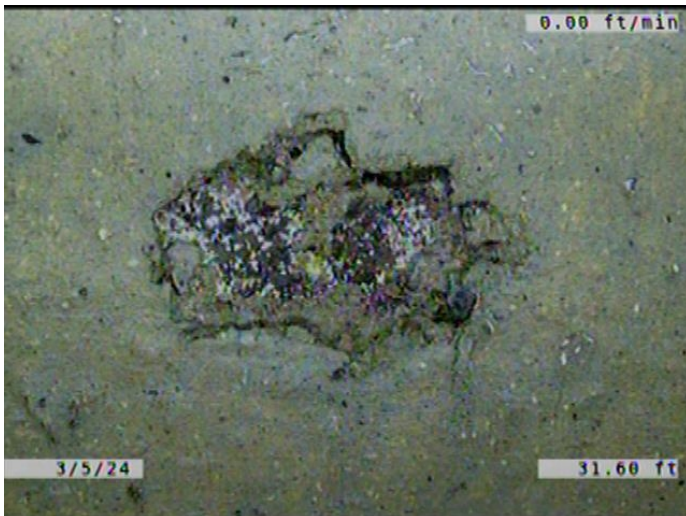
Code: **SSC**  
Description: **Surface Spalling of Damage Coating**

Distance (ft): **31.6**  
Structural Grade: **1**  
O&M Grade: **0**  
Clock Start/From: **1**  
Clock To:  
1st Value:  
2nd Value:  
Value Percent:  
Continuous Index:  
Within 8" of Joint: **YES**  
Remarks:

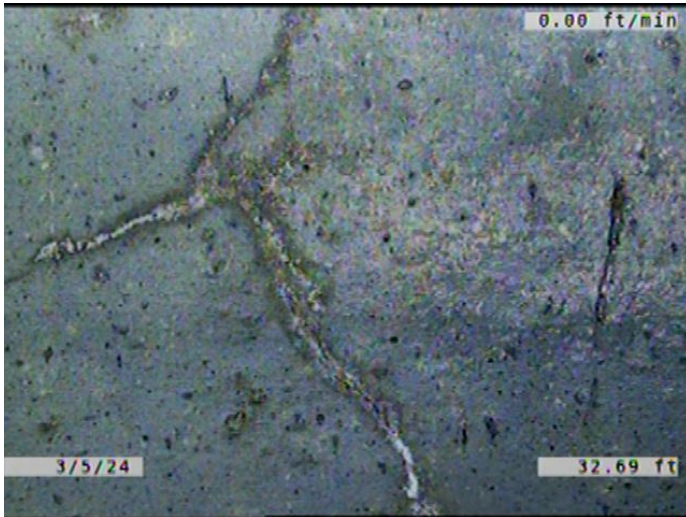
Code: **CM**  
Description: **Crack Multiple**

Distance (ft): **32.7**  
Structural Grade: **3**  
O&M Grade: **0**  
Clock Start/From: **12**  
Clock To: **1**  
1st Value:  
2nd Value:  
Value Percent:  
Continuous Index:  
Within 8" of Joint: **YES**  
Remarks:

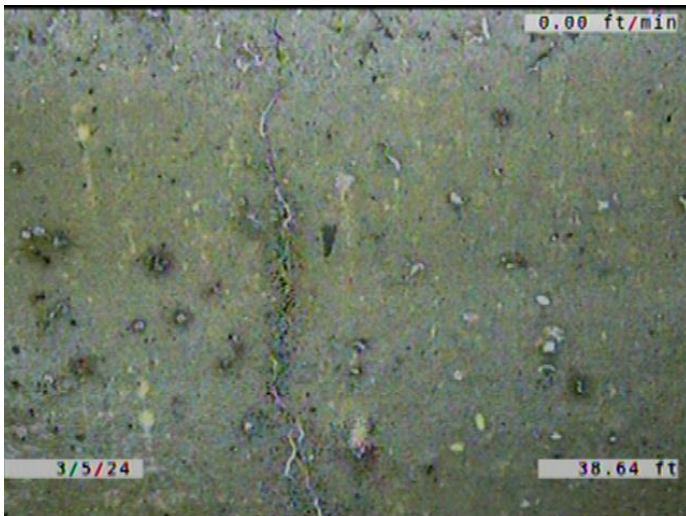
Code: **CL**  
Description: **Crack Longitudinal**

Distance (ft): **38.6**  
Structural Grade: **2**  
O&M Grade: **0**  
Clock Start/From: **1**  
Clock To:  
1st Value:  
2nd Value:  
Value Percent:  
Continuous Index:  
Within 8" of Joint: **YES**  
Remarks:

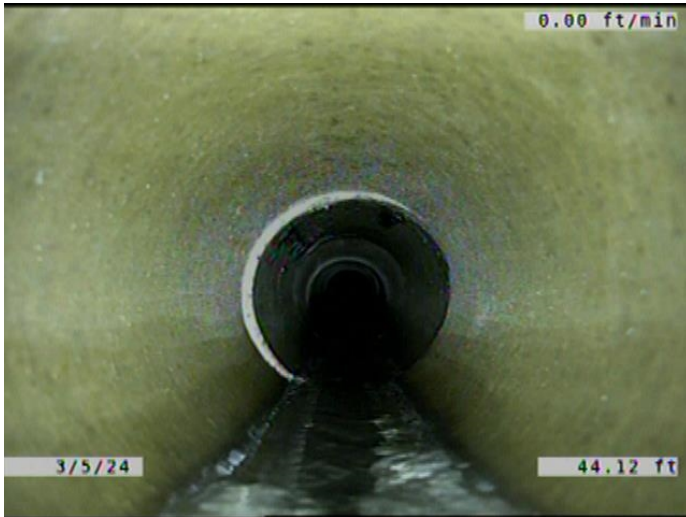
Code: **MWLS**  
Description: **Miscellaneous Water Level Sag**

Distance (ft): **44.1**  
Structural Grade: **2**  
O&M Grade: **0**  
Clock Start/From:  
Clock To:  
1st Value:  
2nd Value:  
Value Percent: **15.000**  
Continuous Index: **F03**  
Within 8" of Joint: **NO**  
Remarks:

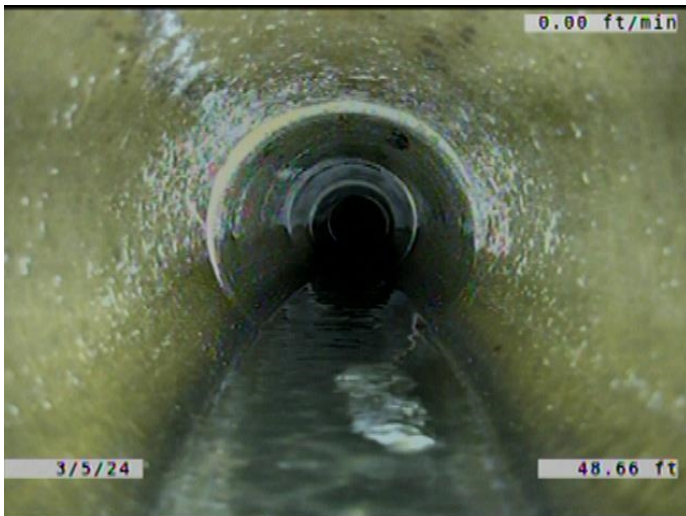
Code: **MWLS**  
Description: **Miscellaneous Water Level Sag**

Distance (ft): **48.7**  
Structural Grade: **2**  
O&M Grade: **0**  
Clock Start/From:  
Clock To:  
1st Value:  
2nd Value:  
Value Percent: **5.000**  
Continuous Index:  
Within 8" of Joint: **NO**  
Remarks:

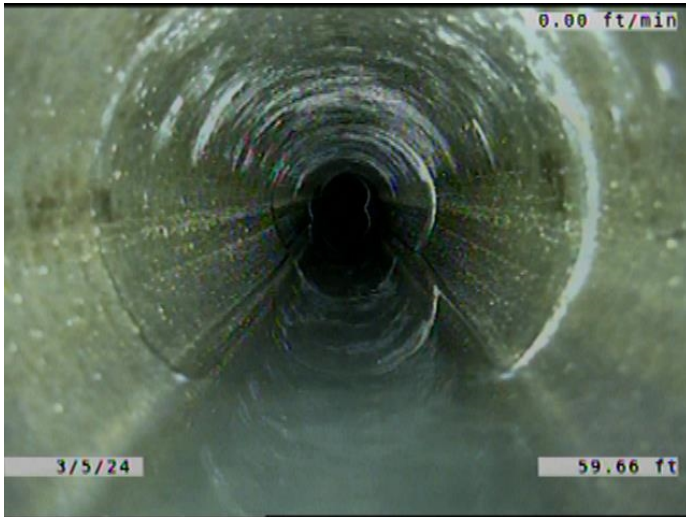
Code: **MWLS**  
Description: **Miscellaneous Water Level Sag**

Distance (ft): **59.7**  
Structural Grade: **2**  
O&M Grade: **0**  
Clock Start/From:  
Clock To:  
1st Value:  
2nd Value:  
Value Percent: **15.000**  
Continuous Index: **S04**  
Within 8" of Joint: **NO**  
Remarks:

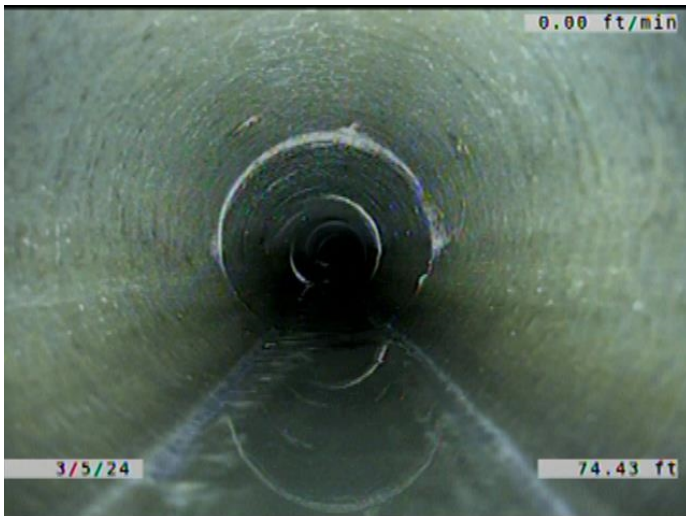
Code: **MWLS**  
Description: **Miscellaneous Water Level Sag**

Distance (ft): **74.4**  
Structural Grade: **2**  
O&M Grade: **0**  
Clock Start/From:  
Clock To:  
1st Value:  
2nd Value:  
Value Percent: **15.000**  
Continuous Index: **F04**  
Within 8" of Joint: **NO**  
Remarks:

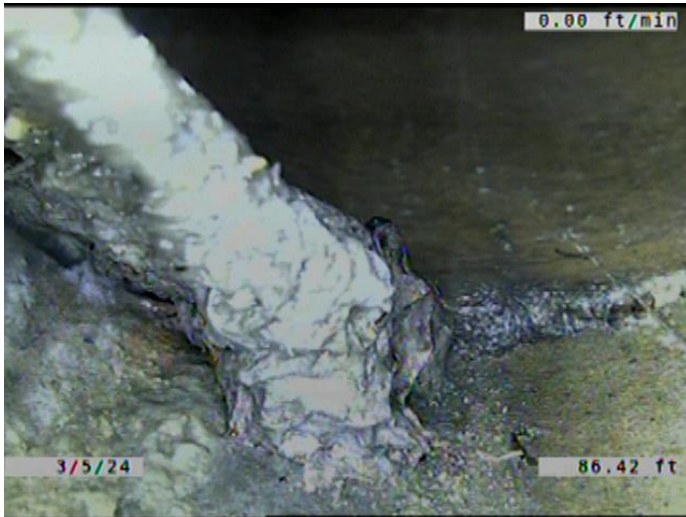
Code: **OBJ**  
Description: **Obstruction Wedged In The Joint**

Distance (ft): **86.4**  
Structural Grade: **0**  
O&M Grade: **2**  
Clock Start/From: **4**  
Clock To: **8**  
1st Value:  
2nd Value:  
Value Percent: **5.000**  
Continuous Index:  
Within 8" of Joint: **YES**  
Remarks: **LOOKS LIKE A STICK WITH TP ON IT.**

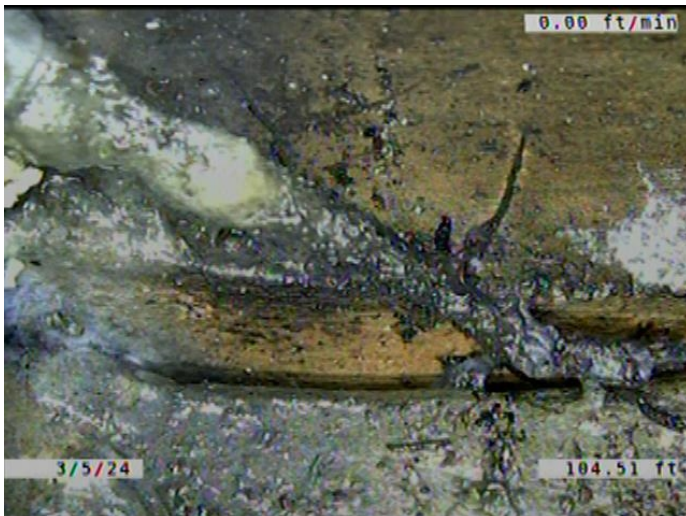
Code: **OBJ**  
Description: **Obstruction Wedged In The Joint**

Distance (ft): **104.5**  
Structural Grade: **0**  
O&M Grade: **2**  
Clock Start/From: **4**  
Clock To: **6**  
1st Value:  
2nd Value:  
Value Percent: **5.000**  
Continuous Index:  
Within 8" of Joint: **YES**  
Remarks: **LOOKS LIKE A STICK**

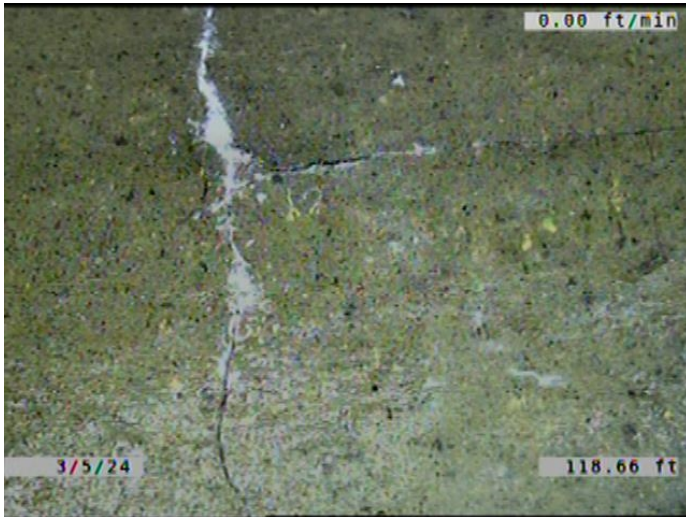
Code: **CM**  
Description: **Crack Multiple**

Distance (ft): **118.7**  
Structural Grade: **3**  
O&M Grade: **0**  
Clock Start/From: **12**  
Clock To: **4**  
1st Value:  
2nd Value:  
Value Percent:  
Continuous Index:  
Within 8" of Joint: **YES**  
Remarks:

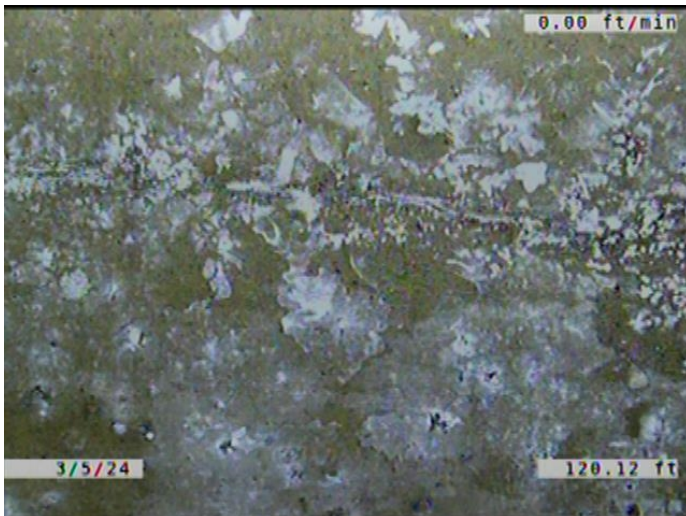
Code: **CC**  
Description: **Crack Circumferential**

Distance (ft): **120.1**  
Structural Grade: **1**  
O&M Grade: **0**  
Clock Start/From: **12**  
Clock To: **12**  
1st Value:  
2nd Value:  
Value Percent:  
Continuous Index:  
Within 8" of Joint: **YES**  
Remarks:

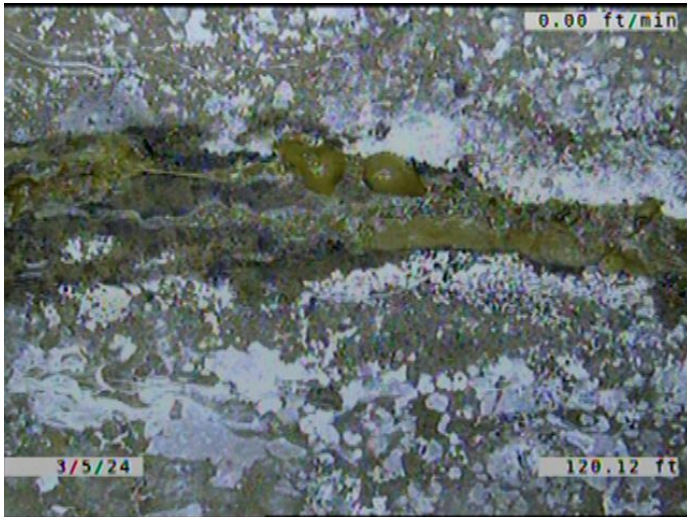
Code: **DAE**  
Description: **Deposits Attached Encrustation**

Distance (ft): **120.1**  
Structural Grade: **0**  
O&M Grade: **2**  
Clock Start/From: **9**  
Clock To: **5**  
1st Value:  
2nd Value:  
Value Percent: **5.000**  
Continuous Index:  
Within 8" of Joint: **YES**  
Remarks:

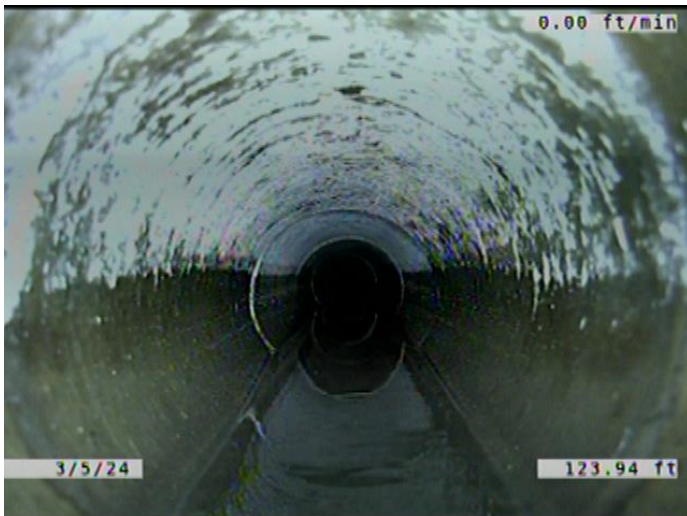
Code: **MWLS**  
Description: **Miscellaneous Water Level Sag**

Distance (ft): **123.9**  
Structural Grade: **2**  
O&M Grade: **0**  
Clock Start/From:  
Clock To:  
1st Value:  
2nd Value:  
Value Percent: **15.000**  
Continuous Index: **S05**  
Within 8" of Joint: **NO**  
Remarks:

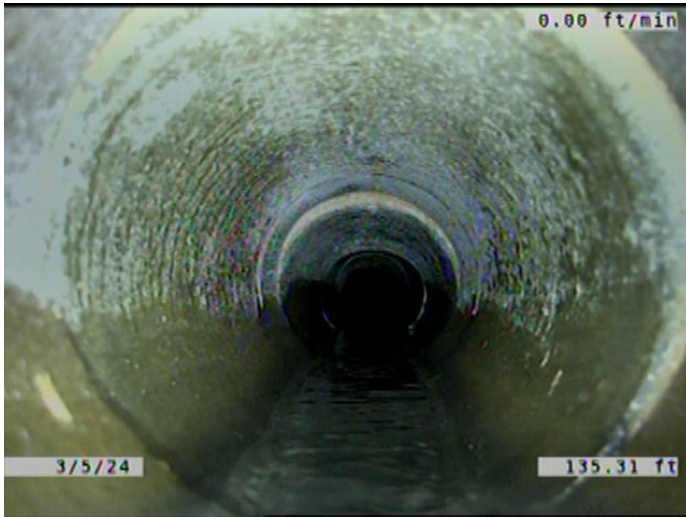
Code: **MWLS**  
 Description: **Miscellaneous Water Level Sag**

Distance (ft): **135.3**  
 Structural Grade: **2**  
 O&M Grade: **0**  
 Clock Start/From:  
 Clock To:  
 1st Value:  
 2nd Value:  
 Value Percent: **15.000**  
 Continuous Index: **F05**  
 Within 8" of Joint: **NO**  
 Remarks:

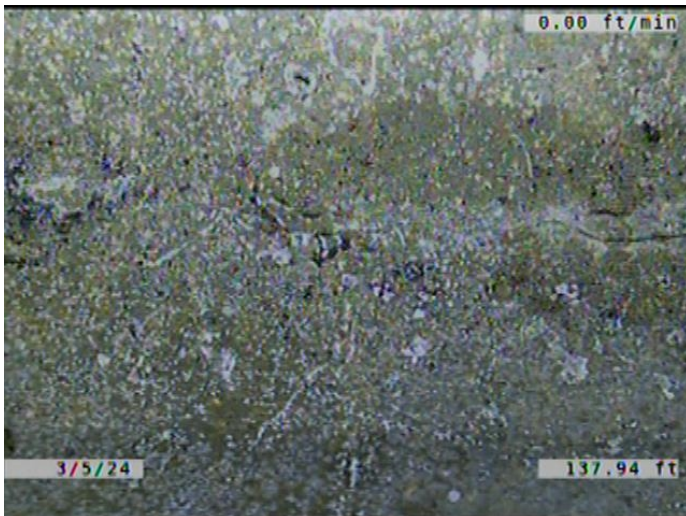
Code: **CC**  
 Description: **Crack Circumferential**

Distance (ft): **137.9**  
 Structural Grade: **1**  
 O&M Grade: **0**  
 Clock Start/From: **12**  
 Clock To: **12**  
 1st Value:  
 2nd Value:  
 Value Percent:  
 Continuous Index:  
 Within 8" of Joint: **YES**  
 Remarks:

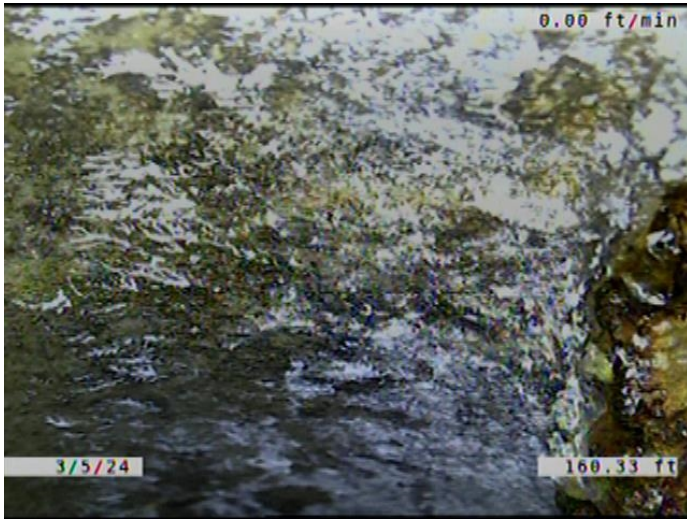
Code: **FM**  
Description: **Fracture Multiple**

Distance (ft): **160.3**  
Structural Grade: **4**  
O&M Grade: **0**  
Clock Start/From: **4**  
Clock To: **12**  
1st Value:  
2nd Value:  
Value Percent:  
Continuous Index:  
Within 8" of Joint: **YES**  
Remarks:

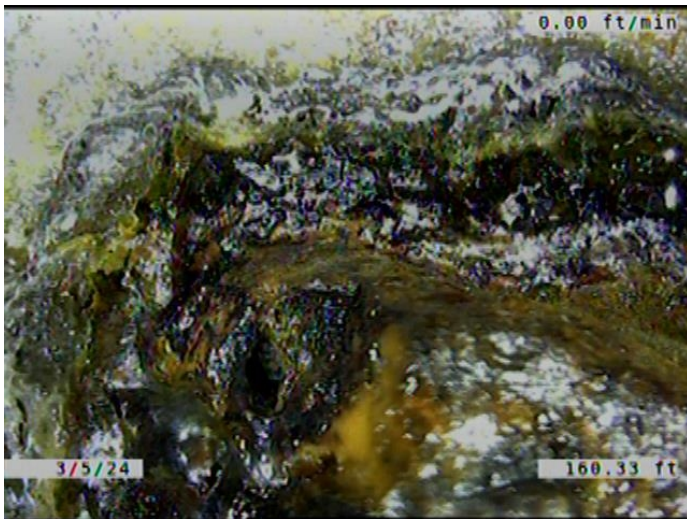
Code: **DAE**  
Description: **Deposits Attached Encrustation**

Distance (ft): **160.3**  
Structural Grade: **0**  
O&M Grade: **2**  
Clock Start/From: **12**  
Clock To: **5**  
1st Value:  
2nd Value:  
Value Percent: **5.000**  
Continuous Index:  
Within 8" of Joint: **YES**  
Remarks:

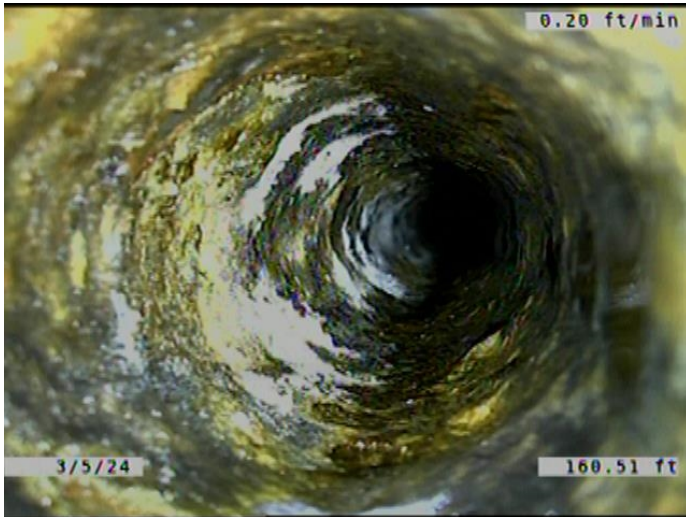
Code: **TBI**  
 Description: **Tap Break-in Intruding**

Distance (ft): **160.5**  
 Structural Grade: **0**  
 O&M Grade: **2**  
 Clock Start/From: **3**  
 Clock To:  
 1st Value: **4.000**  
 2nd Value: **1.000**  
 Value Percent:  
 Continuous Index:  
 Within 8" of Joint: **YES**  
 Remarks: **CAST IRON SERVICE.**

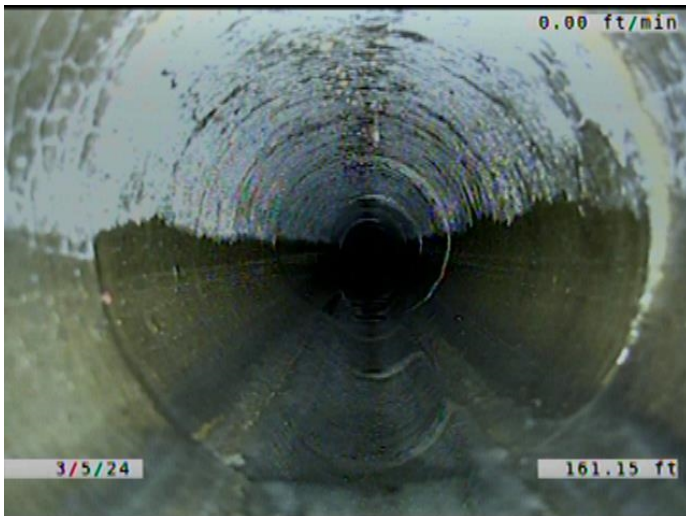
Code: **JOMD**  
 Description: **Joint Offset Medium Defective**

Distance (ft): **161.2**  
 Structural Grade: **3**  
 O&M Grade: **0**  
 Clock Start/From:  
 Clock To:  
 1st Value:  
 2nd Value:  
 Value Percent:  
 Continuous Index: **F02**  
 Within 8" of Joint: **NO**  
 Remarks:

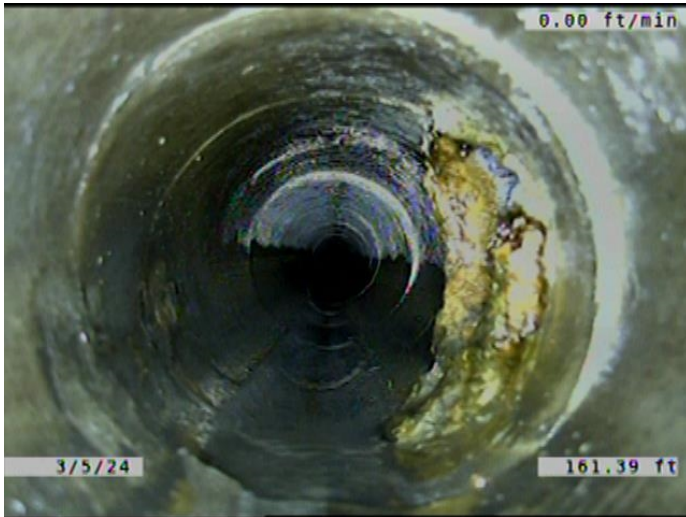
Code:	<b>MSA</b>
Description:	<b>Miscellaneous Survey Abandoned</b>
Distance (ft):	<b>161.4</b>
Structural Grade:	<b>0</b>
O&M Grade:	<b>0</b>
Clock Start/From:	
Clock To:	
1st Value:	
2nd Value:	
Value Percent:	
Continuous Index:	
Within 8" of Joint:	<b>NO</b>
Remarks:	<b>CAMERA CANT MAKE IT PAST PROTRUDING TAP.</b>
