Profile/Photo Observation Report

Date:	03/05/2024	Weather:		Coding:	PACP 7.0
Pipe Length (ft):	215.0	Owner:	City of Hobart	Pre Clean:	Heavy Cleaning
P.O.#:		Surveyor:	S. Bucklin	PSR:	P-805-066.1-066.2
Customer:	City of Hobart	Clean Date:	10/17/2022	Shape:	C

Street:	SR-130	Flow Control:	Not Controlled
City:	Hobart, IN	Year Renewed:	
Location:	Parking Lot	Tape/Media #:	
Purpose:	Sewer System Evaluation Survey (SS	Dia/Height:	6"
Use:	Sanitary Sewage Pipe	Material:	VCP
Drain Area:		Lining:	None
Category:	NA		
Comment:			
Location Details:		Direction of Survey:	Downstream
US MH:	M-805-066.1	DS MH:	M-805-066.2
		Total Length Surveyed (ft):	211.4

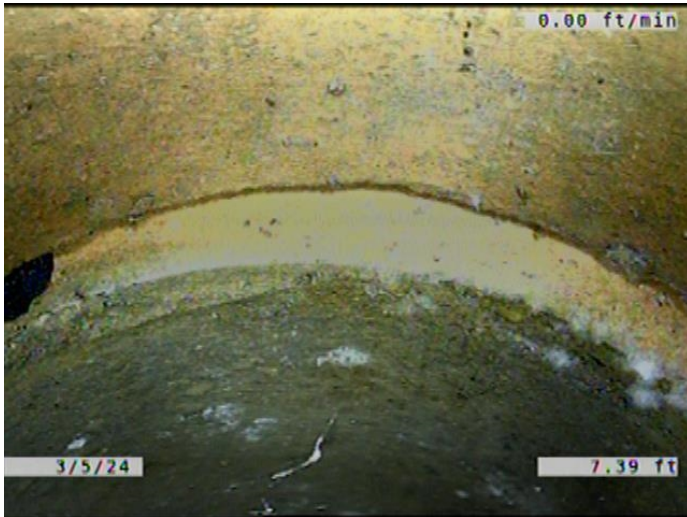
Code: **JOMD**
Description: **Joint Offset Medium Defective**

Distance (ft): **7.4**
Structural Grade: **3**
O&M Grade: **0**
Clock Start/From:
Clock To:
1st Value:
2nd Value:
Value Percent:
Continuous Index: **S01**
Within 8" of Joint: **NO**
Remarks:

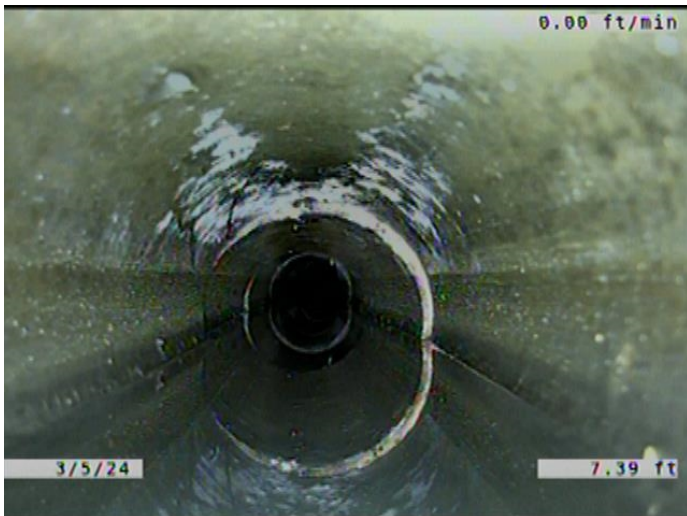
Code: **MWLS**
Description: **Miscellaneous Water Level Sag**

Distance (ft): **7.4**
Structural Grade: **2**
O&M Grade: **0**
Clock Start/From:
Clock To:
1st Value:
2nd Value:
Value Percent: **25.000**
Continuous Index: **S02**
Within 8" of Joint: **NO**
Remarks:

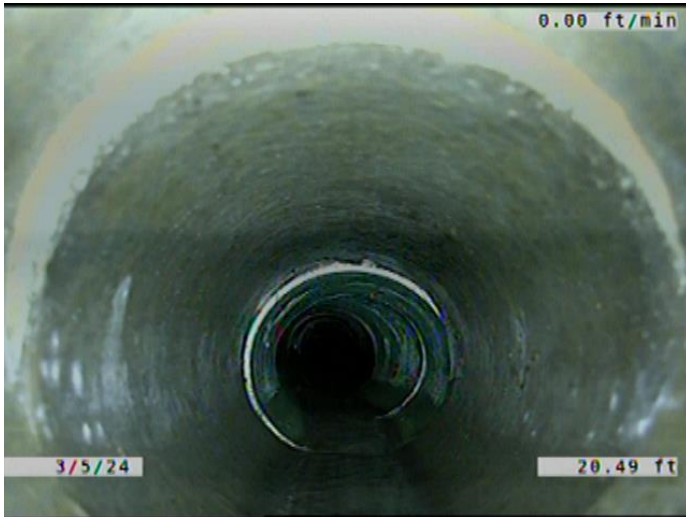
Code: **MWLS**
Description: **Miscellaneous Water Level Sag**

Distance (ft): **20.5**
Structural Grade: **2**
O&M Grade: **0**
Clock Start/From:
Clock To:
1st Value:
2nd Value:
Value Percent: **25.000**
Continuous Index: **F02**
Within 8" of Joint: **NO**
Remarks:

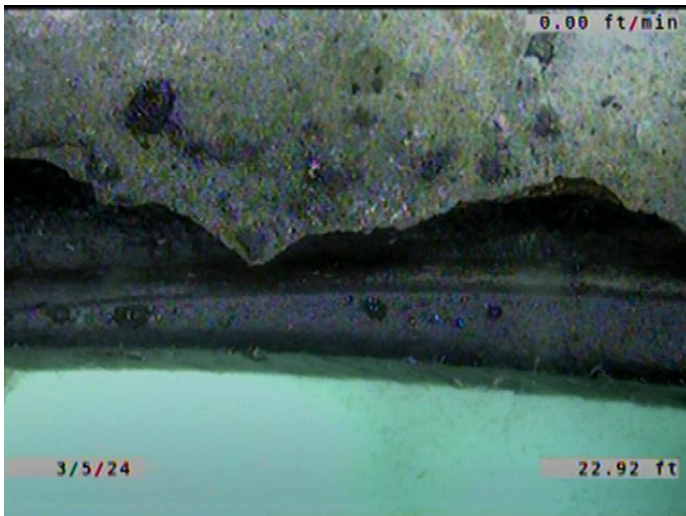
Code: **RPR**
Description: **Point Repair Replacement**

Distance (ft): **22.9**
Structural Grade: **0**
O&M Grade: **0**
Clock Start/From:
Clock To:
1st Value:
2nd Value:
Value Percent:
Continuous Index:
Within 8" of Joint: **YES**
Remarks: **REPLACED WITH PVC.**

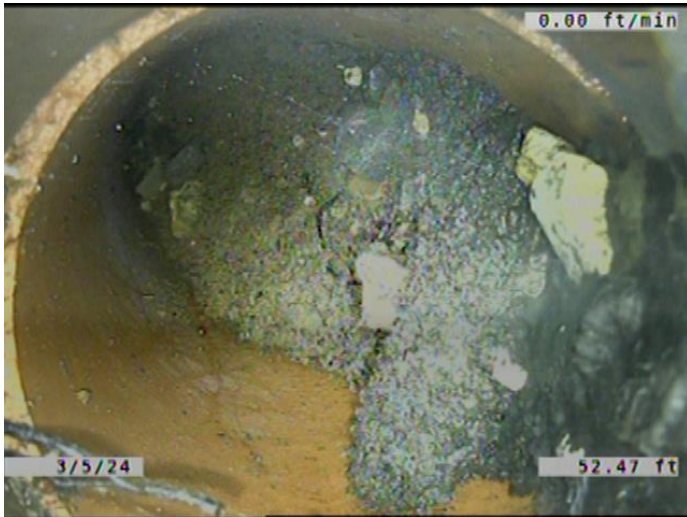
Code:	TFD
Description:	Tap Factory Defective
Distance (ft):	52.5
Structural Grade:	0
O&M Grade:	3
Clock Start/From:	3
Clock To:	
1st Value:	6.000
2nd Value:	
Value Percent:	
Continuous Index:	
Within 8" of Joint:	YES
Remarks:	LOOKS TO BE 100% PLUGGED WITH DIRT AND ROCKS. ROOTS GROWING

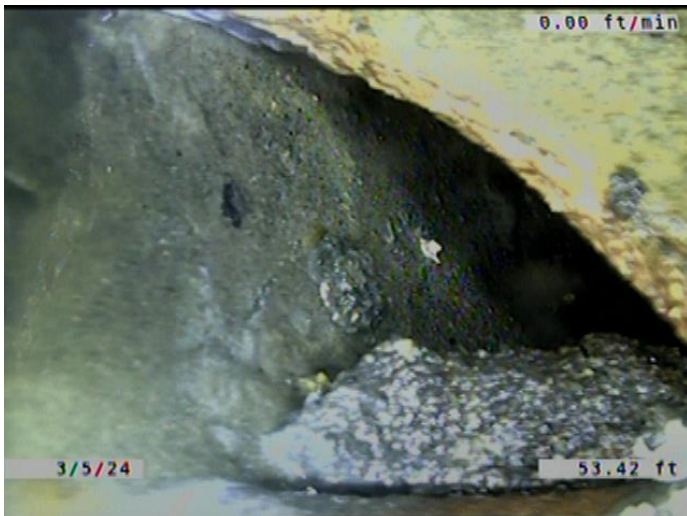
Code:	HSV
Description:	Hole Soil Visible
Distance (ft):	53.4
Structural Grade:	5
O&M Grade:	0
Clock Start/From:	3
Clock To:	6
1st Value:	
2nd Value:	
Value Percent:	
Continuous Index:	
Within 8" of Joint:	YES
Remarks:	VOID AND SOIL VISIBLE. WATER EXITING THE PIPE.

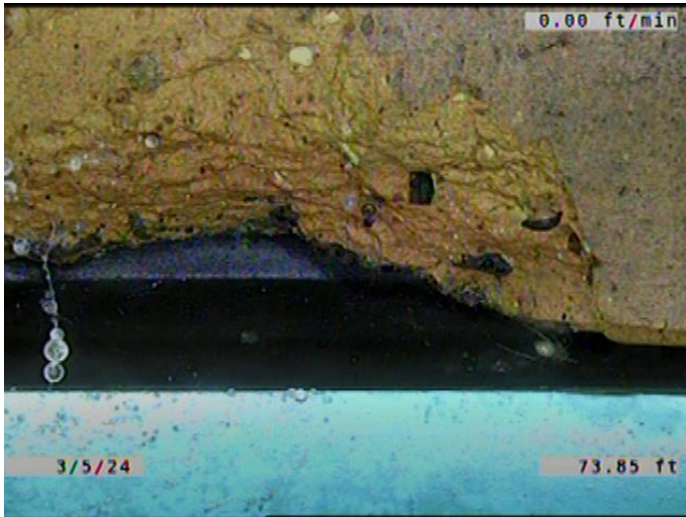
Code: **RPR**
Description: **Point Repair Replacement**

Distance (ft): **73.9**
Structural Grade: **0**
O&M Grade: **0**
Clock Start/From:
Clock To:
1st Value:
2nd Value:
Value Percent:
Continuous Index: **S03**
Within 8" of Joint: **YES**
Remarks: **REPLACED WITH PVC.**

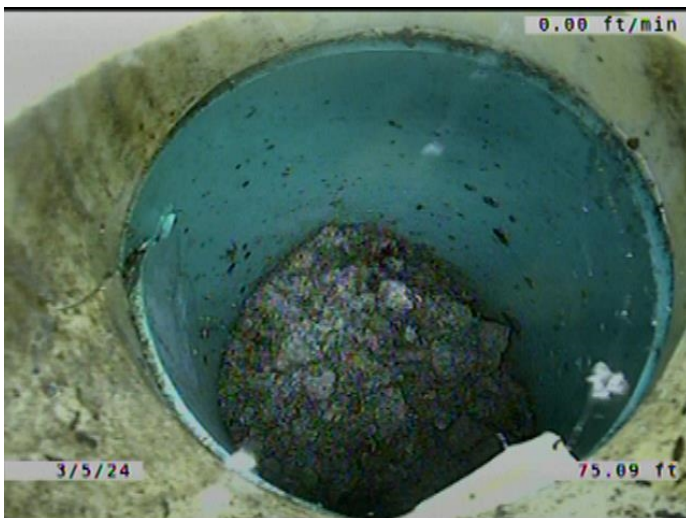
Code: **TFD**
Description: **Tap Factory Defective**

Distance (ft): **75.1**
Structural Grade: **0**
O&M Grade: **3**
Clock Start/From: **12**
Clock To:
1st Value: **6.000**
2nd Value:
Value Percent:
Continuous Index:
Within 8" of Joint: **YES**
Remarks: **TAP BROKEN. SERVICE BROKEN.
SERVICE LOOKS TO BE 100% PLUGGED**

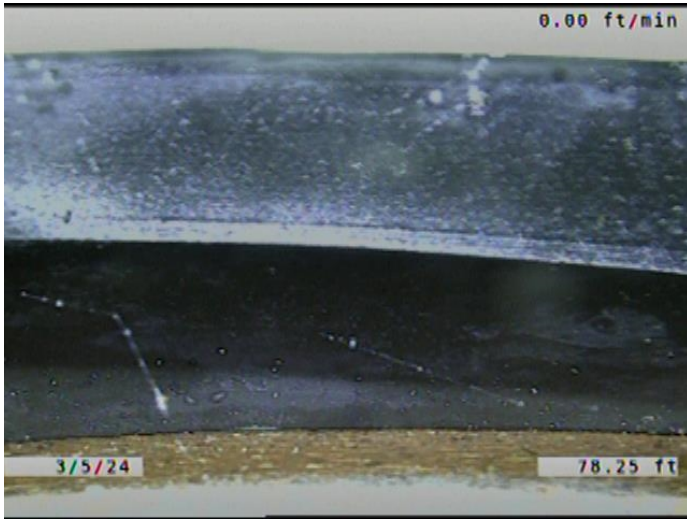
Code: **RPR**
Description: **Point Repair Replacement**

Distance (ft): **78.2**
Structural Grade: **0**
O&M Grade: **0**
Clock Start/From:
Clock To:
1st Value:
2nd Value:
Value Percent:
Continuous Index: **F03**
Within 8" of Joint: **YES**
Remarks: **REPLACED WITH PVC.**

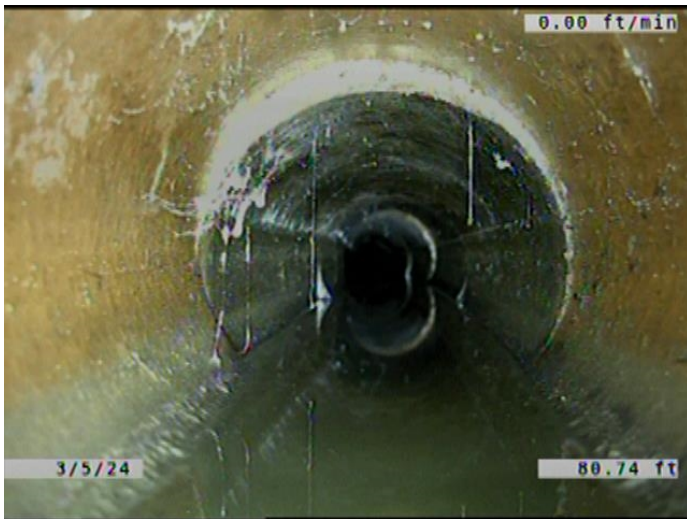
Code: **MWLS**
Description: **Miscellaneous Water Level Sag**

Distance (ft): **80.7**
Structural Grade: **2**
O&M Grade: **0**
Clock Start/From:
Clock To:
1st Value:
2nd Value:
Value Percent: **15.000**
Continuous Index: **S04**
Within 8" of Joint: **NO**
Remarks:

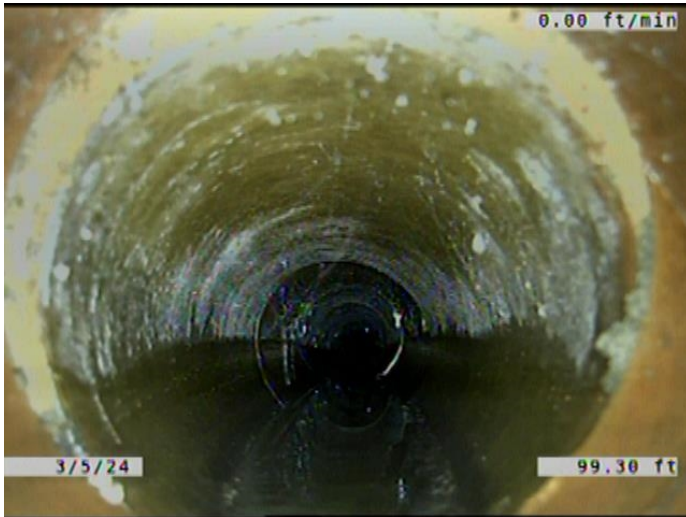
Code: **MWLS**
Description: **Miscellaneous Water Level Sag**

Distance (ft): **99.3**
Structural Grade: **2**
O&M Grade: **0**
Clock Start/From:
Clock To:
1st Value:
2nd Value:
Value Percent: **15.000**
Continuous Index: **F04**
Within 8" of Joint: **NO**
Remarks:

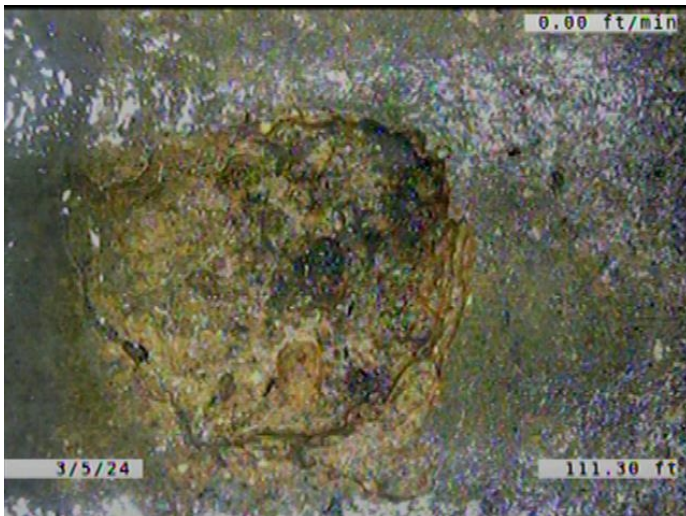
Code: **SSC**
Description: **Surface Spalling of Damage Coating**

Distance (ft): **111.3**
Structural Grade: **1**
O&M Grade: **0**
Clock Start/From: **4**
Clock To: **5**
1st Value:
2nd Value:
Value Percent:
Continuous Index:
Within 8" of Joint: **NO**
Remarks:

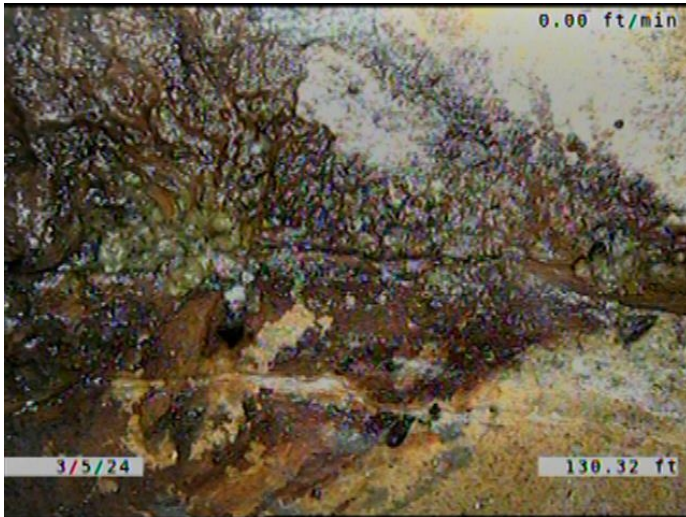
Code:	DAE
Description:	Deposits Attached Encrustation
Distance (ft):	130.3
Structural Grade:	0
O&M Grade:	2
Clock Start/From:	7
Clock To:	10
1st Value:	
2nd Value:	
Value Percent:	5.000
Continuous Index:	
Within 8" of Joint:	YES
Remarks:

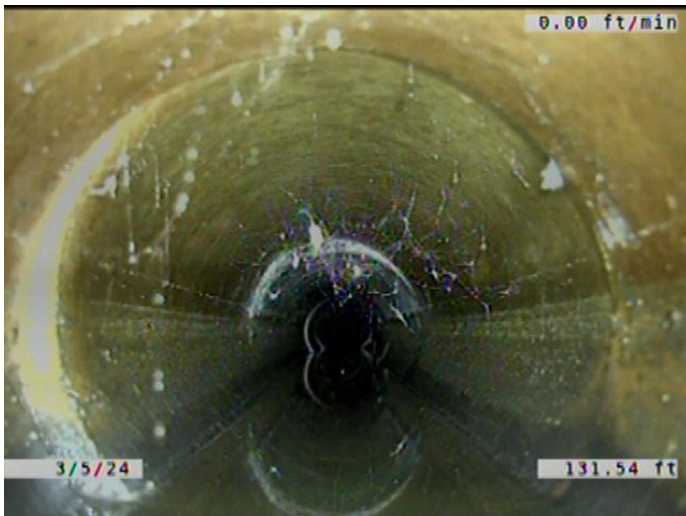
Code:	MWLS
Description:	Miscellaneous Water Level Sag
Distance (ft):	131.5
Structural Grade:	2
O&M Grade:	0
Clock Start/From:	
Clock To:	
1st Value:	
2nd Value:	
Value Percent:	10.000
Continuous Index:	S05
Within 8" of Joint:	NO
Remarks:

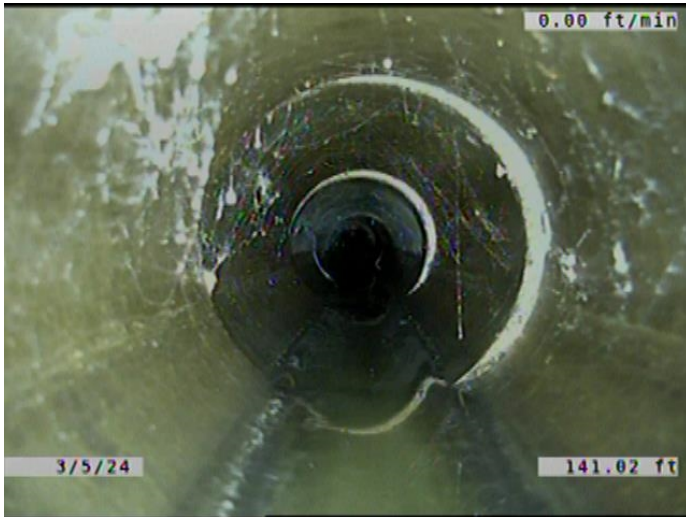
Code: **MWLS**
Description: **Miscellaneous Water Level Sag**

Distance (ft): **141.0**
Structural Grade: **2**
O&M Grade: **0**
Clock Start/From:
Clock To:
1st Value:
2nd Value:
Value Percent: **10.000**
Continuous Index: **F05**
Within 8" of Joint: **NO**
Remarks:

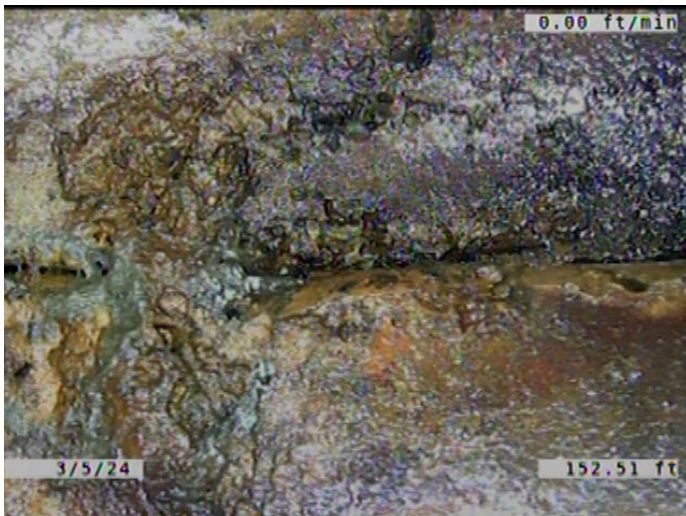
Code: **DAE**
Description: **Deposits Attached Encrustation**

Distance (ft): **152.5**
Structural Grade: **0**
O&M Grade: **2**
Clock Start/From: **7**
Clock To: **9**
1st Value:
2nd Value:
Value Percent: **5.000**
Continuous Index: **S06**
Within 8" of Joint: **YES**
Remarks:

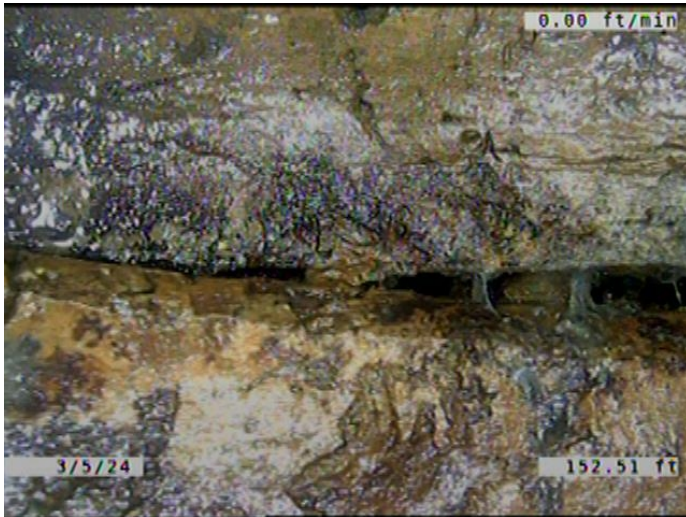
Code: **DAE**
Description: **Deposits Attached Encrustation**

Distance (ft): **152.5**
Structural Grade: **0**
O&M Grade: **2**
Clock Start/From: **3**
Clock To: **5**
1st Value:
2nd Value:
Value Percent: **5.000**
Continuous Index: **S07**
Within 8" of Joint: **YES**
Remarks:

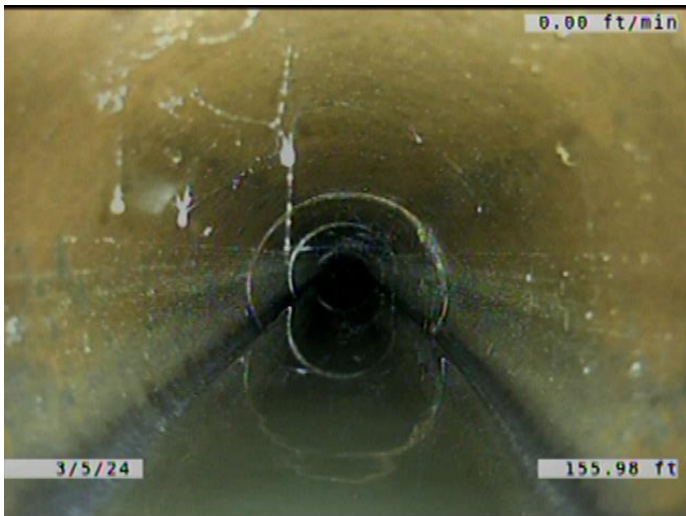
Code: **MWLS**
Description: **Miscellaneous Water Level Sag**

Distance (ft): **156.0**
Structural Grade: **2**
O&M Grade: **0**
Clock Start/From:
Clock To:
1st Value:
2nd Value:
Value Percent: **30.000**
Continuous Index: **S08**
Within 8" of Joint: **NO**
Remarks:

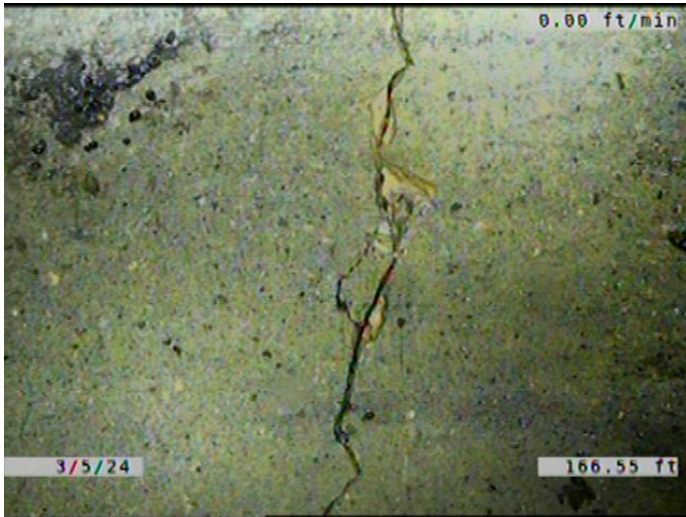
Code: **FL**
Description: **Fracture Longitudinal**

Distance (ft): **166.5**
Structural Grade: **3**
O&M Grade: **0**
Clock Start/From: **1**
Clock To:
1st Value:
2nd Value:
Value Percent:
Continuous Index:
Within 8" of Joint: **YES**
Remarks:

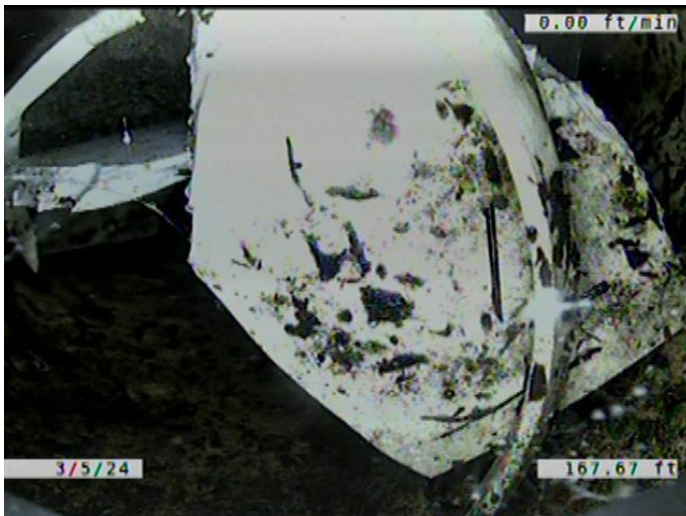
Code: **TBD**
Description: **Tap Break-in/Hammer Defective**

Distance (ft): **167.7**
Structural Grade: **0**
O&M Grade: **3**
Clock Start/From: **12**
Clock To:
1st Value: **6.000**
2nd Value:
Value Percent:
Continuous Index:
Within 8" of Joint: **YES**
Remarks: **SERVICE CRUSHED AND COLLAPSED. PVC SERVICE.**

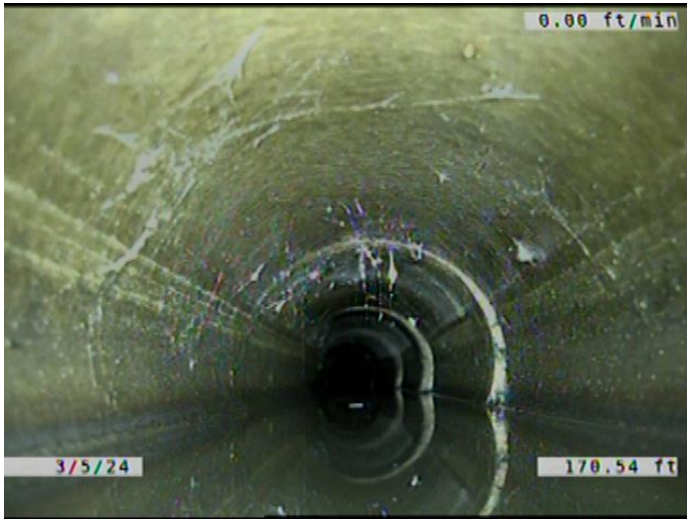
Code: **DAE**
Description: **Deposits Attached Encrustation**

Distance (ft): **170.5**
Structural Grade: **0**
O&M Grade: **2**
Clock Start/From: **7**
Clock To: **9**
1st Value:
2nd Value:
Value Percent: **5.000**
Continuous Index: **F06**
Within 8" of Joint: **YES**
Remarks:

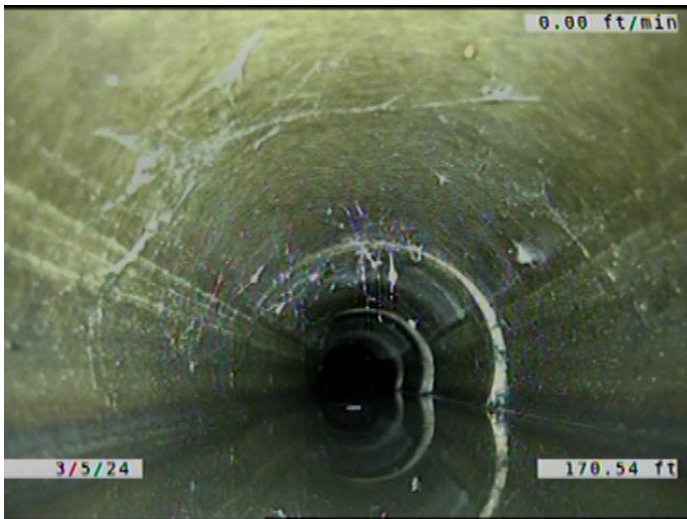
Code: **DAE**
Description: **Deposits Attached Encrustation**

Distance (ft): **170.5**
Structural Grade: **0**
O&M Grade: **2**
Clock Start/From: **3**
Clock To: **5**
1st Value:
2nd Value:
Value Percent: **5.000**
Continuous Index: **F07**
Within 8" of Joint: **YES**
Remarks:

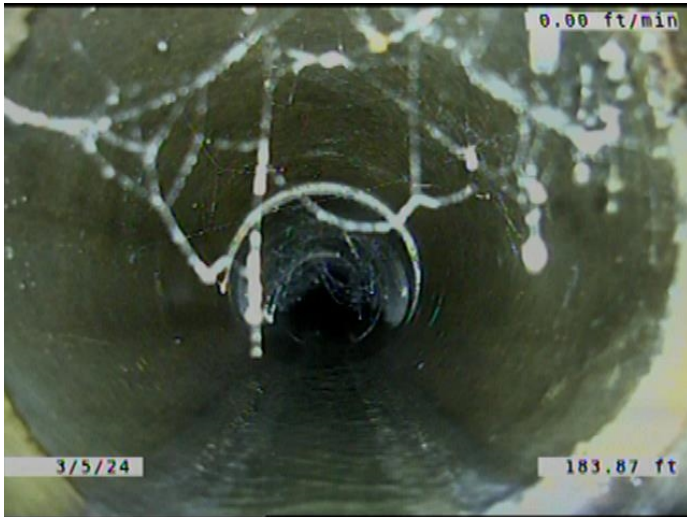
Code: **MWLS**
Description: **Miscellaneous Water Level Sag**

Distance (ft): **183.9**
Structural Grade: **2**
O&M Grade: **0**
Clock Start/From:
Clock To:
1st Value:
2nd Value:
Value Percent: **30.000**
Continuous Index: **F08**
Within 8" of Joint: **NO**
Remarks:

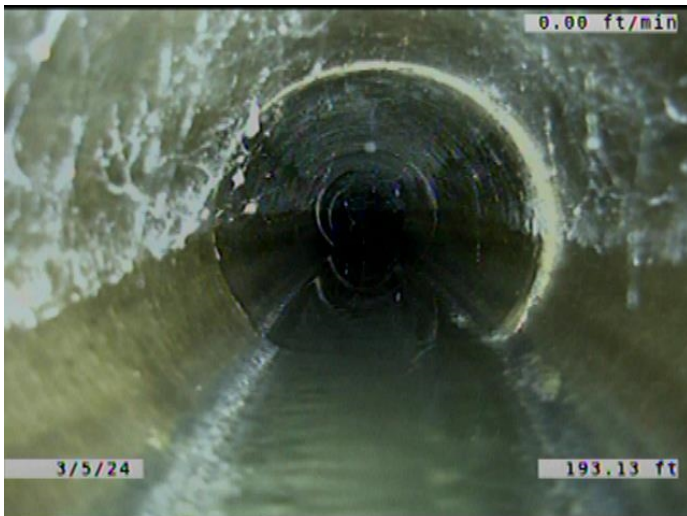
Code: **MWLS**
Description: **Miscellaneous Water Level Sag**

Distance (ft): **193.1**
Structural Grade: **2**
O&M Grade: **0**
Clock Start/From:
Clock To:
1st Value:
2nd Value:
Value Percent: **10.000**
Continuous Index: **S09**
Within 8" of Joint: **NO**
Remarks:

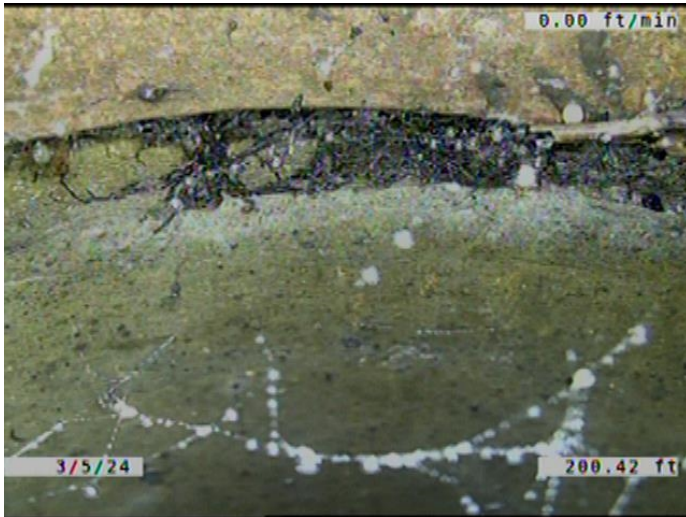
Code: **RFJ**
Description: **Roots Fine Joint**

Distance (ft): **200.4**
Structural Grade: **0**
O&M Grade: **1**
Clock Start/From: **9**
Clock To: **3**
1st Value:
2nd Value:
Value Percent:
Continuous Index:
Within 8" of Joint: **YES**
Remarks:

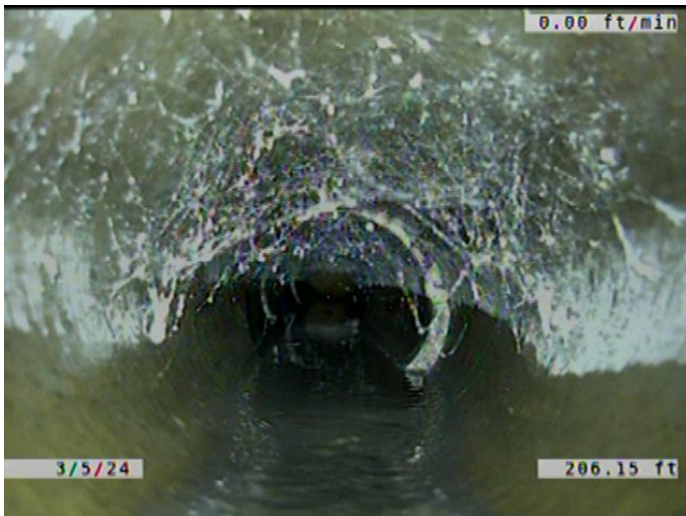
Code: **MWLS**
Description: **Miscellaneous Water Level Sag**

Distance (ft): **206.2**
Structural Grade: **2**
O&M Grade: **0**
Clock Start/From:
Clock To:
1st Value:
2nd Value:
Value Percent: **10.000**
Continuous Index: **F09**
Within 8" of Joint: **NO**
Remarks:

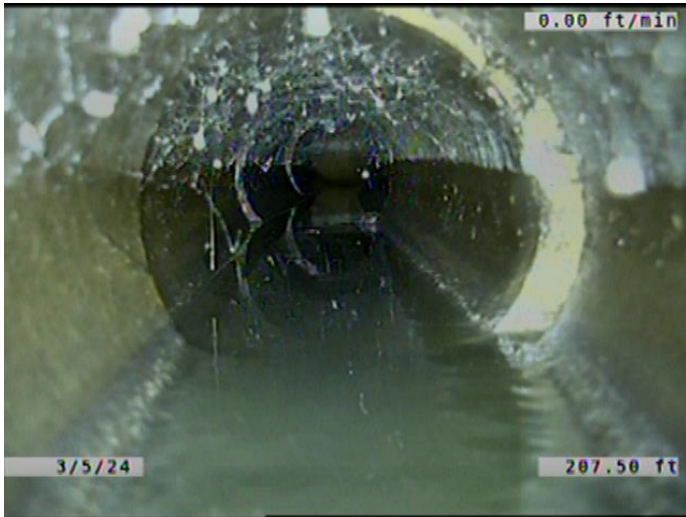
Code: **MWLS**
Description: **Miscellaneous Water Level Sag**

Distance (ft): **207.5**
Structural Grade: **2**
O&M Grade: **0**
Clock Start/From:
Clock To:
1st Value:
2nd Value:
Value Percent: **10.000**
Continuous Index: **S10**
Within 8" of Joint: **NO**
Remarks:

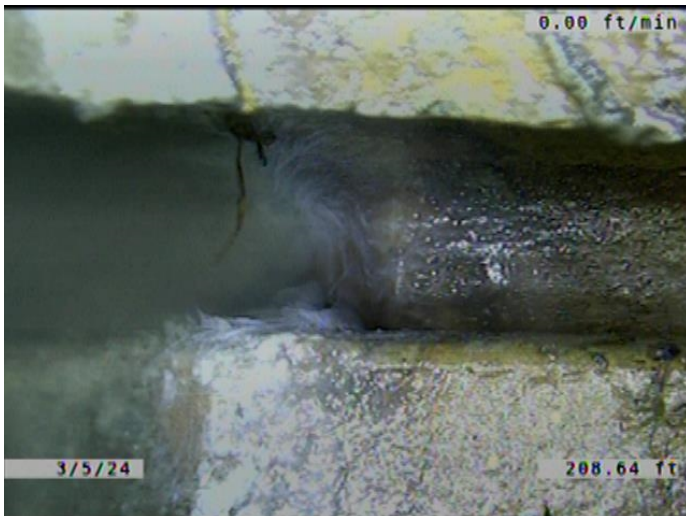
Code: **JAM**
Description: **Joint Angular Medium**

Distance (ft): **208.6**
Structural Grade: **3**
O&M Grade: **0**
Clock Start/From:
Clock To:
1st Value:
2nd Value:
Value Percent:
Continuous Index:
Within 8" of Joint: **NO**
Remarks:

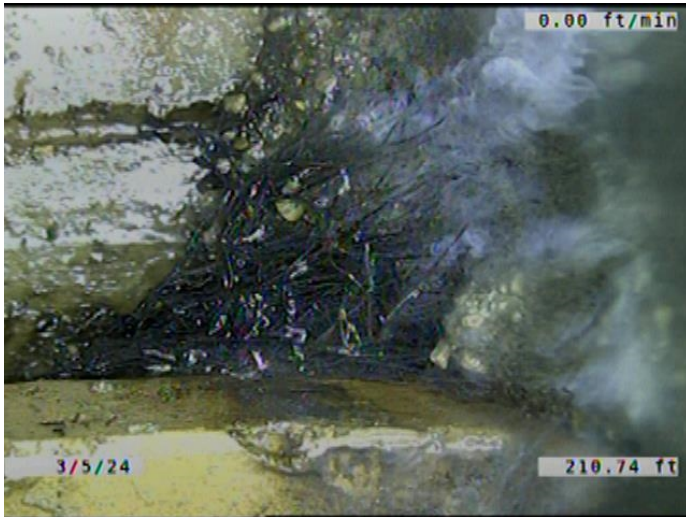
Code: **RFJ**
Description: **Roots Fine Joint**

Distance (ft): **210.7**
Structural Grade: **0**
O&M Grade: **1**
Clock Start/From: **7**
Clock To: **5**
1st Value:
2nd Value:
Value Percent:
Continuous Index:
Within 8" of Joint: **YES**
Remarks:

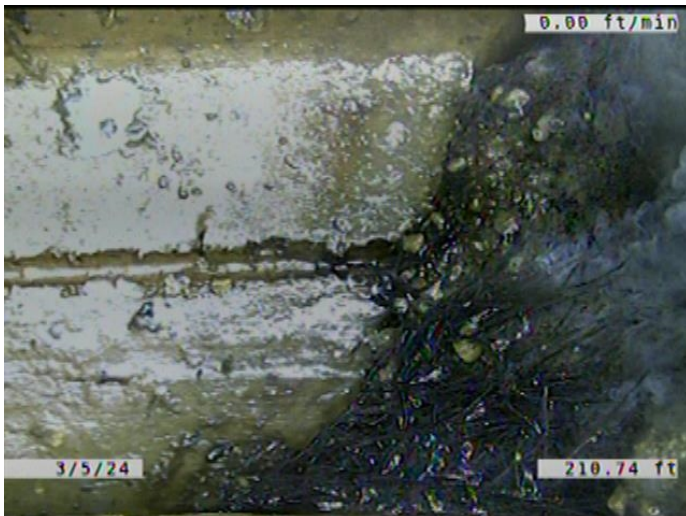
Code: **JAL**
Description: **Joint Angular Large**

Distance (ft): **210.7**
Structural Grade: **4**
O&M Grade: **0**
Clock Start/From:
Clock To:
1st Value:
2nd Value:
Value Percent:
Continuous Index:
Within 8" of Joint: **NO**
Remarks:

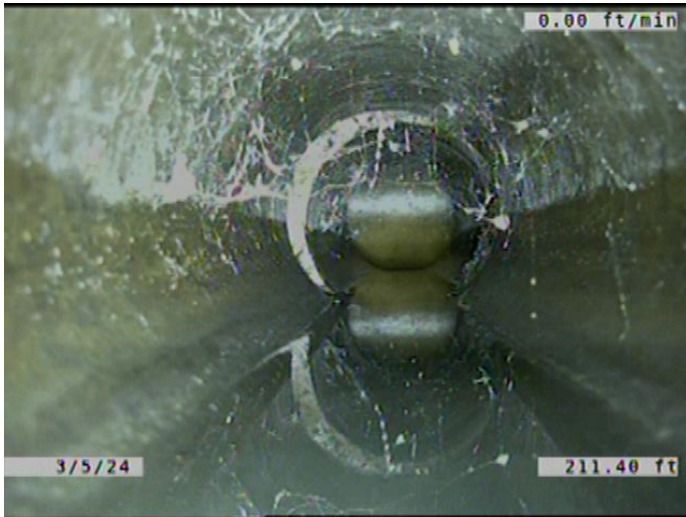
Code: **MWLS**
Description: **Miscellaneous Water Level Sag**

Distance (ft): **211.4**
Structural Grade: **2**
O&M Grade: **0**
Clock Start/From:
Clock To:
1st Value:
2nd Value:
Value Percent: **10.000**
Continuous Index: **F10**
Within 8" of Joint: **NO**
Remarks:

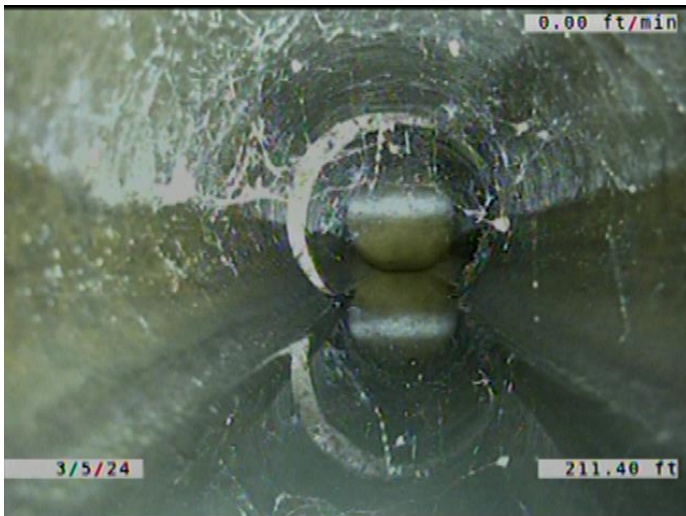
Code: **JOMD**
Description: **Joint Offset Medium Defective**

Distance (ft): **211.4**
Structural Grade: **3**
O&M Grade: **0**
Clock Start/From:
Clock To:
1st Value:
2nd Value:
Value Percent:
Continuous Index: **F01**
Within 8" of Joint: **NO**
Remarks:

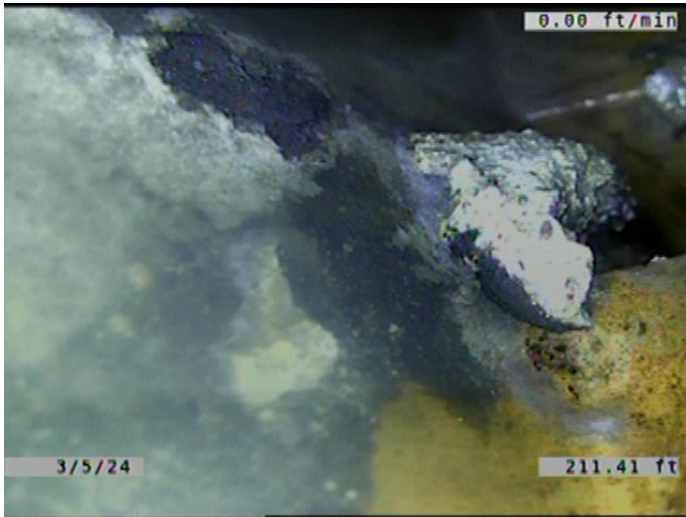
Code: **ISGT**
 Description: **Intruding Sealing Material Grout**

Distance (ft): **211.4**
 Structural Grade: **0**
 O&M Grade: **2**
 Clock Start/From: **5**
 Clock To: **7**
 1st Value:
 2nd Value:
 Value Percent: **5.000**
 Continuous Index:
 Within 8" of Joint: **NO**
 Remarks:

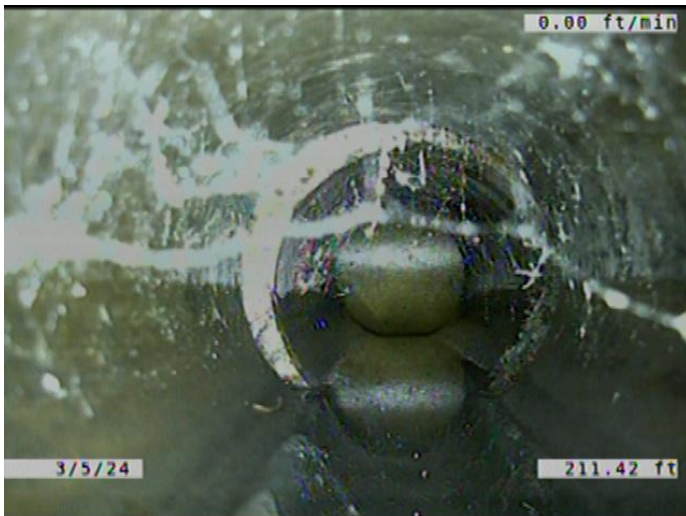
Code: **MSA**
 Description: **Miscellaneous Survey Abandoned**

Distance (ft): **211.4**
 Structural Grade: **0**
 O&M Grade: **0**
 Clock Start/From:
 Clock To:
 1st Value:
 2nd Value:
 Value Percent:
 Continuous Index:
 Within 8" of Joint: **NO**
 Remarks: **CAMERA CANT MAKE IT PAST
 GROUT, OFFSET AND ANGULAR JOIN**
