Profile/Photo Observation Report

Street:	e 34th ct	Flow Control:	Not Controlled
City:	Hobart, IN	Year Renewed:	
Location:	Other	Tape/Media #:	
Purpose:	Not Known	Dia/Height:	10"
Use:	Sanitary	Material:	VCP
Drain Area:	NA	Lining:	
Category:	NA		
Comment:

Location Details:		Direction of Survey:	Downstream
US MH:	M-902-017	DS MH:	M-902-015
		Total Length Surveyed (ft):	41.0

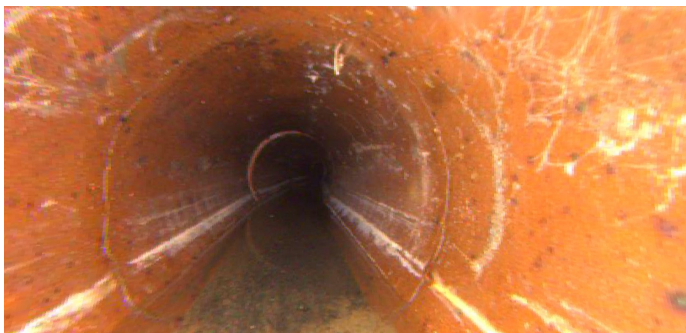
Code: **AMH**
Description: **Manhole**

Distance (ft): **.0**
Structural Grade: **0**
O&M Grade: **0**
Clock Start/From:
Clock To:
1st Value:
2nd Value:
Value Percent:
Continuous Index:
Within 8" of Joint: **NO**
Remarks: **M-902-017**

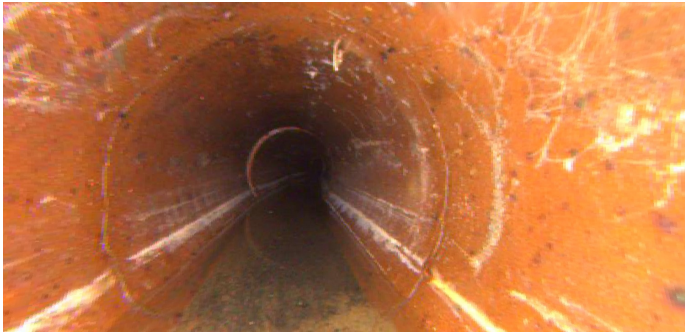
Code:	MWL
Description:	Water Level

Distance (ft):	.0
Structural Grade:	0
O&M Grade:	0
Clock Start/From:	
Clock To:	
1st Value:	
2nd Value:	
Value Percent:	5.000
Continuous Index:	
Within 8" of Joint:	NO
Remarks:

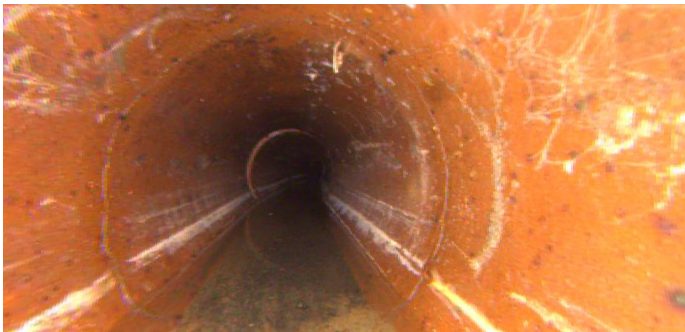
Code:	CC
Description:	Crack Circumferential

Distance (ft):	.0
Structural Grade:	1
O&M Grade:	0
Clock Start/From:	7
Clock To:	5
1st Value:	
2nd Value:	
Value Percent:	
Continuous Index:	
Within 8" of Joint:	
Remarks:

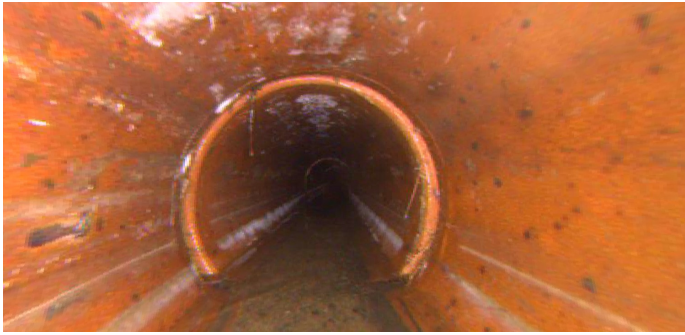
Code: **RFJ**
Description: **Roots Fine Joint**

Distance (ft): **5.7**
Structural Grade: **0**
O&M Grade: **1**
Clock Start/From: **7**
Clock To: **5**
1st Value:
2nd Value:
Value Percent:
Continuous Index: **S01**
Within 8" of Joint: **YES**
Remarks: **wandering**

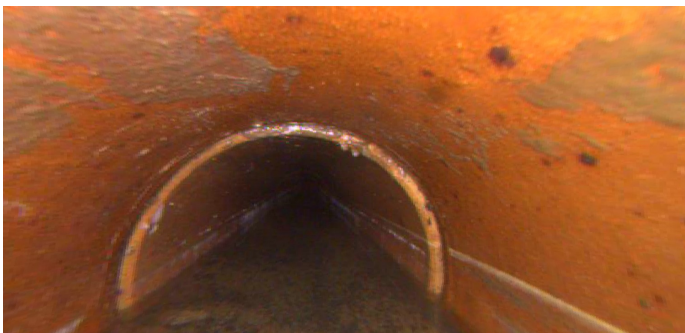
Code: **MWL**
Description: **Water Level**

Distance (ft): **33.9**
Structural Grade: **0**
O&M Grade: **0**
Clock Start/From:
Clock To:
1st Value:
2nd Value:
Value Percent: **25.000**
Continuous Index:
Within 8" of Joint: **NO**
Remarks:

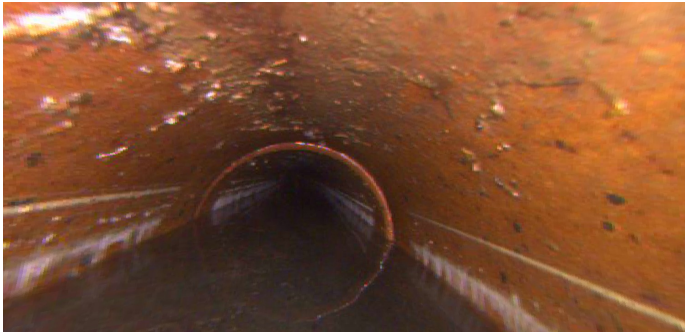
Code: **RFJ**
Description: **Roots Fine Joint**

Distance (ft): **39.7**
Structural Grade: **0**
O&M Grade: **1**
Clock Start/From: **7**
Clock To: **5**
1st Value:
2nd Value:
Value Percent:
Continuous Index: **F01**
Within 8" of Joint: **YES**
Remarks: **wandering**

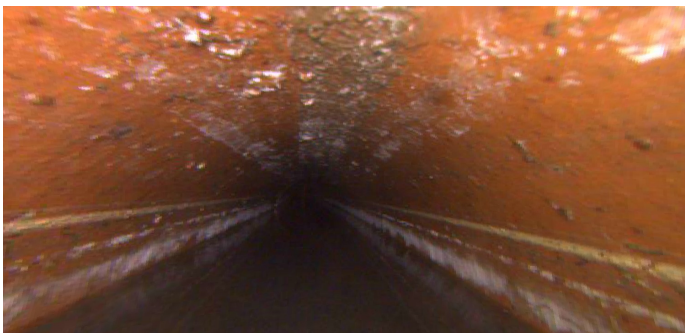
Code: **MSA**
Description: **Abandoned Survey**

Distance (ft): **41.0**
Structural Grade: **0**
O&M Grade: **0**
Clock Start/From:
Clock To:
1st Value:
2nd Value:
Value Percent:
Continuous Index:
Within 8" of Joint: **NO**
Remarks: **stuck on joint/ debris**
