## Profile/Photo Observation Report

Street:	<b>e 34th ct</b>	Flow Control:	<b>Not Controlled</b>
City:	<b>Hobart, IN</b>	Year Renewed:	
Location:	<b>Other</b>	Tape/Media #:	
Purpose:	<b>Not Known</b>	Dia/Height:	<b>10"</b>
Use:	<b>Sanitary</b>	Material:	<b>VCP</b>
Drain Area:	<b>NA</b>	Lining:	
Category:	<b>NA</b>		
Comment:

Location Details:		Direction of Survey:	<b>Upstream</b>
US MH:	<b>M-902-017</b>	DS MH:	<b>M-902-015</b>
		Total Length Surveyed (ft):	<b>26.0</b>

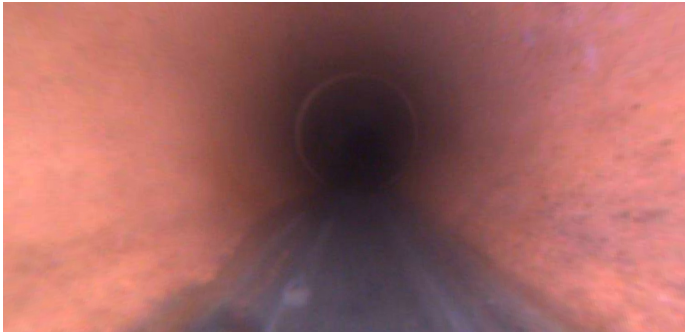
Code:	<b>MWL</b>
Description:	<b>Water Level</b>

Distance (ft):	<b>.0</b>
Structural Grade:	<b>0</b>
O&M Grade:	<b>0</b>
Clock Start/From:	
Clock To:	
1st Value:	
2nd Value:	
Value Percent:	<b>5.000</b>
Continuous Index:	
Within 8" of Joint:	<b>NO</b>
Remarks:

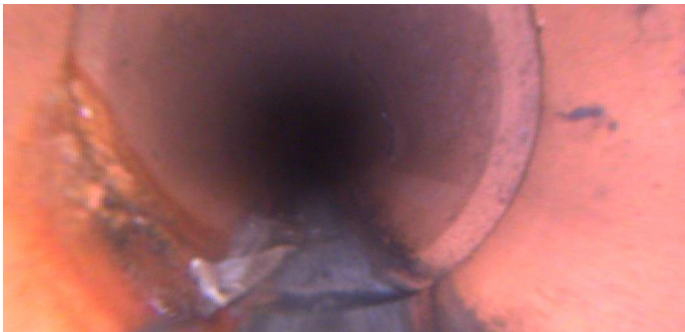
Code:	<b>DAE</b>
Description:	<b>Deposits Attached Encrustation</b>

Distance (ft):	<b>7.4</b>
Structural Grade:	<b>0</b>
O&M Grade:	<b>2</b>
Clock Start/From:	<b>7</b>
Clock To:	<b>9</b>
1st Value:	
2nd Value:	
Value Percent:	<b>5.000</b>
Continuous Index:	
Within 8" of Joint:	<b>YES</b>
Remarks:

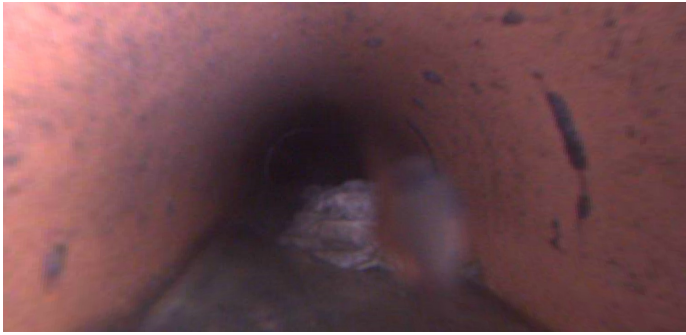
Code: **DSZ**  
Description: **Deposits Settled Other**

Distance (ft): **24.6**  
Structural Grade: **0**  
O&M Grade: **3**  
Clock Start/From: **6**  
Clock To:  
1st Value:  
2nd Value:  
Value Percent: **15.000**  
Continuous Index:  
Within 8" of Joint: **NO**  
Remarks: **wad of tissue**

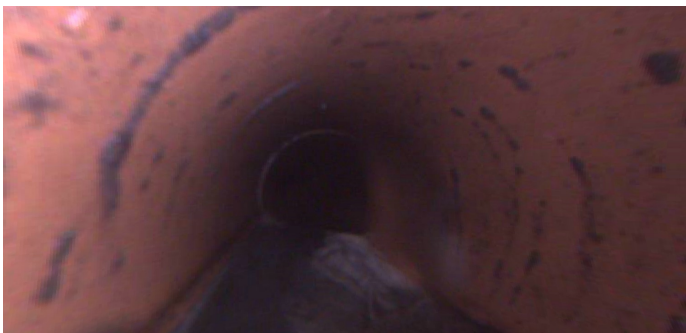
Code: **MSA**  
Description: **Abandoned Survey**

Distance (ft): **26.0**  
Structural Grade: **0**  
O&M Grade: **0**  
Clock Start/From:  
Clock To:  
1st Value:  
2nd Value:  
Value Percent:  
Continuous Index:  
Within 8" of Joint: **NO**  
Remarks: **stuck in tissue**
