Profile/Photo Observation Report

Street:	shelby pl	Flow Control:	Not Controlled
City:	Hobart, IN	Year Renewed:	
Location:	Other	Tape/Media #:	
Purpose:	Not Known	Dia/Height:	10"
Use:	Sanitary	Material:	VCP
Drain Area:	NA	Lining:	
Category:	NA		
Comment:

Location Details:		Direction of Survey:	Downstream
US MH:	M-902-017	DS MH:	M-902-019B
		Total Length Surveyed (ft):	2.7

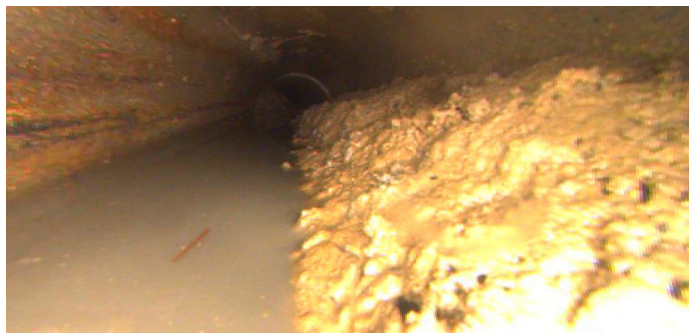
Code: **AMH**
Description: **Manhole**

Distance (ft): **.0**
Structural Grade: **0**
O&M Grade: **0**
Clock Start/From:
Clock To:
1st Value:
2nd Value:
Value Percent:
Continuous Index:
Within 8" of Joint: **NO**
Remarks: **M-902-017**

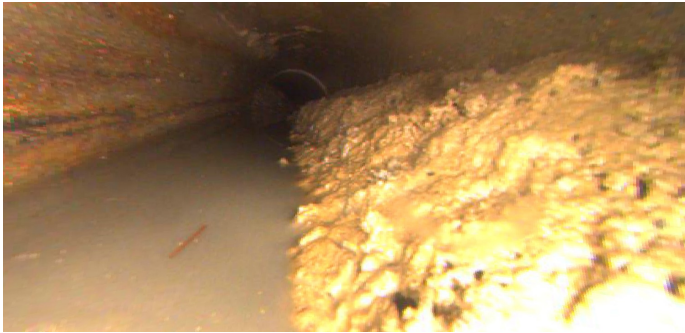
Code:	MWL
Description:	Water Level

Distance (ft):	.0
Structural Grade:	0
O&M Grade:	0
Clock Start/From:	
Clock To:	
1st Value:	
2nd Value:	
Value Percent:	5.000
Continuous Index:	
Within 8" of Joint:	NO
Remarks:

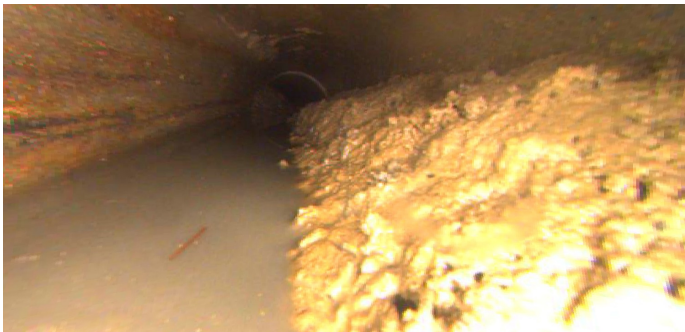
Code:	DAZ
Description:	Deposits Attached Other

Distance (ft):	.0
Structural Grade:	0
O&M Grade:	4
Clock Start/From:	2
Clock To:	6
1st Value:	
2nd Value:	
Value Percent:	25.000
Continuous Index:	
Within 8" of Joint:	NO
Remarks:	mud???
