Profile/Photo Observation Report

Date:	03/21/2018	Weather:		Coding:	PACP 6.0
Pipe Length (ft):	141.2	Owner:	NA	Pre Clean:	Not Known
P.O.#:		Surveyor:	Selasie Honu	PSR:	P-902-075-048
Customer:		Clean Date:	01/01/1900	Shape:	C

Street:	38th pl	Flow Control:	Not Controlled
City:	Hobart, IN	Year Renewed:	
Location:	Other	Tape/Media #:	
Purpose:	Not Known	Dia/Height:	8"
Use:	Sanitary	Material:	PVC
Drain Area:	NA	Lining:	
Category:	NA		
Comment:

Location Details:		Direction of Survey:	Downstream
US MH:	M-902-048	DS MH:	M-902-075
		Total Length Surveyed (ft):	204.4

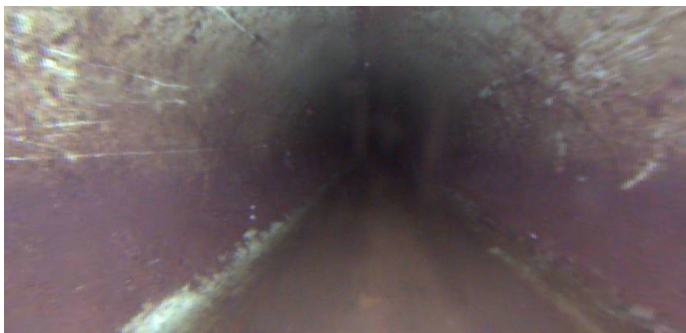
Code: **AMH**
Description: **Manhole**

Distance (ft): **.0**
Structural Grade: **0**
O&M Grade: **0**
Clock Start/From:
Clock To:
1st Value:
2nd Value:
Value Percent:
Continuous Index:
Within 8" of Joint: **NO**
Remarks: **M-902-048**

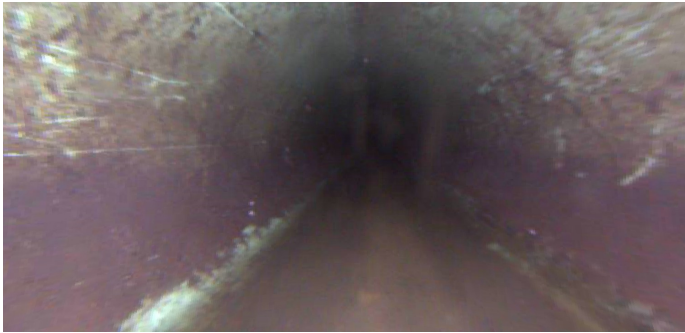
Code:	MWL
Description:	Water Level

Distance (ft):	.0
Structural Grade:	0
O&M Grade:	0
Clock Start/From:	
Clock To:	
1st Value:	
2nd Value:	
Value Percent:	5.000
Continuous Index:	
Within 8" of Joint:	NO
Remarks:

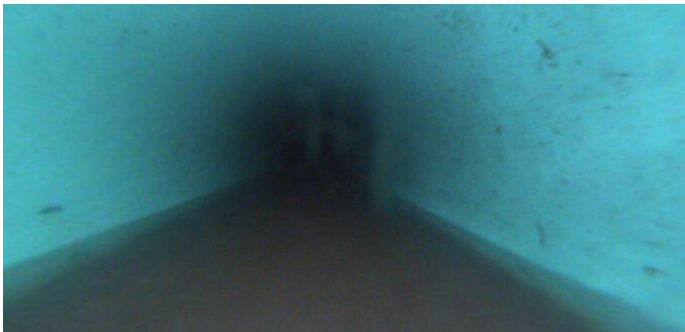
Code:	MWL
Description:	Water Level

Distance (ft):	152.3
Structural Grade:	0
O&M Grade:	0
Clock Start/From:	
Clock To:	
1st Value:	
2nd Value:	
Value Percent:	40.000
Continuous Index:	
Within 8" of Joint:	NO
Remarks:

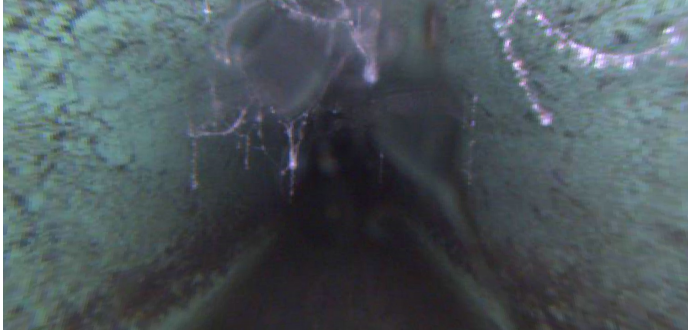
Code:	MSA
Description:	Abandoned Survey
Distance (ft):	204.4
Structural Grade:	0
O&M Grade:	0
Clock Start/From:	
Clock To:	
1st Value:	
2nd Value:	
Value Percent:	
Continuous Index:	
Within 8" of Joint:	NO
Remarks:	pipe appears to get smaller
