## Profile/Photo Observation Report

Street:	<b>e 37th ave</b>	Flow Control:	<b>Not Controlled</b>
City:	<b>Hobart, IN</b>	Year Renewed:	
Location:	<b>Other</b>	Tape/Media #:	
Purpose:	<b>Not Known</b>	Dia/Height:	<b>10"</b>
Use:	<b>Sanitary</b>	Material:	<b>PVC</b>
Drain Area:	<b>NA</b>	Lining:	
Category:	<b>NA</b>		
Comment:

Location Details:		Direction of Survey:	<b>Upstream</b>
US MH:	<b>M-903-063</b>	DS MH:	<b>M-903-062</b>
		Total Length Surveyed (ft):	<b>144.3</b>

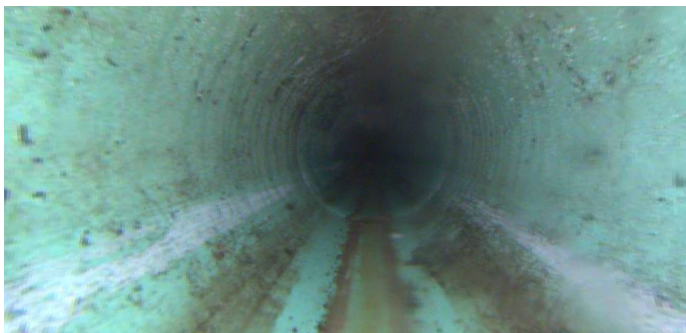
Code: **AMH**  
Description: **Manhole**

Distance (ft): **.0**  
Structural Grade: **0**  
O&M Grade: **0**  
Clock Start/From:  
Clock To:  
1st Value:  
2nd Value:  
Value Percent:  
Continuous Index:  
Within 8" of Joint: **NO**  
Remarks: **M-903-062**

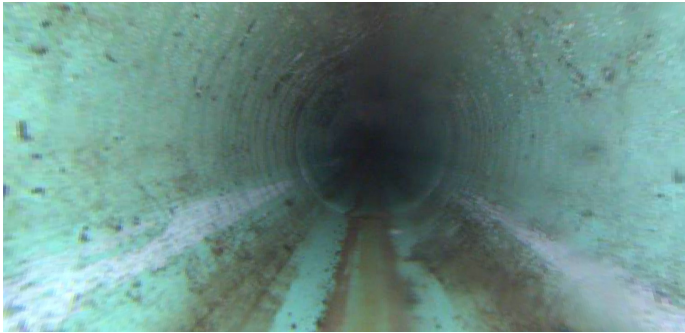
Code: **MWL**  
Description: **Water Level**

Distance (ft): **.0**  
Structural Grade: **0**  
O&M Grade: **0**  
Clock Start/From:  
Clock To:  
1st Value:  
2nd Value:  
Value Percent: **5.000**  
Continuous Index:  
Within 8" of Joint: **NO**  
Remarks:

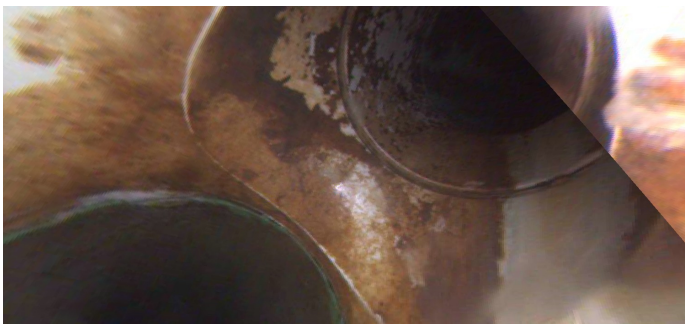
Code: **TF**  
Description: **Tap Factory**

Distance (ft): **68.8**  
Structural Grade: **0**  
O&M Grade: **0**  
Clock Start/From: **2**  
Clock To:  
1st Value: **4.000**  
2nd Value:  
Value Percent:  
Continuous Index:  
Within 8" of Joint:  
Remarks:

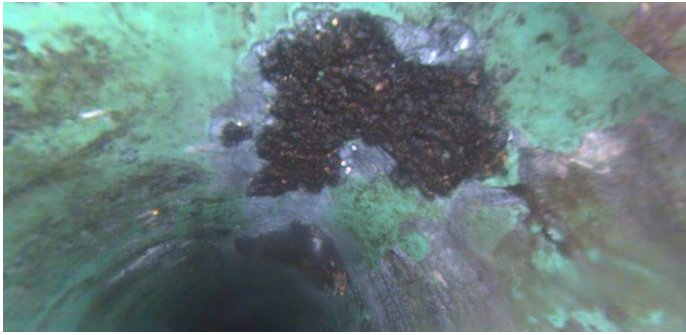
Code: **DAZ**  
Description: **Deposits Attached Other**

Distance (ft): **87.0**  
Structural Grade: **0**  
O&M Grade: **2**  
Clock Start/From: **12**  
Clock To: **1**  
1st Value:  
2nd Value:  
Value Percent: **5.000**  
Continuous Index:  
Within 8" of Joint: **NO**  
Remarks:

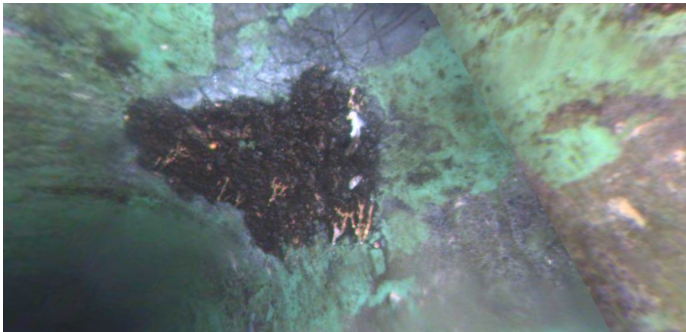
Code: **RFB**  
Description: **Roots Fine Barrel**

Distance (ft): **87.5**  
Structural Grade: **0**  
O&M Grade: **2**  
Clock Start/From: **1**  
Clock To: **2**  
1st Value:  
2nd Value:  
Value Percent:  
Continuous Index:  
Within 8" of Joint: **NO**  
Remarks:

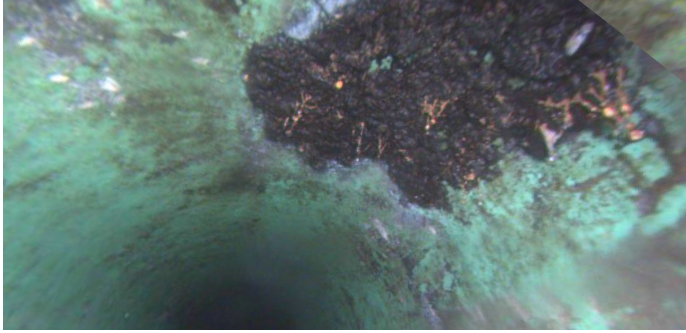
Code: **DAZ**  
Description: **Deposits Attached Other**

Distance (ft): **87.7**  
Structural Grade: **0**  
O&M Grade: **2**  
Clock Start/From: **12**  
Clock To: **1**  
1st Value:  
2nd Value:  
Value Percent: **5.000**  
Continuous Index:  
Within 8" of Joint: **NO**  
Remarks:

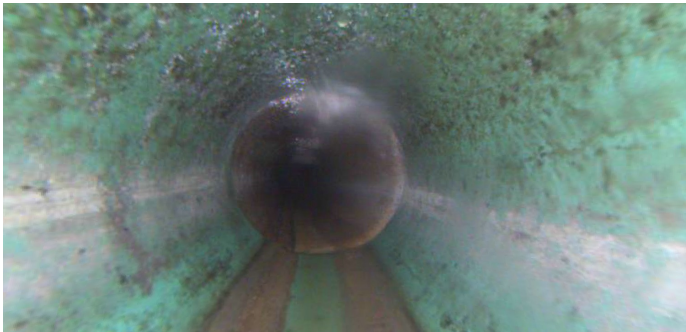
Code: **LL**  
Description: **Alignment Left**

Distance (ft): **134.4**  
Structural Grade: **0**  
O&M Grade: **1**  
Clock Start/From:  
Clock To:  
1st Value:  
2nd Value:  
Value Percent: **5.000**  
Continuous Index:  
Within 8" of Joint: **NO**  
Remarks:

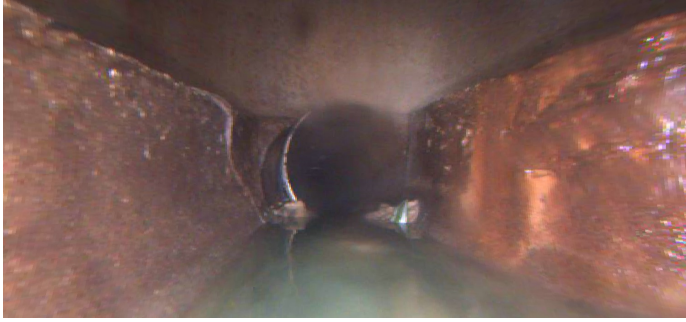
Code:	<b>AMH</b>
Description:	<b>Manhole</b>
Distance (ft):	<b>144.3</b>
Structural Grade:	<b>0</b>
O&M Grade:	<b>0</b>
Clock Start/From:	
Clock To:	
1st Value:	
2nd Value:	
Value Percent:	
Continuous Index:	
Within 8" of Joint:	<b>NO</b>
Remarks:	<b>M-903-063</b>
