Profile/Photo Observation Report

ROBOTICS	
02259	Weather: Owner: Surveyor:	City of Hobart S. Bucklin		Coding: Pre Clean: PSR:	M-103-127-M-103-128	
	Clean Date:			·	C	
				Not Controlled

-						
/		Tape/Media	#:			
er System Evalua	ation Survey (S	S Dia/Height:		8"		
tary Sewage Pip	e	Material:		PVC		
		Lining:		None		
		Direction of	Survey:	Downstream		
L27	DS MH:	M-103-128	То	tal Length Surveyed (ft)	206.8

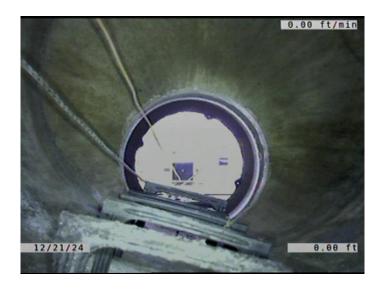
Code: AMH Description: Manhole

Distance (ft): .0 Structural Grade: 0 0 O&M Grade:

Remarks: M-103-127

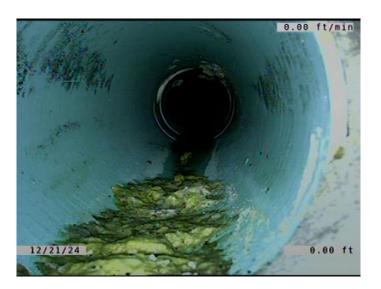
MWL Code:

Description: **Miscellaneous Water Level**

Distance (ft): .0 Structural Grade: 0 O&M Grade: 0

Value Percent: 5.000

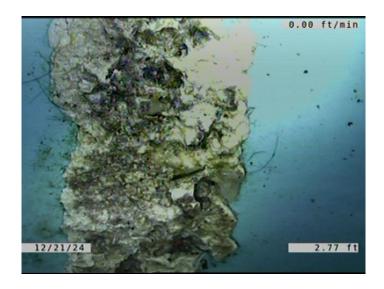
Code: DAGS

Description: Deposits Attached Grease

Distance (ft): 2.8
Structural Grade: 0
O&M Grade: 2
Clock Start/From: 11
Clock To: 2

Value Percent: 5.000
Continuous Index: S01
Within 8" of Joint: YES

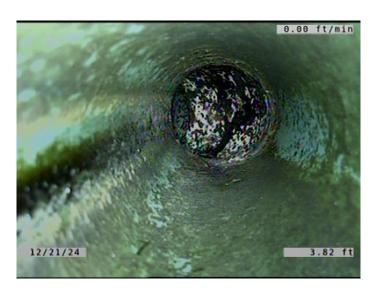
Code: TF

Description: Tap Factory

Distance (ft): 3.8
Structural Grade: 0

Remarks: CONSTANTLY RUNNING WATER.

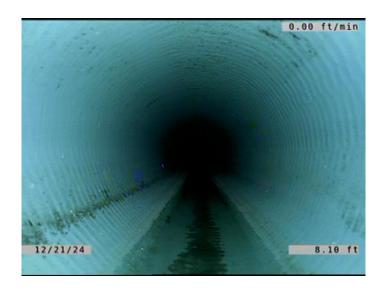
Code: DAGS

Description: **Deposits Attached Grease**

Distance (ft): 8.1 Structural Grade: 0 2 O&M Grade: Clock Start/From: 11 Clock To: 2

Value Percent: 5.000 Continuous Index: F01 Within 8" of Joint: YES

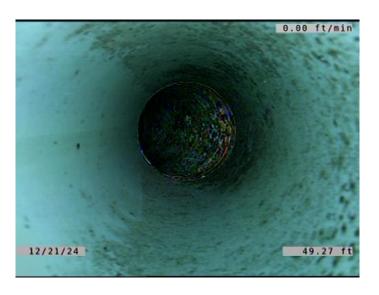
Code: TF

Description: **Tap Factory**

Distance (ft): 49.3 Structural Grade: 0 O&M Grade: 0 Clock Start/From: 10

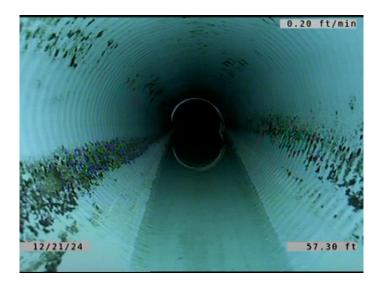
Description: Miscellaneous Water Level Sag

Distance (ft): 57.3
Structural Grade: 2
O&M Grade: 0

Value Percent: 15.000
Continuous Index: S02
Within 8" of Joint: NO

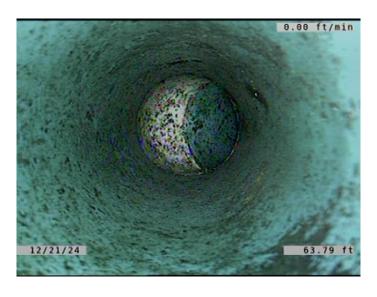
Code: TF

Description: Tap Factory

Distance (ft): 63.8
Structural Grade: 0

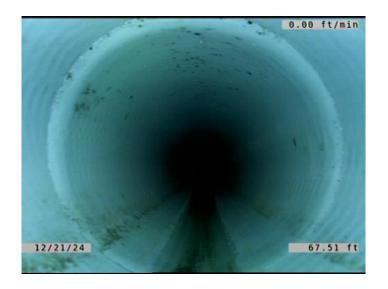
Description: Miscellaneous Water Level Sag

Distance (ft): 67.5
Structural Grade: 2
O&M Grade: 0

Value Percent: 15.000
Continuous Index: F02
Within 8" of Joint: NO

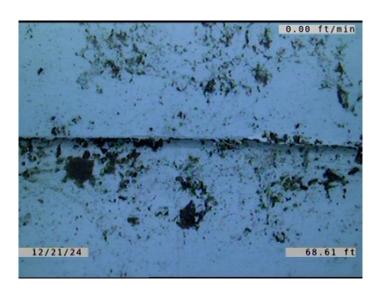
Code: JAM

Description: Joint Angular Medium

Distance (ft): 68.6
Structural Grade: 3
O&M Grade: 0

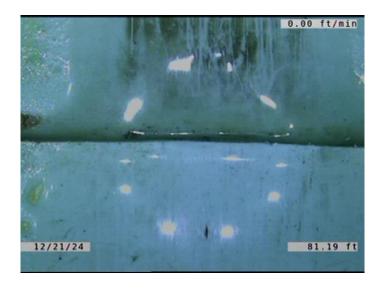
Code: JAM

Description: Joint Angular Medium

Distance (ft): 81.2 Structural Grade: 3 0 O&M Grade:

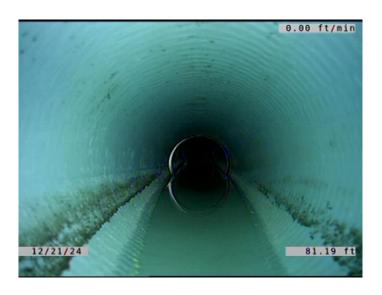
Code: **MWLS**

Description: **Miscellaneous Water Level Sag**

Distance (ft): 81.2 Structural Grade: 2 O&M Grade: 0

Value Percent: 20.000 Continuous Index: S03 Within 8" of Joint: NO

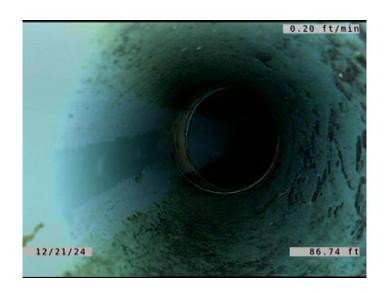
Code: **TF**

Description: Tap Factory

Distance (ft): 86.7
Structural Grade: 0

Remarks: CONSTANTLY RUNNING WATER.

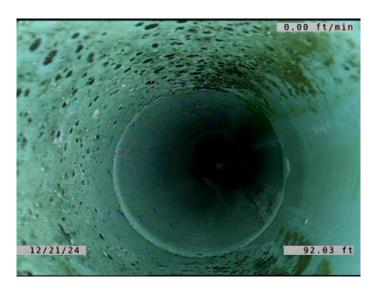
Code: TFA

Description: Tap Factory Activity

Distance (ft): 92.0
Structural Grade: 0
O&M Grade: 0
Clock Start/From: 2

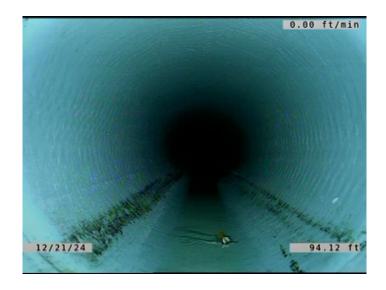
Description: Miscellaneous Water Level Sag

Distance (ft): 94.1
Structural Grade: 2
O&M Grade: 0

Value Percent: 20.000
Continuous Index: F03
Within 8" of Joint: NO

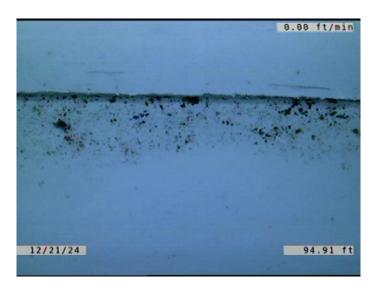
Code: JAM

Description: Joint Angular Medium

Distance (ft): 94.9
Structural Grade: 3
O&M Grade: 0

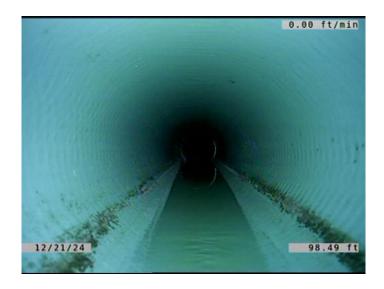
Description: Miscellaneous Water Level Sag

Distance (ft): 98.5
Structural Grade: 2
O&M Grade: 0

Value Percent: 10.000
Continuous Index: S04
Within 8" of Joint: NO

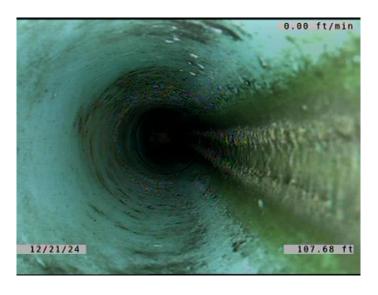
Code: TF

Description: Tap Factory

Distance (ft): 107.7
Structural Grade: 0
O&M Grade: 0
Clock Start/From: 2

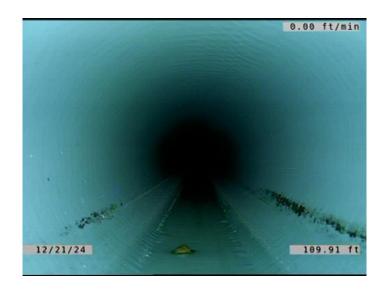
Description: **Miscellaneous Water Level Sag**

109.9 Distance (ft): Structural Grade: 2 0 O&M Grade:

Value Percent: 10.000 Continuous Index: F04 Within 8" of Joint: NO

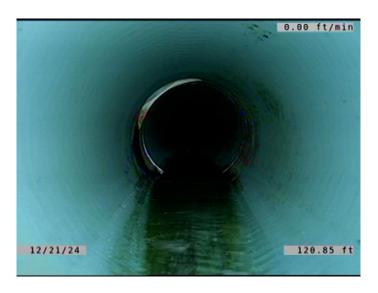
Code: **MWLS**

Description: **Miscellaneous Water Level Sag**

Distance (ft): 120.8 Structural Grade: 2 O&M Grade: 0

Value Percent: 5.000 Continuous Index: **S05** Within 8" of Joint: NO

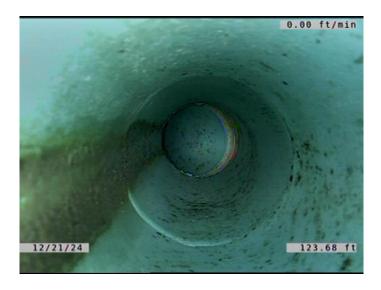
Code: TF

Description: **Tap Factory**

Distance (ft): 123.7 Structural Grade: 0 0 O&M Grade: Clock Start/From: 10

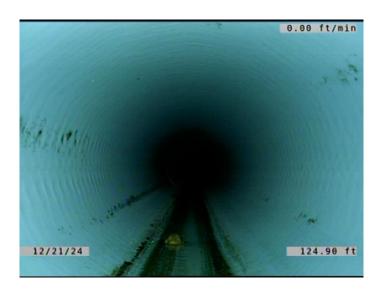
Code: **MWLS**

Description: **Miscellaneous Water Level Sag**

Distance (ft): 124.9 Structural Grade: 2 O&M Grade: 0

Value Percent: 5.000 Continuous Index: F05 Within 8" of Joint: NO

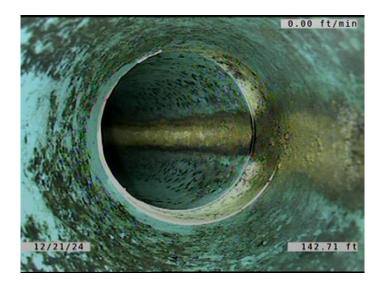
Code: **TF**

Description: **Tap Factory**

Distance (ft): 142.7
Structural Grade: 0
O&M Grade: 0
Clock Start/From: 2

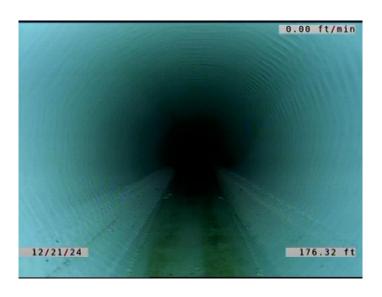
Code: MWLS

Description: Miscellaneous Water Level Sag

Distance (ft): 176.3
Structural Grade: 2
O&M Grade: 0

Value Percent: 15.000
Continuous Index: S06
Within 8" of Joint: NO

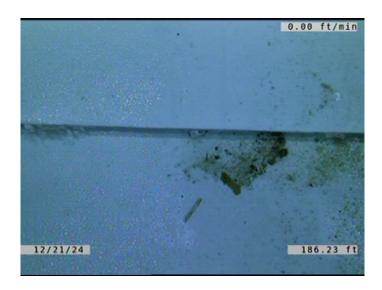
Code: JAM

Description: Joint Angular Medium

Distance (ft): 186.2
Structural Grade: 3
O&M Grade: 0

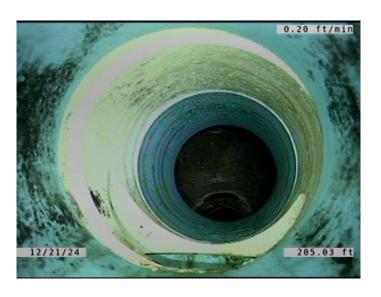
Code: MWLS

Description: Miscellaneous Water Level Sag

Distance (ft): 205.0
Structural Grade: 2
O&M Grade: 0

Value Percent: 15.000
Continuous Index: F06
Within 8" of Joint: NO

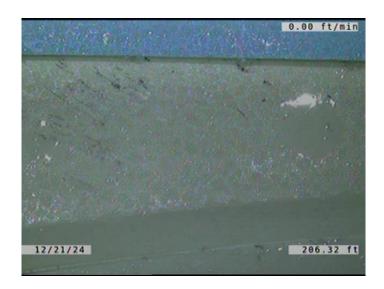
Code: LRD

Description: Line Right Down

Distance (ft): 206.3
Structural Grade: 0
O&M Grade: 2

Value Percent: 15.000

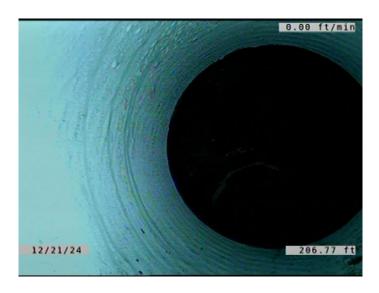
Code: AMH
Description: Manhole

Distance (ft): 206.8
Structural Grade: 0

Remarks: M-103-128
