Profile/Photo Observation Report

Date:	12/21/2024	Weather:		Coding:	PACP 7.0
Pipe Length (ft):	112.0	Owner:	City of Hobart	Pre Clean:	Heavy Cleaning
P.O.#:	YES502259	Surveyor:	S. Bucklin	PSR:	P-203-059-058
Customer:	City of Hobart	Clean Date:	12/21/2024	Shape:	C

Street:	West 37th Avenue	Flow Control:	Not Controlled
City:	Hobart, IN	Year Renewed:	
Location:	Alley	Tape/Media #:	
Purpose:	Sewer System Evaluation Survey (SS	Dia/Height:	6"
Use:	Sanitary Sewage Pipe	Material:	VCP
Drain Area:		Lining:	None
Category:	NA		
Comment:			
Location Details:		Direction of Survey:	Upstream
US MH:	M-203-058	DS MH:	M-203-059
		Total Length Surveyed (ft):	33.6

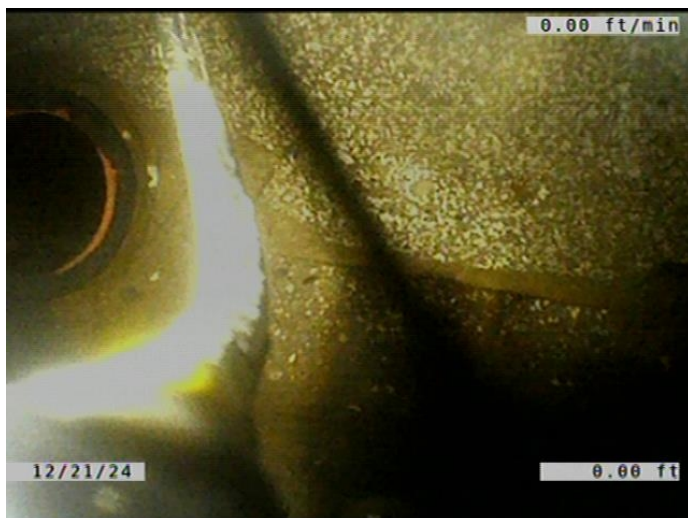
Code: **AMH**
Description: **Manhole**

Distance (ft): **.0**
Structural Grade: **0**
O&M Grade: **0**
Clock Start/From:
Clock To:
1st Value:
2nd Value:
Value Percent:
Continuous Index:
Within 8" of Joint: **NO**
Remarks: **M-203-059**

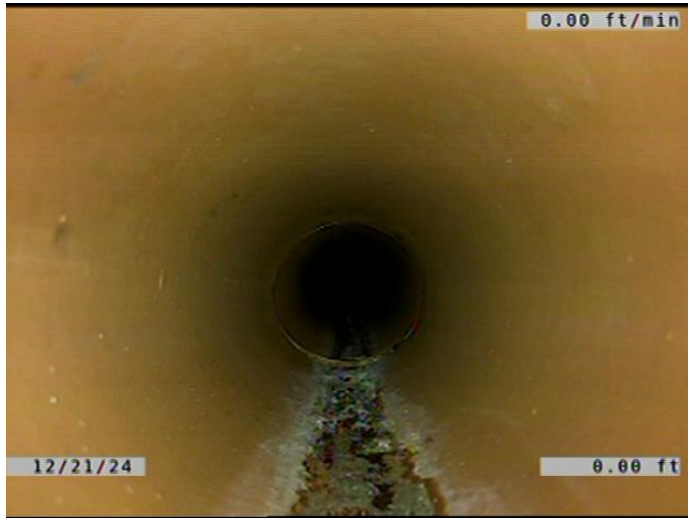
Code: **MWL**
Description: **Miscellaneous Water Level**

Distance (ft): **.0**
Structural Grade: **0**
O&M Grade: **0**
Clock Start/From:
Clock To:
1st Value:
2nd Value:
Value Percent: **5.000**
Continuous Index:
Within 8" of Joint: **NO**
Remarks:

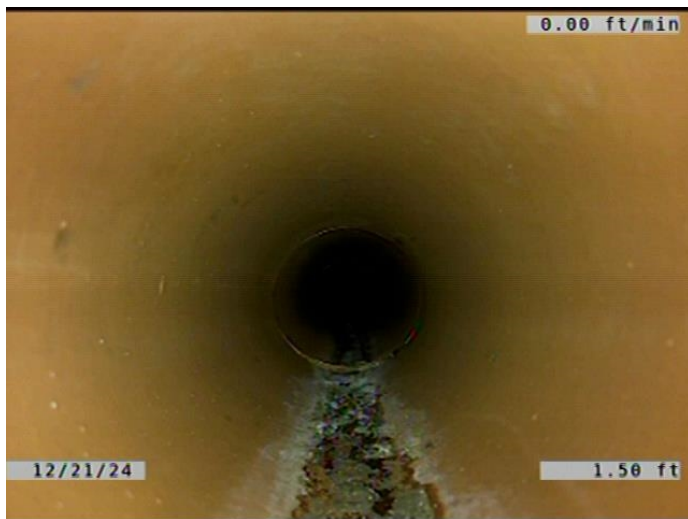
Code: **MGO**
Description: **Miscellaneous General Observation**

Distance (ft): **1.5**
Structural Grade: **0**
O&M Grade: **0**
Clock Start/From:
Clock To:
1st Value:
2nd Value:
Value Percent:
Continuous Index:
Within 8" of Joint: **NO**
Remarks: **DROP INTO THE MANHOLE. HAD TO START INTO THE PIPE.**

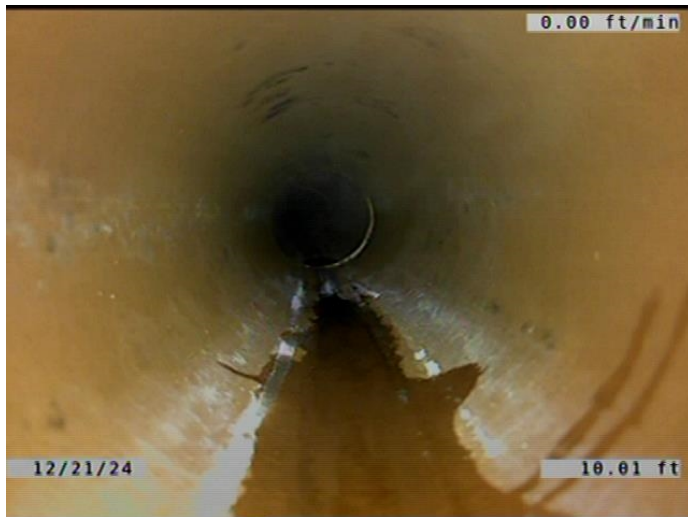
Code: **LL**
 Description: **Line Left**

Distance (ft): **10.0**
 Structural Grade: **0**
 O&M Grade: **2**
 Clock Start/From:
 Clock To:
 1st Value:
 2nd Value:
 Value Percent: **15.000**
 Continuous Index:
 Within 8" of Joint: **NO**
 Remarks:

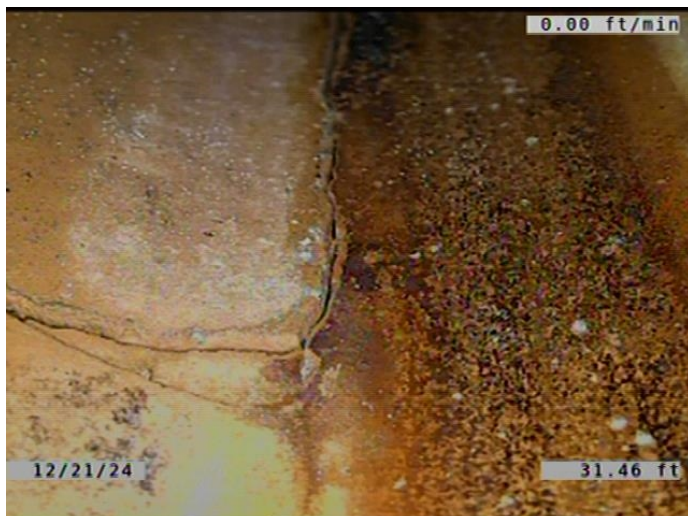
Code: **BSV**
 Description: **Broken Soil Visible**

Distance (ft): **31.5**
 Structural Grade: **5**
 O&M Grade: **0**
 Clock Start/From: **12**
 Clock To: **12**
 1st Value:
 2nd Value:
 Value Percent:
 Continuous Index:
 Within 8" of Joint: **YES**
 Remarks:

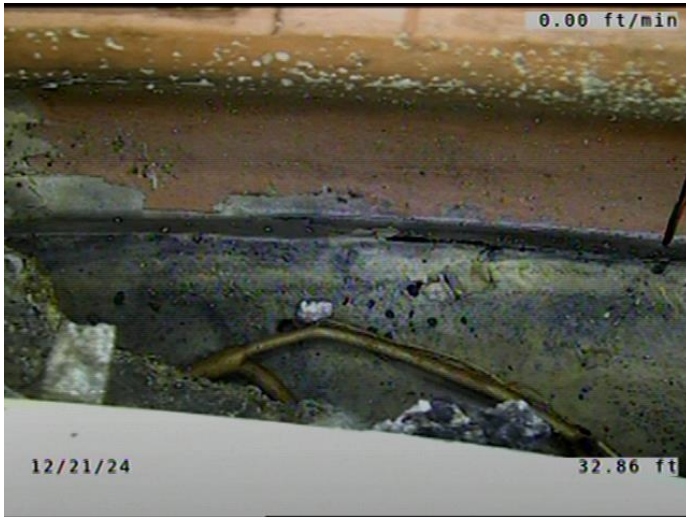
Code: **RFJ**
Description: **Roots Fine Joint**

Distance (ft): **32.9**
Structural Grade: **0**
O&M Grade: **1**
Clock Start/From: **11**
Clock To: **3**
1st Value:
2nd Value:
Value Percent:
Continuous Index:
Within 8" of Joint: **YES**
Remarks:

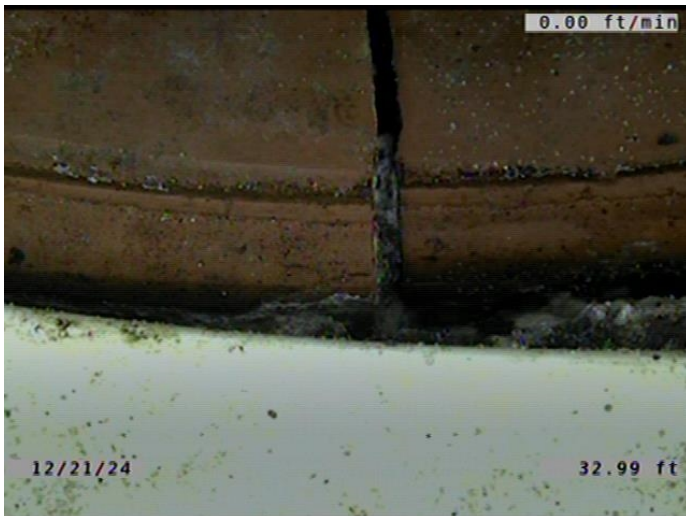
Code: **MMC**
Description: **Miscellaneous Material Change**

Distance (ft): **33.0**
Structural Grade: **0**
O&M Grade: **0**
Clock Start/From:
Clock To:
1st Value:
2nd Value:
Value Percent:
Continuous Index:
Within 8" of Joint: **NO**
Remarks: **6" PVC**

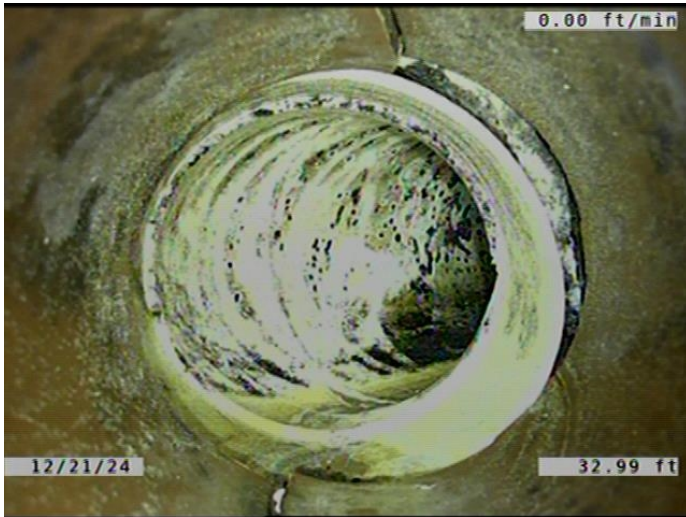
Code: **MGO**
 Description: **Miscellaneous General Observation**

Distance (ft): **33.0**
 Structural Grade: **0**
 O&M Grade: **0**
 Clock Start/From:
 Clock To:
 1st Value:
 2nd Value:
 Value Percent:
 Continuous Index:
 Within 8" of Joint: **NO**
 Remarks: **6" VCP TO 6" PVC**

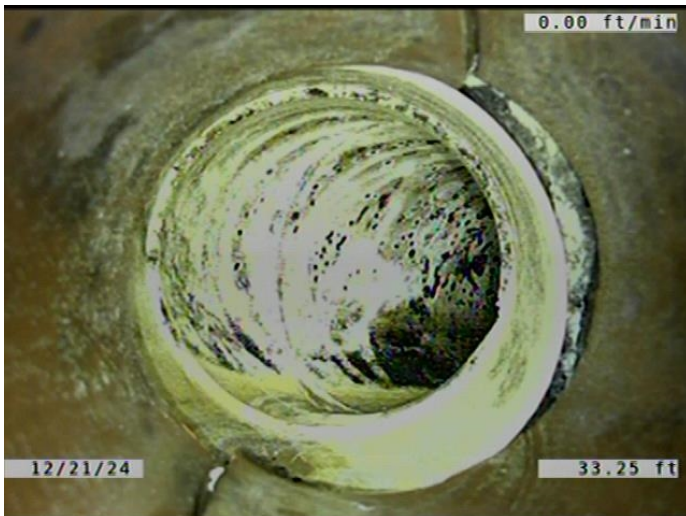
Code: **LR**
 Description: **Line Right**

Distance (ft): **33.2**
 Structural Grade: **0**
 O&M Grade: **4**
 Clock Start/From:
 Clock To:
 1st Value:
 2nd Value:
 Value Percent: **25.000**
 Continuous Index:
 Within 8" of Joint: **NO**
 Remarks:

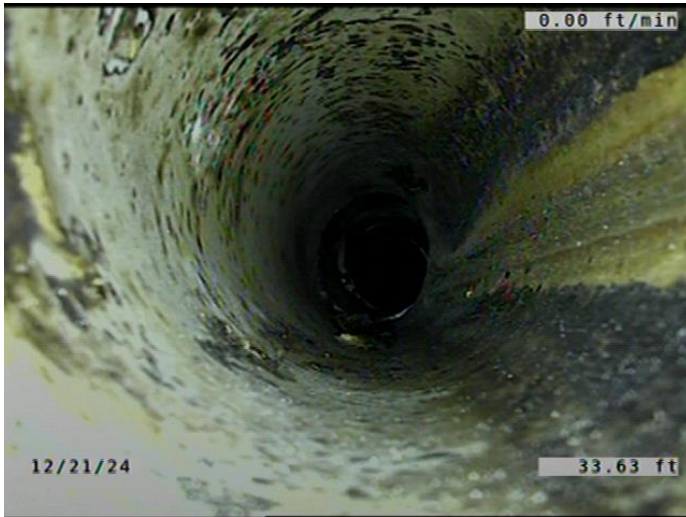
Code:	MSA
Description:	Miscellaneous Survey Abandoned
Distance (ft):	33.6
Structural Grade:	0
O&M Grade:	0
Clock Start/From:	
Clock To:	
1st Value:	
2nd Value:	
Value Percent:	
Continuous Index:	
Within 8" of Joint:	NO
Remarks:	CAMERA CANT MAKE IT PAST THE BEND.
