Profile/Photo Observation Report

Date:	12/03/2024	Weather:		Coding:	PACP 7.0
Pipe Length (ft):	288.0	Owner:	City of Hobart	Pre Clean:	Heavy Cleaning
P.O.#:	YES502259	Surveyor:	S. Bucklin	PSR:	P-209-022.1-022
Customer:	City of Hobart	Clean Date:	06/13/2024	Shape:	C

Street:	East 62nd Place	Flow Control:	Not Controlled
City:	Hobart, IN	Year Renewed:	
Location:	Easement/Right of Way	Tape/Media #:	
Purpose:	Sewer System Evaluation Survey (SS	Dia/Height:	15"
Use:	Sanitary Sewage Pipe	Material:	VCP
Drain Area:		Lining:	None
Category:	NA		
Comment:

Location Details:		Direction of Survey:	Downstream
US MH:	M-209-022.1	DS MH:	M-209-022
		Total Length Surveyed (ft):	288.2

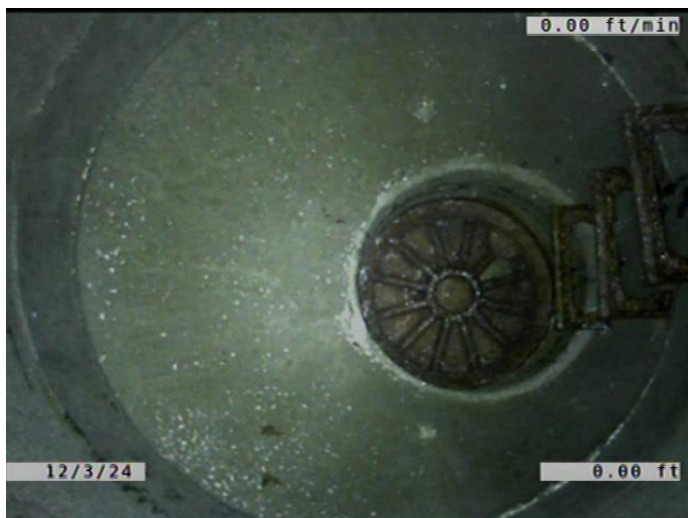
Code: **AMH**
 Description: **Manhole**

Distance (ft): **.0**
 Structural Grade: **0**
 O&M Grade: **0**
 Clock Start/From:
 Clock To:
 1st Value:
 2nd Value:
 Value Percent:
 Continuous Index:
 Within 8" of Joint: **NO**
 Remarks: **M-209-022.1**

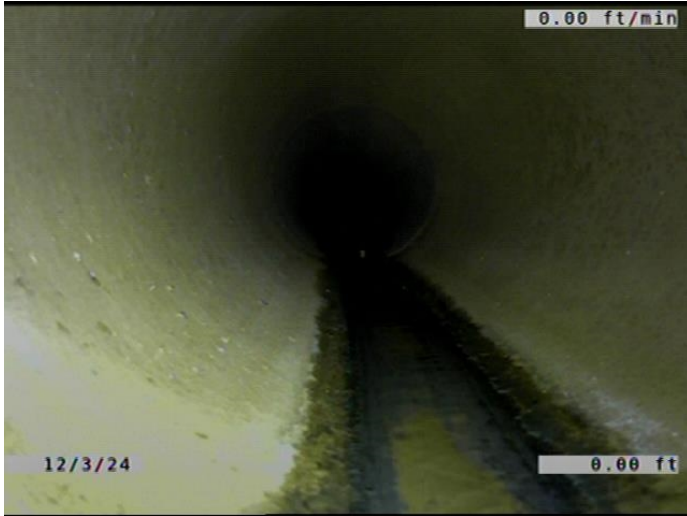
Code: **MWL**
Description: **Miscellaneous Water Level**

Distance (ft): **.0**
Structural Grade: **0**
O&M Grade: **0**
Clock Start/From:
Clock To:
1st Value:
2nd Value:
Value Percent: **5.000**
Continuous Index:
Within 8" of Joint: **NO**
Remarks:

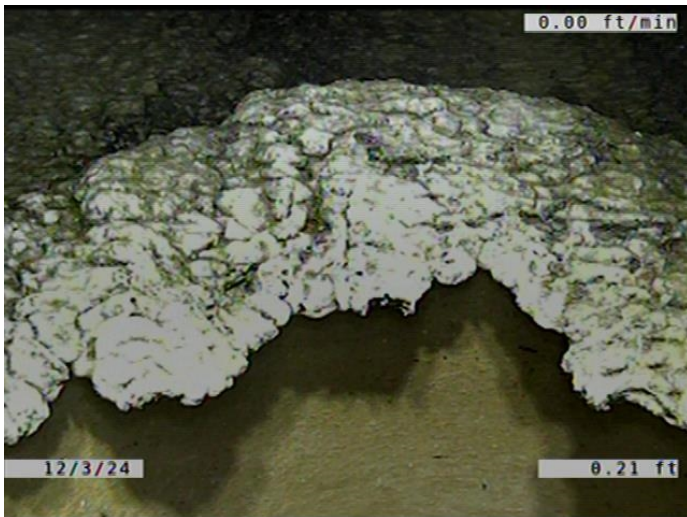
Code: **DAE**
Description: **Deposits Attached Encrustation**

Distance (ft): **.2**
Structural Grade: **0**
O&M Grade: **2**
Clock Start/From: **7**
Clock To: **5**
1st Value:
2nd Value:
Value Percent: **5.000**
Continuous Index:
Within 8" of Joint: **YES**
Remarks:

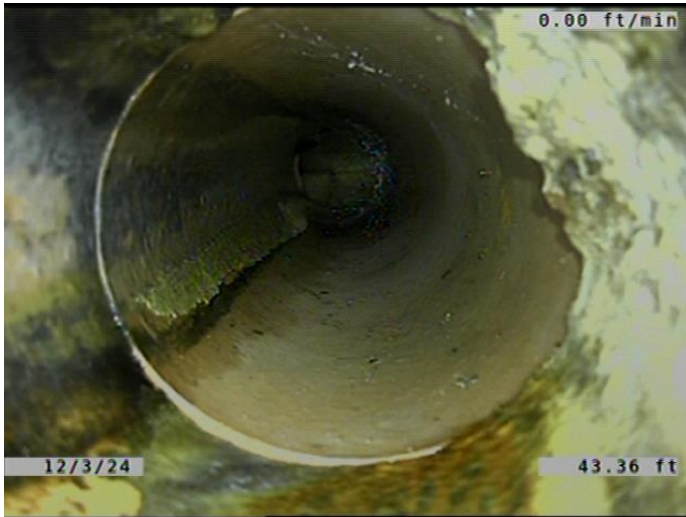
Code:	TFD
Description:	Tap Factory Defective
Distance (ft):	43.4
Structural Grade:	0
O&M Grade:	3
Clock Start/From:	11
Clock To:	
1st Value:	6.000
2nd Value:	
Value Percent:	
Continuous Index:	
Within 8" of Joint:	YES
Remarks:	ENCrustation COMING DOWN THE TAP AND FROM AROUND THE SERVI

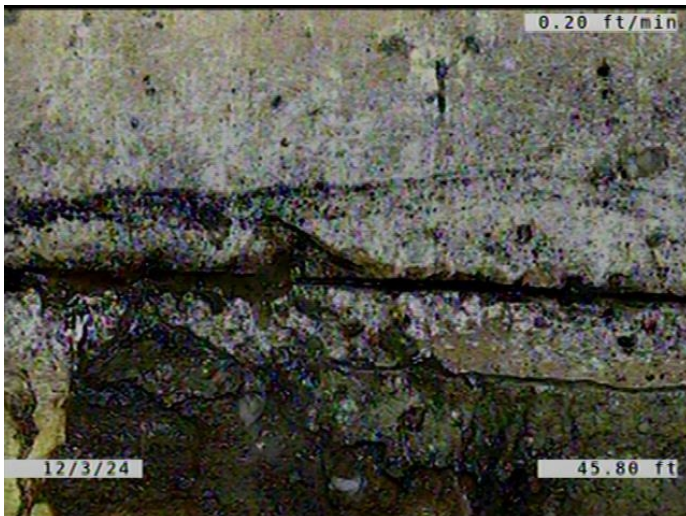
Code:	DAE
Description:	Deposits Attached Encrustation
Distance (ft):	45.8
Structural Grade:	0
O&M Grade:	2
Clock Start/From:	12
Clock To:	5
1st Value:	
2nd Value:	
Value Percent:	5.000
Continuous Index:	
Within 8" of Joint:	YES
Remarks:

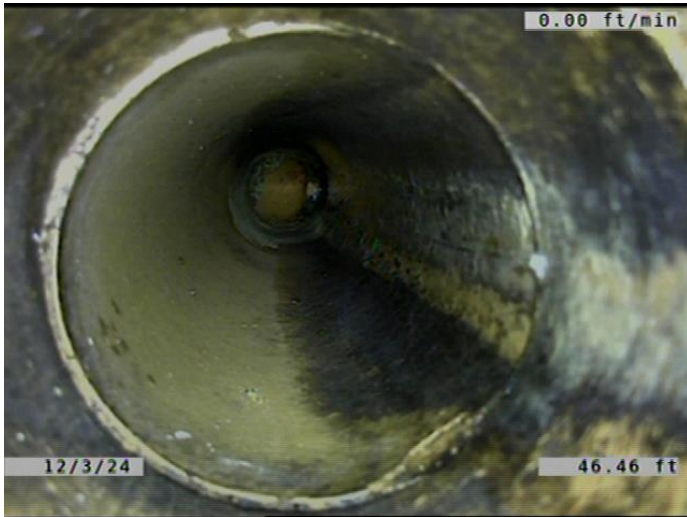
Code: **TF**
Description: **Tap Factory**

Distance (ft): **46.5**
Structural Grade: **0**
O&M Grade: **0**
Clock Start/From: **1**
Clock To:
1st Value: **6.000**
2nd Value:
Value Percent:
Continuous Index:
Within 8" of Joint: **YES**
Remarks: **CONSTANTLY DRIPPING WATER.**

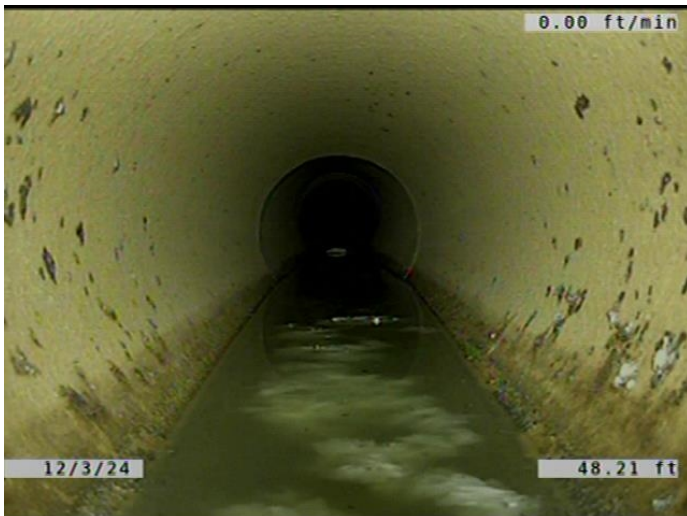
Code: **MWLS**
Description: **Miscellaneous Water Level Sag**

Distance (ft): **48.2**
Structural Grade: **2**
O&M Grade: **0**
Clock Start/From:
Clock To:
1st Value:
2nd Value:
Value Percent: **10.000**
Continuous Index: **S01**
Within 8" of Joint: **NO**
Remarks:

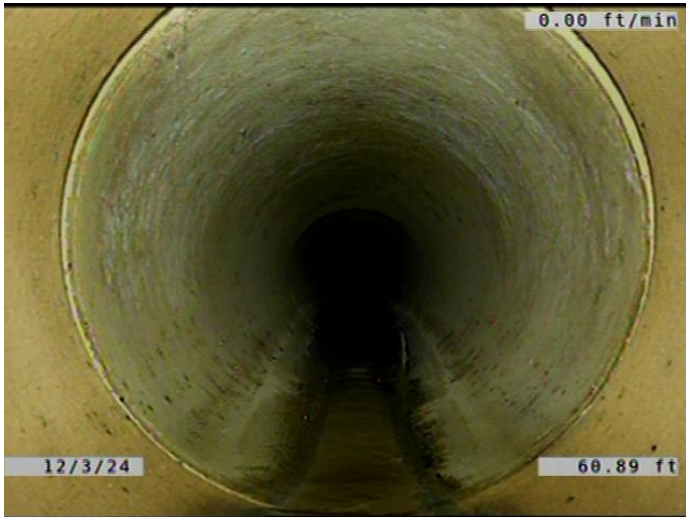
Code: **MWLS**
Description: **Miscellaneous Water Level Sag**

Distance (ft): **60.9**
Structural Grade: **2**
O&M Grade: **0**
Clock Start/From:
Clock To:
1st Value:
2nd Value:
Value Percent: **10.000**
Continuous Index: **F01**
Within 8" of Joint: **NO**
Remarks:

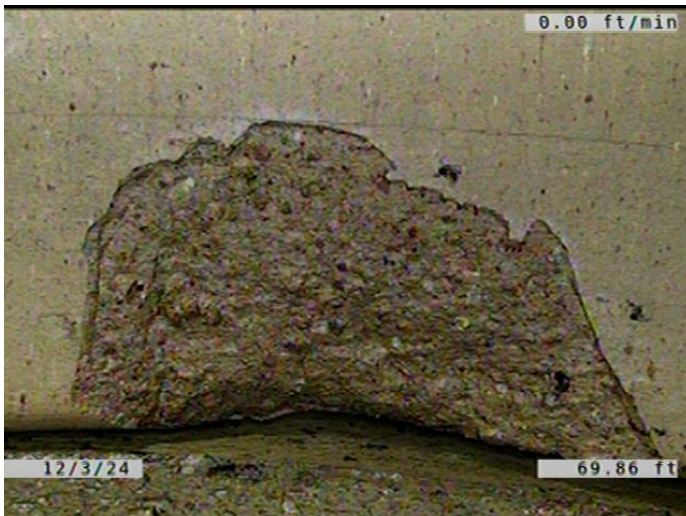
Code: **SZ**
Description: **Surface Damage Other**

Distance (ft): **69.9**
Structural Grade: **0**
O&M Grade: **0**
Clock Start/From: **1**
Clock To: **2**
1st Value:
2nd Value:
Value Percent:
Continuous Index:
Within 8" of Joint: **YES**
Remarks: **A PIECE CHIPPED AWAY FROM THE JOINT.**

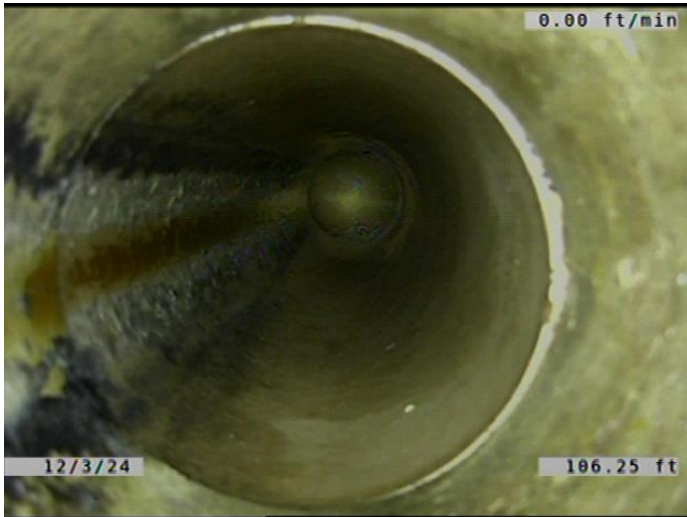
Code: **TF**
Description: **Tap Factory**

Distance (ft): **106.2**
Structural Grade: **0**
O&M Grade: **0**
Clock Start/From: **11**
Clock To:
1st Value: **9.000**
2nd Value:
Value Percent:
Continuous Index:
Within 8" of Joint: **YES**
Remarks:

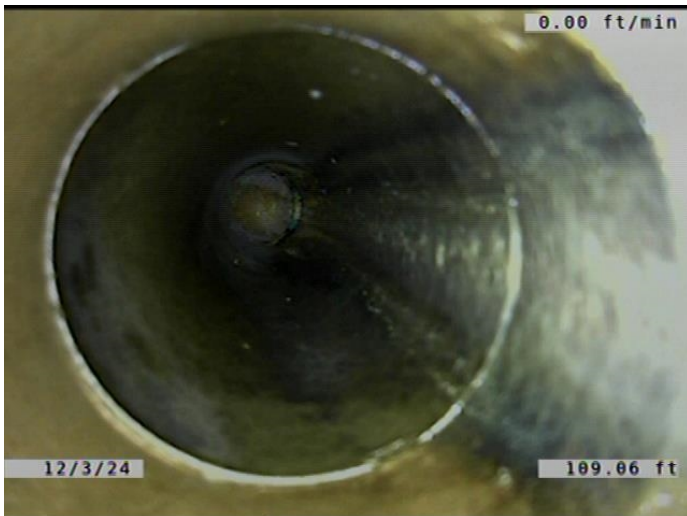
Code: **TF**
Description: **Tap Factory**

Distance (ft): **109.0**
Structural Grade: **0**
O&M Grade: **0**
Clock Start/From: **1**
Clock To:
1st Value: **6.000**
2nd Value:
Value Percent:
Continuous Index:
Within 8" of Joint: **YES**
Remarks:

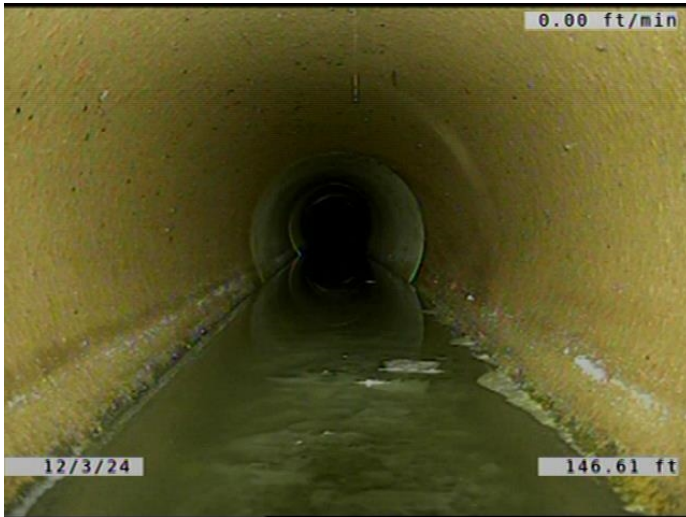
Code: **MWLS**
Description: **Miscellaneous Water Level Sag**

Distance (ft): **146.6**
Structural Grade: **2**
O&M Grade: **0**
Clock Start/From:
Clock To:
1st Value:
2nd Value:
Value Percent: **10.000**
Continuous Index: **S02**
Within 8" of Joint: **NO**
Remarks:

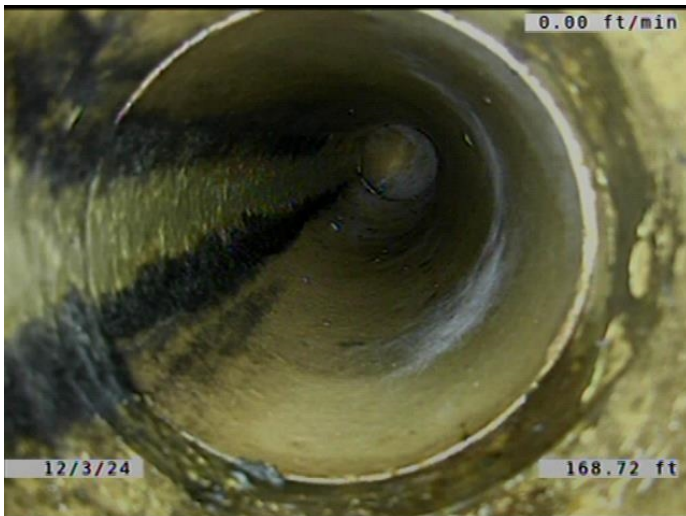
Code: **TF**
Description: **Tap Factory**

Distance (ft): **168.7**
Structural Grade: **0**
O&M Grade: **0**
Clock Start/From: **11**
Clock To:
1st Value: **6.000**
2nd Value:
Value Percent:
Continuous Index:
Within 8" of Joint: **YES**
Remarks:

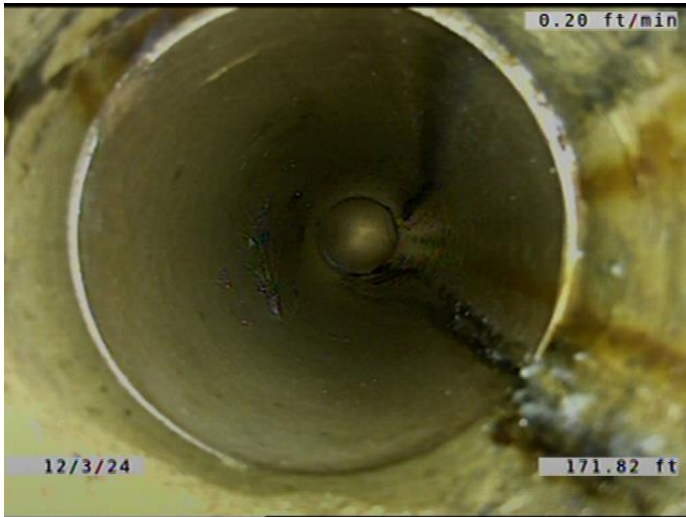
Code:	TFD
Description:	Tap Factory Defective
Distance (ft):	171.8
Structural Grade:	0
O&M Grade:	3
Clock Start/From:	1
Clock To:	
1st Value:	6.000
2nd Value:	
Value Percent:	
Continuous Index:	
Within 8" of Joint:	YES
Remarks:	INFILTRATION STAINING AT THE SERVICE TO MAIN CONNECTION. SE

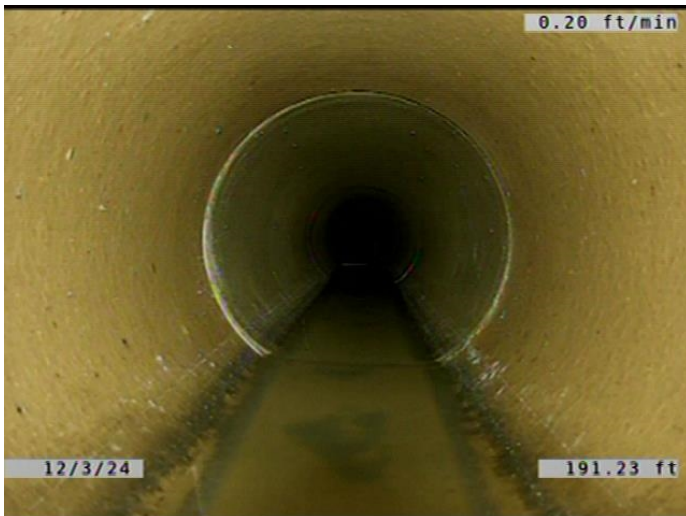
Code:	MWLS
Description:	Miscellaneous Water Level Sag
Distance (ft):	191.2
Structural Grade:	2
O&M Grade:	0
Clock Start/From:	
Clock To:	
1st Value:	
2nd Value:	
Value Percent:	10.000
Continuous Index:	F02
Within 8" of Joint:	NO
Remarks:

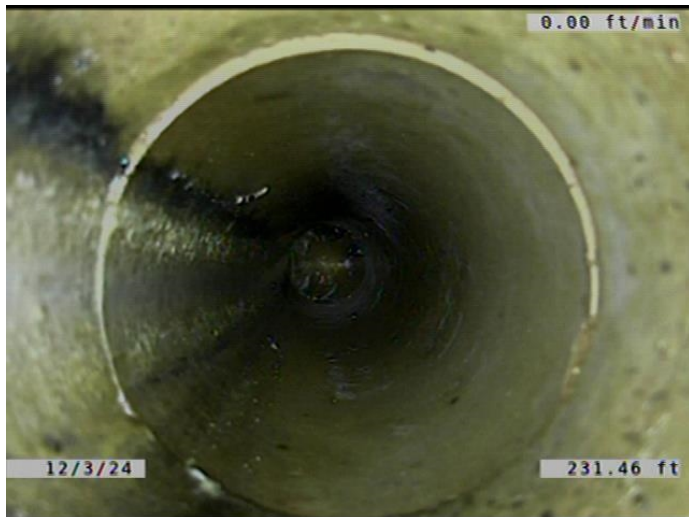
Code: **TF**
Description: **Tap Factory**

Distance (ft): **231.5**
Structural Grade: **0**
O&M Grade: **0**
Clock Start/From: **11**
Clock To:
1st Value: **6.000**
2nd Value:
Value Percent:
Continuous Index:
Within 8" of Joint: **YES**
Remarks:

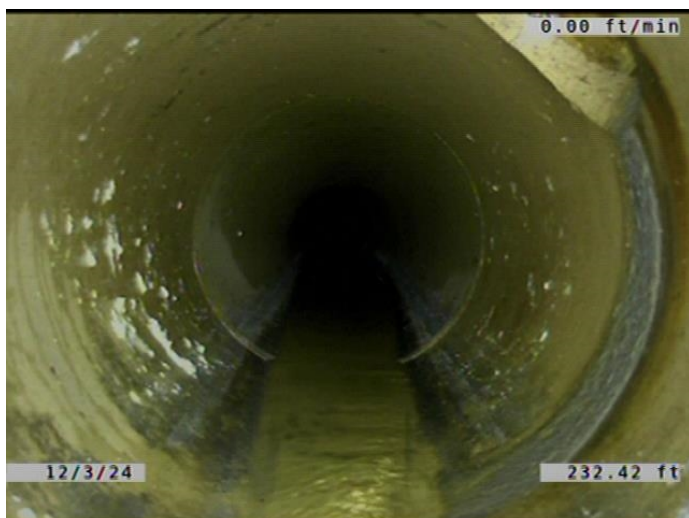
Code: **MWLS**
Description: **Miscellaneous Water Level Sag**

Distance (ft): **232.4**
Structural Grade: **2**
O&M Grade: **0**
Clock Start/From:
Clock To:
1st Value:
2nd Value:
Value Percent: **10.000**
Continuous Index: **S03**
Within 8" of Joint: **NO**
Remarks:

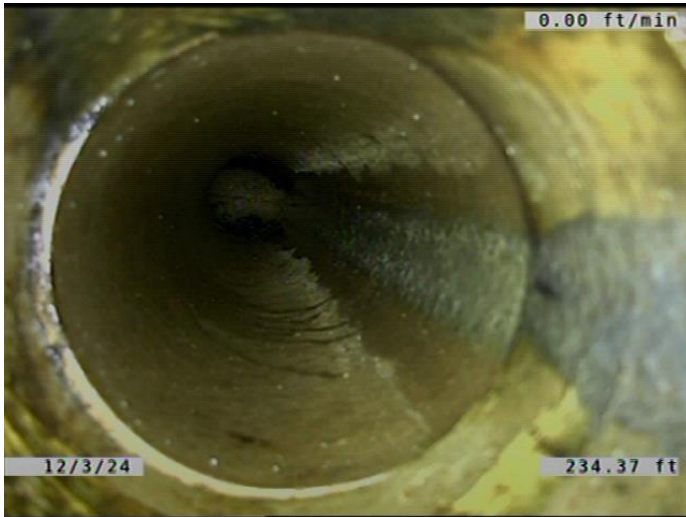
Code: **TFD**
Description: **Tap Factory Defective**

Distance (ft): **234.4**
Structural Grade: **0**
O&M Grade: **3**
Clock Start/From: **1**
Clock To:
1st Value: **6.000**
2nd Value:
Value Percent:
Continuous Index:
Within 8" of Joint: **YES**
Remarks: **ENCrustATION COMING FROM THE SERVICE TO MAIN CONNECTION.**

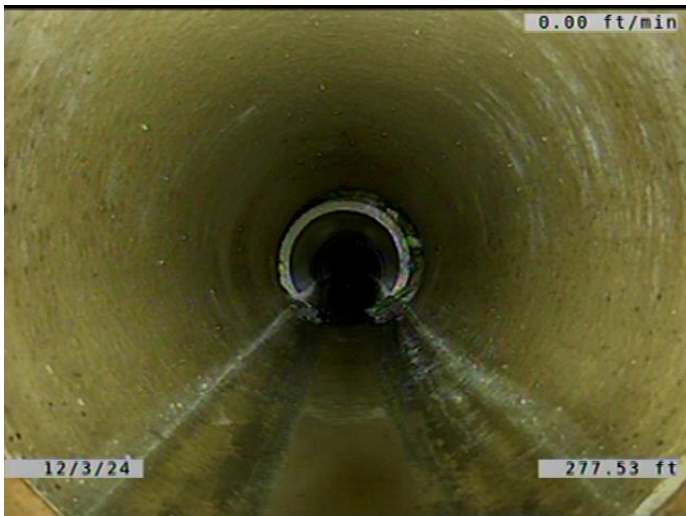
Code: **MWLS**
Description: **Miscellaneous Water Level Sag**

Distance (ft): **277.5**
Structural Grade: **2**
O&M Grade: **0**
Clock Start/From:
Clock To:
1st Value:
2nd Value:
Value Percent: **10.000**
Continuous Index: **F03**
Within 8" of Joint: **NO**
Remarks:

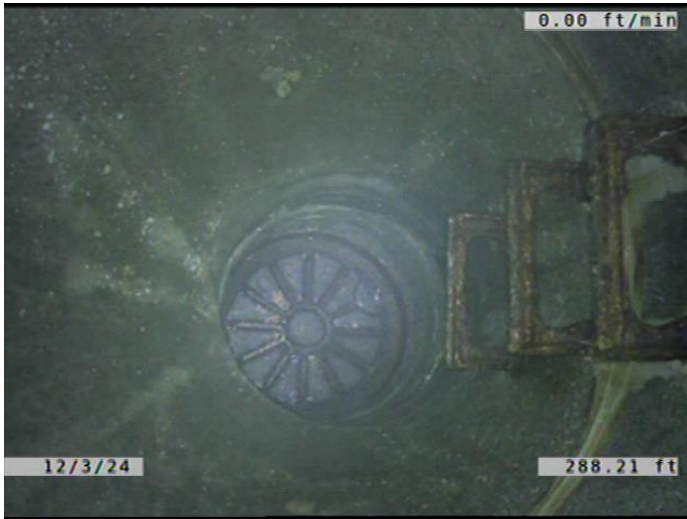
Code:	AMH
Description:	Manhole
Distance (ft):	288.2
Structural Grade:	0
O&M Grade:	0
Clock Start/From:	
Clock To:	
1st Value:	
2nd Value:	
Value Percent:	
Continuous Index:	
Within 8" of Joint:	NO
Remarks:	M-209-022
