Profile/Photo Observation Report

Date:	12/03/2024	Weather:		Coding:	PACP 7.0
Pipe Length (ft):	217.0	Owner:	City of Hobart	Pre Clean:	Heavy Cleaning
P.O.#:	YES502259	Surveyor:	S. Bucklin	PSR:	P-209-025-021
Customer:	City of Hobart	Clean Date:	07/16/2024	Shape:	C

Street:	Liverpool Road	Flow Control:	Not Controlled
City:	Hobart, IN	Year Renewed:	
Location:	Local rural streets with light traffic, t	Tape/Media #:	
Purpose:	Sewer System Evaluation Survey (SS	Dia/Height:	18"
Use:	Sanitary Sewage Pipe	Material:	VCP
Drain Area:		Lining:	None
Category:	NA		
Comment:			
Location Details:		Direction of Survey:	Downstream
US MH:	M-208-021	DS MH:	M-209-025
		Total Length Surveyed (ft):	216.8

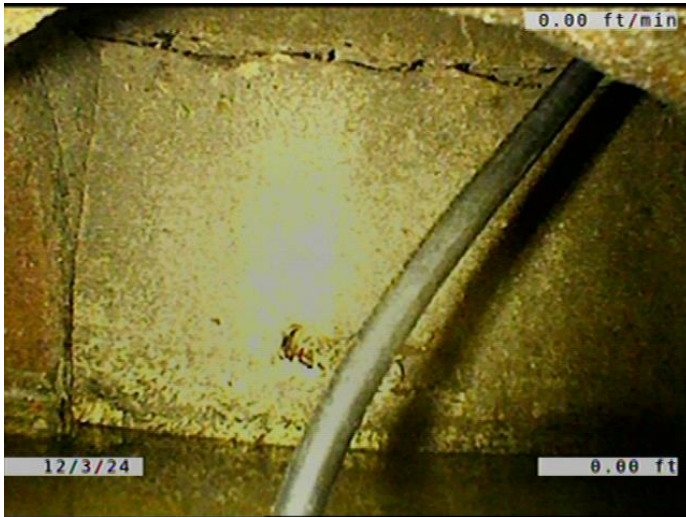
Code: **AMH**
Description: **Manhole**

Distance (ft): **.0**
Structural Grade: **0**
O&M Grade: **0**
Clock Start/From:
Clock To:
1st Value:
2nd Value:
Value Percent:
Continuous Index:
Within 8" of Joint: **NO**
Remarks: **M-208-021**

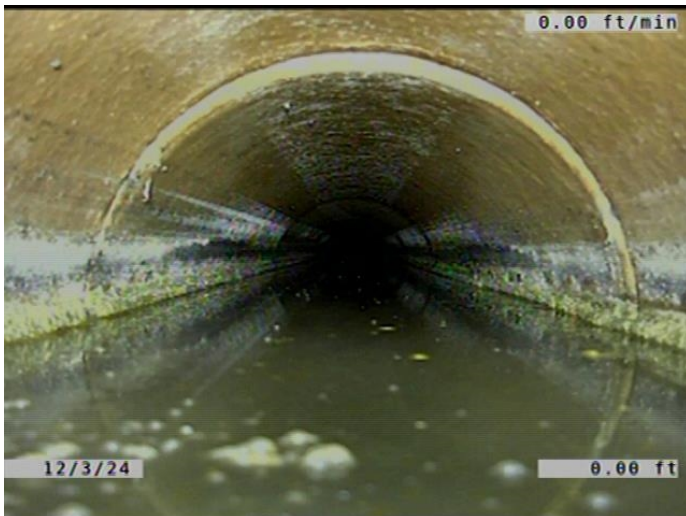
Code: **MWL**
Description: **Miscellaneous Water Level**

Distance (ft): **.0**
Structural Grade: **0**
O&M Grade: **0**
Clock Start/From:
Clock To:
1st Value:
2nd Value:
Value Percent: **45.000**
Continuous Index:
Within 8" of Joint: **NO**
Remarks:

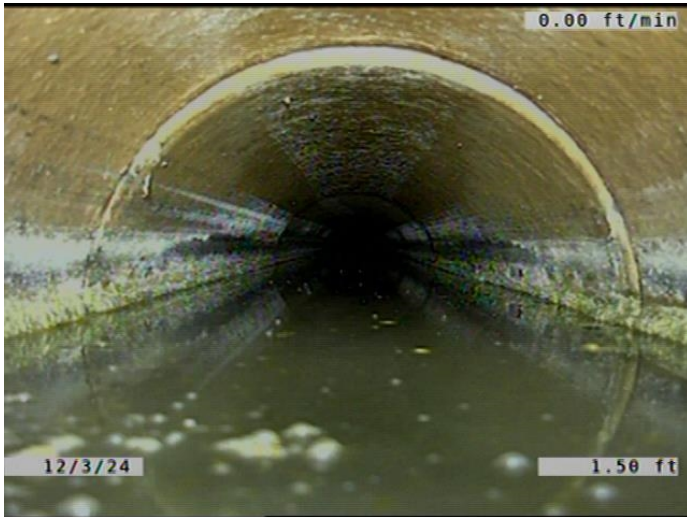
Code: **MGO**
Description: **Miscellaneous General Observation**

Distance (ft): **1.5**
Structural Grade: **0**
O&M Grade: **0**
Clock Start/From:
Clock To:
1st Value:
2nd Value:
Value Percent:
Continuous Index:
Within 8" of Joint: **NO**
Remarks: **DROP INTO THE MAINHOLE. HAD TO START IN THE PIPE.**

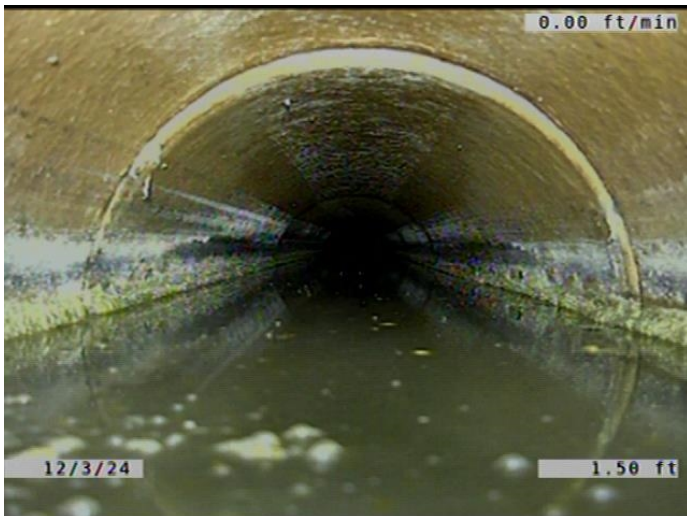
Code: **DAGS**
Description: **Deposits Attached Grease**

Distance (ft): **1.5**
Structural Grade: **0**
O&M Grade: **2**
Clock Start/From: **9**
Clock To: **3**
1st Value:
2nd Value:
Value Percent: **5.000**
Continuous Index: **S01**
Within 8" of Joint: **YES**
Remarks:

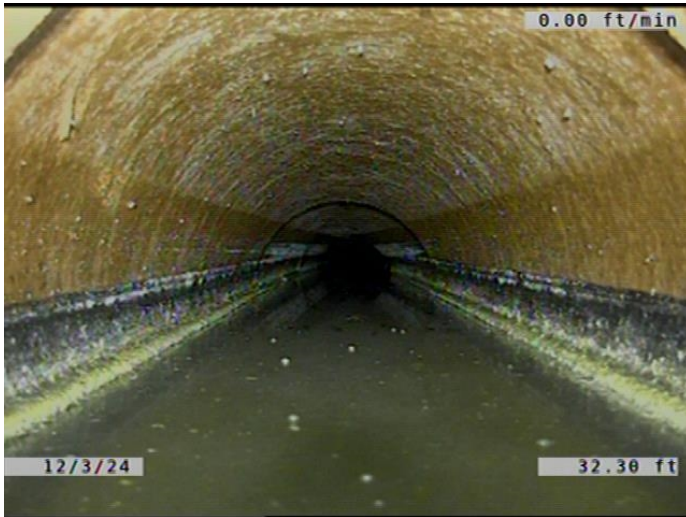
Code: **MWL**
Description: **Miscellaneous Water Level**

Distance (ft): **32.3**
Structural Grade: **0**
O&M Grade: **0**
Clock Start/From:
Clock To:
1st Value:
2nd Value:
Value Percent: **35.000**
Continuous Index:
Within 8" of Joint: **NO**
Remarks:

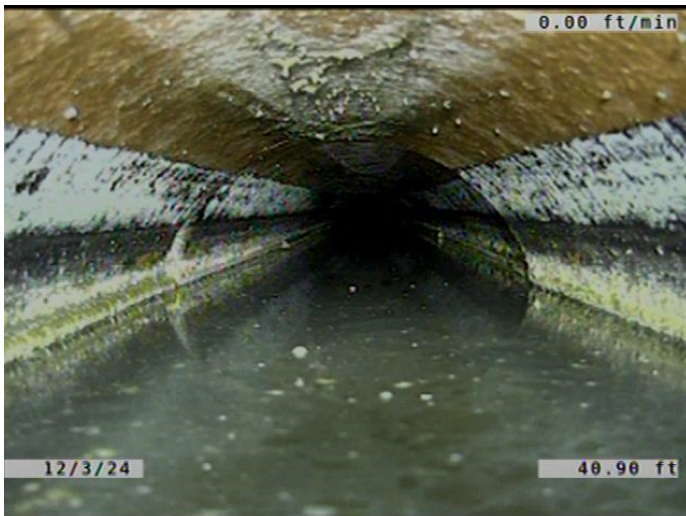
Code: **MWL**
Description: **Miscellaneous Water Level**

Distance (ft): **40.9**
Structural Grade: **0**
O&M Grade: **0**
Clock Start/From:
Clock To:
1st Value:
2nd Value:
Value Percent: **50.000**
Continuous Index:
Within 8" of Joint: **NO**
Remarks:

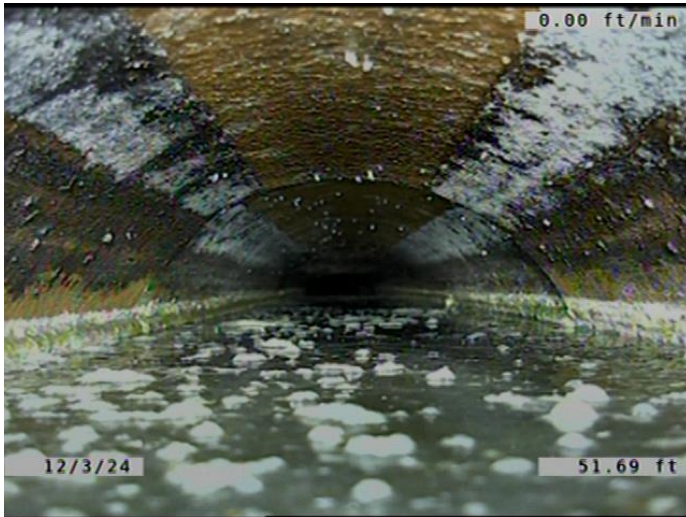
Code: **MWL**
Description: **Miscellaneous Water Level**

Distance (ft): **51.7**
Structural Grade: **0**
O&M Grade: **0**
Clock Start/From:
Clock To:
1st Value:
2nd Value:
Value Percent: **65.000**
Continuous Index:
Within 8" of Joint: **NO**
Remarks:

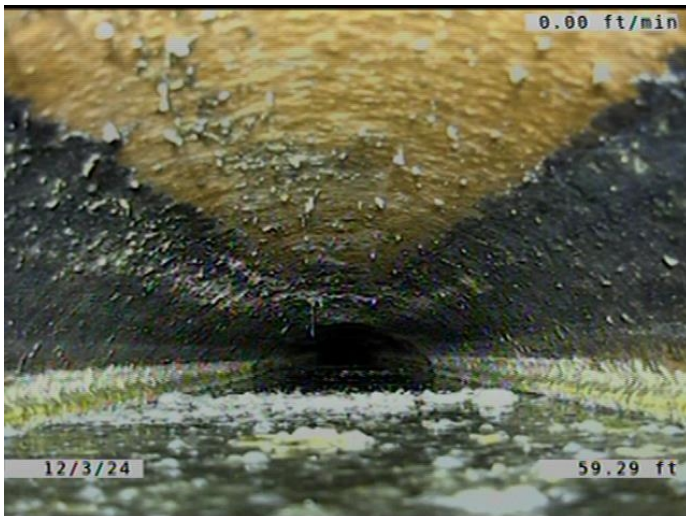
Code: **MWL**
Description: **Miscellaneous Water Level**

Distance (ft): **59.3**
Structural Grade: **0**
O&M Grade: **0**
Clock Start/From:
Clock To:
1st Value:
2nd Value:
Value Percent: **75.000**
Continuous Index:
Within 8" of Joint: **NO**
Remarks:

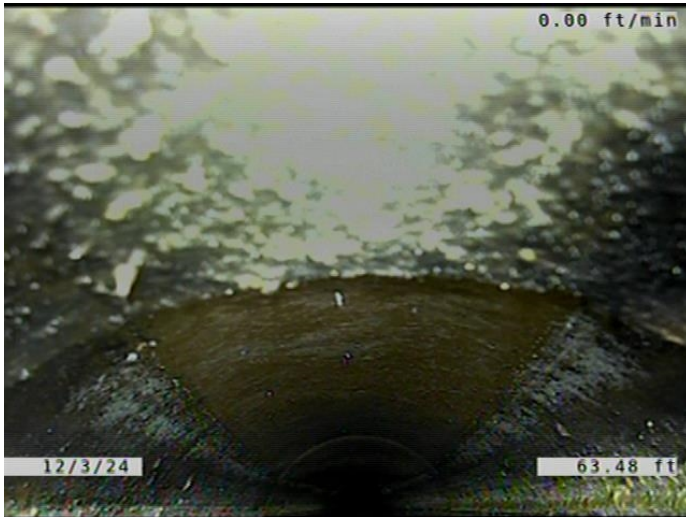
Code: **MWL**
Description: **Miscellaneous Water Level**

Distance (ft): **63.5**
Structural Grade: **0**
O&M Grade: **0**
Clock Start/From:
Clock To:
1st Value:
2nd Value:
Value Percent: **85.000**
Continuous Index:
Within 8" of Joint: **NO**
Remarks:

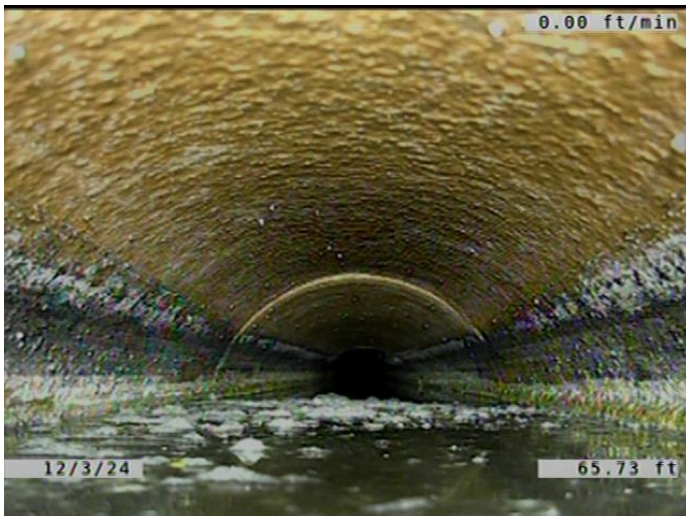
Code: **MWL**
Description: **Miscellaneous Water Level**

Distance (ft): **65.7**
Structural Grade: **0**
O&M Grade: **0**
Clock Start/From:
Clock To:
1st Value:
2nd Value:
Value Percent: **60.000**
Continuous Index:
Within 8" of Joint: **NO**
Remarks:

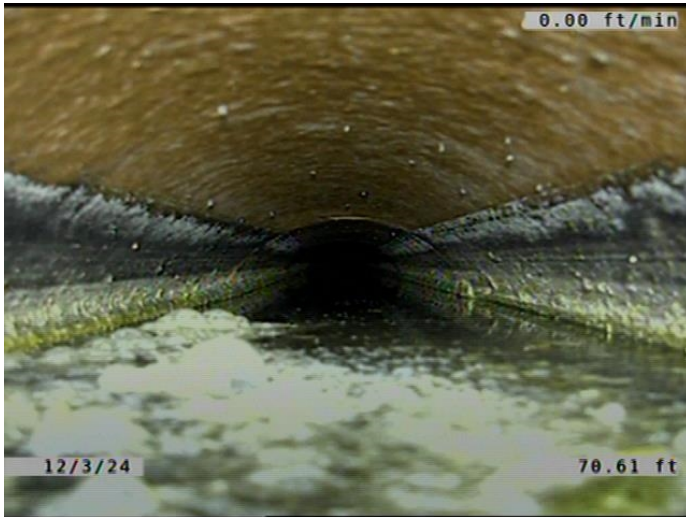
Code: **MWLS**
Description: **Miscellaneous Water Level Sag**

Distance (ft): **70.6**
Structural Grade: **4**
O&M Grade: **0**
Clock Start/From:
Clock To:
1st Value:
2nd Value:
Value Percent: **65.000**
Continuous Index: **S02**
Within 8" of Joint: **NO**
Remarks:

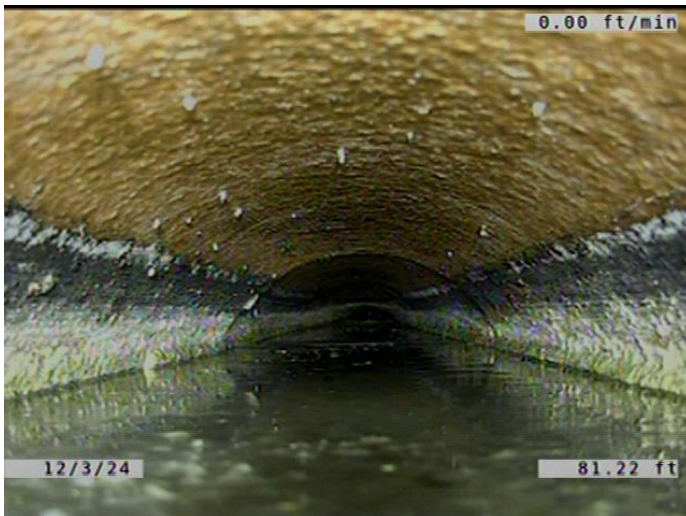
Code: **MWLS**
Description: **Miscellaneous Water Level Sag**

Distance (ft): **81.2**
Structural Grade: **4**
O&M Grade: **0**
Clock Start/From:
Clock To:
1st Value:
2nd Value:
Value Percent: **65.000**
Continuous Index: **F02**
Within 8" of Joint: **NO**
Remarks:

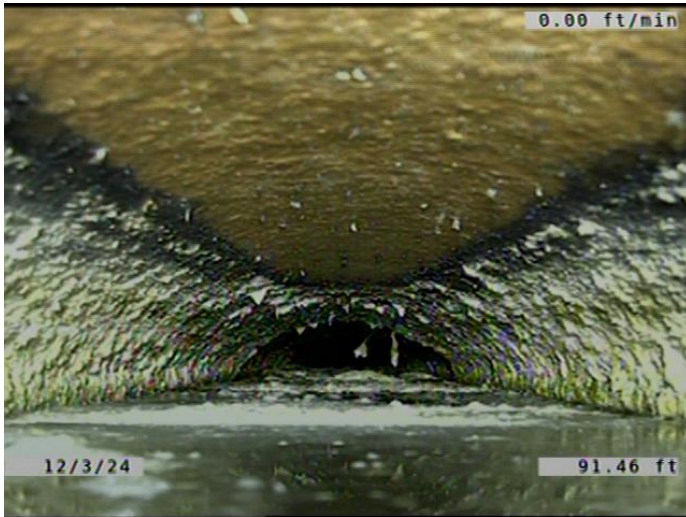
Code:	MWL
Description:	Miscellaneous Water Level
Distance (ft):	91.5
Structural Grade:	0
O&M Grade:	0
Clock Start/From:	
Clock To:	
1st Value:	
2nd Value:	
Value Percent:	75.000
Continuous Index:	
Within 8" of Joint:	NO
Remarks:

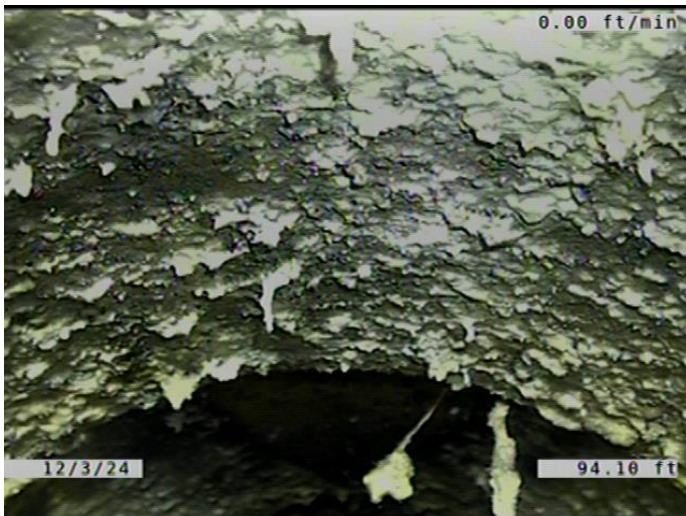
Code:	MWL
Description:	Miscellaneous Water Level
Distance (ft):	94.1
Structural Grade:	0
O&M Grade:	0
Clock Start/From:	
Clock To:	
1st Value:	
2nd Value:	
Value Percent:	85.000
Continuous Index:	
Within 8" of Joint:	NO
Remarks:

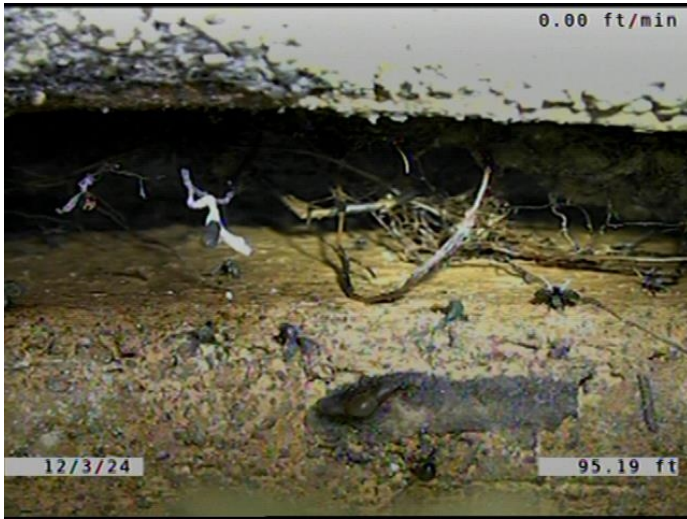
Code: **RFJ**
Description: **Roots Fine Joint**

Distance (ft): **95.2**
Structural Grade: **0**
O&M Grade: **1**
Clock Start/From: **10**
Clock To: **2**
1st Value:
2nd Value:
Value Percent:
Continuous Index:
Within 8" of Joint: **YES**
Remarks:

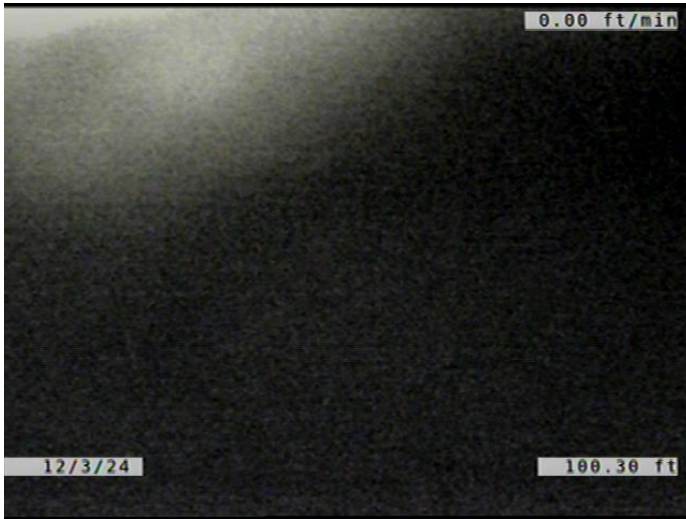
Code: **MWL**
Description: **Miscellaneous Water Level**

Distance (ft): **100.3**
Structural Grade: **0**
O&M Grade: **0**
Clock Start/From:
Clock To:
1st Value:
2nd Value:
Value Percent: **100.000**
Continuous Index:
Within 8" of Joint: **NO**
Remarks:

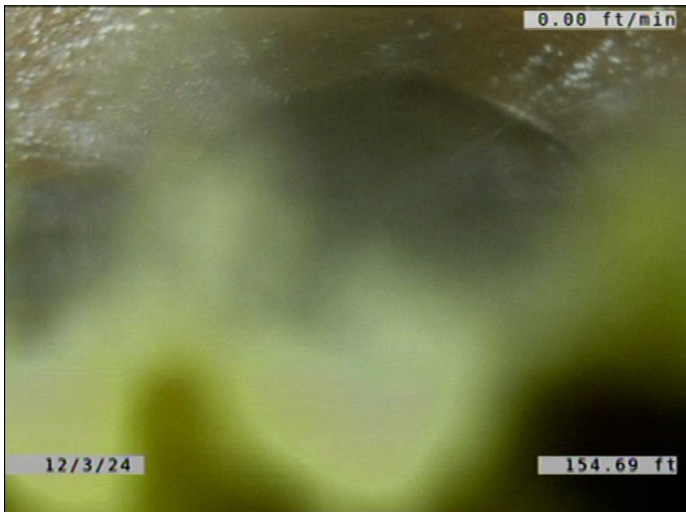
Code: **MGO**
Description: **Miscellaneous General Observation**

Distance (ft): **154.7**
Structural Grade: **0**
O&M Grade: **0**
Clock Start/From:
Clock To:
1st Value:
2nd Value:
Value Percent:
Continuous Index:
Within 8" of Joint: **NO**
Remarks: **Camera obscured**

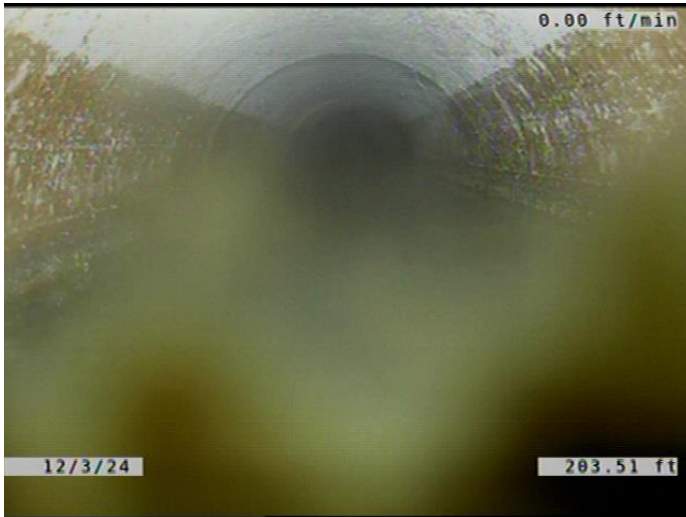
Code: **MWL**
Description: **Miscellaneous Water Level**

Distance (ft): **203.5**
Structural Grade: **0**
O&M Grade: **0**
Clock Start/From:
Clock To:
1st Value:
2nd Value:
Value Percent: **25.000**
Continuous Index:
Within 8" of Joint: **NO**
Remarks:

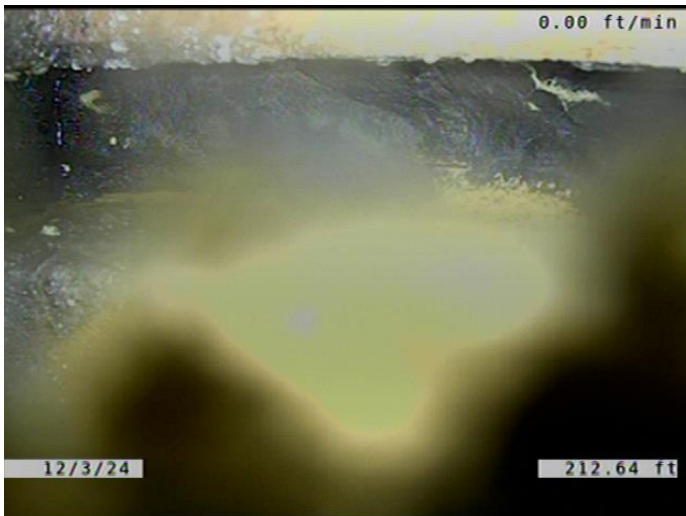
Code: **JAM**
Description: **Joint Angular Medium**

Distance (ft): **212.6**
Structural Grade: **3**
O&M Grade: **0**
Clock Start/From:
Clock To:
1st Value:
2nd Value:
Value Percent:
Continuous Index:
Within 8" of Joint: **NO**
Remarks:

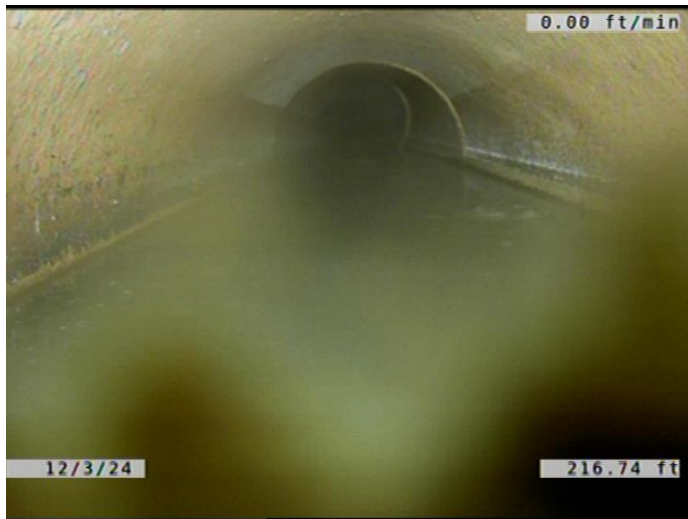
Code: **DAGS**
Description: **Deposits Attached Grease**

Distance (ft): **216.7**
Structural Grade: **0**
O&M Grade: **2**
Clock Start/From: **9**
Clock To: **3**
1st Value:
2nd Value:
Value Percent: **5.000**
Continuous Index: **F01**
Within 8" of Joint: **YES**
Remarks:

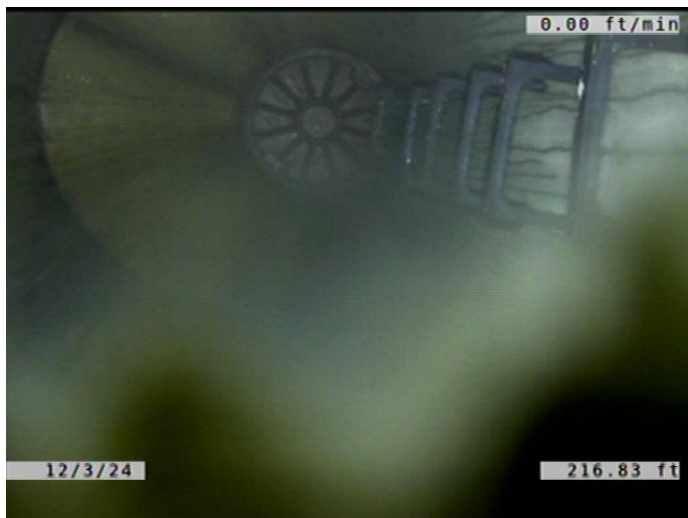
Code: **AMH**
Description: **Manhole**

Distance (ft): **216.8**
Structural Grade: **0**
O&M Grade: **0**
Clock Start/From:
Clock To:
1st Value:
2nd Value:
Value Percent:
Continuous Index:
Within 8" of Joint: **NO**
Remarks: **M-209-025**

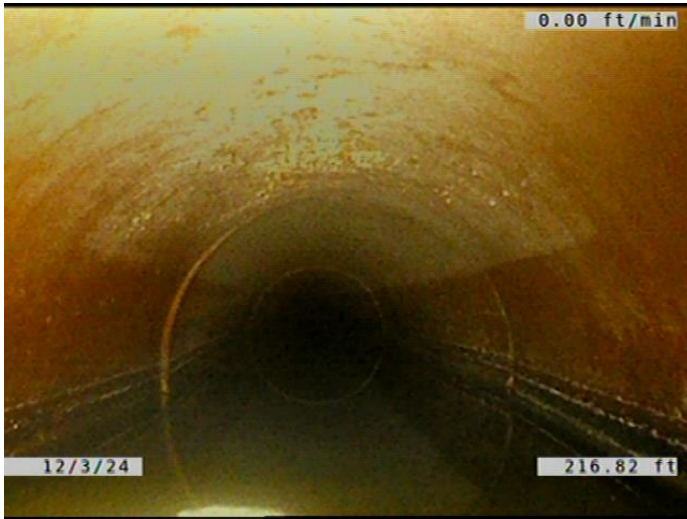
Code:	MGP
Description:	Miscellaneous General Photograph
Distance (ft):	216.8
Structural Grade:	0
O&M Grade:	0
Clock Start/From:	12
Clock To:	12
1st Value:	
2nd Value:	
Value Percent:	
Continuous Index:	
Within 8" of Joint:	NO
Remarks:	BACK UP CAMERA VIEW.
