RedZone
ROBOTICS

Street:	South Dekalb Street		Flow Control:	Not Controlled	
City:	Hobart, IN		Year Renewed:		
Location:	Easement/Right of Way		Tape/Media #:		
Purpose:	Sewer System Evaluation Survey (SS		Dia/Height:	10"	
Use:	Sanitary Sewage Pipe		Material:	VCP	
Drain Area:			Lining:	None	
Category:	NA				
Comment:					
Location Details:			Direction of Survey:	Upstream	
US MH:	M-507-085	DS MH:	M-507-027	Total Length Surveyed (ft):	170.6

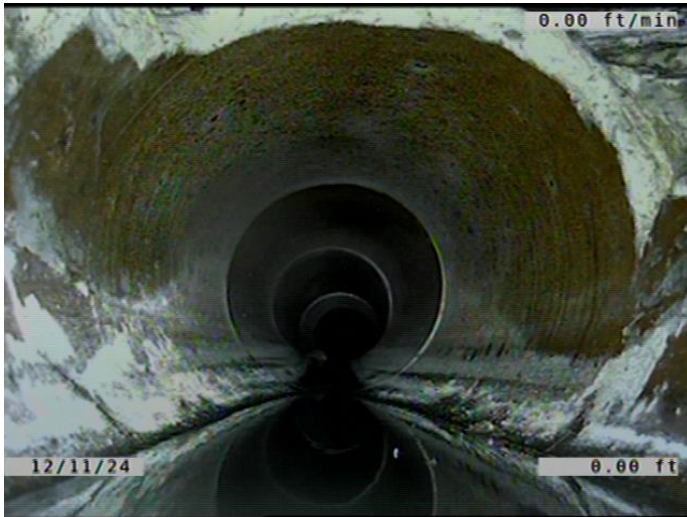
Code: **MWL**
Description: **Miscellaneous Water Level**

Distance (ft): **.0**
Structural Grade: **0**
O&M Grade: **0**
Clock Start/From:
Clock To:
1st Value:
2nd Value:
Value Percent: **5.000**
Continuous Index:
Within 8" of Joint: **NO**
Remarks:

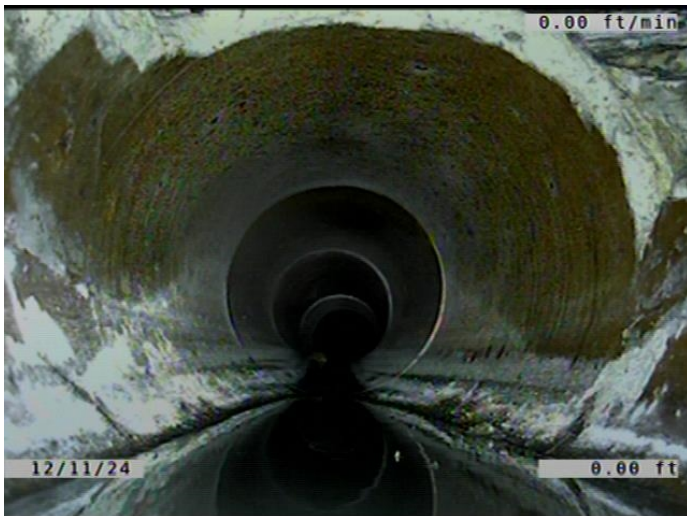
Code: **MWLS**
Description: **Miscellaneous Water Level Sag**

Distance (ft): **.0**
Structural Grade: **2**
O&M Grade: **0**
Clock Start/From:
Clock To:
1st Value:
2nd Value:
Value Percent: **10.000**
Continuous Index: **S01**
Within 8" of Joint: **NO**
Remarks:

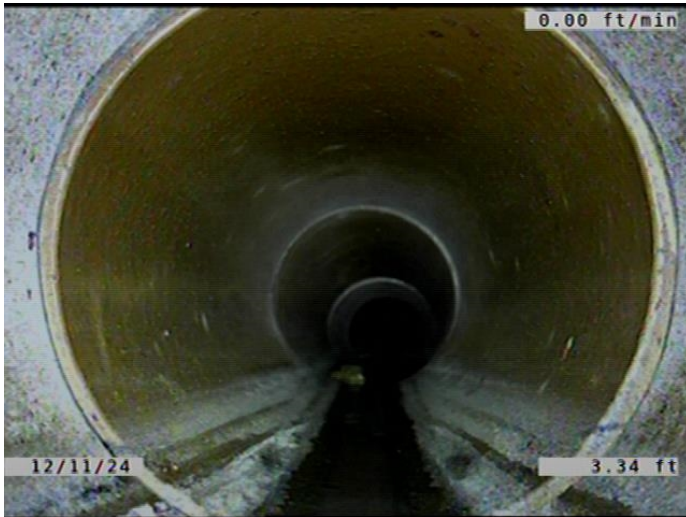
Code: **MWLS**
Description: **Miscellaneous Water Level Sag**

Distance (ft): **3.3**
Structural Grade: **2**
O&M Grade: **0**
Clock Start/From:
Clock To:
1st Value:
2nd Value:
Value Percent: **10.000**
Continuous Index: **F01**
Within 8" of Joint: **NO**
Remarks:

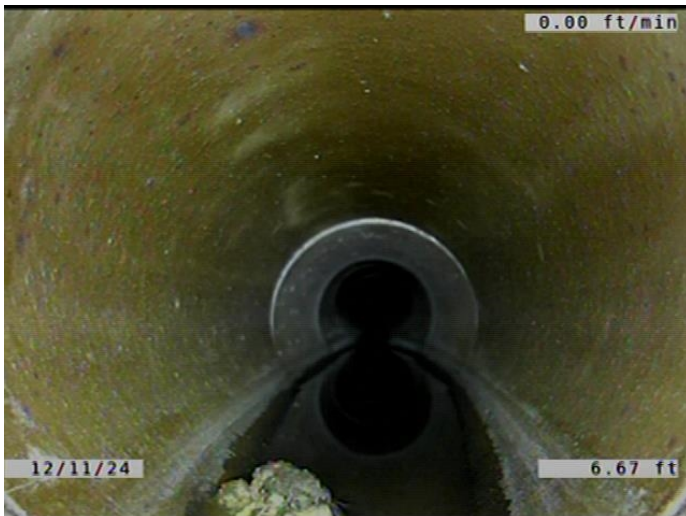
Code: **MWLS**
Description: **Miscellaneous Water Level Sag**

Distance (ft): **6.7**
Structural Grade: **2**
O&M Grade: **0**
Clock Start/From:
Clock To:
1st Value:
2nd Value:
Value Percent: **10.000**
Continuous Index: **S02**
Within 8" of Joint: **NO**
Remarks:

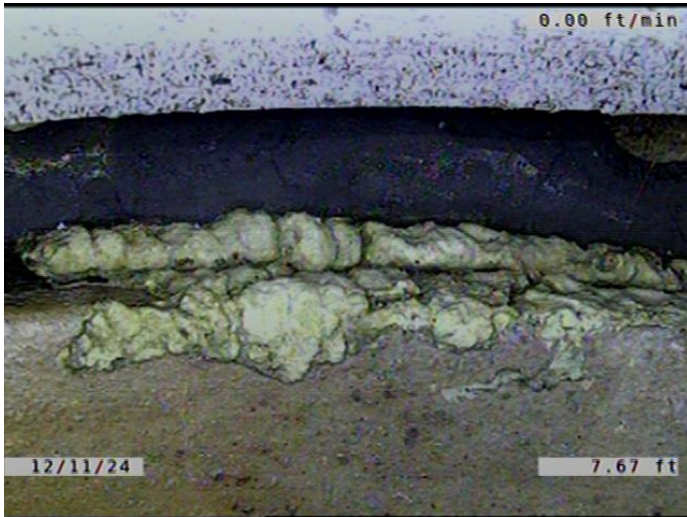
Code: **DAE**
Description: **Deposits Attached Encrustation**

Distance (ft): **7.7**
Structural Grade: **0**
O&M Grade: **2**
Clock Start/From: **8**
Clock To: **4**
1st Value:
2nd Value:
Value Percent: **5.000**
Continuous Index:
Within 8" of Joint: **YES**
Remarks:

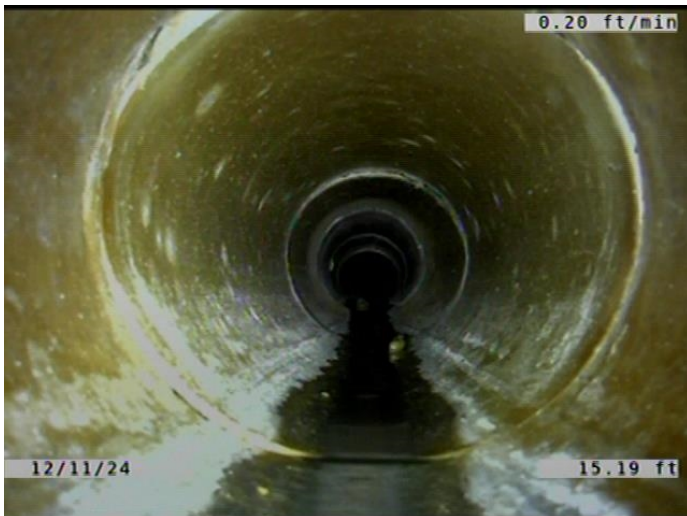
Code: **MWLS**
Description: **Miscellaneous Water Level Sag**

Distance (ft): **15.2**
Structural Grade: **2**
O&M Grade: **0**
Clock Start/From:
Clock To:
1st Value:
2nd Value:
Value Percent: **10.000**
Continuous Index: **F02**
Within 8" of Joint: **NO**
Remarks:

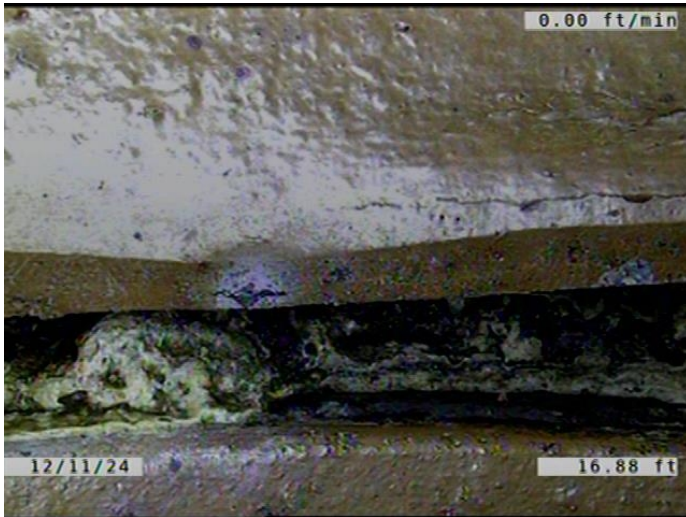
Code: **DAE**
Description: **Deposits Attached Encrustation**

Distance (ft): **16.9**
Structural Grade: **0**
O&M Grade: **2**
Clock Start/From: **7**
Clock To: **5**
1st Value:
2nd Value:
Value Percent: **5.000**
Continuous Index: **S03**
Within 8" of Joint: **YES**
Remarks:

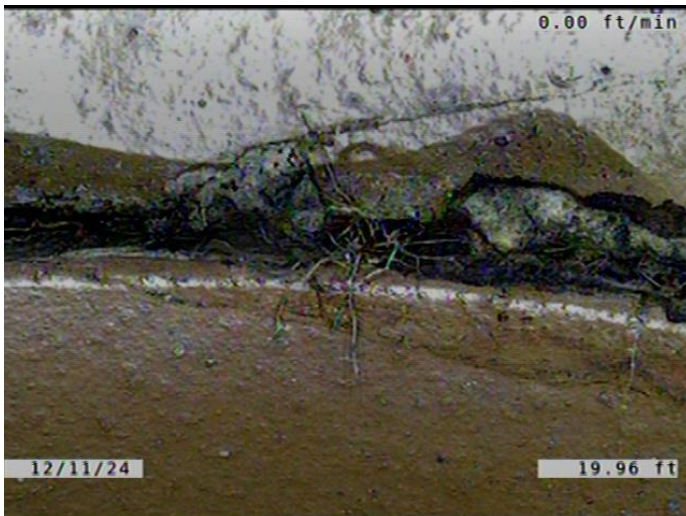
Code: **RFJ**
Description: **Roots Fine Joint**

Distance (ft): **19.9**
Structural Grade: **0**
O&M Grade: **1**
Clock Start/From: **10**
Clock To: **2**
1st Value:
2nd Value:
Value Percent:
Continuous Index: **S04**
Within 8" of Joint: **YES**
Remarks:

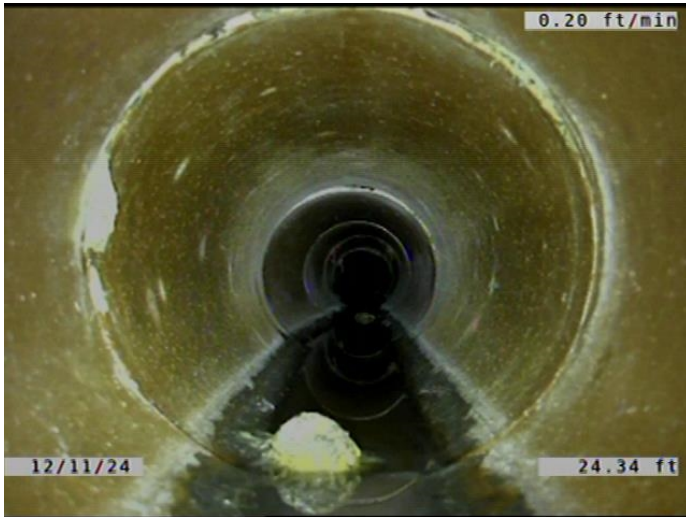
Code: **MWLS**
Description: **Miscellaneous Water Level Sag**

Distance (ft): **24.3**
Structural Grade: **2**
O&M Grade: **0**
Clock Start/From:
Clock To:
1st Value:
2nd Value:
Value Percent: **5.000**
Continuous Index: **S05**
Within 8" of Joint: **NO**
Remarks:

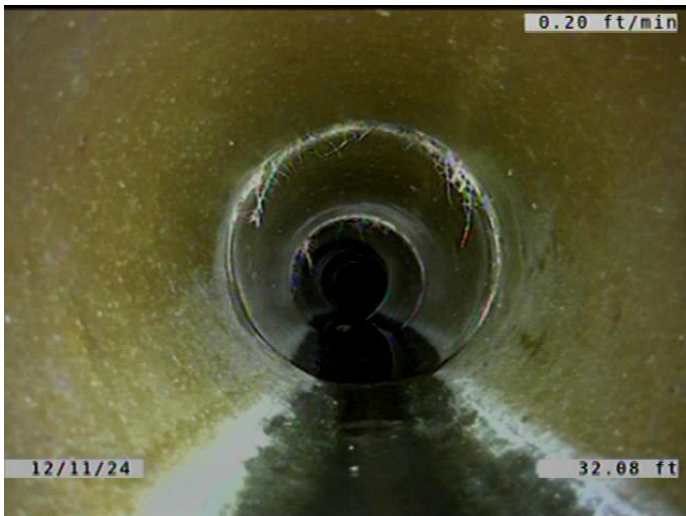
Code: **MWLS**
Description: **Miscellaneous Water Level Sag**

Distance (ft): **32.0**
Structural Grade: **2**
O&M Grade: **0**
Clock Start/From:
Clock To:
1st Value:
2nd Value:
Value Percent: **5.000**
Continuous Index: **F05**
Within 8" of Joint: **NO**
Remarks:

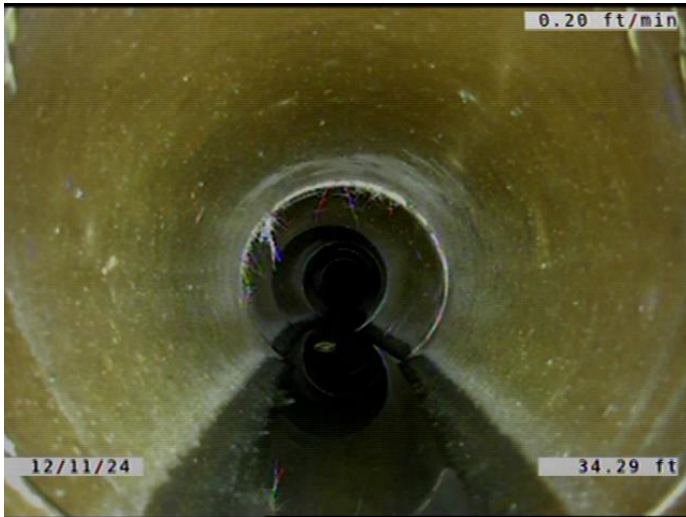
Code: **MWLS**
Description: **Miscellaneous Water Level Sag**

Distance (ft): **34.2**
Structural Grade: **2**
O&M Grade: **0**
Clock Start/From:
Clock To:
1st Value:
2nd Value:
Value Percent: **5.000**
Continuous Index: **S06**
Within 8" of Joint: **NO**
Remarks:

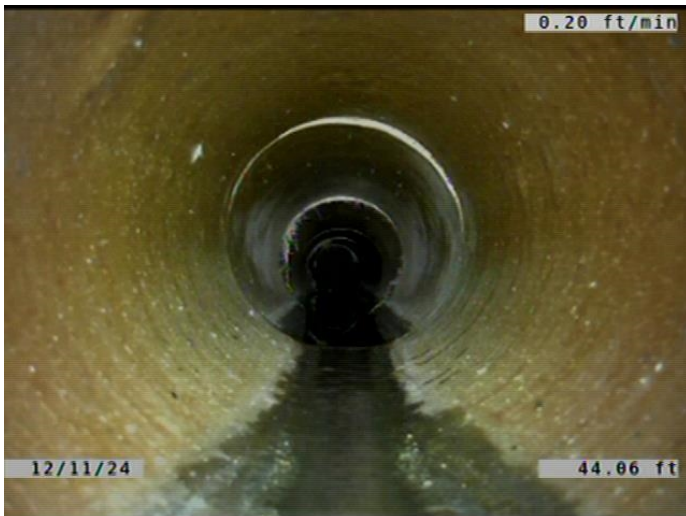
Code: **MWLS**
Description: **Miscellaneous Water Level Sag**

Distance (ft): **44.1**
Structural Grade: **2**
O&M Grade: **0**
Clock Start/From:
Clock To:
1st Value:
2nd Value:
Value Percent: **5.000**
Continuous Index: **F06**
Within 8" of Joint: **NO**
Remarks:

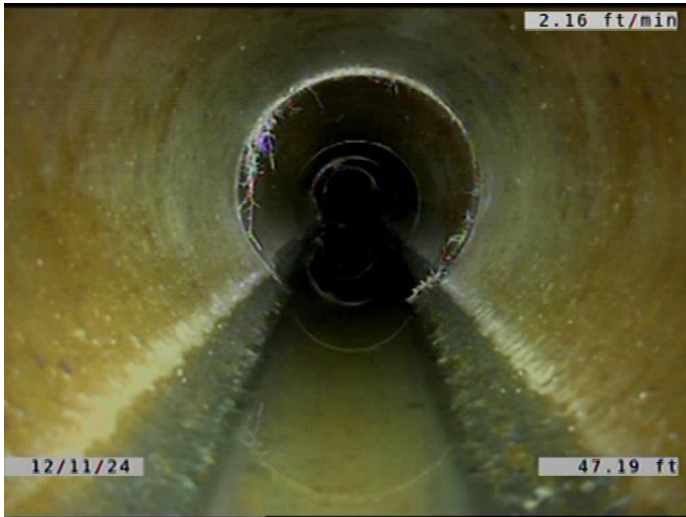
Code: **MWLS**
 Description: **Miscellaneous Water Level Sag**

Distance (ft): **47.1**
 Structural Grade: **2**
 O&M Grade: **0**
 Clock Start/From:
 Clock To:
 1st Value:
 2nd Value:
 Value Percent: **10.000**
 Continuous Index: **S07**
 Within 8" of Joint: **NO**
 Remarks:

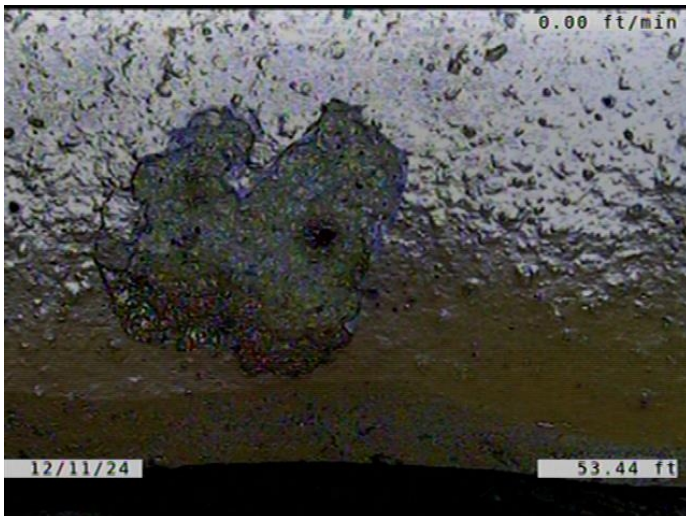
Code: **SSS**
 Description: **Surface Damage Surface Spalling**

Distance (ft): **53.4**
 Structural Grade: **2**
 O&M Grade: **0**
 Clock Start/From: **12**
 Clock To:
 1st Value:
 2nd Value:
 Value Percent:
 Continuous Index:
 Within 8" of Joint: **YES**
 Remarks:

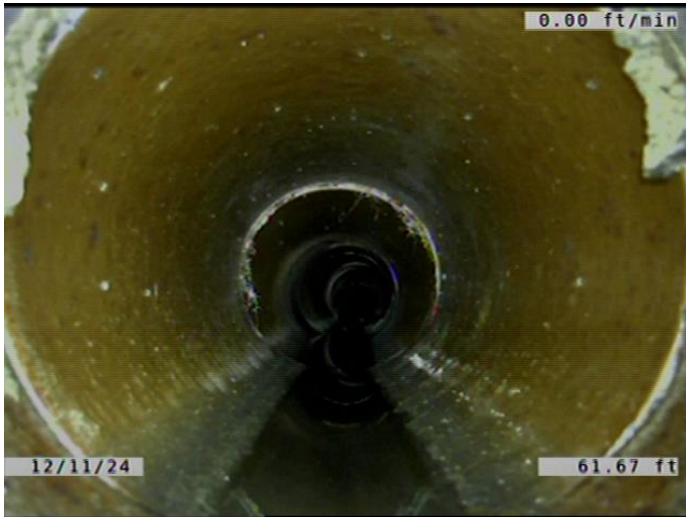
Code: **MWLS**
Description: **Miscellaneous Water Level Sag**

Distance (ft): **61.7**
Structural Grade: **2**
O&M Grade: **0**
Clock Start/From:
Clock To:
1st Value:
2nd Value:
Value Percent: **10.000**
Continuous Index: **F07**
Within 8" of Joint: **NO**
Remarks:

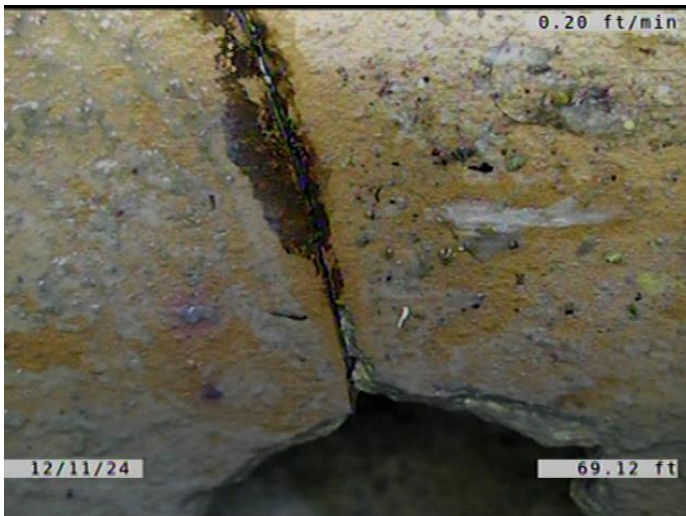
Code: **B**
Description: **Broken**

Distance (ft): **69.1**
Structural Grade: **4**
O&M Grade: **0**
Clock Start/From: **11**
Clock To: **1**
1st Value:
2nd Value:
Value Percent:
Continuous Index:
Within 8" of Joint: **YES**
Remarks:

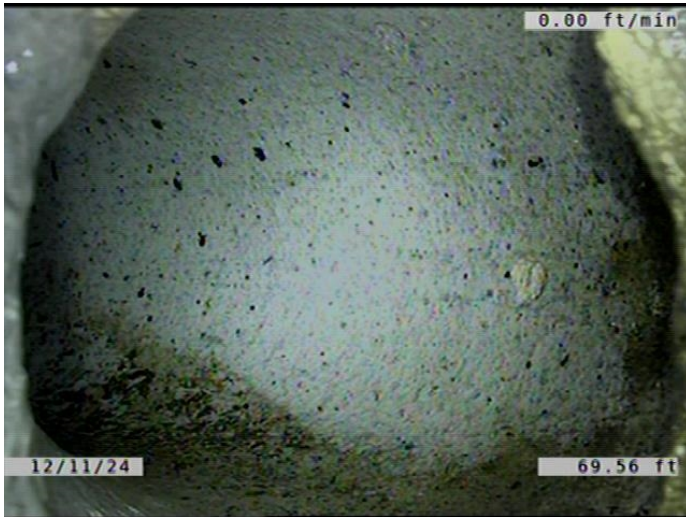
Code:	TBD
Description:	Tap Break-in/Hammer Defective
Distance (ft):	69.6
Structural Grade:	0
O&M Grade:	3
Clock Start/From:	12
Clock To:	
1st Value:	6.000
2nd Value:	
Value Percent:	
Continuous Index:	
Within 8" of Joint:	YES
Remarks:	SERVICE COMES FROM THE LEFT (NORTH). ACTIVITY. CONSTANTLY R

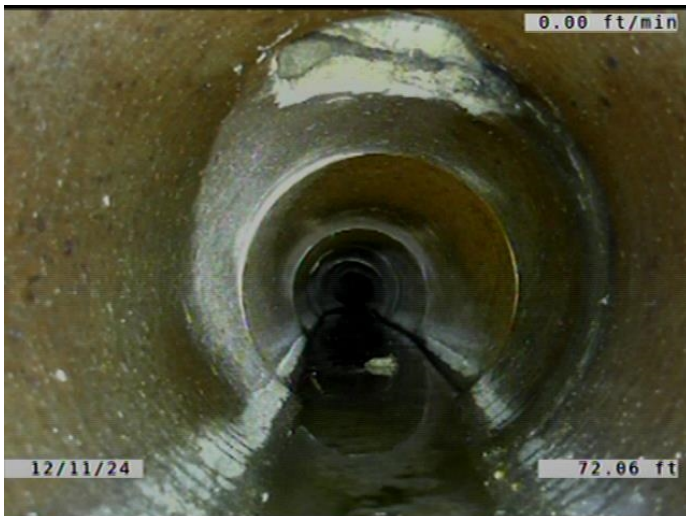
Code:	MWLS
Description:	Miscellaneous Water Level Sag
Distance (ft):	72.0
Structural Grade:	2
O&M Grade:	0
Clock Start/From:	
Clock To:	
1st Value:	
2nd Value:	
Value Percent:	15.000
Continuous Index:	S08
Within 8" of Joint:	NO
Remarks:

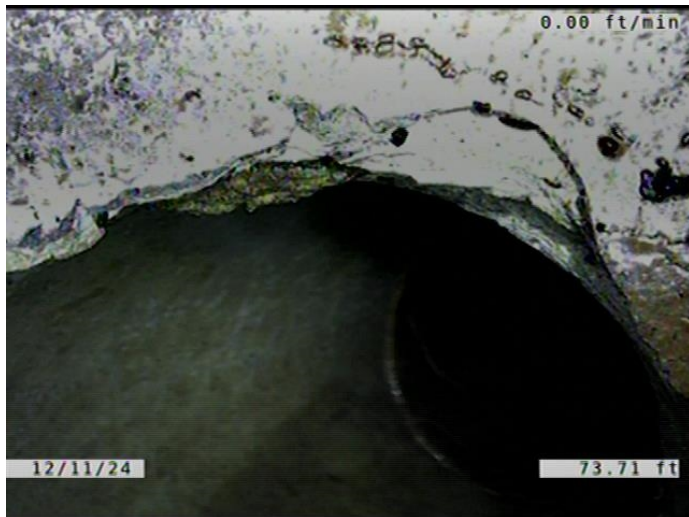
Code: **SSS**
 Description: **Surface Damage Surface Spalling**

Distance (ft): **73.7**
 Structural Grade: **2**
 O&M Grade: **0**
 Clock Start/From: **11**
 Clock To: **1**
 1st Value:
 2nd Value:
 Value Percent:
 Continuous Index:
 Within 8" of Joint: **YES**
 Remarks:

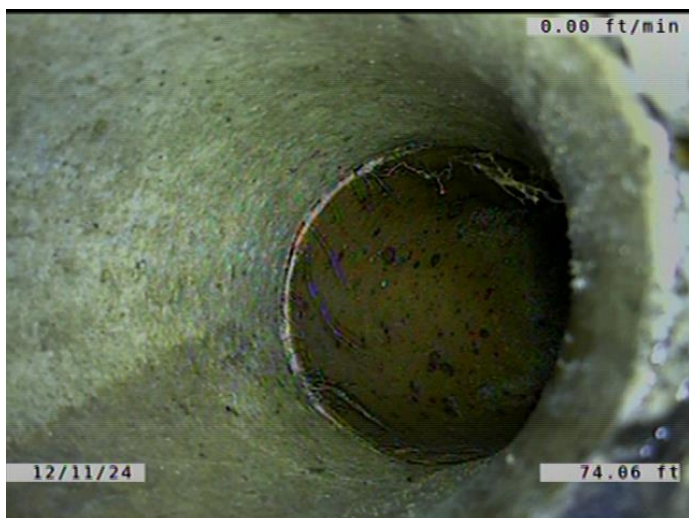
Code: **TBD**
 Description: **Tap Break-in/Hammer Defective**

Distance (ft): **74.1**
 Structural Grade: **0**
 O&M Grade: **3**
 Clock Start/From: **12**
 Clock To:
 1st Value: **6.000**
 2nd Value:
 Value Percent:
 Continuous Index:
 Within 8" of Joint: **YES**
 Remarks: **SERVICE COMES FROM THE RIGHT (SOUTH). ROOTS GROWING IN THE J**

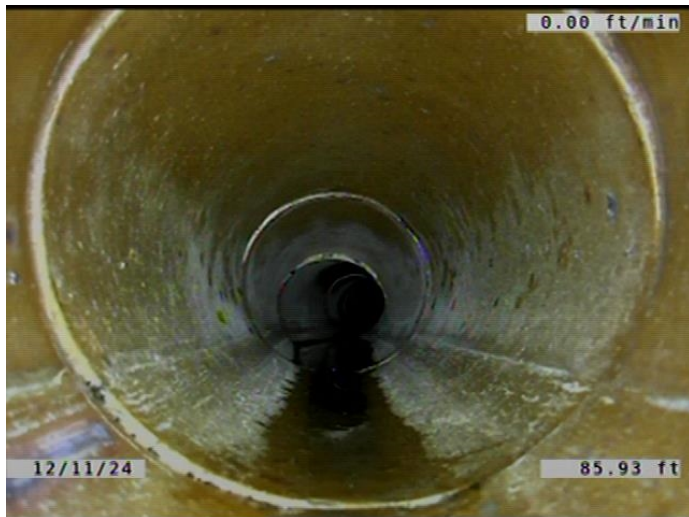
Code: **MWLS**
Description: **Miscellaneous Water Level Sag**

Distance (ft): **85.9**
Structural Grade: **2**
O&M Grade: **0**
Clock Start/From:
Clock To:
1st Value:
2nd Value:
Value Percent: **15.000**
Continuous Index: **F08**
Within 8" of Joint: **NO**
Remarks:

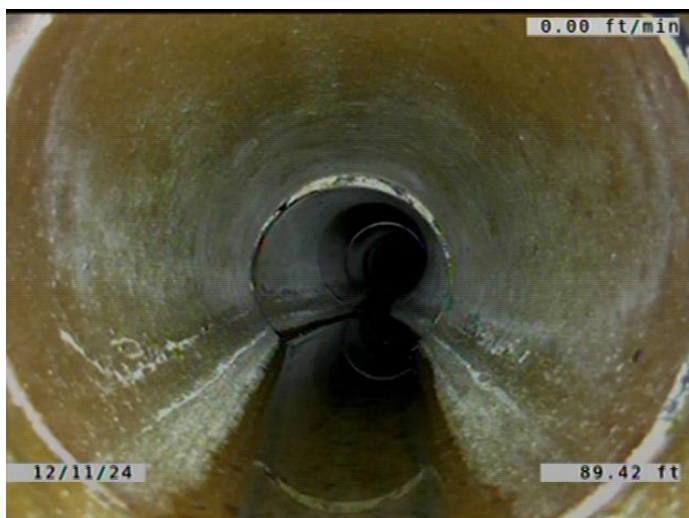
Code: **MWLS**
Description: **Miscellaneous Water Level Sag**

Distance (ft): **89.4**
Structural Grade: **2**
O&M Grade: **0**
Clock Start/From:
Clock To:
1st Value:
2nd Value:
Value Percent: **10.000**
Continuous Index: **S09**
Within 8" of Joint: **NO**
Remarks:

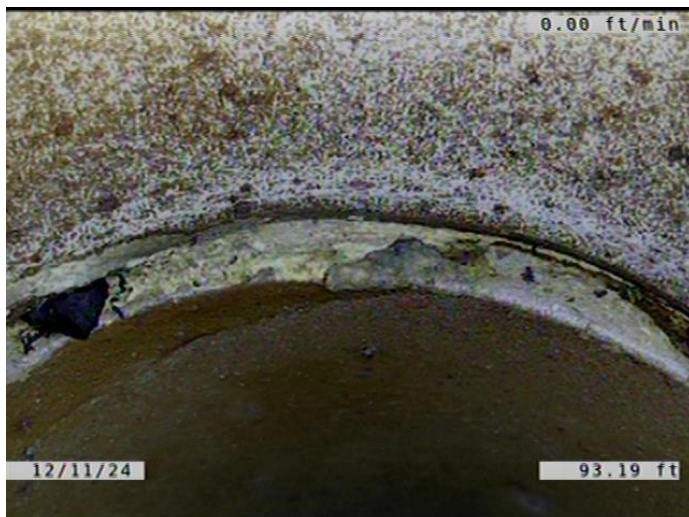
Code: **JOMD**
 Description: **Joint Offset Medium Defective**

Distance (ft): **93.2**
 Structural Grade: **3**
 O&M Grade: **0**
 Clock Start/From:
 Clock To:
 1st Value:
 2nd Value:
 Value Percent:
 Continuous Index:
 Within 8" of Joint: **NO**
 Remarks:

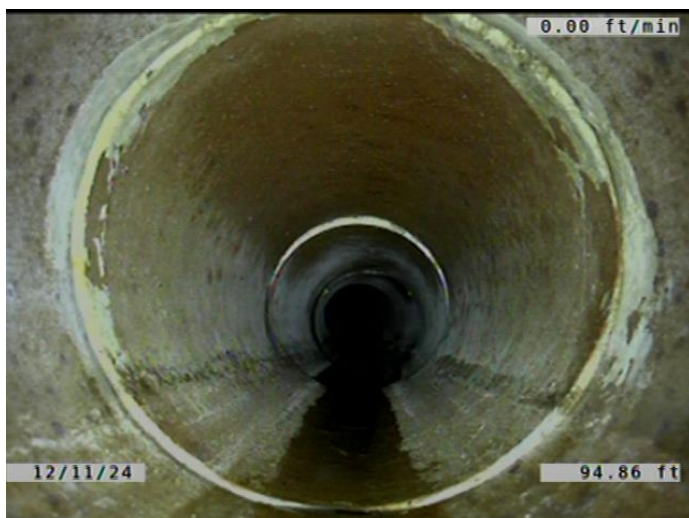
Code: **MWLS**
 Description: **Miscellaneous Water Level Sag**

Distance (ft): **94.8**
 Structural Grade: **2**
 O&M Grade: **0**
 Clock Start/From:
 Clock To:
 1st Value:
 2nd Value:
 Value Percent: **10.000**
 Continuous Index: **F09**
 Within 8" of Joint: **NO**
 Remarks:

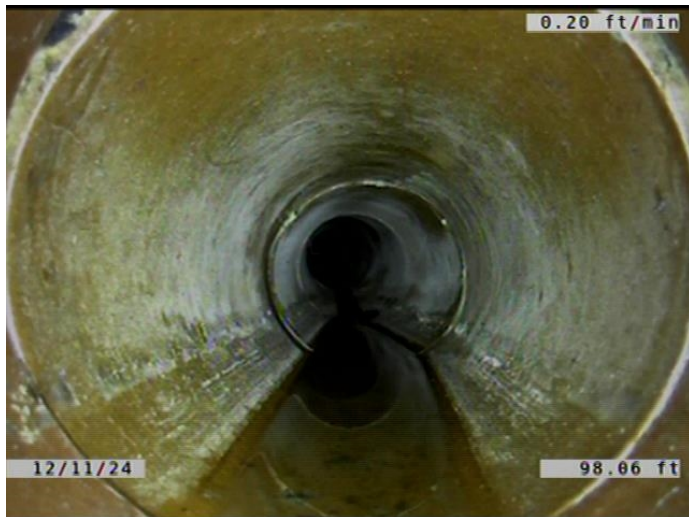
Code: **MWLS**
Description: **Miscellaneous Water Level Sag**

Distance (ft): **98.1**
Structural Grade: **2**
O&M Grade: **0**
Clock Start/From:
Clock To:
1st Value:
2nd Value:
Value Percent: **10.000**
Continuous Index: **S10**
Within 8" of Joint: **NO**
Remarks:

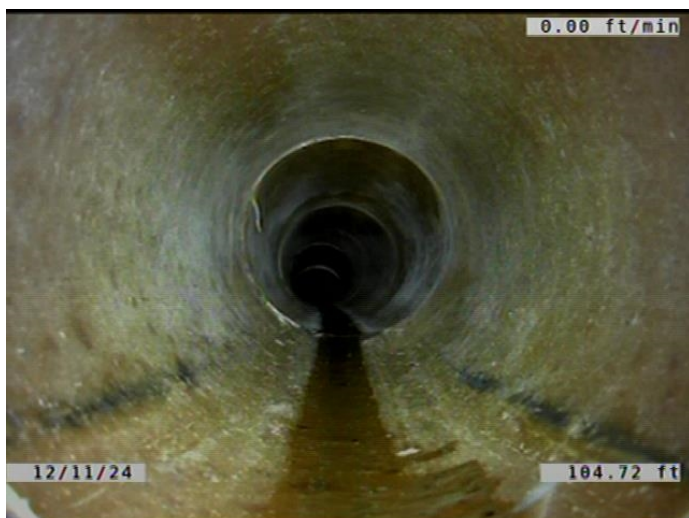
Code: **MWLS**
Description: **Miscellaneous Water Level Sag**

Distance (ft): **104.7**
Structural Grade: **2**
O&M Grade: **0**
Clock Start/From:
Clock To:
1st Value:
2nd Value:
Value Percent: **10.000**
Continuous Index: **F10**
Within 8" of Joint: **NO**
Remarks:

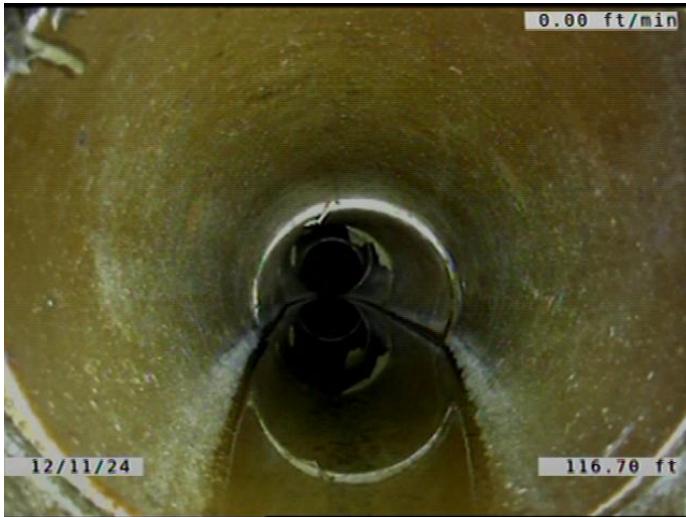
Code: **MWLS**
Description: **Miscellaneous Water Level Sag**

Distance (ft): **116.7**
Structural Grade: **2**
O&M Grade: **0**
Clock Start/From:
Clock To:
1st Value:
2nd Value:
Value Percent: **20.000**
Continuous Index: **S11**
Within 8" of Joint: **NO**
Remarks:

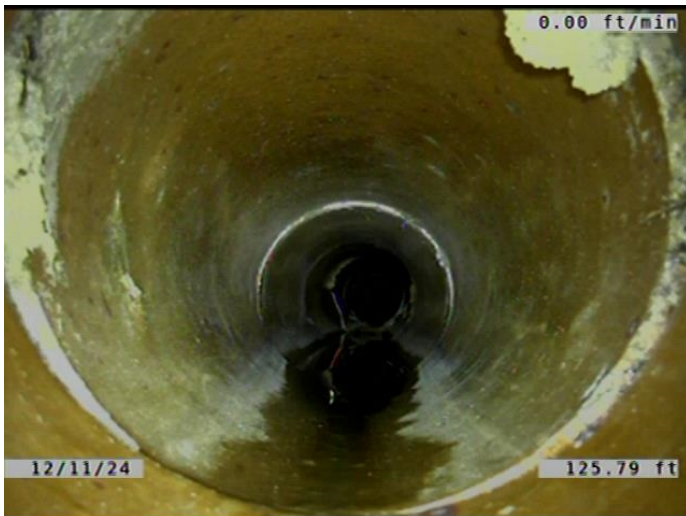
Code: **MWLS**
Description: **Miscellaneous Water Level Sag**

Distance (ft): **125.8**
Structural Grade: **2**
O&M Grade: **0**
Clock Start/From:
Clock To:
1st Value:
2nd Value:
Value Percent: **20.000**
Continuous Index: **F11**
Within 8" of Joint: **NO**
Remarks:

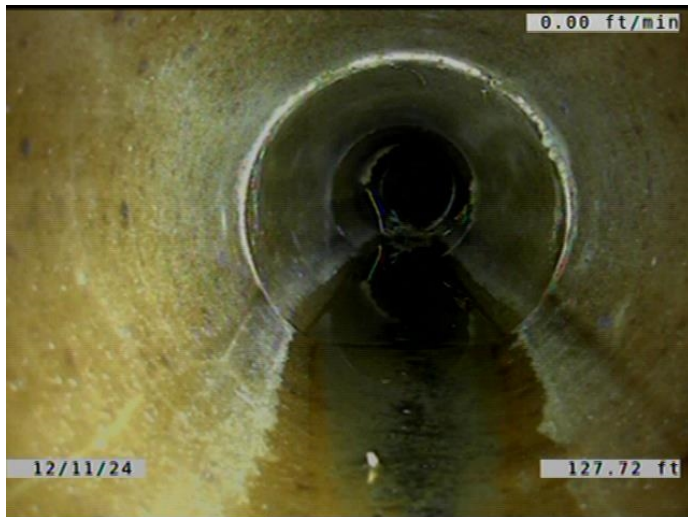
Code: **MWLS**
Description: **Miscellaneous Water Level Sag**

Distance (ft): **127.7**
Structural Grade: **2**
O&M Grade: **0**
Clock Start/From:
Clock To:
1st Value:
2nd Value:
Value Percent: **10.000**
Continuous Index: **S12**
Within 8" of Joint: **NO**
Remarks:

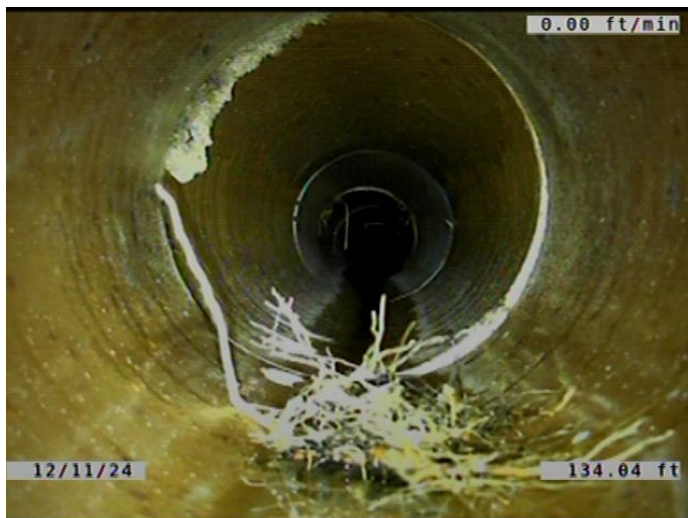
Code: **MWLS**
Description: **Miscellaneous Water Level Sag**

Distance (ft): **134.0**
Structural Grade: **2**
O&M Grade: **0**
Clock Start/From:
Clock To:
1st Value:
2nd Value:
Value Percent: **10.000**
Continuous Index: **F12**
Within 8" of Joint: **NO**
Remarks:

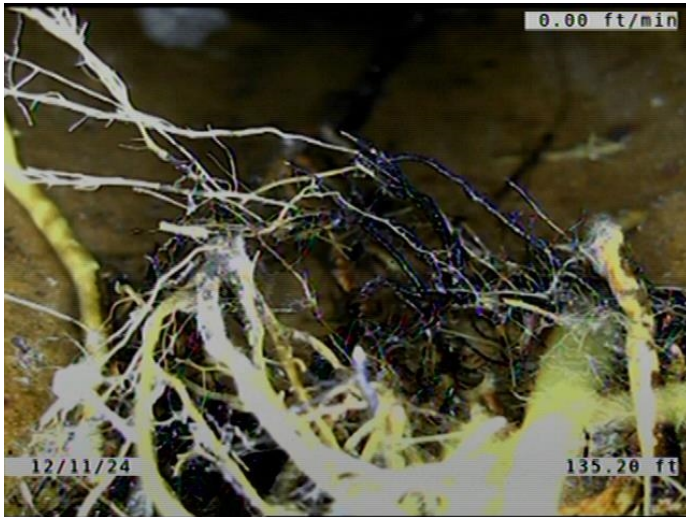
Code: **OBZ**
Description: **Obstruction Other**

Distance (ft): **135.2**
Structural Grade: **0**
O&M Grade: **2**
Clock Start/From: **6**
Clock To:
1st Value:
2nd Value:
Value Percent: **5.000**
Continuous Index:
Within 8" of Joint: **YES**
Remarks: **ROOTS THAT HAVE BEEN CUT FROM THE PIPE.**

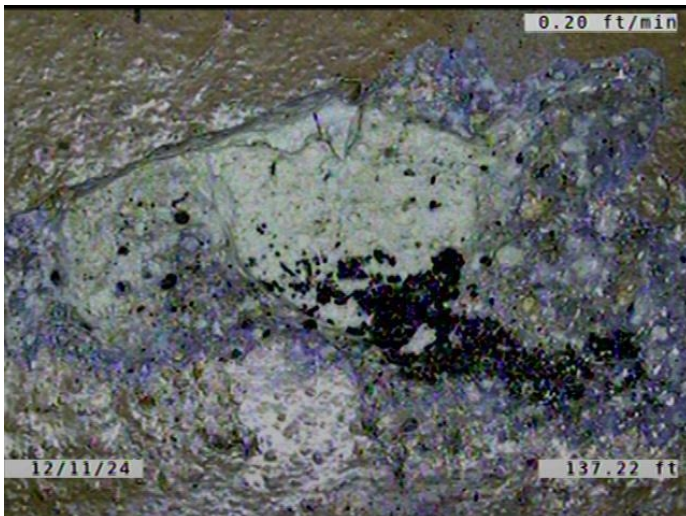
Code: **SSS**
Description: **Surface Damage Surface Spalling**

Distance (ft): **137.2**
Structural Grade: **2**
O&M Grade: **0**
Clock Start/From: **7**
Clock To:
1st Value:
2nd Value:
Value Percent:
Continuous Index:
Within 8" of Joint: **YES**
Remarks:

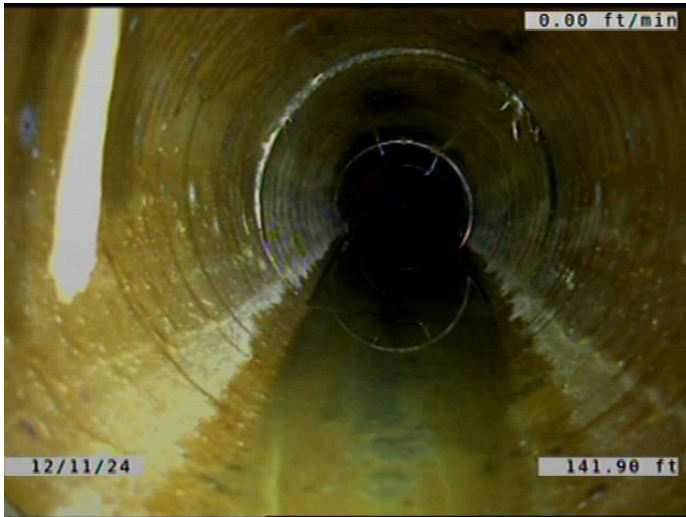
Code: **MWLS**
Description: **Miscellaneous Water Level Sag**

Distance (ft): **141.9**
Structural Grade: **2**
O&M Grade: **0**
Clock Start/From:
Clock To:
1st Value:
2nd Value:
Value Percent: **15.000**
Continuous Index: **S13**
Within 8" of Joint: **NO**
Remarks:

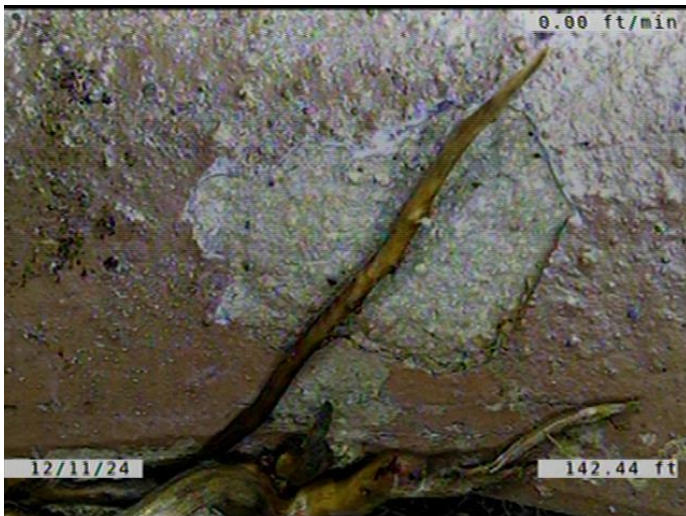
Code: **SSS**
Description: **Surface Damage Surface Spalling**

Distance (ft): **142.4**
Structural Grade: **2**
O&M Grade: **0**
Clock Start/From: **2**
Clock To:
1st Value:
2nd Value:
Value Percent:
Continuous Index:
Within 8" of Joint: **YES**
Remarks:

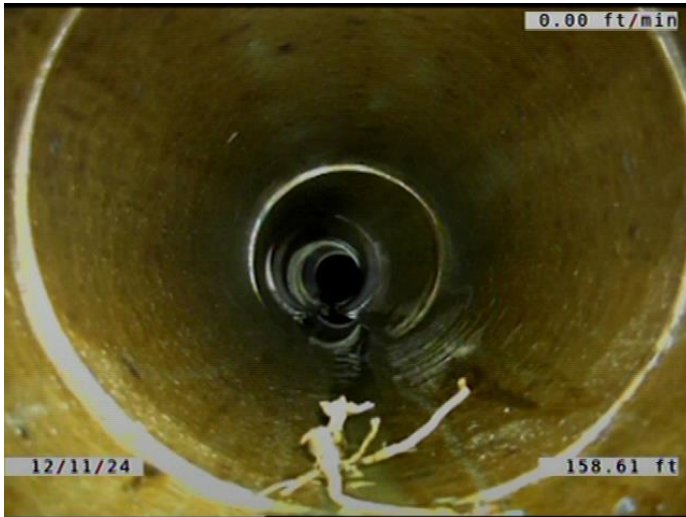
Code: **MWLS**
Description: **Miscellaneous Water Level Sag**

Distance (ft): **158.6**
Structural Grade: **2**
O&M Grade: **0**
Clock Start/From:
Clock To:
1st Value:
2nd Value:
Value Percent: **15.000**
Continuous Index: **F13**
Within 8" of Joint: **NO**
Remarks:

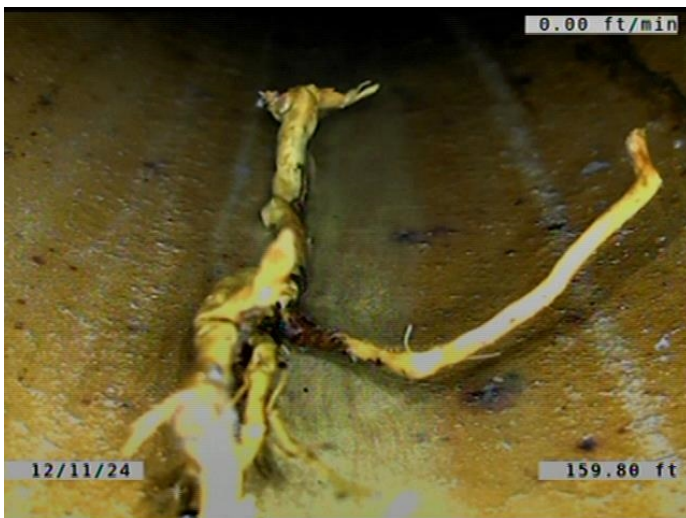
Code: **OBZ**
Description: **Obstruction Other**

Distance (ft): **159.8**
Structural Grade: **0**
O&M Grade: **2**
Clock Start/From: **6**
Clock To:
1st Value:
2nd Value:
Value Percent: **5.000**
Continuous Index:
Within 8" of Joint: **YES**
Remarks: **ROOTS THAT HAVE BEEN CUT FROM THE PIPE.**

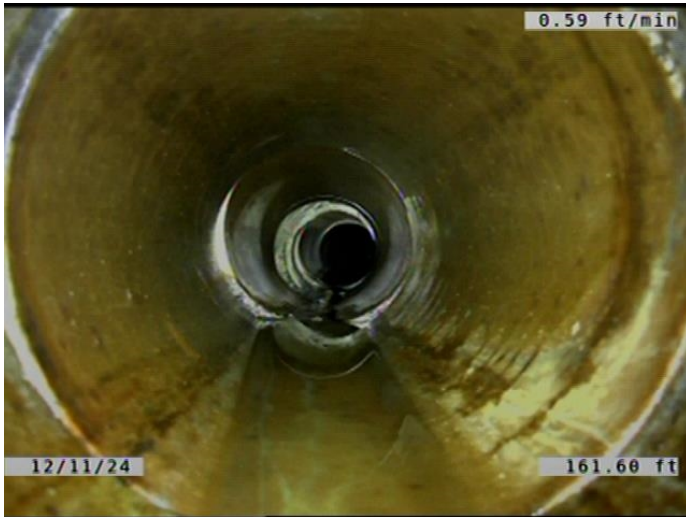
Code: **MWLS**
 Description: **Miscellaneous Water Level Sag**

Distance (ft): **161.5**
 Structural Grade: **2**
 O&M Grade: **0**
 Clock Start/From:
 Clock To:
 1st Value:
 2nd Value:
 Value Percent: **10.000**
 Continuous Index: **S14**
 Within 8" of Joint: **NO**
 Remarks:

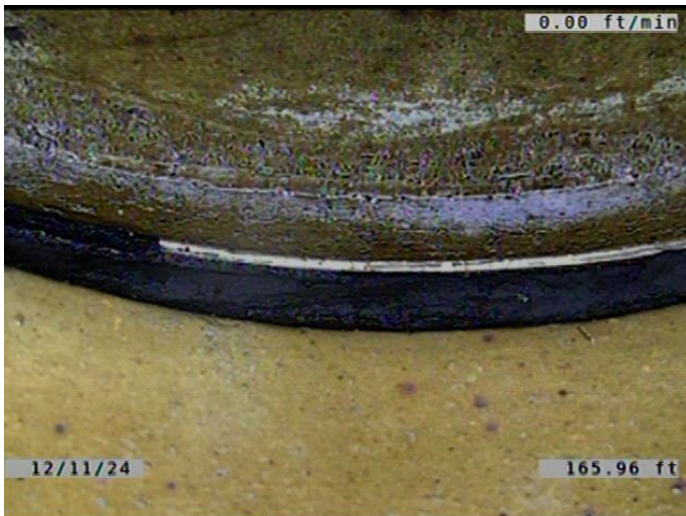
Code: **JOMD**
 Description: **Joint Offset Medium Defective**

Distance (ft): **166.0**
 Structural Grade: **3**
 O&M Grade: **0**
 Clock Start/From:
 Clock To:
 1st Value:
 2nd Value:
 Value Percent:
 Continuous Index:
 Within 8" of Joint: **NO**
 Remarks:

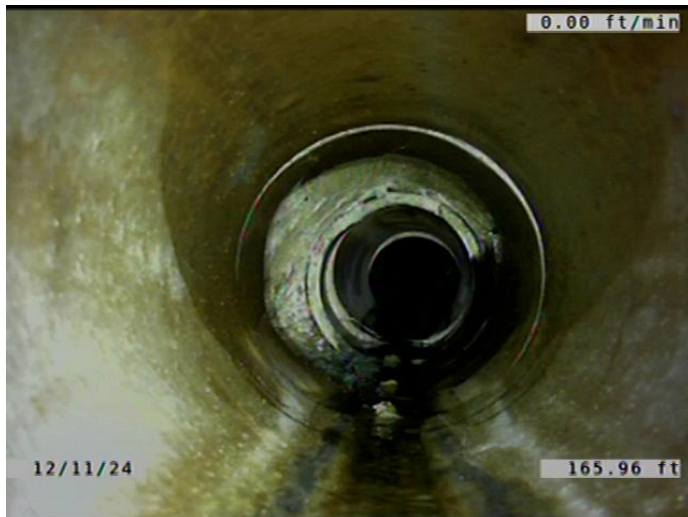
Code: **MWLS**
Description: **Miscellaneous Water Level Sag**

Distance (ft): **166.0**
Structural Grade: **2**
O&M Grade: **0**
Clock Start/From:
Clock To:
1st Value:
2nd Value:
Value Percent: **10.000**
Continuous Index: **F14**
Within 8" of Joint: **NO**
Remarks:

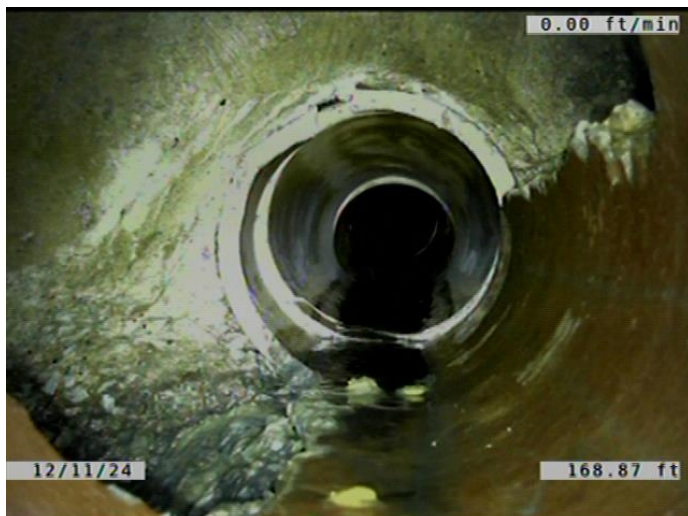
Code: **DAE**
Description: **Deposits Attached Encrustation**

Distance (ft): **168.9**
Structural Grade: **0**
O&M Grade: **2**
Clock Start/From: **7**
Clock To: **5**
1st Value:
2nd Value:
Value Percent: **5.000**
Continuous Index: **F03**
Within 8" of Joint: **YES**
Remarks:

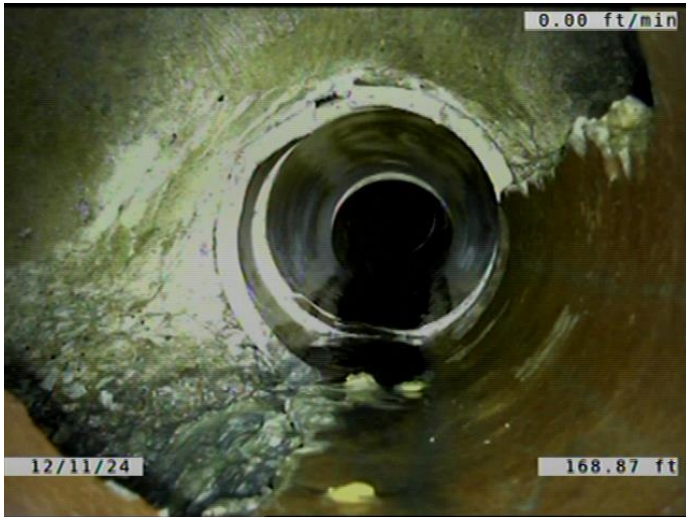
Code: **RFJ**
 Description: **Roots Fine Joint**

Distance (ft): **168.9**
 Structural Grade: **0**
 O&M Grade: **1**
 Clock Start/From: **10**
 Clock To: **2**
 1st Value:
 2nd Value:
 Value Percent:
 Continuous Index: **F04**
 Within 8" of Joint: **YES**
 Remarks:
