Profile/Photo Observation Report

Date:	12/11/2024	Weather:		Coding:	PACP 7.0
Pipe Length (ft):	196.0	Owner:	City of Hobart	Pre Clean:	Heavy Cleaning
P.O.#:	YES502259	Surveyor:	S. Bucklin	PSR:	P-507-028-027
Customer:	City of Hobart	Clean Date:	09/27/2024	Shape:	C

Street:	South Dekalb Street	Flow Control:	Not Controlled
City:	Hobart, IN	Year Renewed:	
Location:	Sidewalk	Tape/Media #:	
Purpose:	Sewer System Evaluation Survey (SS)	Dia/Height:	10"
Use:	Sanitary Sewage Pipe	Material:	VCP
Drain Area:		Lining:	None
Category:	NA		
Comment:			
Location Details:		Direction of Survey:	Downstream
US MH:	M-507-027	DS MH:	M-507-028
		Total Length Surveyed (ft):	191.9

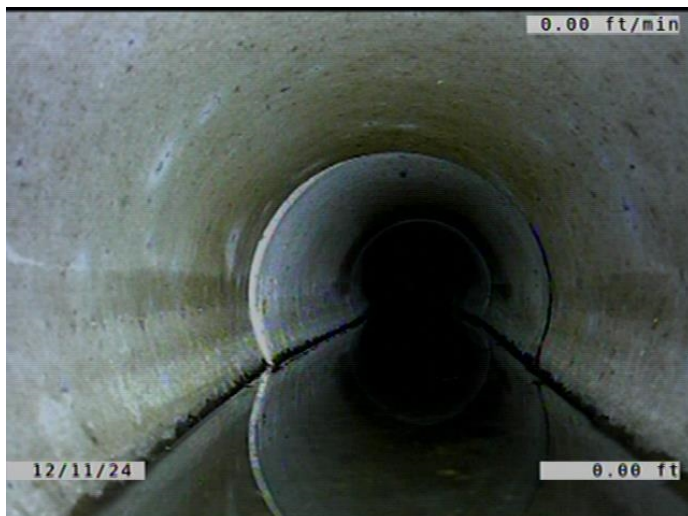
Code: **DSF**
Description: **Deposits Settled Fine**

Distance (ft): **.0**
Structural Grade: **0**
O&M Grade: **2**
Clock Start/From: **5**
Clock To: **7**
1st Value:
2nd Value:
Value Percent: **5.000**
Continuous Index: **S01**
Within 8" of Joint: **YES**
Remarks:

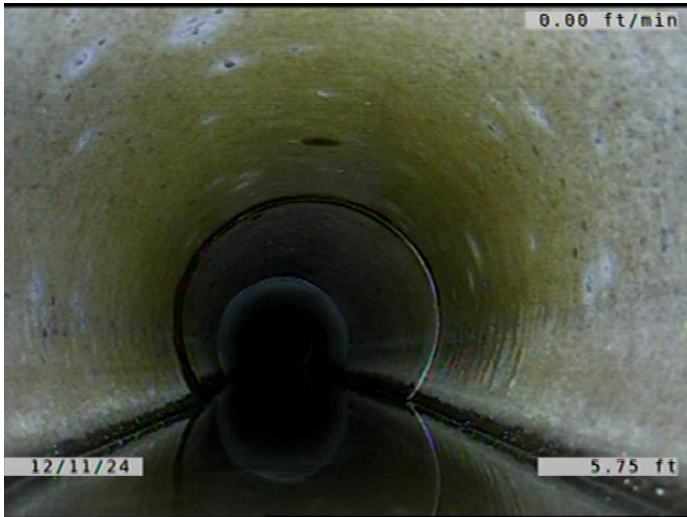
Code: **LL**
Description: **Line Left**

Distance (ft): **5.7**
Structural Grade: **0**
O&M Grade: **1**
Clock Start/From:
Clock To:
1st Value:
2nd Value:
Value Percent: **5.000**
Continuous Index:
Within 8" of Joint: **NO**
Remarks:

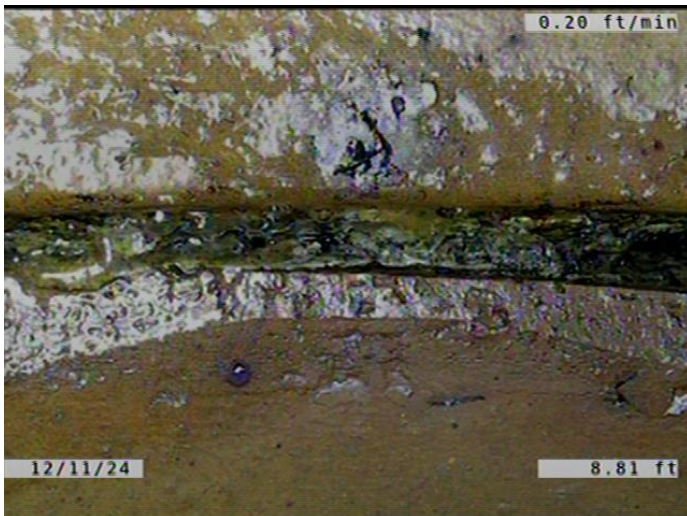
Code: **DAE**
Description: **Deposits Attached Encrustation**

Distance (ft): **8.8**
Structural Grade: **0**
O&M Grade: **2**
Clock Start/From: **8**
Clock To: **4**
1st Value:
2nd Value:
Value Percent: **5.000**
Continuous Index:
Within 8" of Joint: **YES**
Remarks: **JOINT IS WET ALSO.**

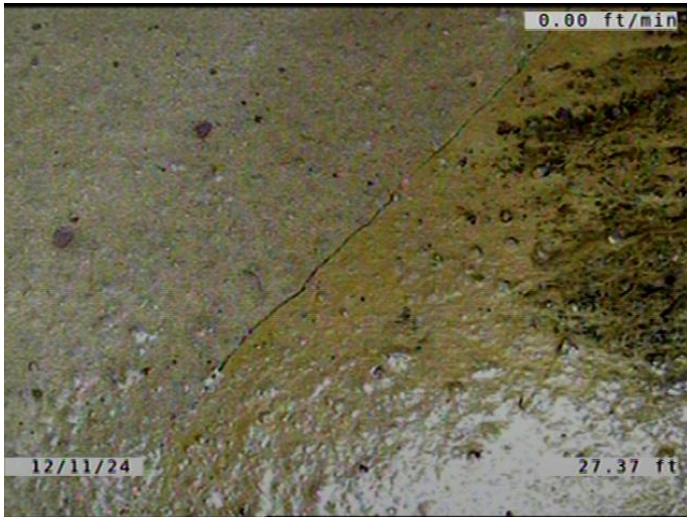
Code: **CS**
Description: **Crack Spiral**

Distance (ft): **27.4**
Structural Grade: **2**
O&M Grade: **0**
Clock Start/From: **4**
Clock To: **8**
1st Value:
2nd Value:
Value Percent:
Continuous Index:
Within 8" of Joint: **YES**
Remarks:

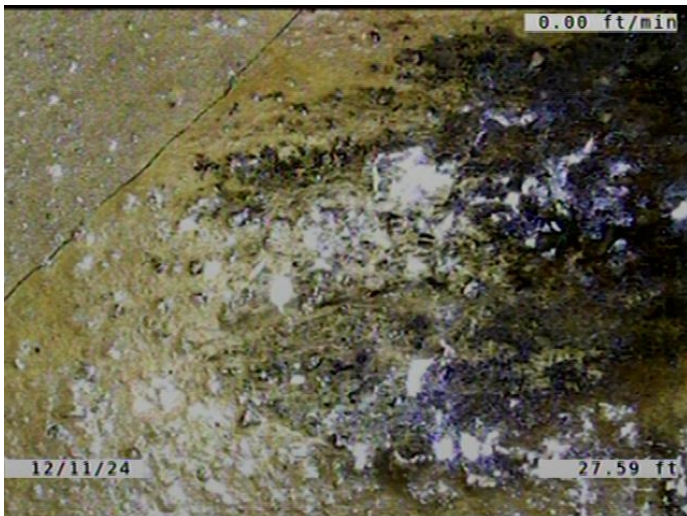
Code: **DAE**
Description: **Deposits Attached Encrustation**

Distance (ft): **27.6**
Structural Grade: **0**
O&M Grade: **2**
Clock Start/From: **4**
Clock To: **8**
1st Value:
2nd Value:
Value Percent: **5.000**
Continuous Index:
Within 8" of Joint: **YES**
Remarks:

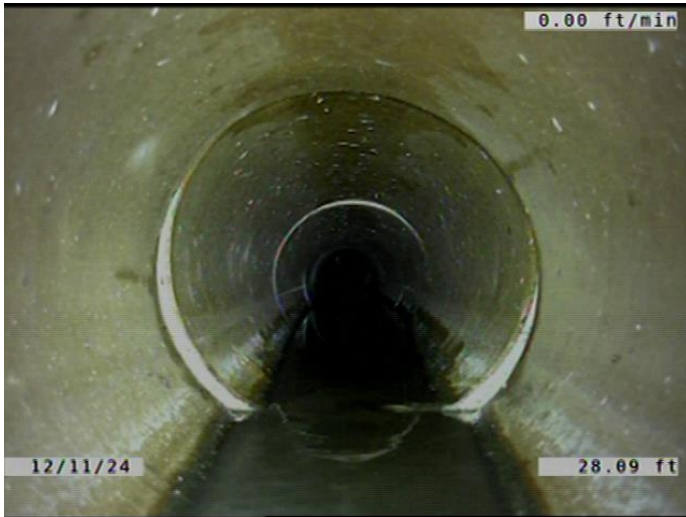
Code: **MWLS**
Description: **Miscellaneous Water Level Sag**

Distance (ft): **28.1**
Structural Grade: **2**
O&M Grade: **0**
Clock Start/From:
Clock To:
1st Value:
2nd Value:
Value Percent: **15.000**
Continuous Index: **S02**
Within 8" of Joint: **NO**
Remarks:

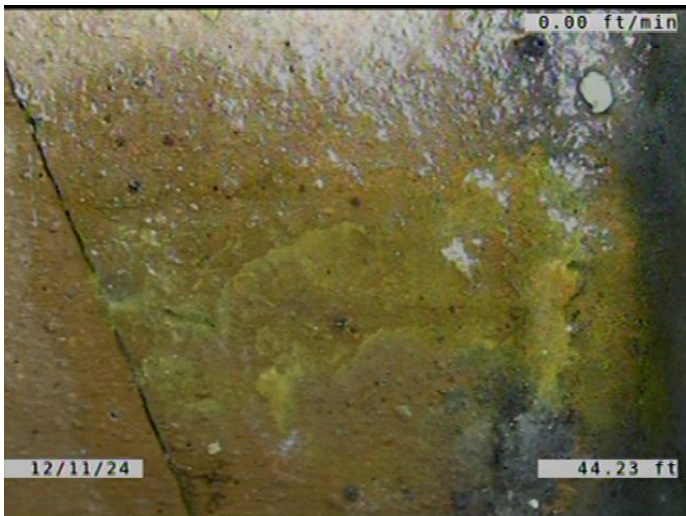
Code: **DAE**
Description: **Deposits Attached Encrustation**

Distance (ft): **44.2**
Structural Grade: **0**
O&M Grade: **2**
Clock Start/From: **8**
Clock To: **4**
1st Value:
2nd Value:
Value Percent: **5.000**
Continuous Index:
Within 8" of Joint: **YES**
Remarks:

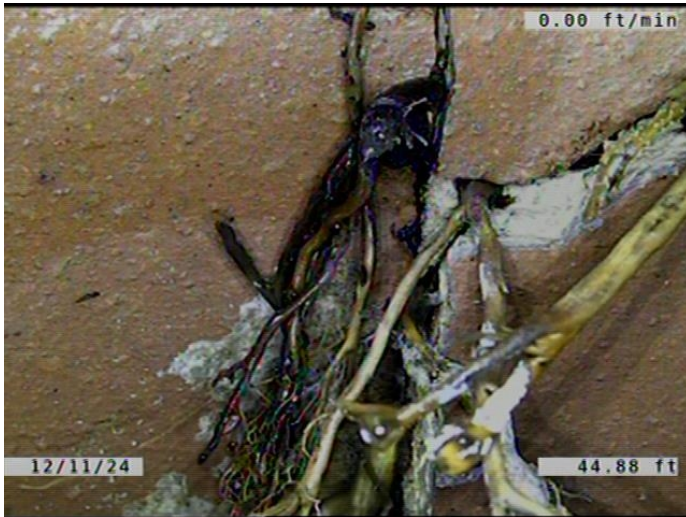
Code: **RMB**
 Description: **Roots Medium Barrel**

Distance (ft): **44.9**
 Structural Grade: **0**
 O&M Grade: **4**
 Clock Start/From: **10**
 Clock To: **2**
 1st Value:
 2nd Value:
 Value Percent: **15.000**
 Continuous Index:
 Within 8" of Joint: **NO**
 Remarks:

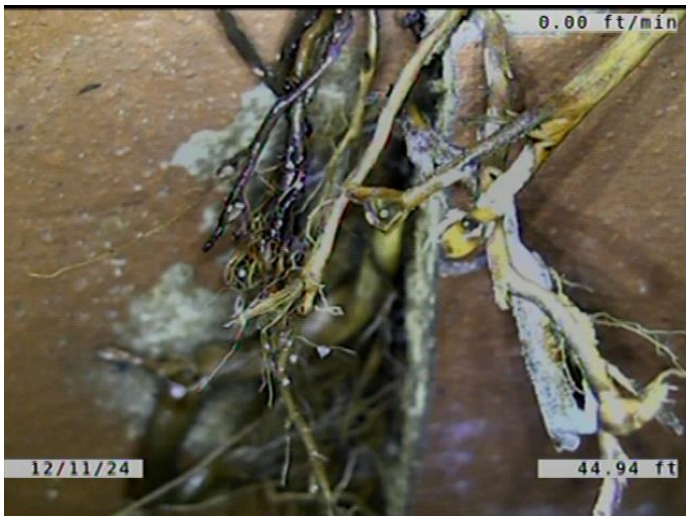
Code: **IWB**
 Description: **Infiltration Weeper Barrel**

Distance (ft): **44.9**
 Structural Grade: **0**
 O&M Grade: **2**
 Clock Start/From: **11**
 Clock To: **1**
 1st Value:
 2nd Value:
 Value Percent:
 Continuous Index:
 Within 8" of Joint: **YES**
 Remarks:

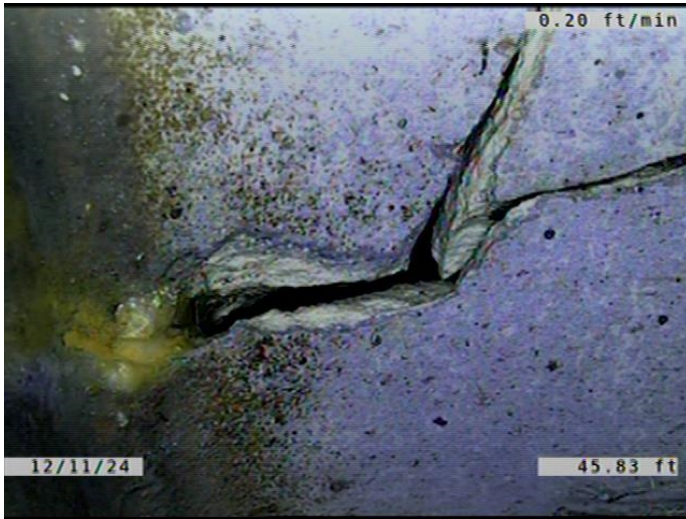
Code: **BVV**
Description: **Broken Void Visible**

Distance (ft): **45.8**
Structural Grade: **5**
O&M Grade: **0**
Clock Start/From: **7**
Clock To: **5**
1st Value:
2nd Value:
Value Percent:
Continuous Index:
Within 8" of Joint: **YES**
Remarks:

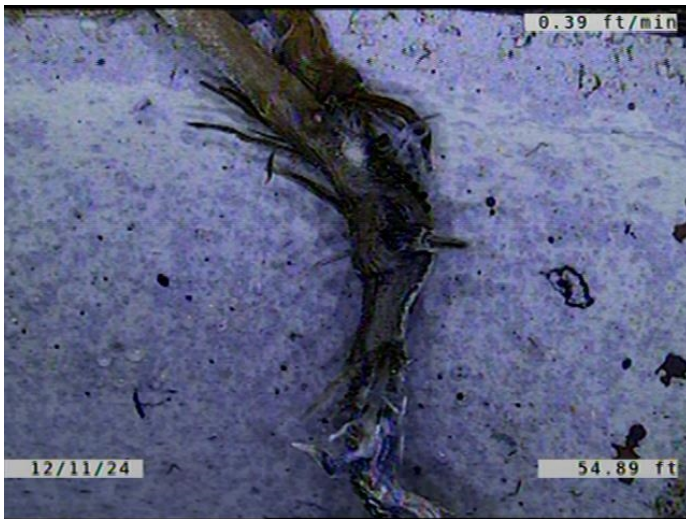
Code: **RFJ**
Description: **Roots Fine Joint**

Distance (ft): **54.9**
Structural Grade: **0**
O&M Grade: **1**
Clock Start/From: **10**
Clock To: **2**
1st Value:
2nd Value:
Value Percent:
Continuous Index:
Within 8" of Joint: **YES**
Remarks:

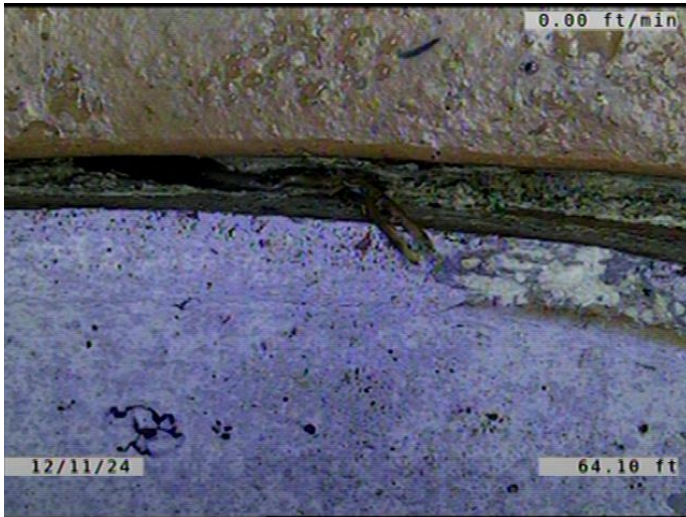
Code: **RFJ**
Description: **Roots Fine Joint**

Distance (ft): **64.1**
Structural Grade: **0**
O&M Grade: **1**
Clock Start/From: **1**
Clock To:
1st Value:
2nd Value:
Value Percent:
Continuous Index:
Within 8" of Joint: **YES**
Remarks:

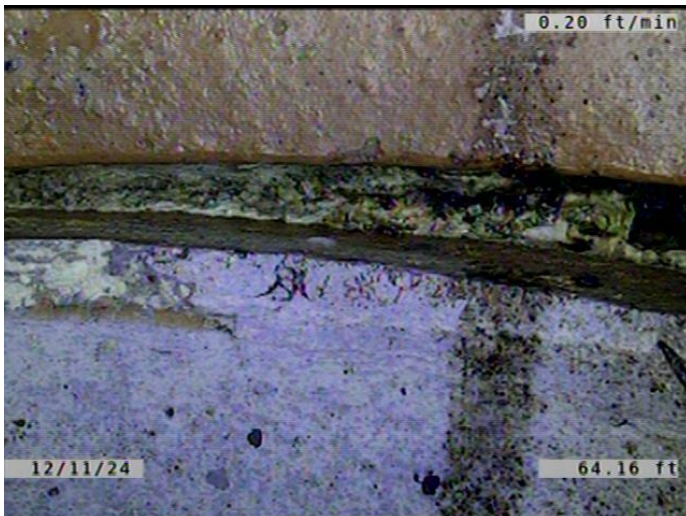
Code: **DAE**
Description: **Deposits Attached Encrustation**

Distance (ft): **64.1**
Structural Grade: **0**
O&M Grade: **2**
Clock Start/From: **8**
Clock To: **4**
1st Value:
2nd Value:
Value Percent: **5.000**
Continuous Index:
Within 8" of Joint: **YES**
Remarks:

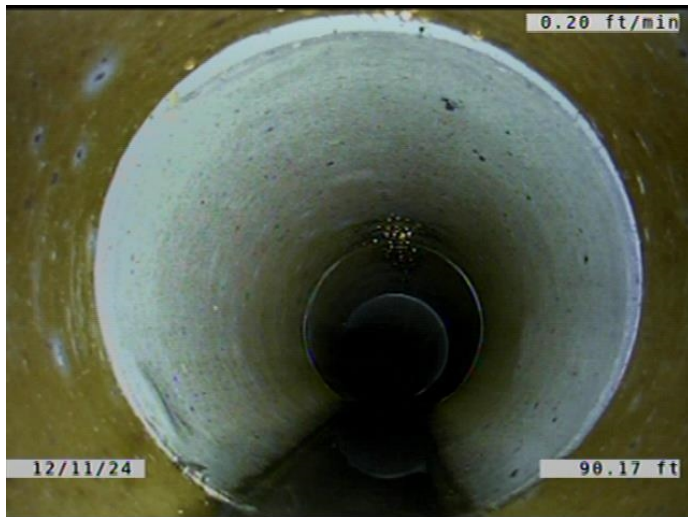
Code: **MWLS**
 Description: **Miscellaneous Water Level Sag**

Distance (ft): **90.2**
 Structural Grade: **2**
 O&M Grade: **0**
 Clock Start/From:
 Clock To:
 1st Value:
 2nd Value:
 Value Percent: **15.000**
 Continuous Index: **F02**
 Within 8" of Joint: **NO**
 Remarks:

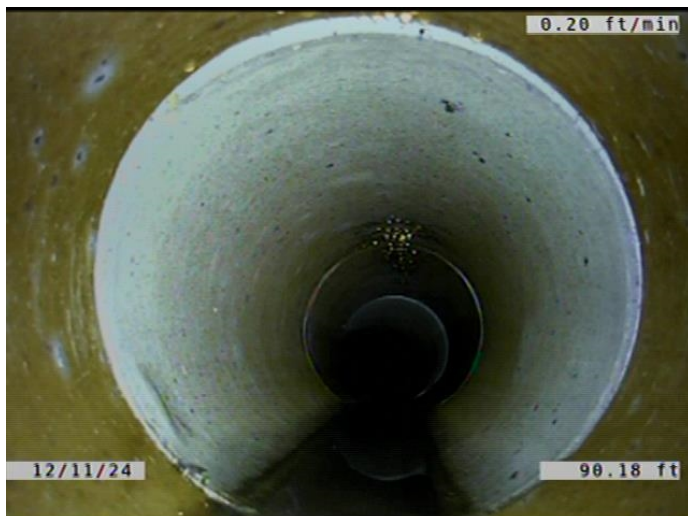
Code: **DSF**
 Description: **Deposits Settled Fine**

Distance (ft): **90.2**
 Structural Grade: **0**
 O&M Grade: **2**
 Clock Start/From: **5**
 Clock To: **7**
 1st Value:
 2nd Value:
 Value Percent: **5.000**
 Continuous Index: **F01**
 Within 8" of Joint: **YES**
 Remarks:

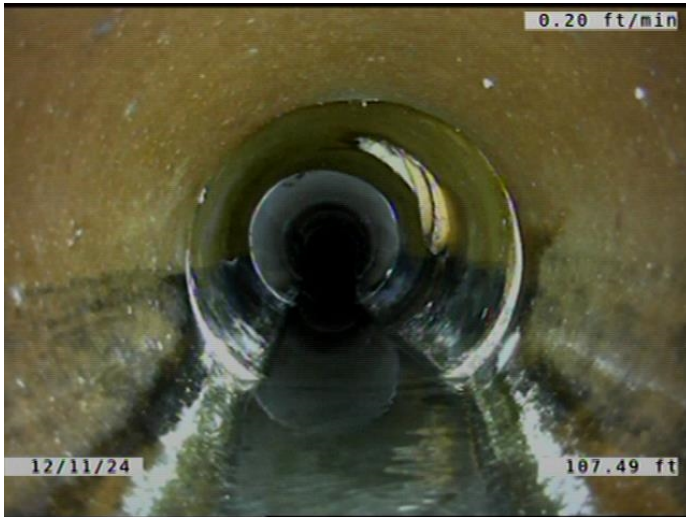
Code: **MWLS**
Description: **Miscellaneous Water Level Sag**

Distance (ft): **107.5**
Structural Grade: **2**
O&M Grade: **0**
Clock Start/From:
Clock To:
1st Value:
2nd Value:
Value Percent: **15.000**
Continuous Index: **S03**
Within 8" of Joint: **NO**
Remarks:

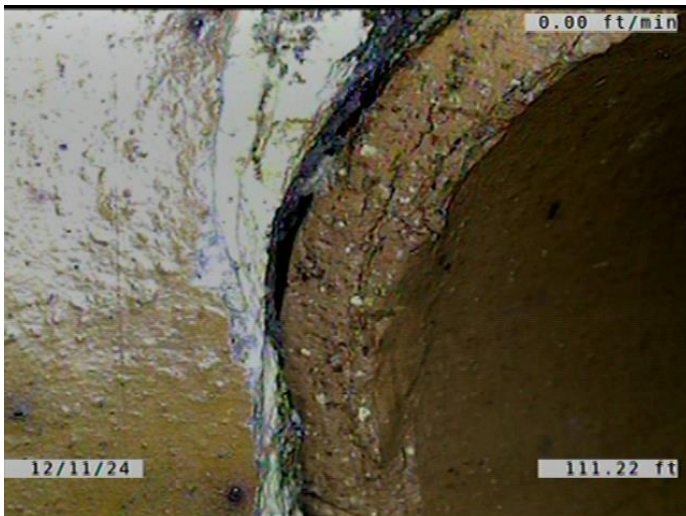
Code: **SSS**
Description: **Surface Damage Surface Spalling**

Distance (ft): **111.2**
Structural Grade: **2**
O&M Grade: **0**
Clock Start/From: **12**
Clock To: **3**
1st Value:
2nd Value:
Value Percent:
Continuous Index:
Within 8" of Joint: **YES**
Remarks:

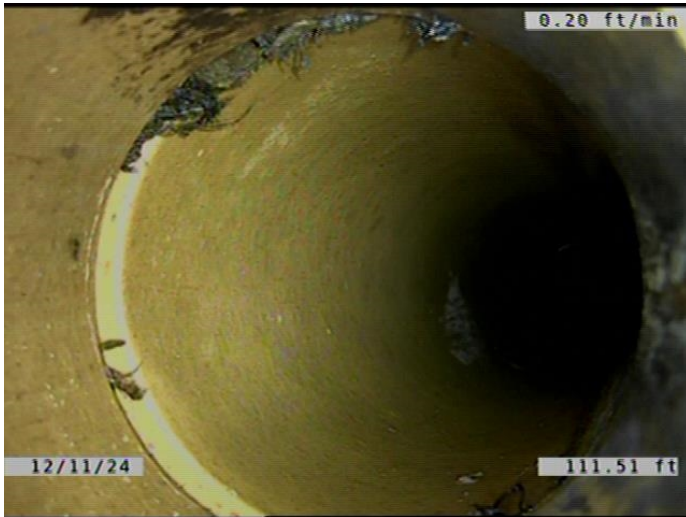
Code:	TBI
Description:	Tap Break-in Intruding
Distance (ft):	111.5
Structural Grade:	0
O&M Grade:	2
Clock Start/From:	2
Clock To:	
1st Value:	6.000
2nd Value:	1.000
Value Percent:	
Continuous Index:	
Within 8" of Joint:	YES
Remarks:	ROOTS GROWING IN THE JOINTS OF THE SERVICE.

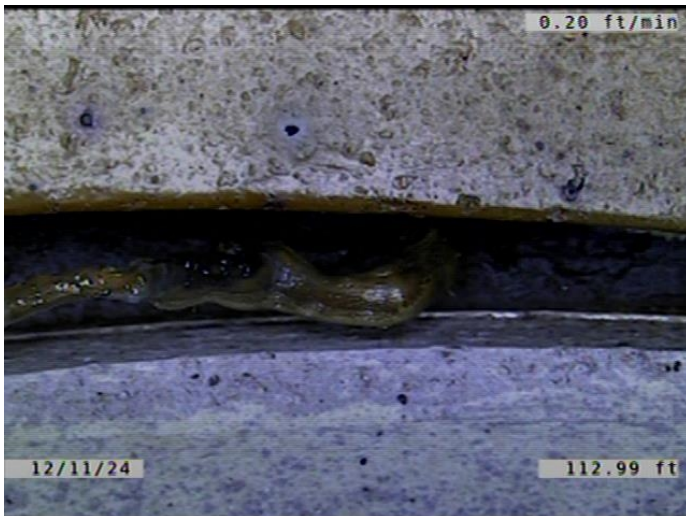
Code:	RFJ
Description:	Roots Fine Joint
Distance (ft):	113.0
Structural Grade:	0
O&M Grade:	1
Clock Start/From:	12
Clock To:	
1st Value:	
2nd Value:	
Value Percent:	
Continuous Index:	
Within 8" of Joint:	YES
Remarks:

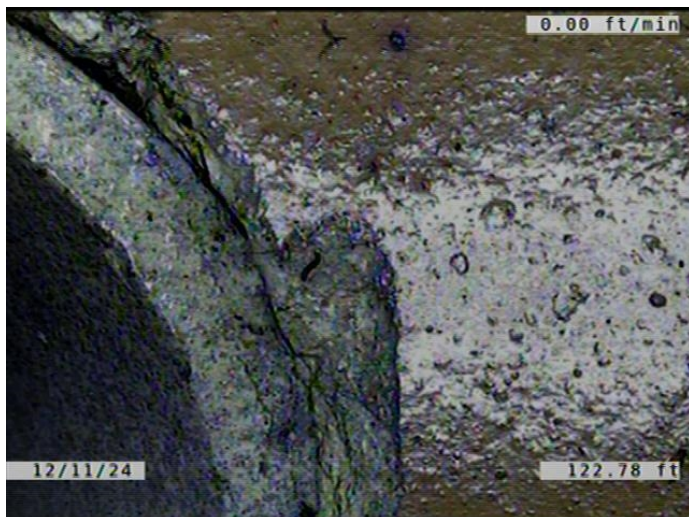
Code: **FM**
 Description: **Fracture Multiple**

Distance (ft): **122.8**
 Structural Grade: **4**
 O&M Grade: **0**
 Clock Start/From: **9**
 Clock To: **12**
 1st Value:
 2nd Value:
 Value Percent:
 Continuous Index:
 Within 8" of Joint: **YES**
 Remarks:

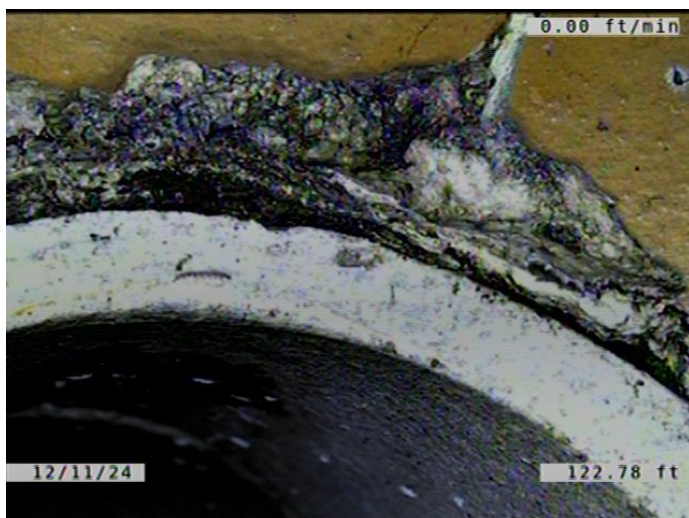
Code: **DAE**
 Description: **Deposits Attached Encrustation**

Distance (ft): **122.8**
 Structural Grade: **0**
 O&M Grade: **2**
 Clock Start/From: **9**
 Clock To: **12**
 1st Value:
 2nd Value:
 Value Percent: **5.000**
 Continuous Index:
 Within 8" of Joint: **YES**
 Remarks:

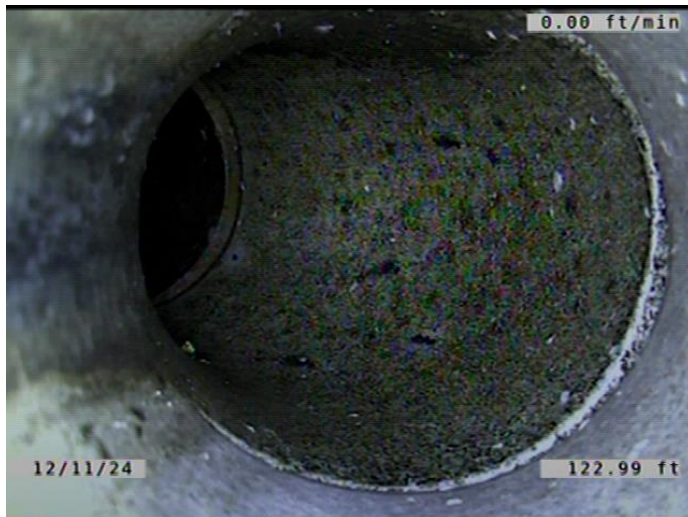
Code: **TBI**
 Description: **Tap Break-in Intruding**

Distance (ft): **123.0**
 Structural Grade: **0**
 O&M Grade: **2**
 Clock Start/From: **10**
 Clock To:
 1st Value: **6.000**
 2nd Value: **1.000**
 Value Percent:
 Continuous Index:
 Within 8" of Joint: **YES**
 Remarks: **ACTIVITY. CONSTANTLY RUNNING WATER.**

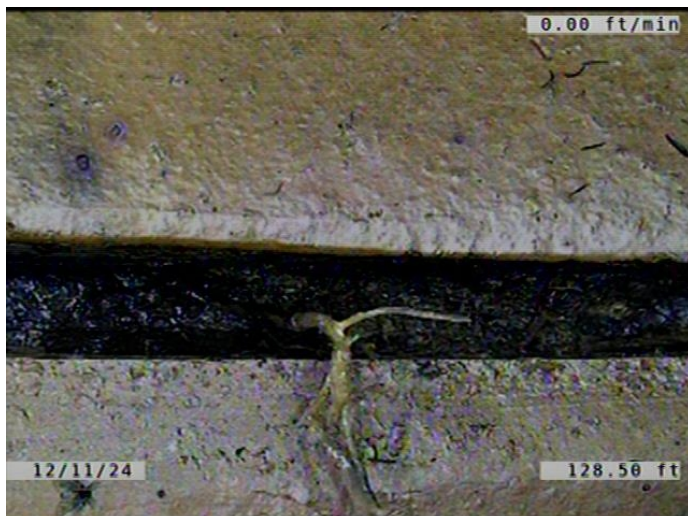
Code: **RFJ**
 Description: **Roots Fine Joint**

Distance (ft): **128.5**
 Structural Grade: **0**
 O&M Grade: **1**
 Clock Start/From: **10**
 Clock To: **11**
 1st Value:
 2nd Value:
 Value Percent:
 Continuous Index:
 Within 8" of Joint: **YES**
 Remarks:

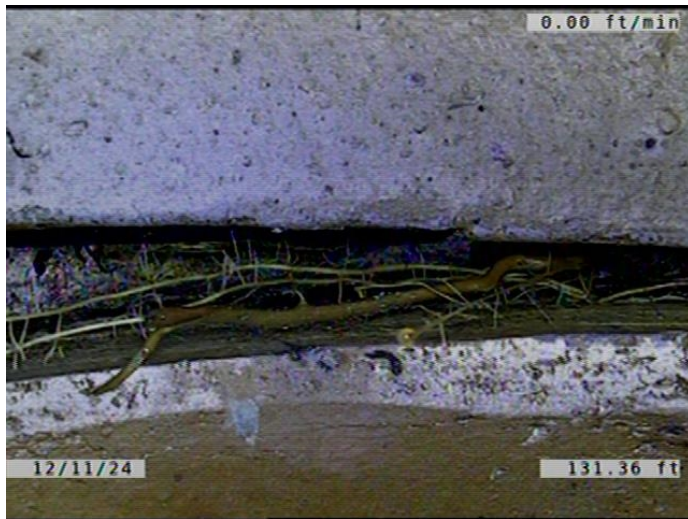
Code: **RFJ**
 Description: **Roots Fine Joint**

Distance (ft): **131.4**
 Structural Grade: **0**
 O&M Grade: **1**
 Clock Start/From: **11**
 Clock To: **1**
 1st Value:
 2nd Value:
 Value Percent:
 Continuous Index:
 Within 8" of Joint: **YES**
 Remarks:

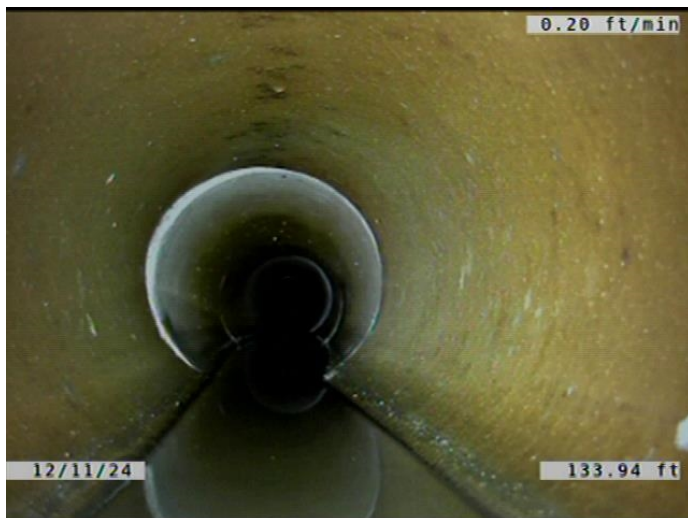
Code: **LL**
 Description: **Line Left**

Distance (ft): **133.9**
 Structural Grade: **0**
 O&M Grade: **1**
 Clock Start/From:
 Clock To:
 1st Value:
 2nd Value:
 Value Percent: **5.000**
 Continuous Index:
 Within 8" of Joint: **NO**
 Remarks:

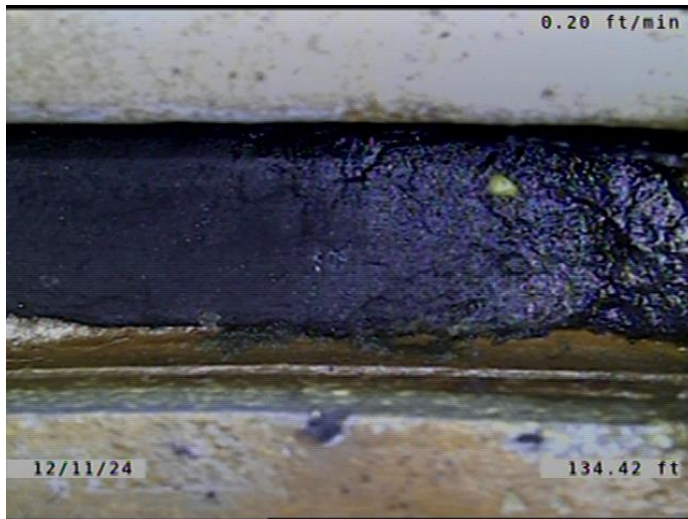
Code: **JAM**
Description: **Joint Angular Medium**

Distance (ft): **134.4**
Structural Grade: **3**
O&M Grade: **0**
Clock Start/From:
Clock To:
1st Value:
2nd Value:
Value Percent:
Continuous Index:
Within 8" of Joint: **NO**
Remarks:

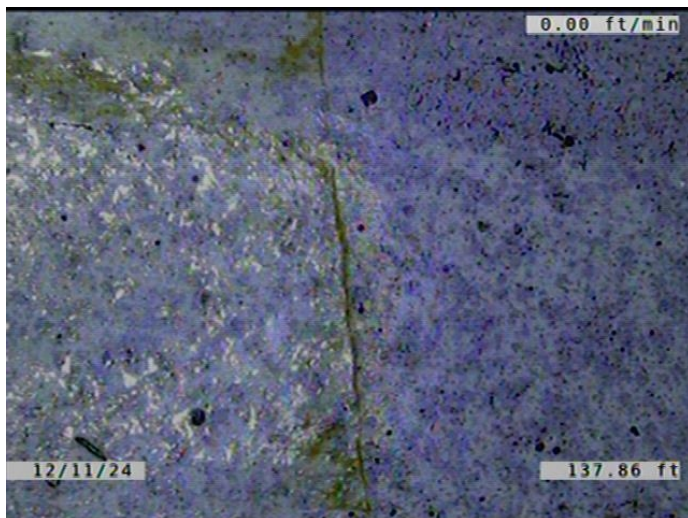
Code: **CL**
Description: **Crack Longitudinal**

Distance (ft): **137.8**
Structural Grade: **2**
O&M Grade: **0**
Clock Start/From: **9**
Clock To:
1st Value:
2nd Value:
Value Percent:
Continuous Index:
Within 8" of Joint: **YES**
Remarks:

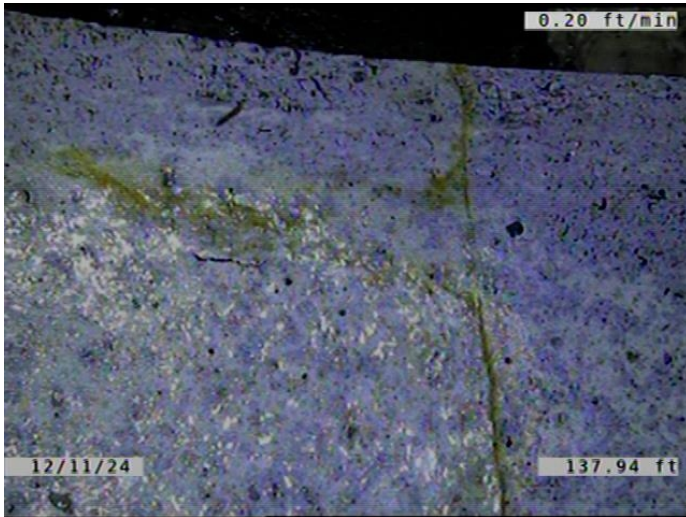
Code: **ISB**
Description: **Infiltration Stain Barrel**

Distance (ft): **137.9**
Structural Grade: **0**
O&M Grade: **1**
Clock Start/From: **7**
Clock To: **9**
1st Value:
2nd Value:
Value Percent:
Continuous Index:
Within 8" of Joint: **YES**
Remarks:

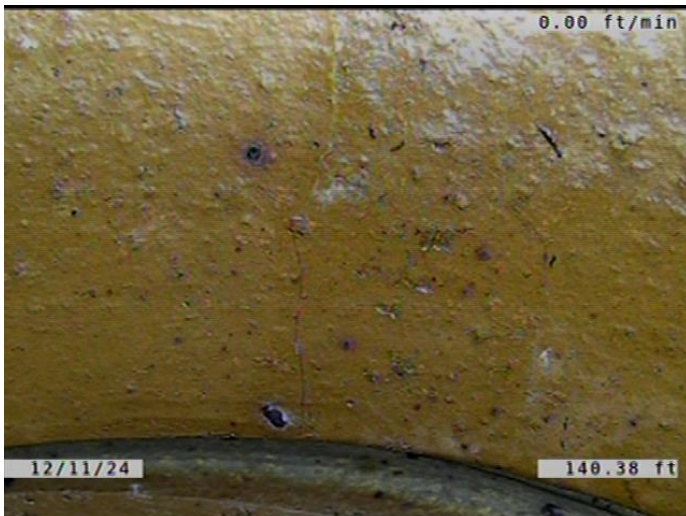
Code: **CL**
Description: **Crack Longitudinal**

Distance (ft): **140.4**
Structural Grade: **2**
O&M Grade: **0**
Clock Start/From: **2**
Clock To:
1st Value:
2nd Value:
Value Percent:
Continuous Index:
Within 8" of Joint: **YES**
Remarks:

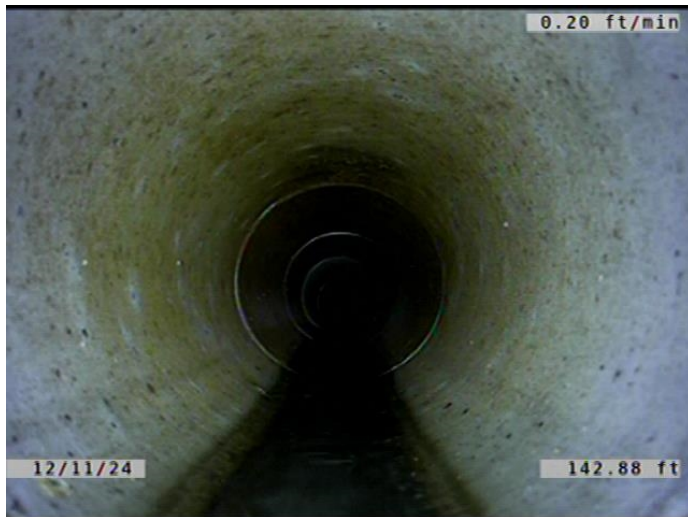
Code: **MWLS**
Description: **Miscellaneous Water Level Sag**

Distance (ft): **142.9**
Structural Grade: **2**
O&M Grade: **0**
Clock Start/From:
Clock To:
1st Value:
2nd Value:
Value Percent: **15.000**
Continuous Index: **F03**
Within 8" of Joint: **NO**
Remarks:

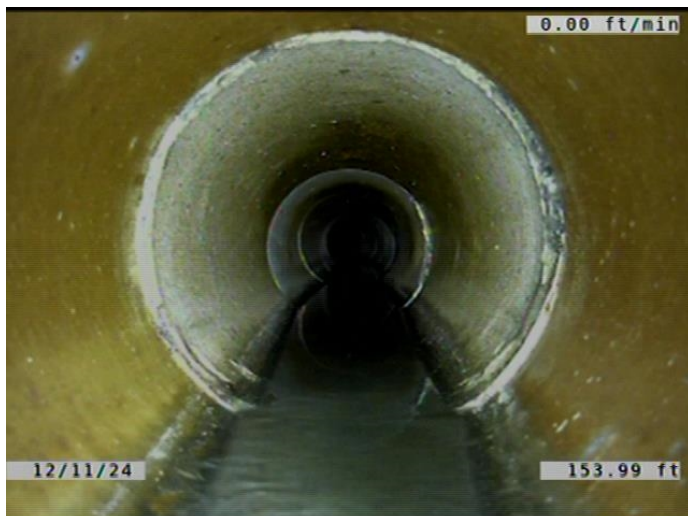
Code: **MWLS**
Description: **Miscellaneous Water Level Sag**

Distance (ft): **154.0**
Structural Grade: **2**
O&M Grade: **0**
Clock Start/From:
Clock To:
1st Value:
2nd Value:
Value Percent: **10.000**
Continuous Index: **S04**
Within 8" of Joint: **NO**
Remarks:

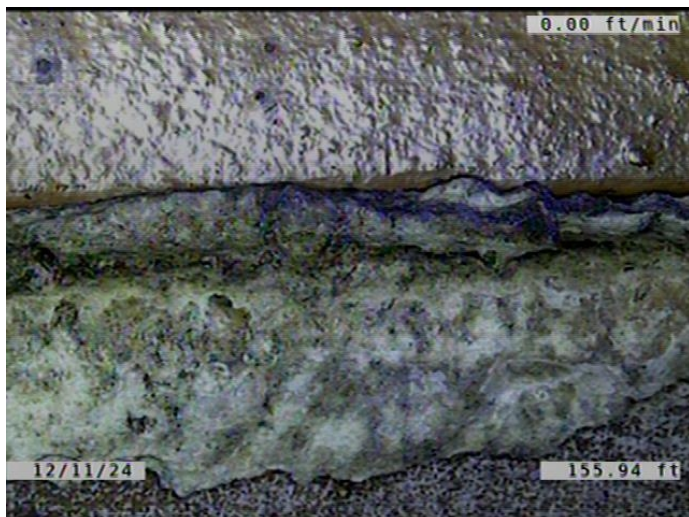
Code: **DAE**
 Description: **Deposits Attached Encrustation**

Distance (ft): **155.9**
 Structural Grade: **0**
 O&M Grade: **2**
 Clock Start/From: **7**
 Clock To: **5**
 1st Value:
 2nd Value:
 Value Percent: **5.000**
 Continuous Index: **S05**
 Within 8" of Joint: **YES**
 Remarks:

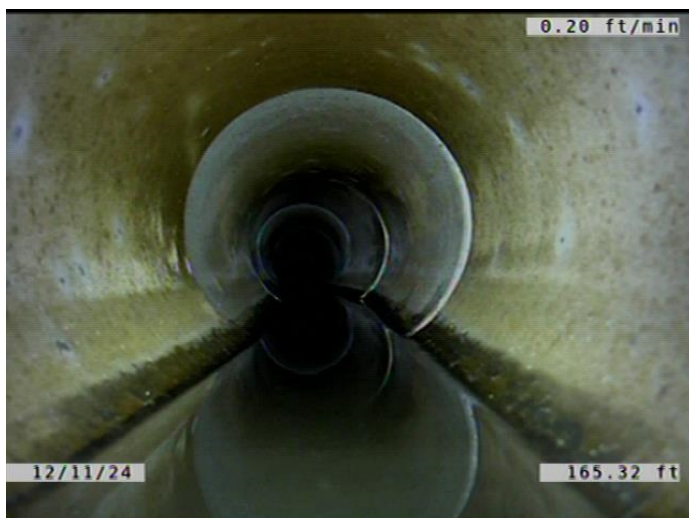
Code: **DAE**
 Description: **Deposits Attached Encrustation**

Distance (ft): **165.3**
 Structural Grade: **0**
 O&M Grade: **2**
 Clock Start/From: **7**
 Clock To: **5**
 1st Value:
 2nd Value:
 Value Percent: **5.000**
 Continuous Index: **F05**
 Within 8" of Joint: **YES**
 Remarks:

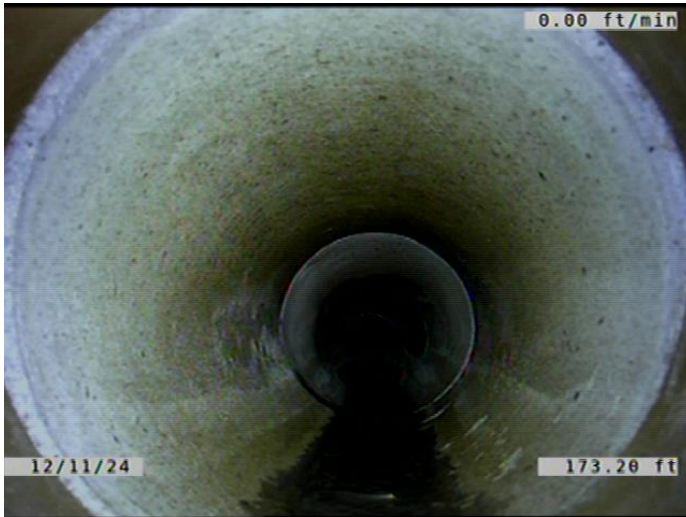
Code: **MWLS**
Description: **Miscellaneous Water Level Sag**

Distance (ft): **173.2**
Structural Grade: **2**
O&M Grade: **0**
Clock Start/From:
Clock To:
1st Value:
2nd Value:
Value Percent: **10.000**
Continuous Index: **F04**
Within 8" of Joint: **NO**
Remarks:

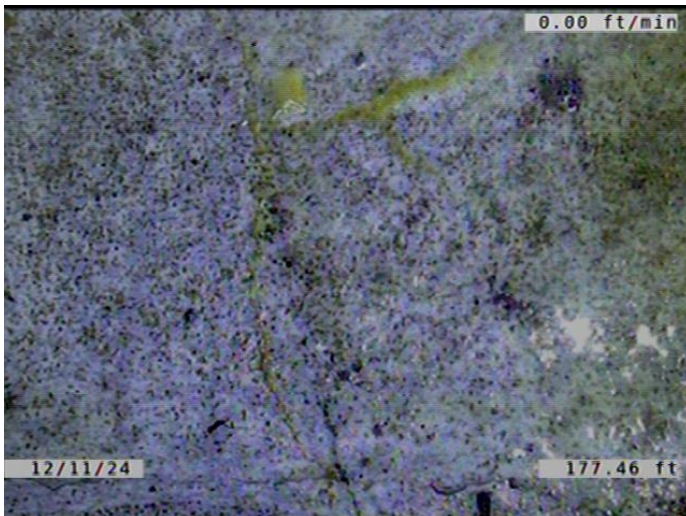
Code: **CM**
Description: **Crack Multiple**

Distance (ft): **177.4**
Structural Grade: **3**
O&M Grade: **0**
Clock Start/From: **7**
Clock To: **9**
1st Value:
2nd Value:
Value Percent:
Continuous Index:
Within 8" of Joint: **YES**
Remarks:

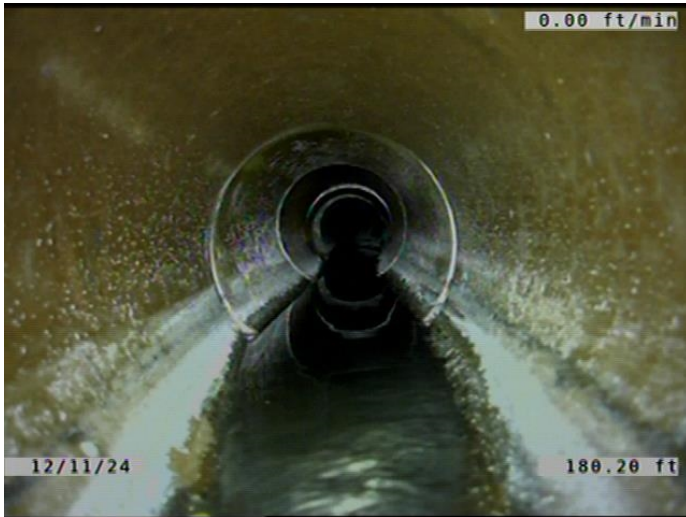
Code: **MWLS**
Description: **Miscellaneous Water Level Sag**

Distance (ft): **180.2**
Structural Grade: **2**
O&M Grade: **0**
Clock Start/From:
Clock To:
1st Value:
2nd Value:
Value Percent: **10.000**
Continuous Index: **S06**
Within 8" of Joint: **NO**
Remarks:

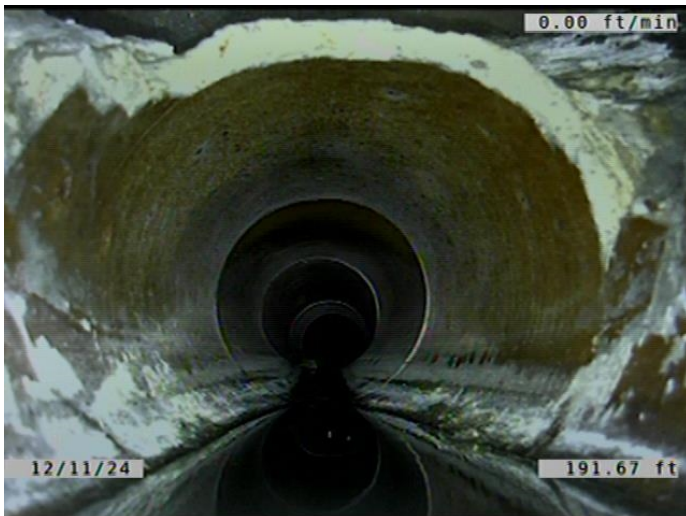
Code: **MWLS**
Description: **Miscellaneous Water Level Sag**

Distance (ft): **191.7**
Structural Grade: **2**
O&M Grade: **0**
Clock Start/From:
Clock To:
1st Value:
2nd Value:
Value Percent: **10.000**
Continuous Index: **F06**
Within 8" of Joint: **NO**
Remarks:
